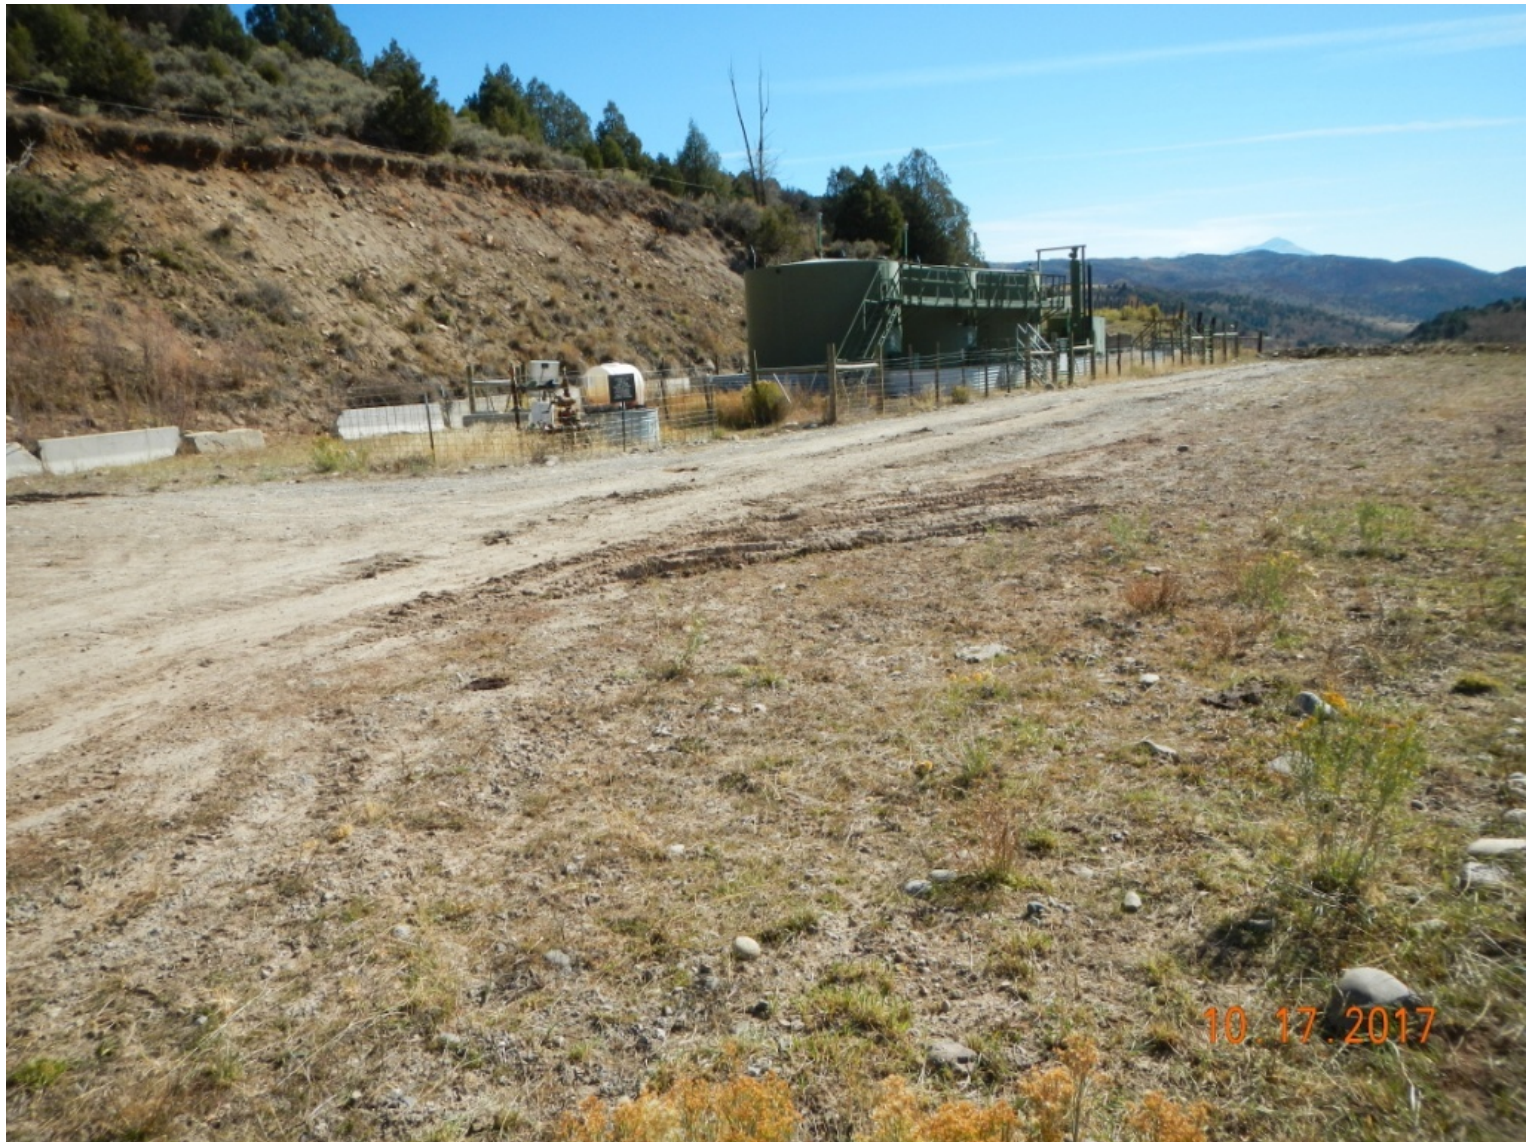
Photo 1. View of the project area from the northwestern corner of the working area facing center.

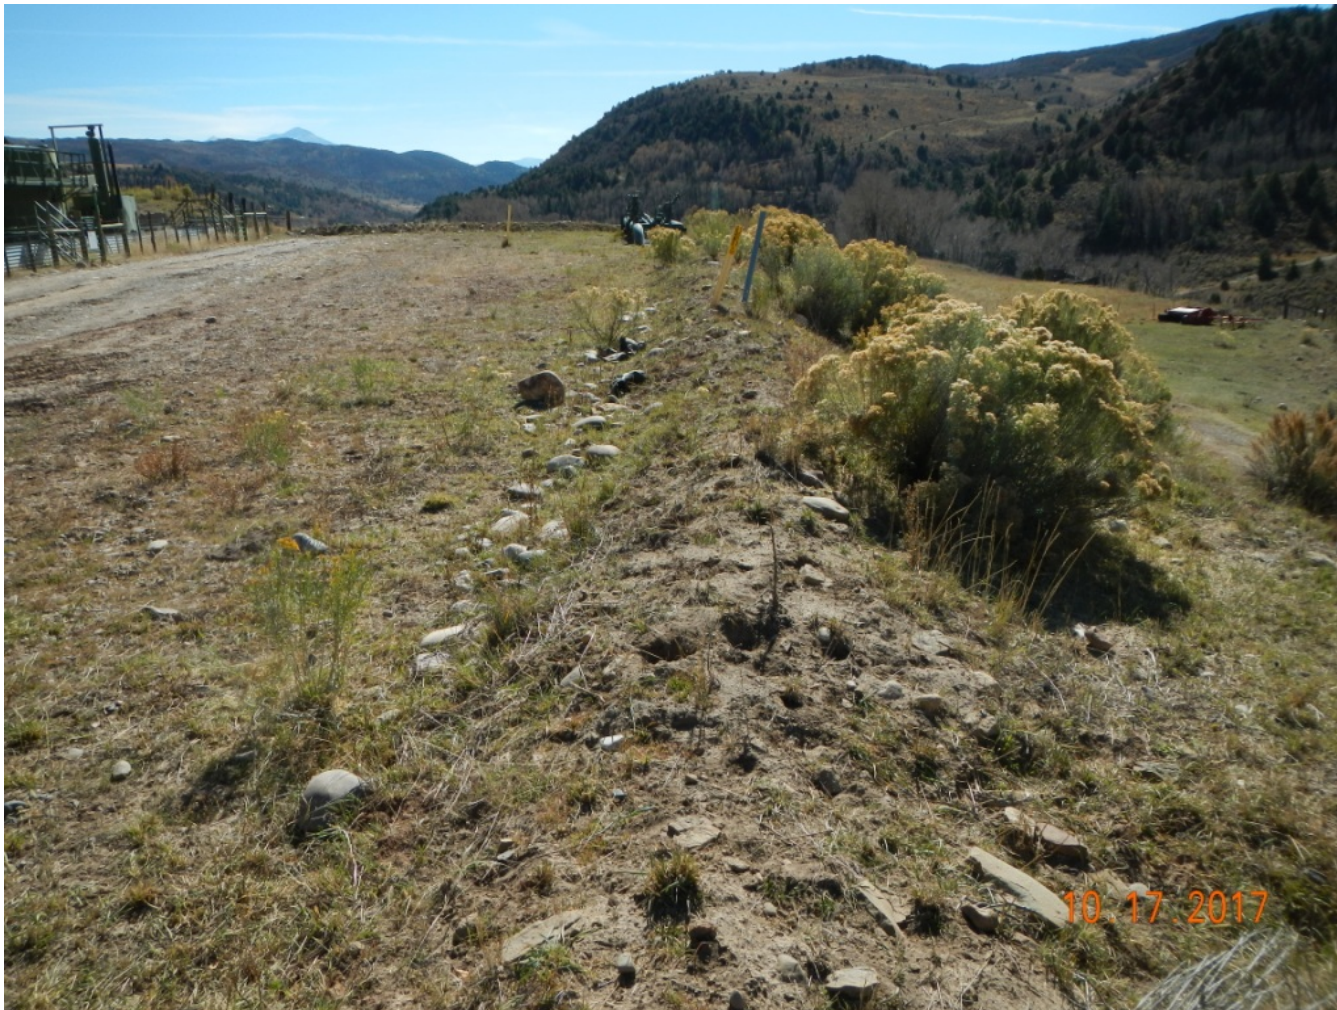
Photo 2. View of the western portion of the project area from the northwestern corner of the working area facing southward. Revegetation is largely comprised of grazed grasses and rubber rabbitbrush (*Chrysothamnus nauseosus*).

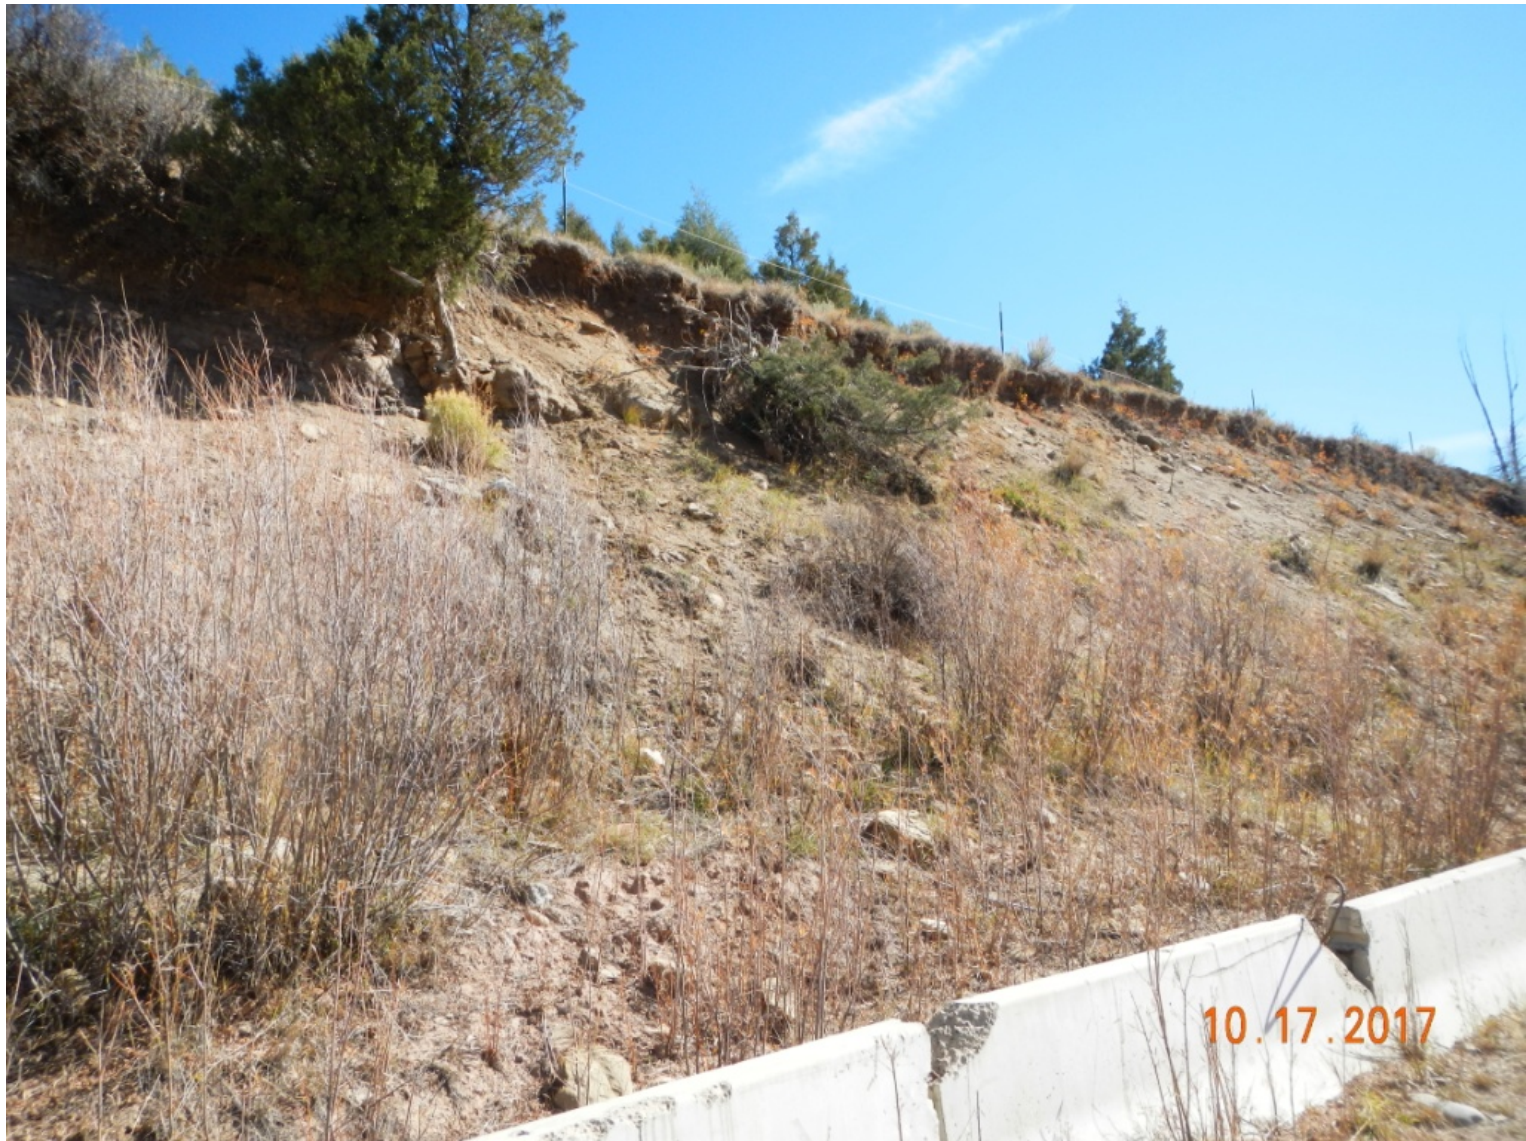
Photo 3. View of the eastern cut-slope. The slope is not stabilized, as evidenced by overhanging vegetation at the top of the slope, and fallen pinyon tree, where eroding soil is exposing roots and resulting in sloughing.

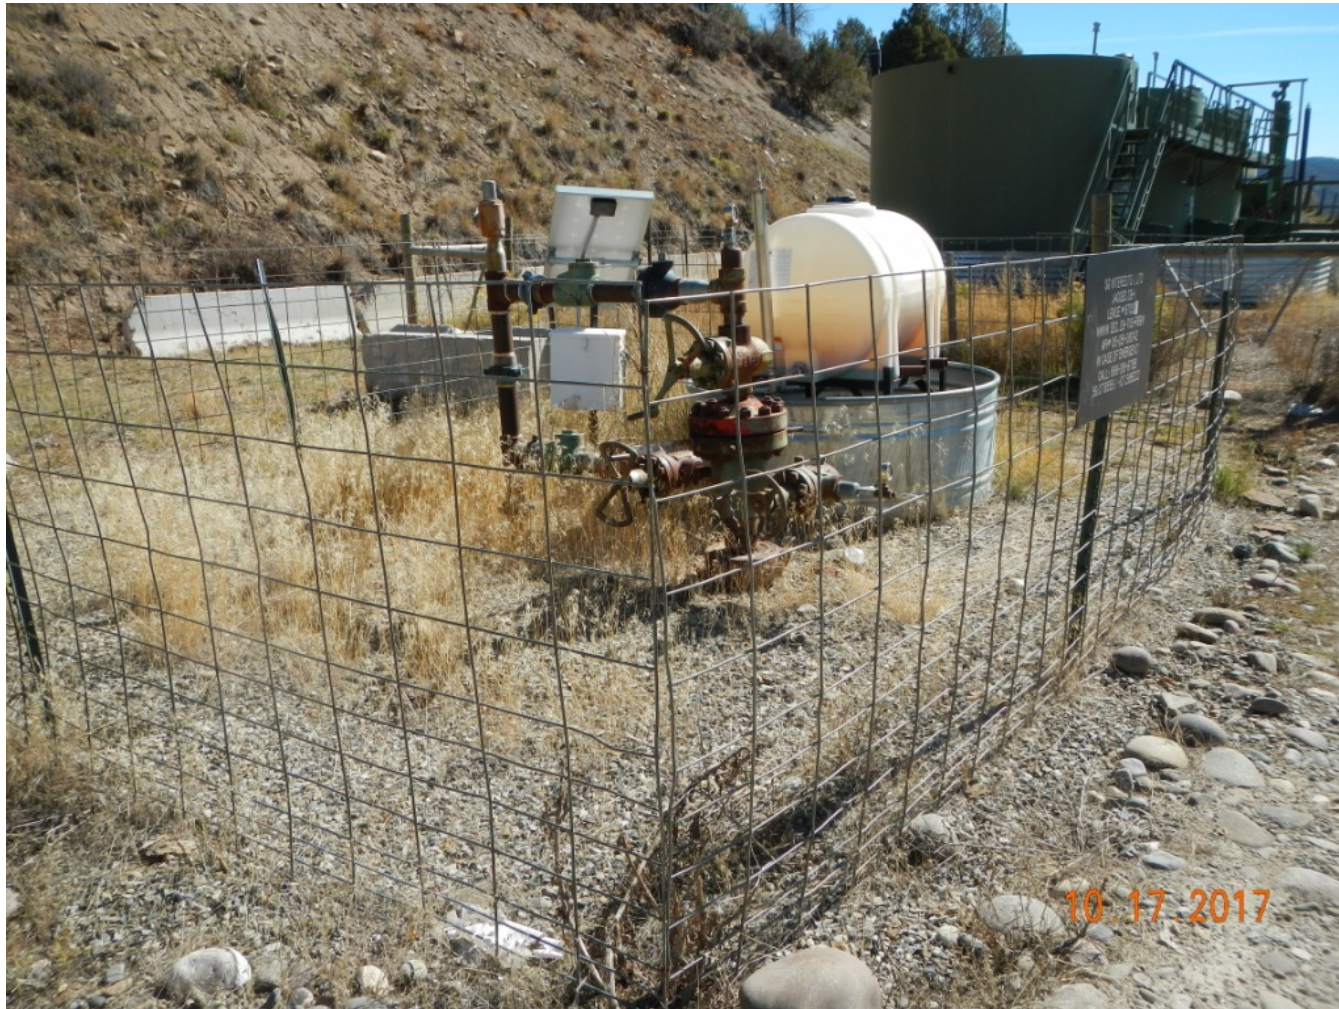
Photo 4. View of weeds around equipment that need to be removed.
