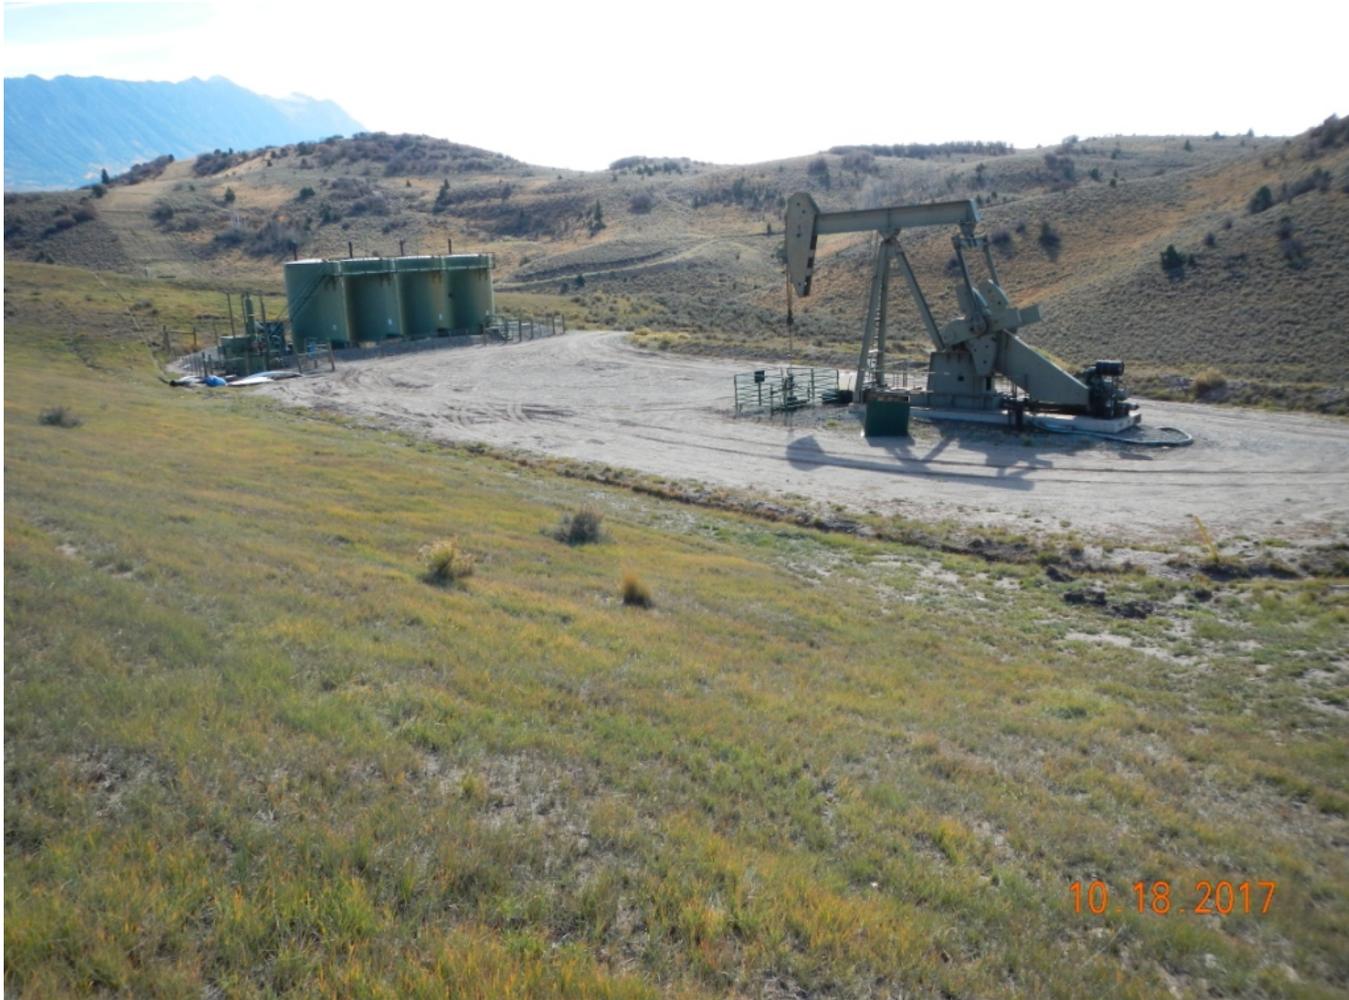
Photo 1. View of the project area from the northwestern corner of the project area facing center.

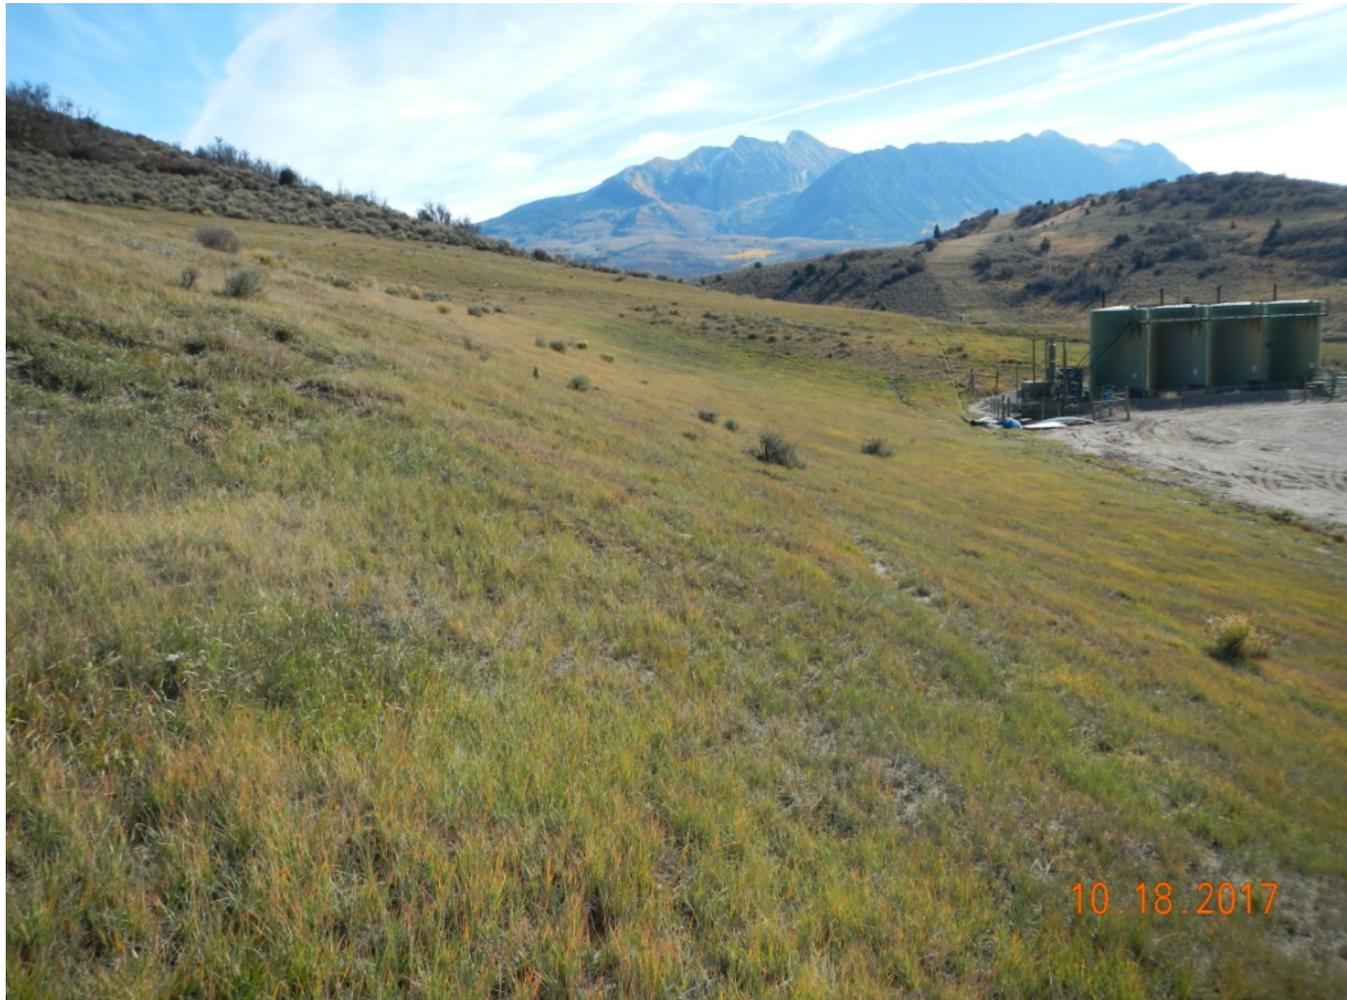
Photo 2. View of the northern portion of the project area from the northwestern corner of the working area facing eastward. Revegetation is well established with grasses such as western wheatgrass (*Pascopyrum smithii*), and brome grass (*Bromus* sp.).

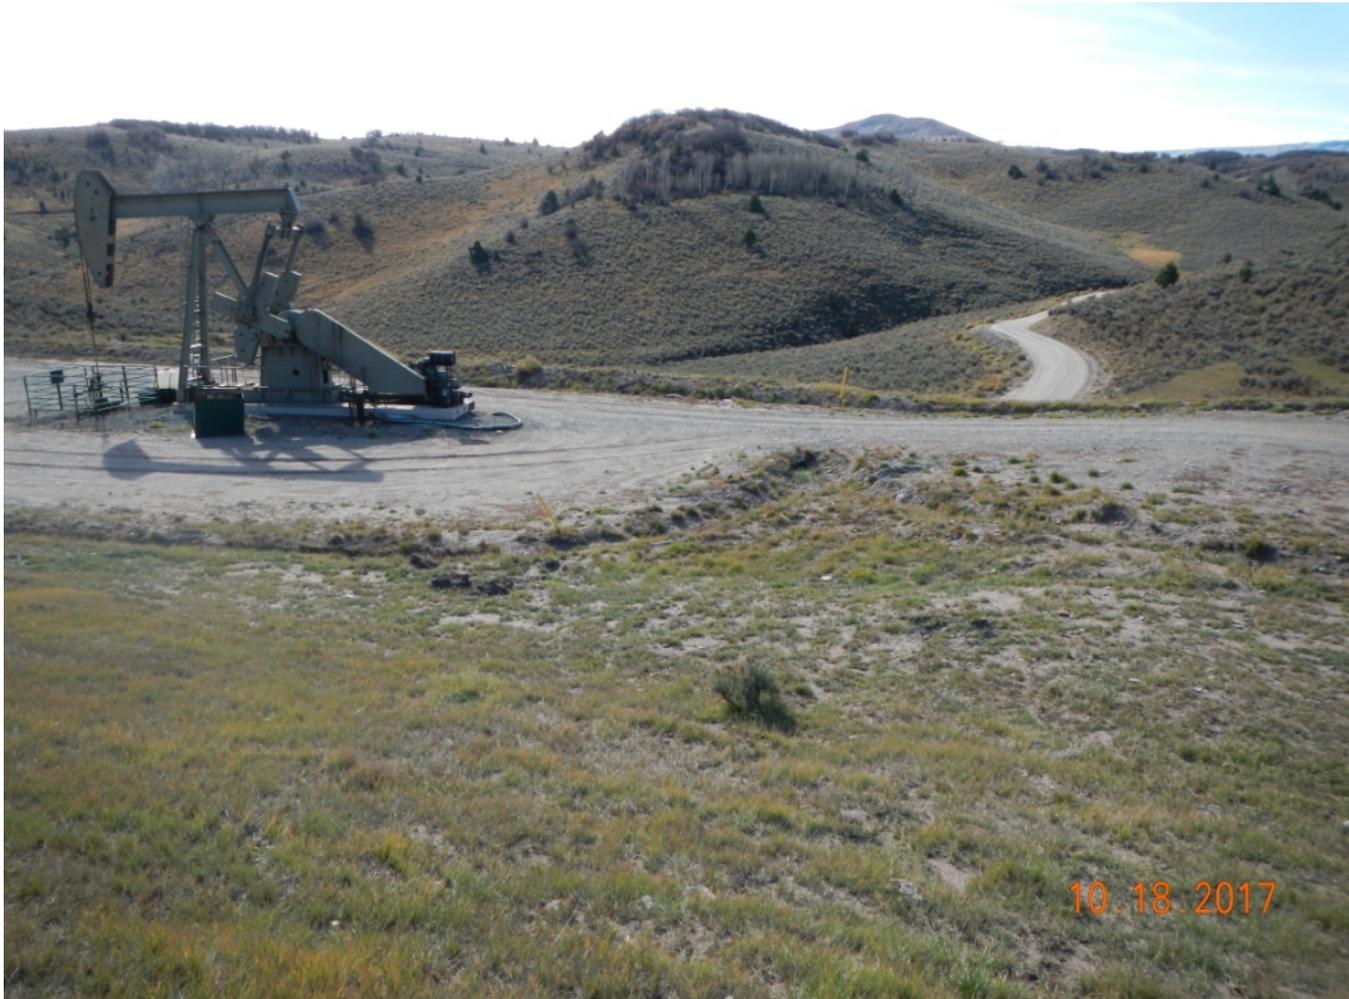
Photo 3. View of the western portion of the project area from the northwestern corner of the working area facing southward.

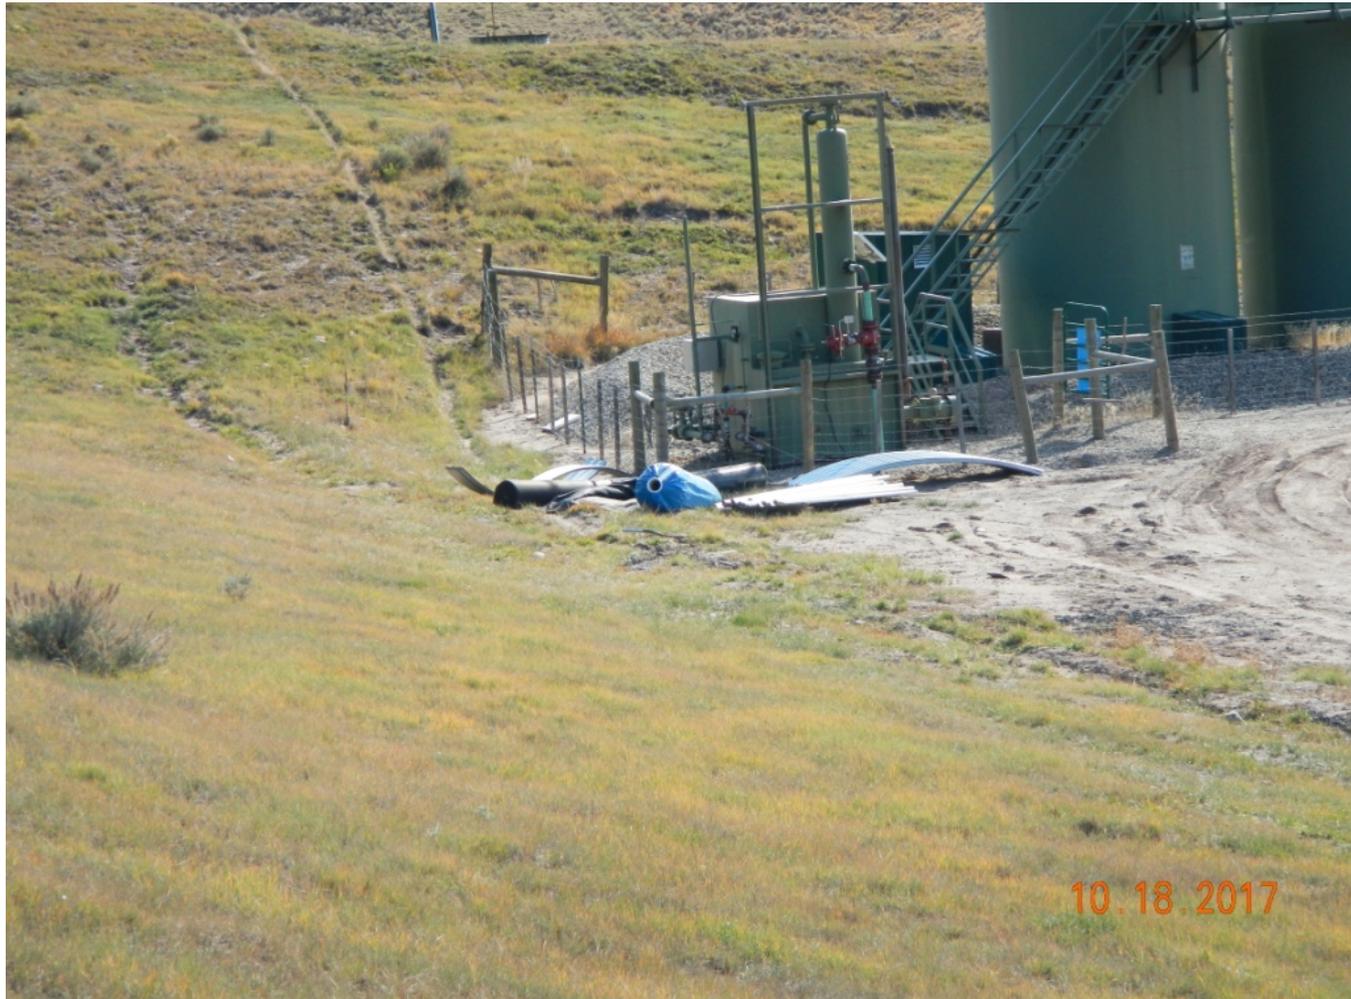
Photo 4. View of unused equipment and debris within the northeastern corner of the working area.

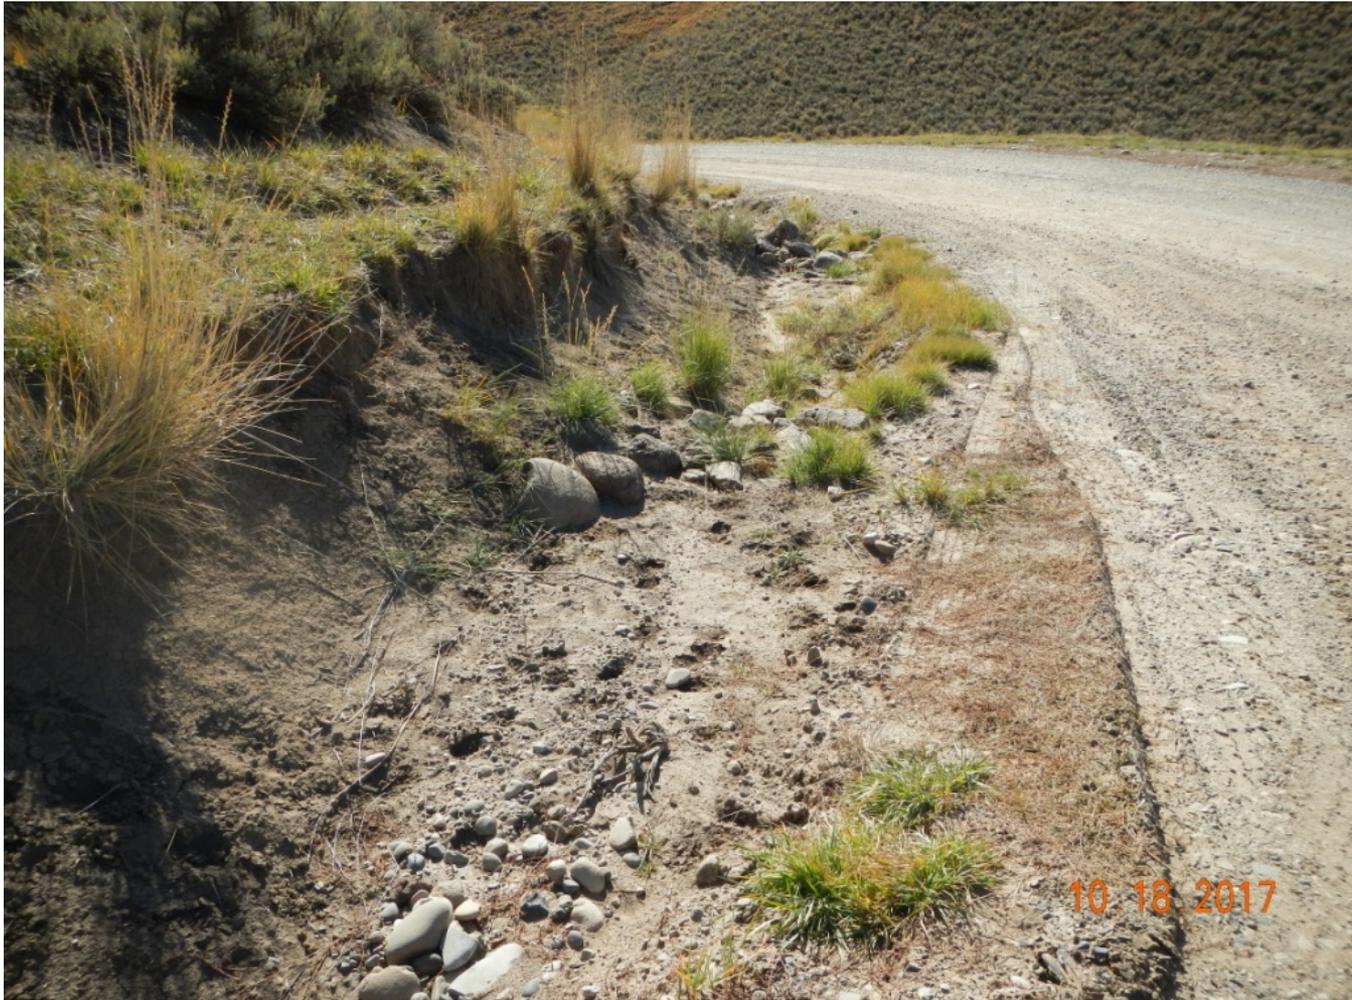
Photo 5. View of rock check dams along the access road that are full of sediment and need maintenance.

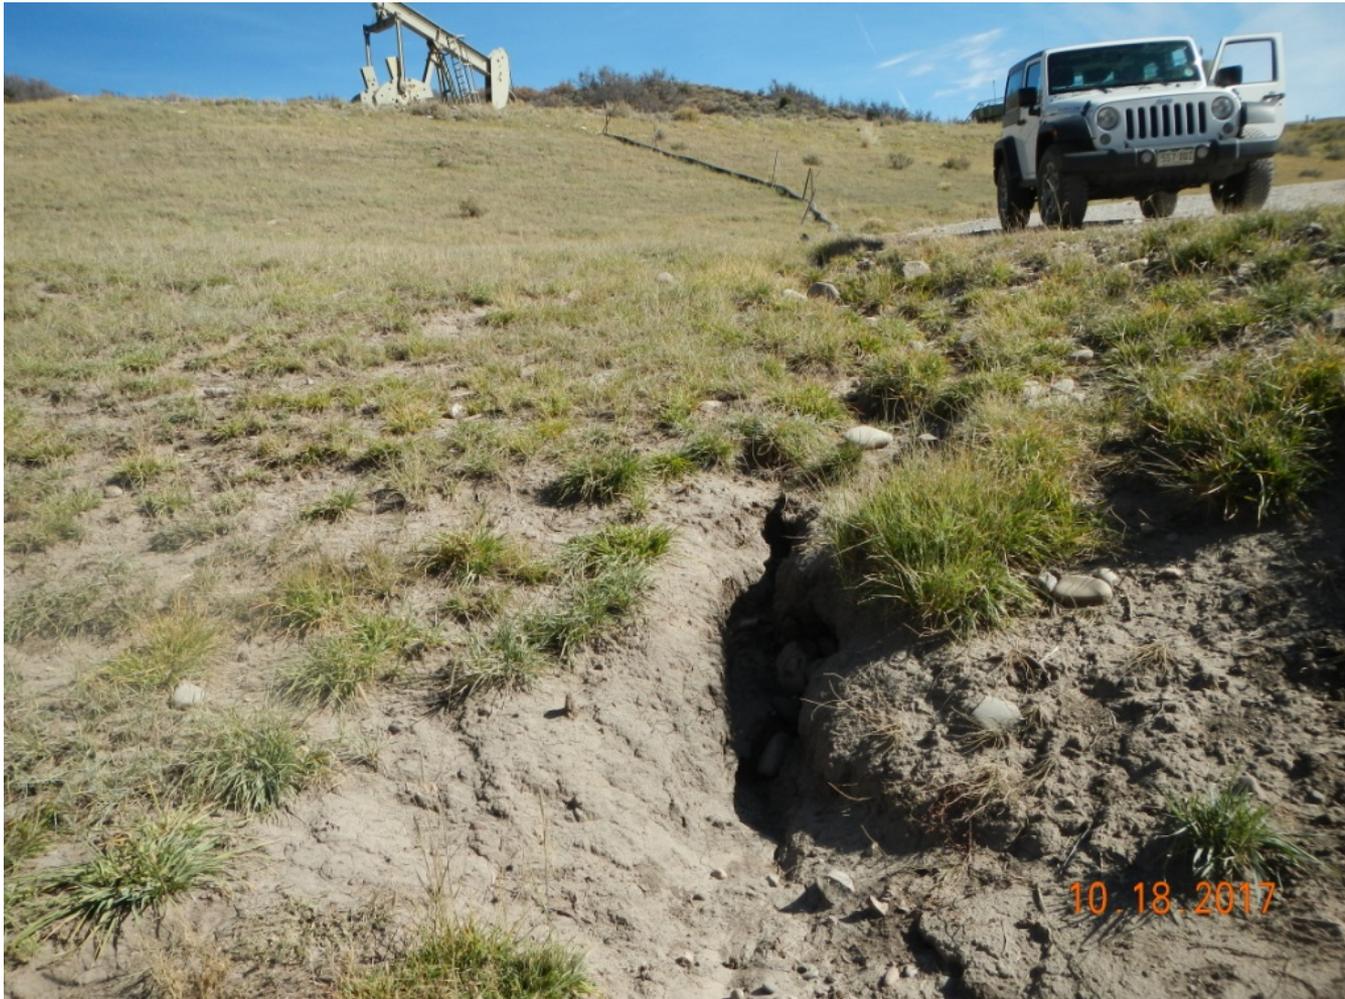
Photo 6. View of erosion that is occurring where concentrated stormwater exits a black pipe diversion from the southeastern edge of the well pad to a silt trap that is located upstream from a culvert adjacent to the lease road.
