Inspection Photos
Location Name: Wickstrom #6-5
API: 05-123-21315
Inspection Date: October 17, 2017

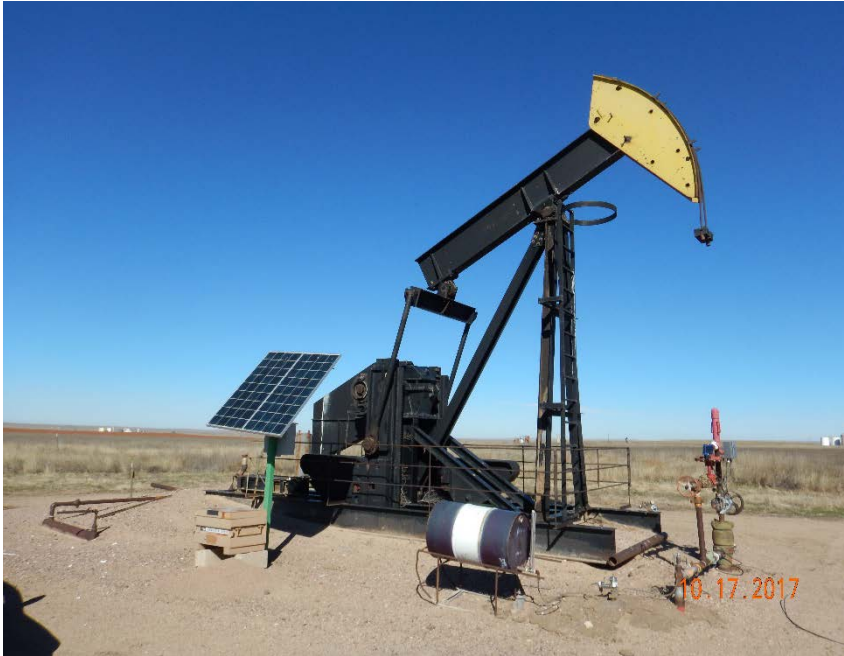
Photo #1 – View of wellhead and pump jack from south.

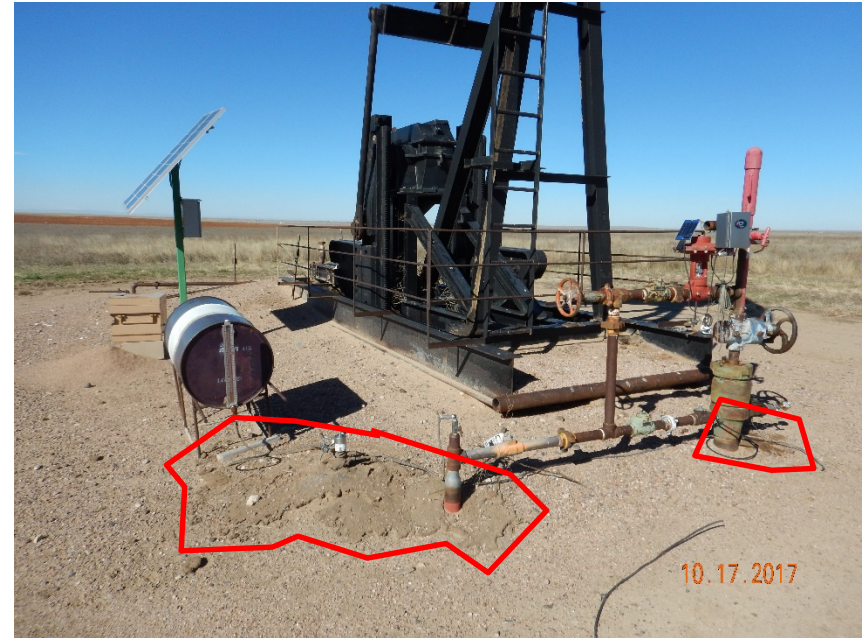
Photo #2 – Historical accumulations of oil-stained soil beneath wellhead, day tank, and flowline riser at SE corner of pump jack. Note: day tank lacking secondary containment device.

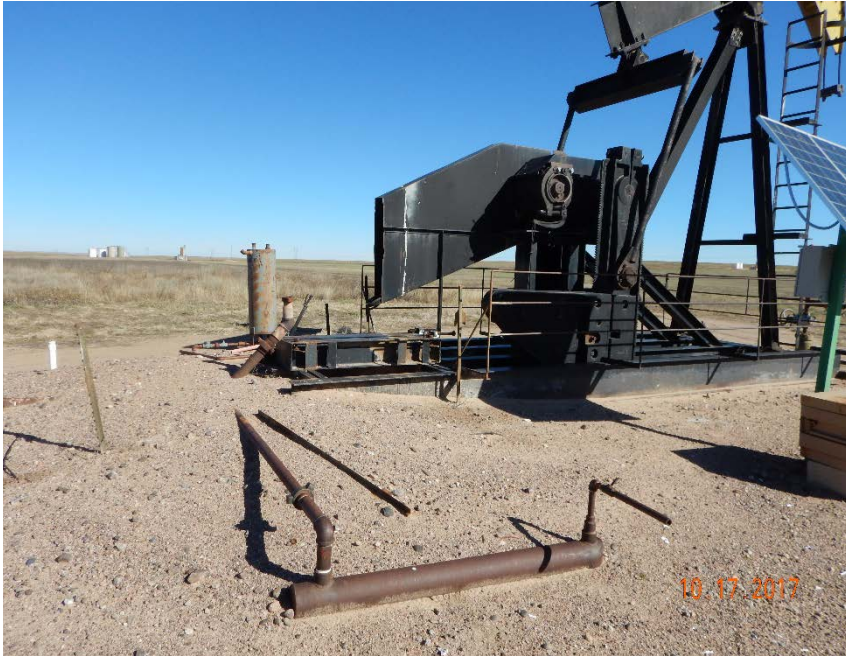
Photo #3 – Disassembled pump jack suggests that well may be incapable of production, although well is equipped with a plunger lift.

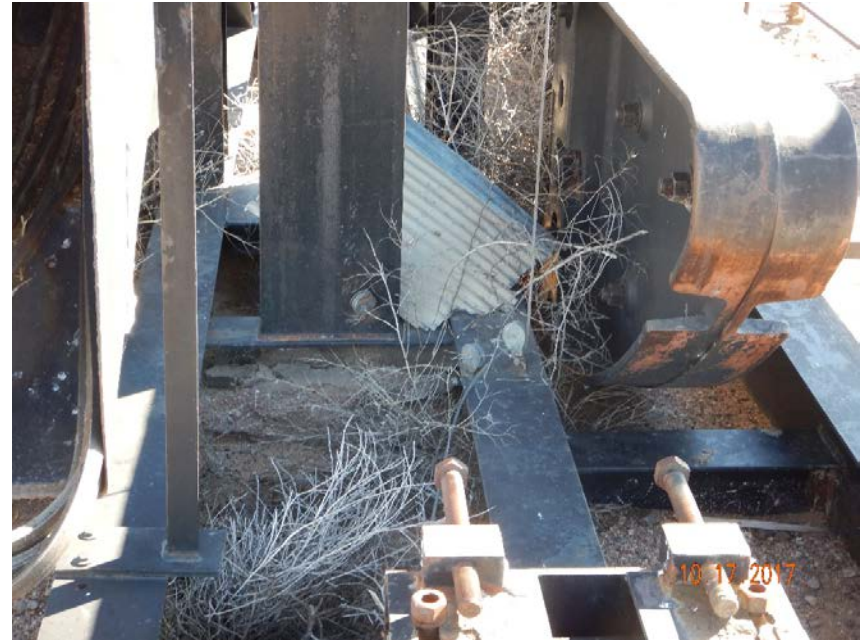
Photo #4 – Accumulation of debris and wind-blown weeds beneath pump jack.

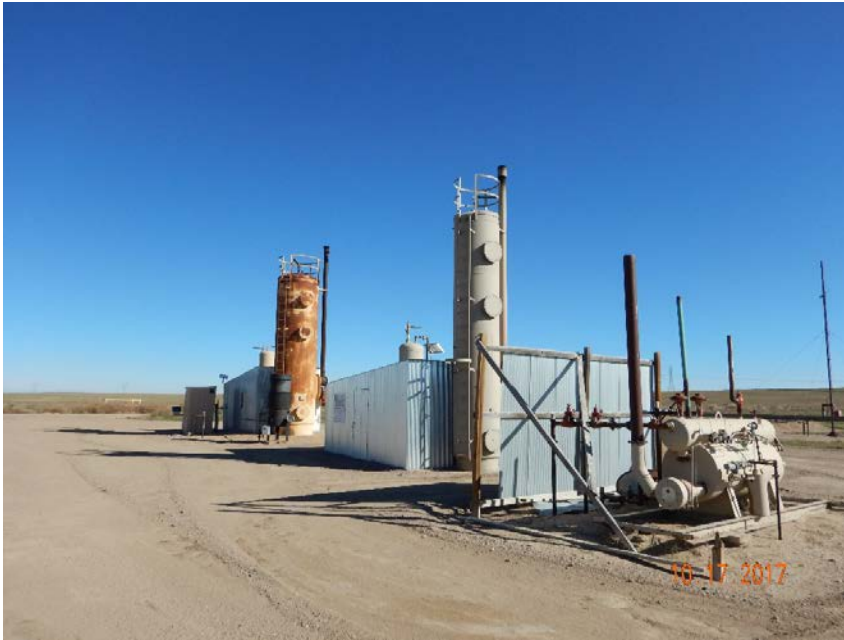
Photo #5 – View of unused horizontal treater and treater/separator sheds from SW corner.

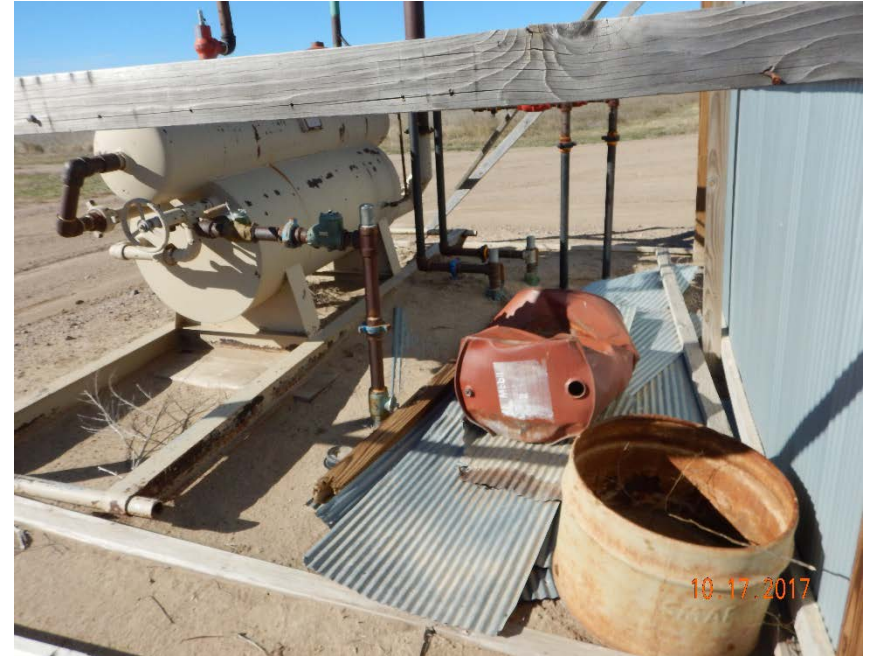
Photo #6 – Junk/debris at former treater shed.

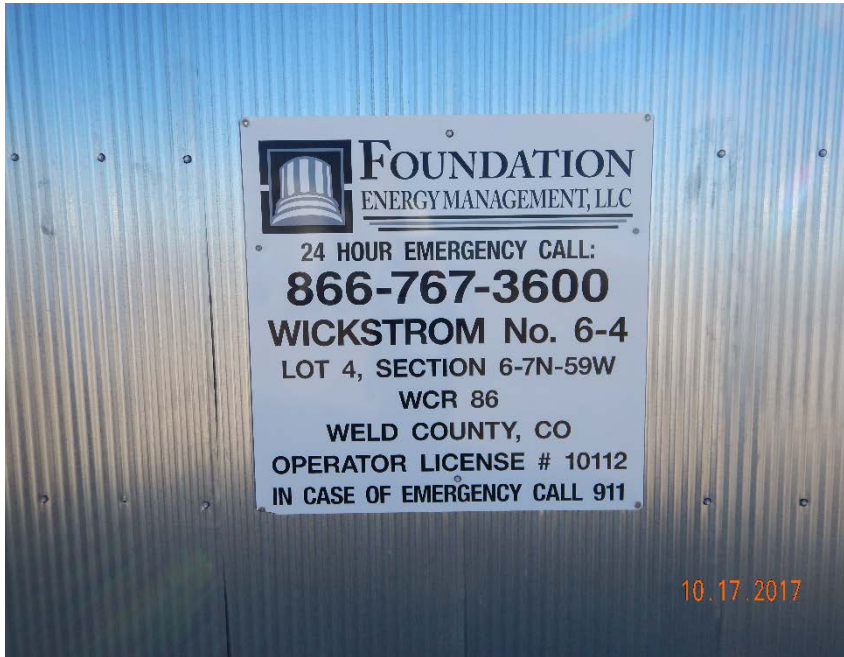
Photo #7 – Sign for Wickstrom #6-4 attached to corresponding treater/separator shed.

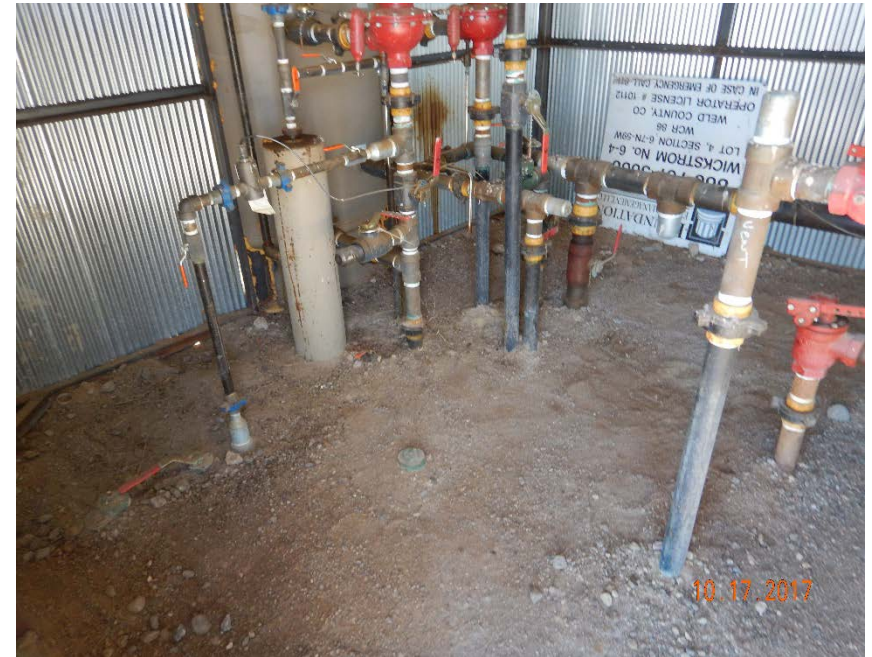
Photo #8 – Satisfactory conditions at Wickstrom #6-4 vertical separator.

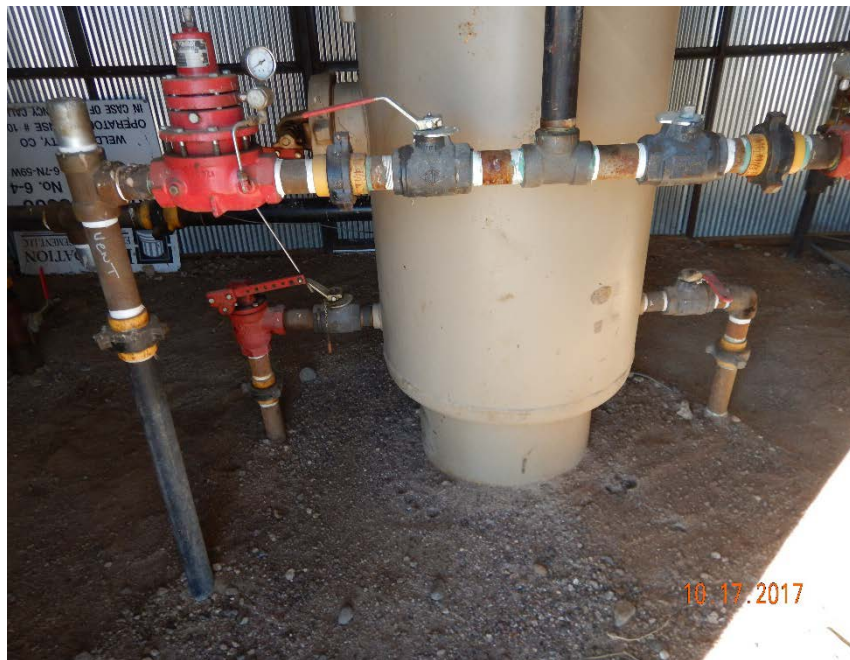
Photo #9 - Satisfactory conditions at Wickstrom #6-4 vertical treater.

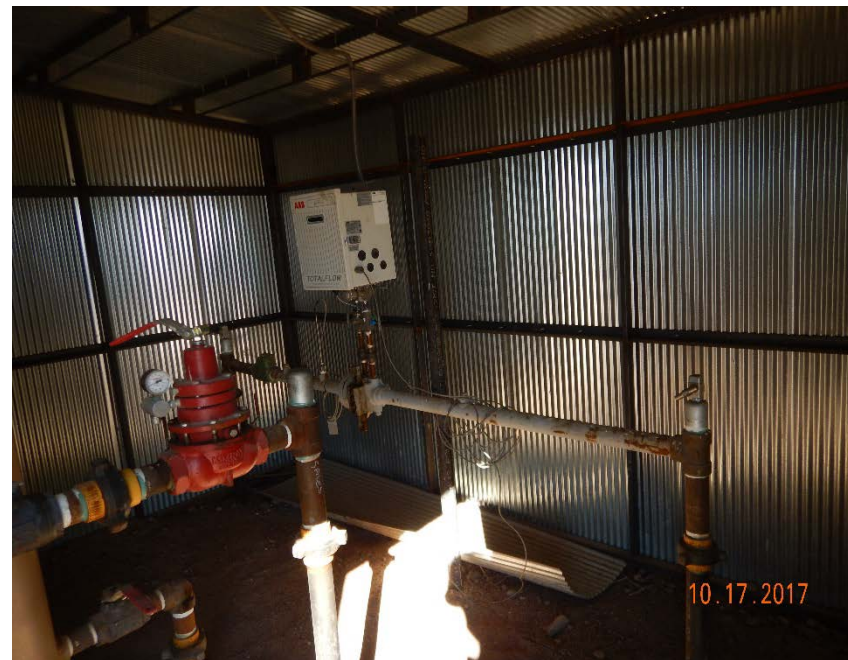
Photo #10 - Satisfactory conditions at Wickstrom #6-4 gas meter.

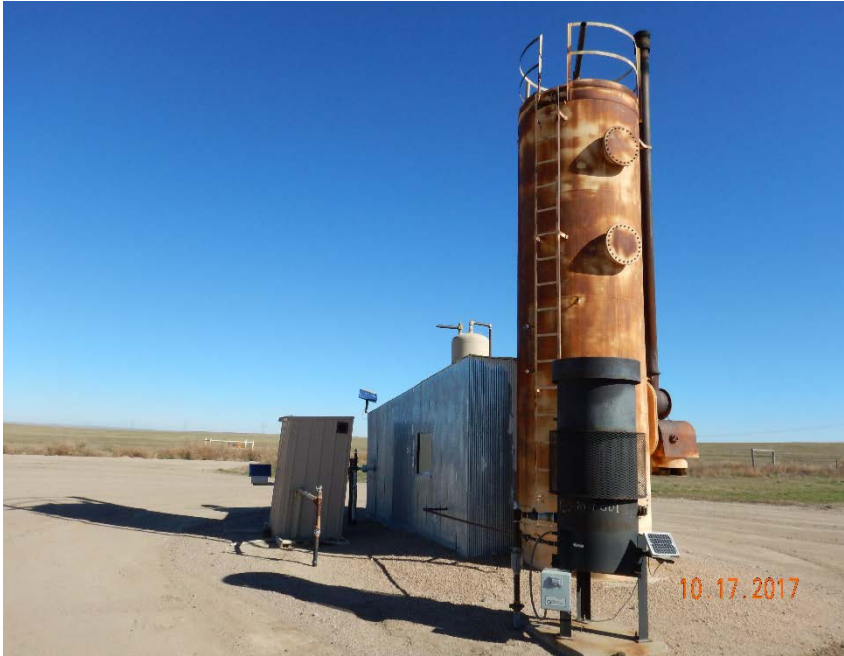
Photo #11 – View of Wickstrom #6-5 treater/separator shed with gas meter to west and ECD to south.

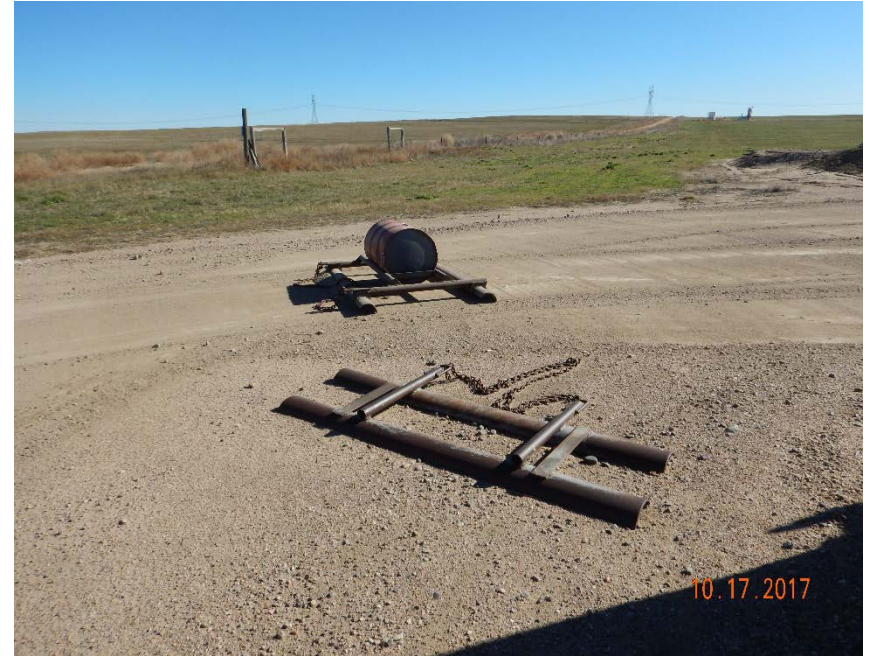
Photo #12 – Drag sleds stored NE of Wickstrom #6-5 treater/separator shed.

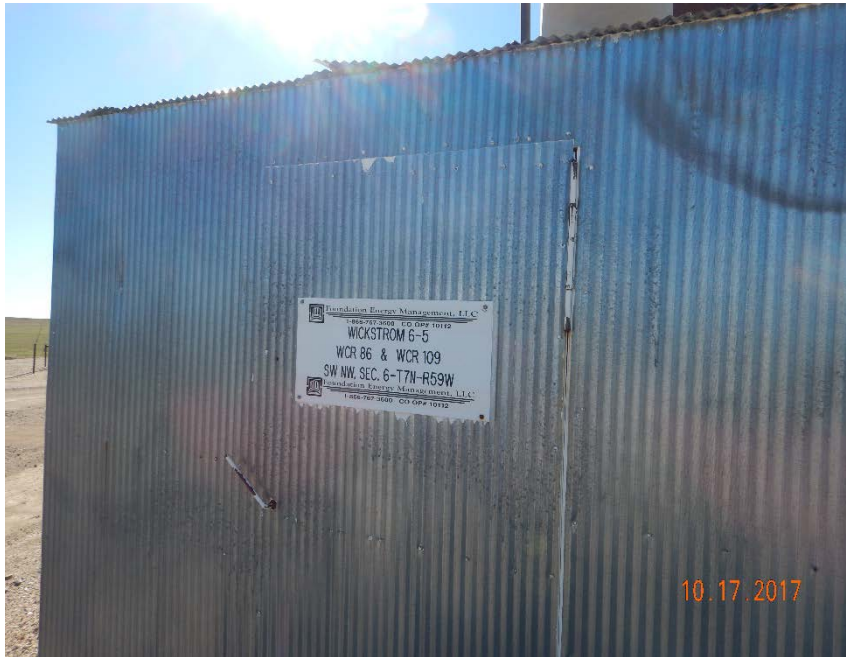
Photo #13 – Sign attached to Wickstrom #6-5 treater/separator shed.

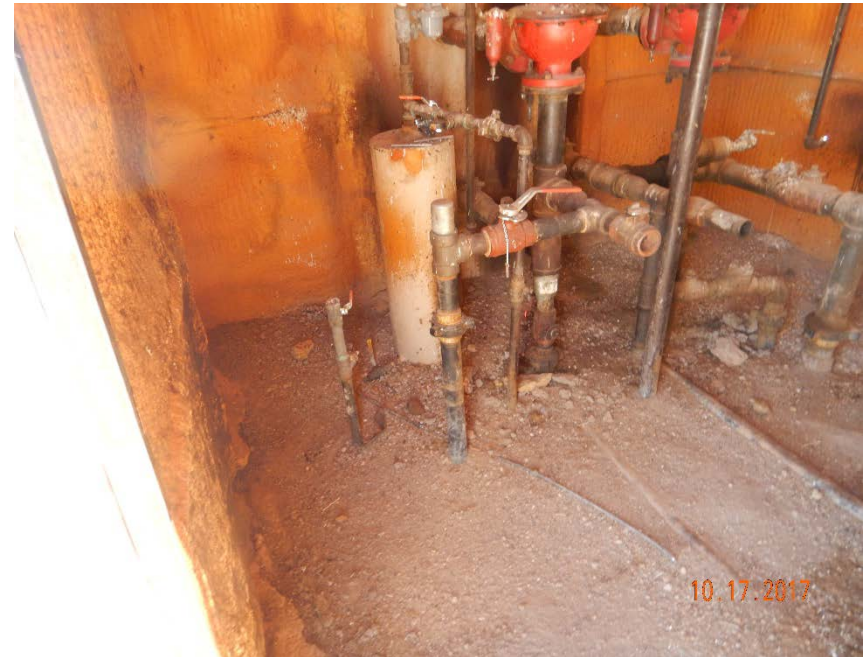
Photo #14 – Localized, historical accumulations of oily waste inside of Wickstrom #6-5 treater/separator shed (1).

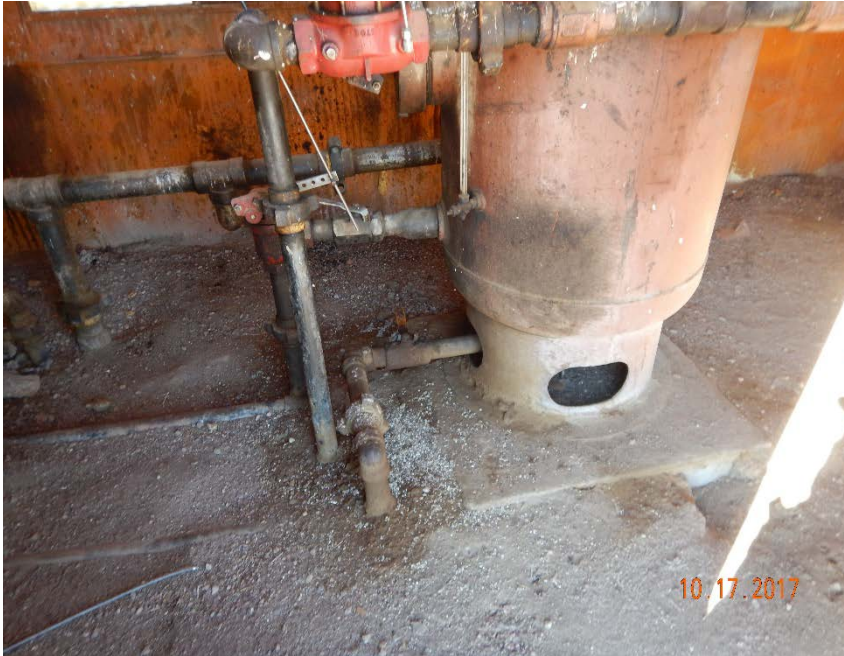
Photo #15 - Localized, historical accumulations of oily waste inside of Wickstrom #6-5 treater/separator shed (2).

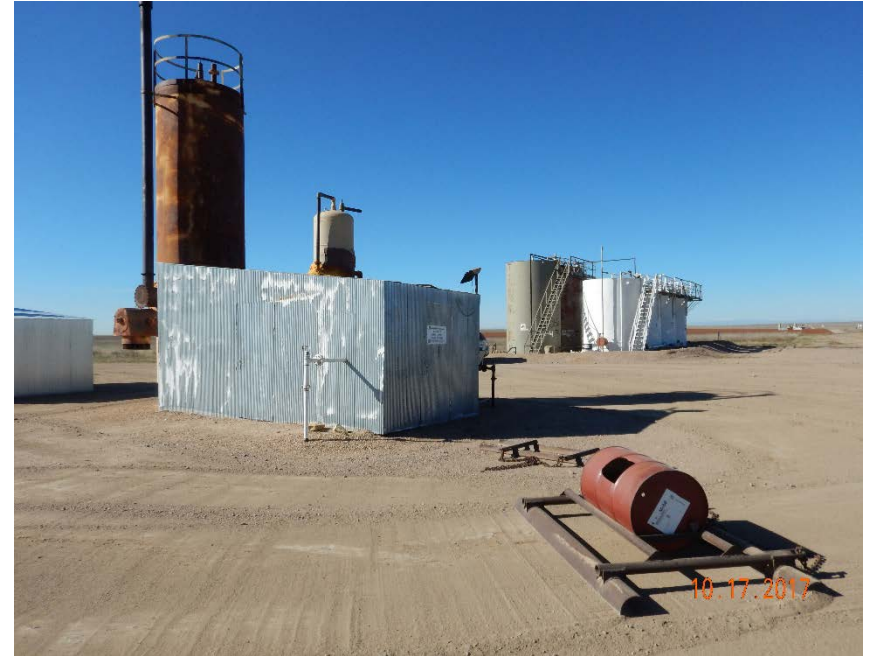
Photo #16 – View of crude oil tank battery west of treater/separator sheds.

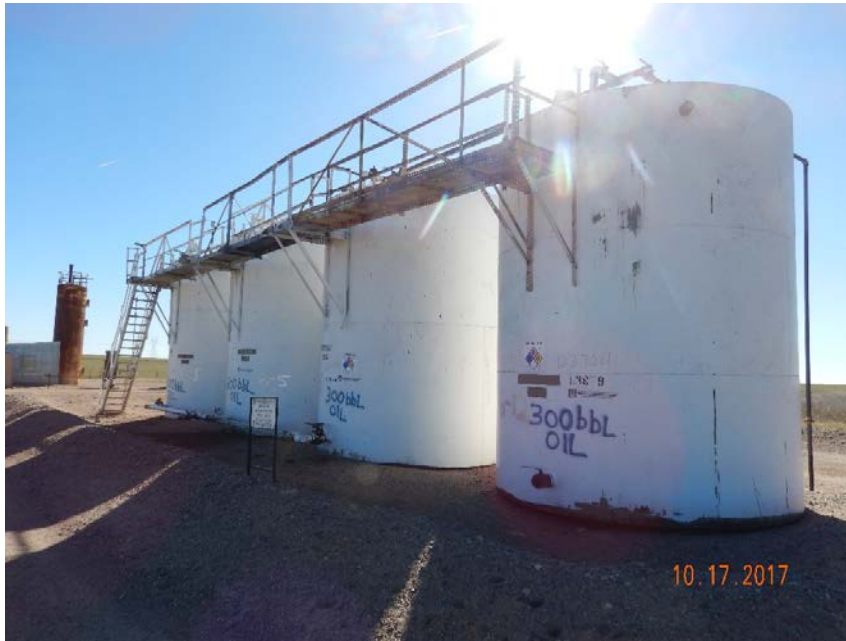
Photo #17 – View of 300 bbl crude oil ASTs from NW. Note: well sign for Wickstrom #6-12 is visible north of tanks.

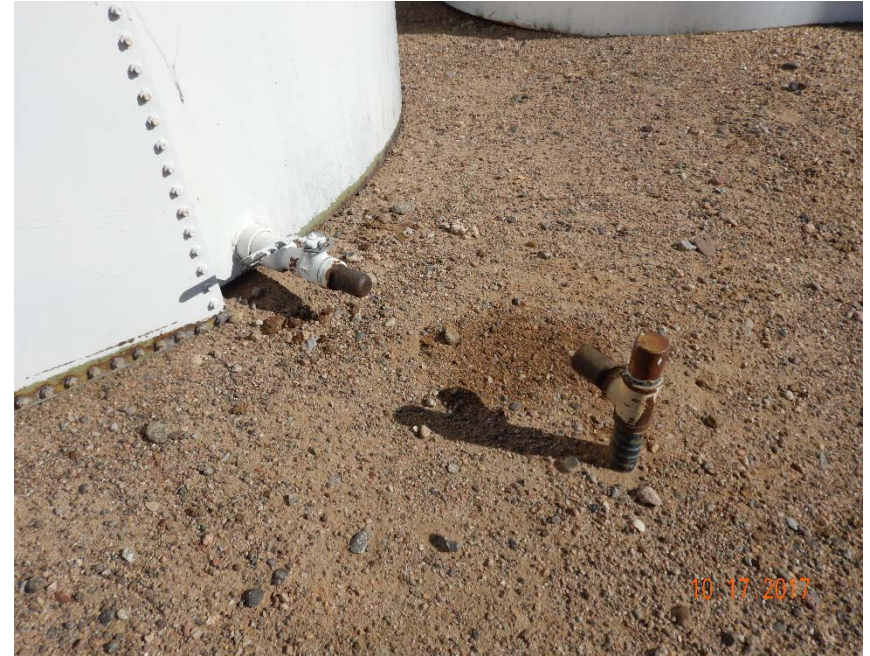
Photo #18 – Unused flowline riser with localized, oil-stained soil on south side of western 300 bbl crude oil AST.

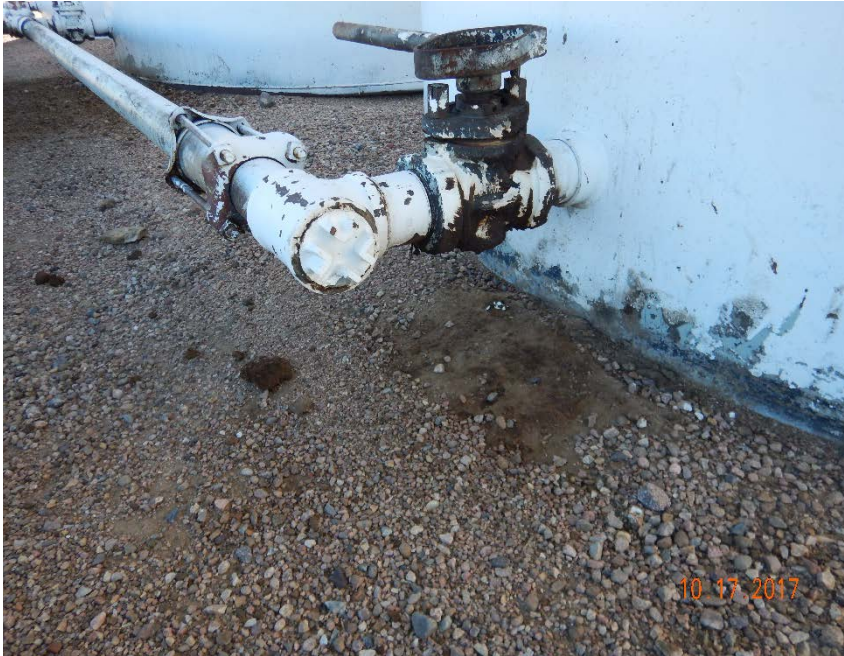
Photo #19 – Localized historical accumulation of oily waste and oil-stained soil beneath 300 bbl crude oil AST loadout valves (1).

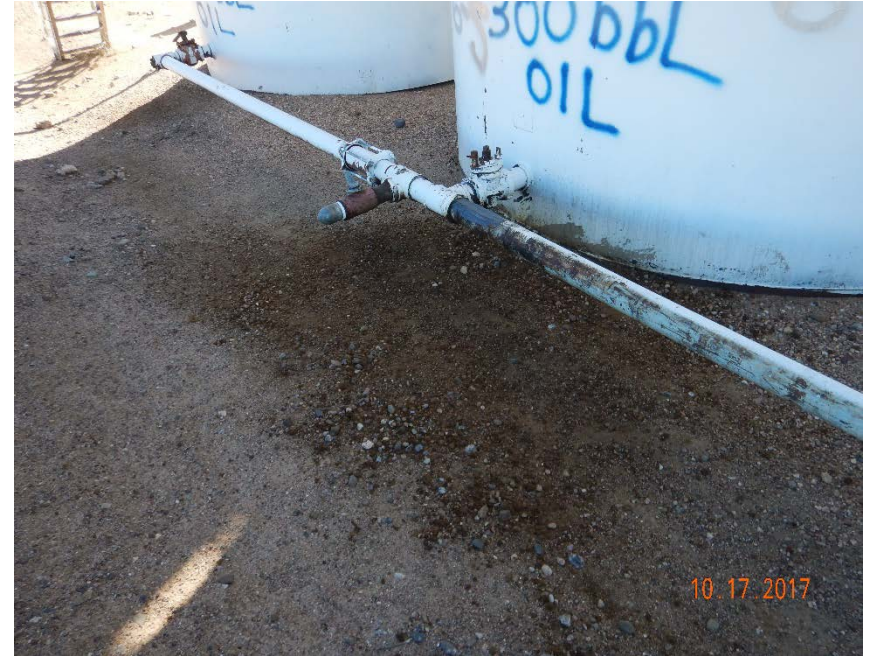
Photo #20 - Localized historical accumulation of oily waste and oil-stained soil beneath 300 bbl crude oil AST loadout valves (2).

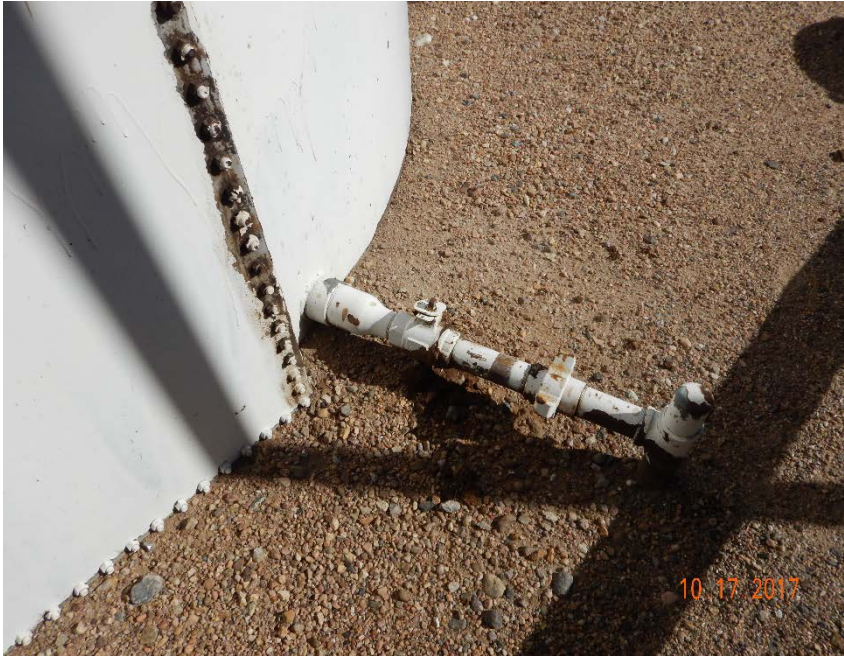
Photo #21 – Localized, oil-stained soil beneath valve on south side of 300 bbl crude oil AST.

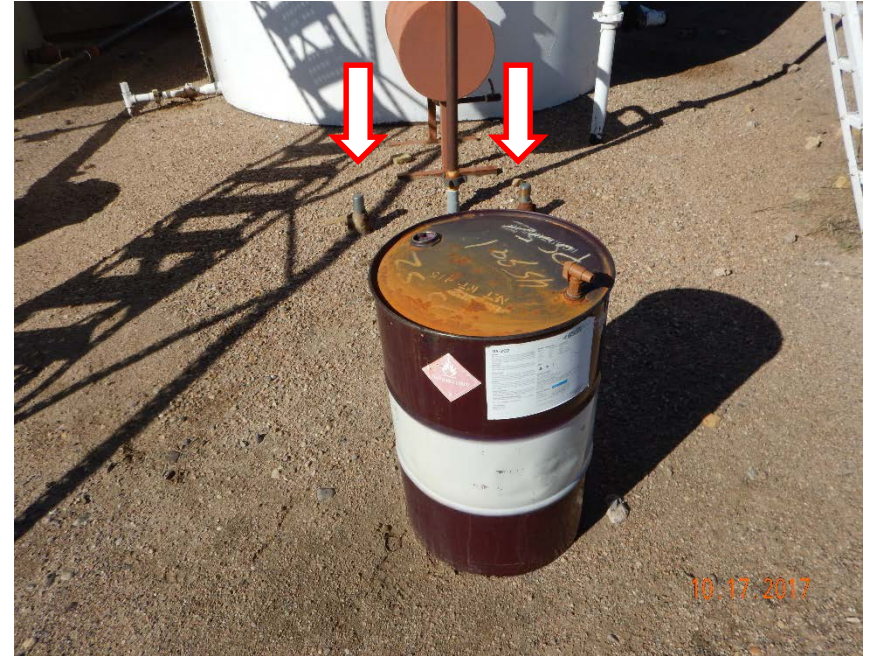
Photo #22 – Rusty 55-gallon drum and unused 2" flowline risers east of 300 bbl crude oil ASTs.

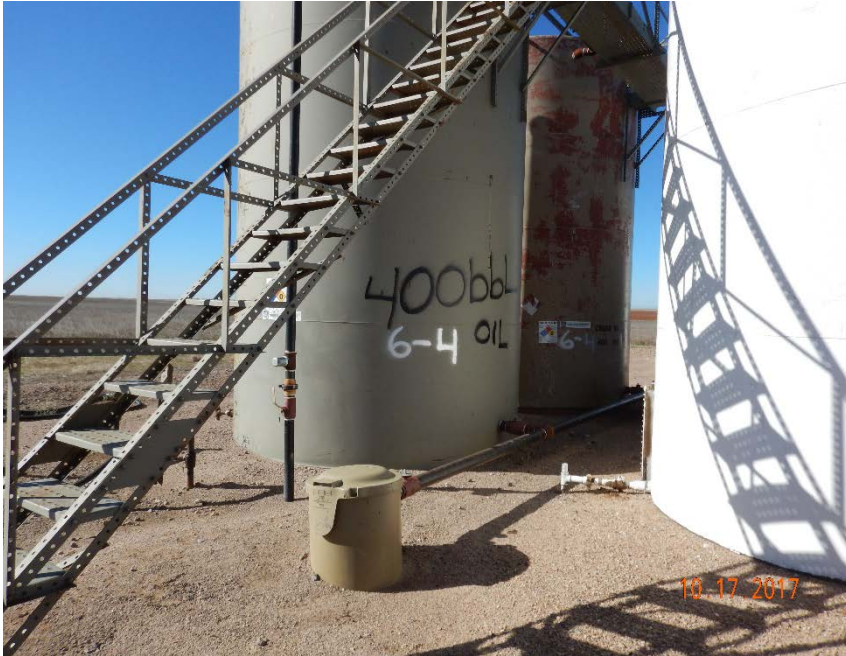
Photo #23 – 400 bbl crude oil ASTs south of 300 bbl crude oil ASTs.

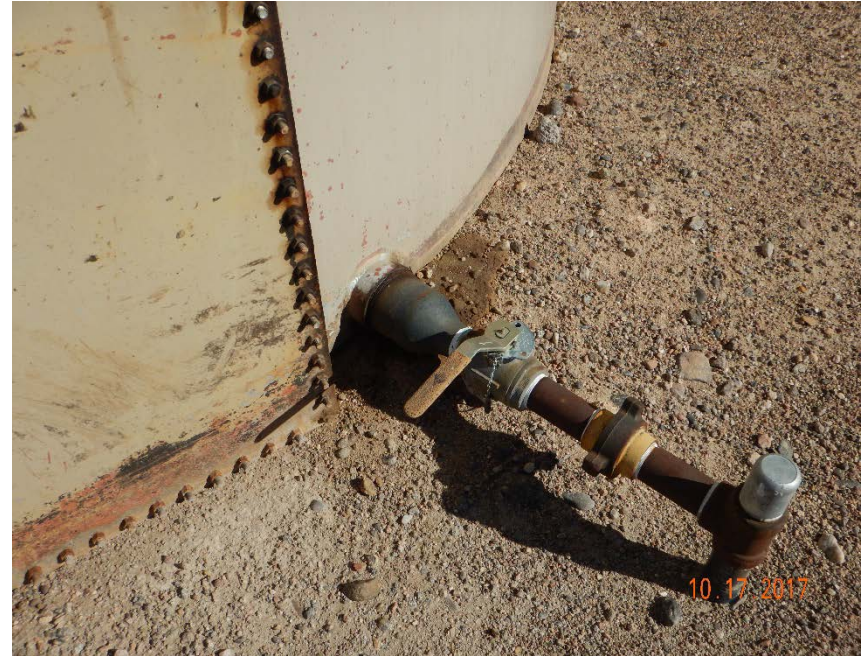
Photo #24 – Localized, oil-stained soil beneath valve on south side of 400 bbl crude oil AST.

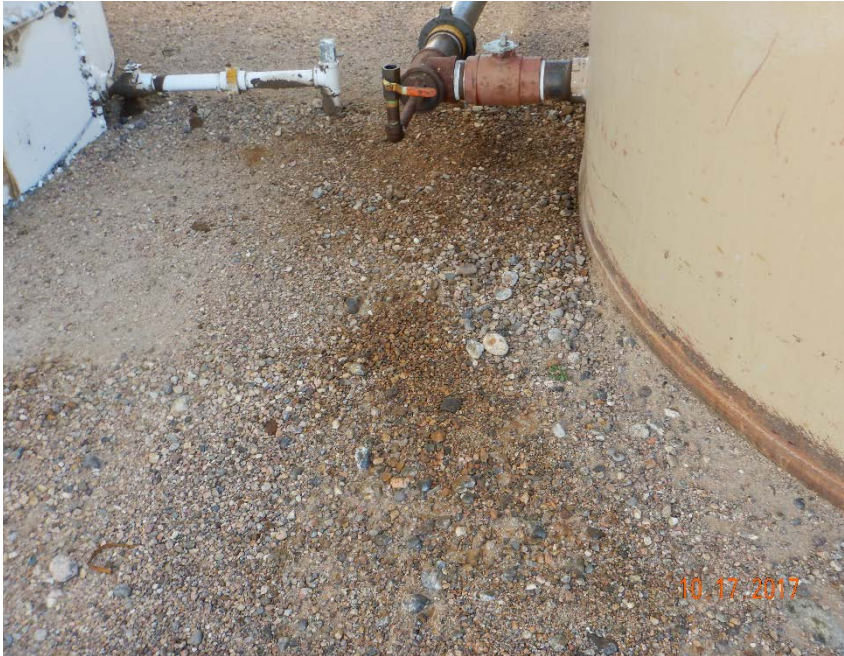
Photo #25 – Localized, oil-stained soil beneath valve on north side of 400 bbl crude oil ASTs.

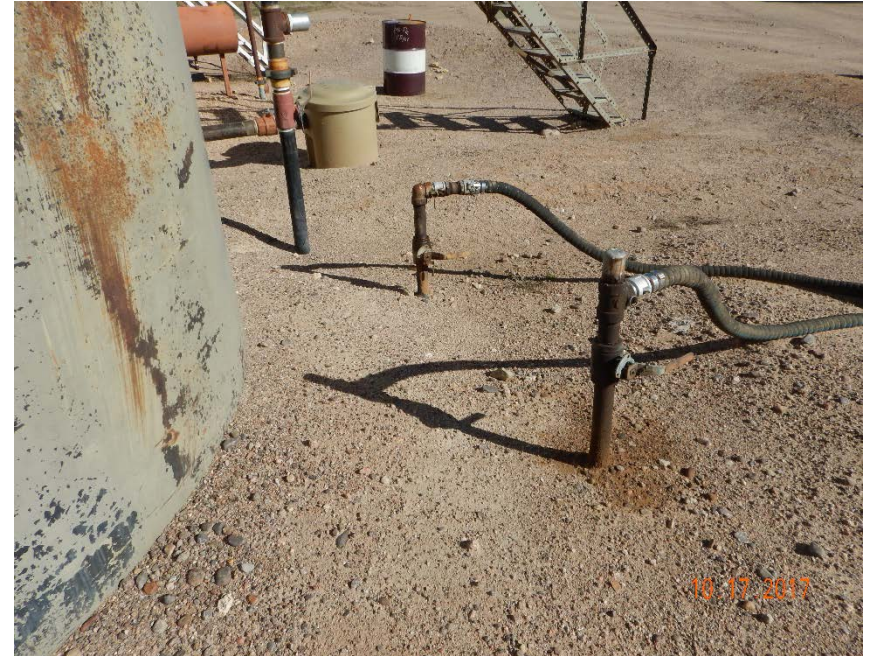
Photo #26 – Active 2" flowline risers with localized, oil-stained soil located east of 400 bbl crude oil ASTs.

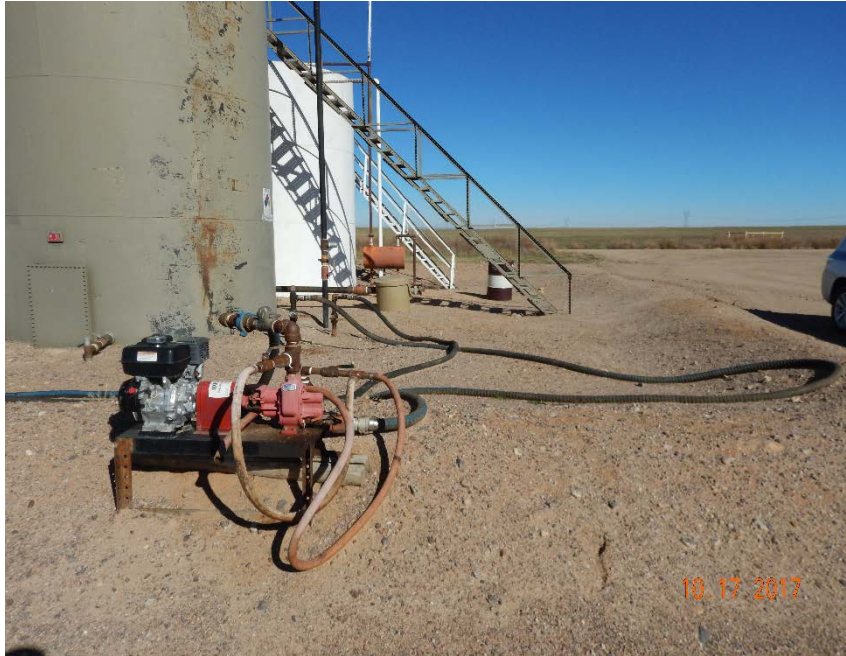
Photo #27 – Gas-powered pump plumbed to active flowline risers at SE corner of crude oil tank battery.

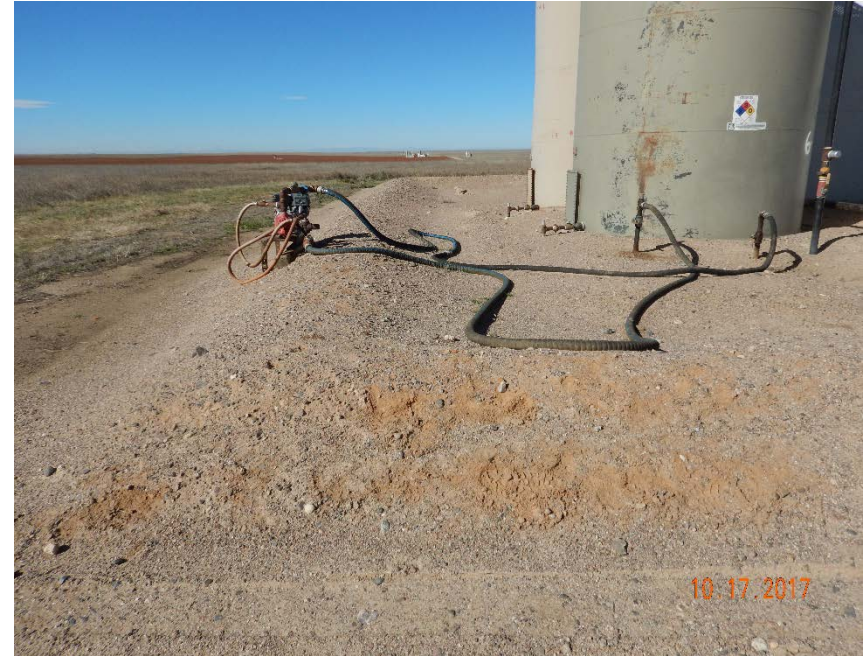
Photo #28 – Shallow/damaged earthen berms at SE corner of crude oil tank battery.

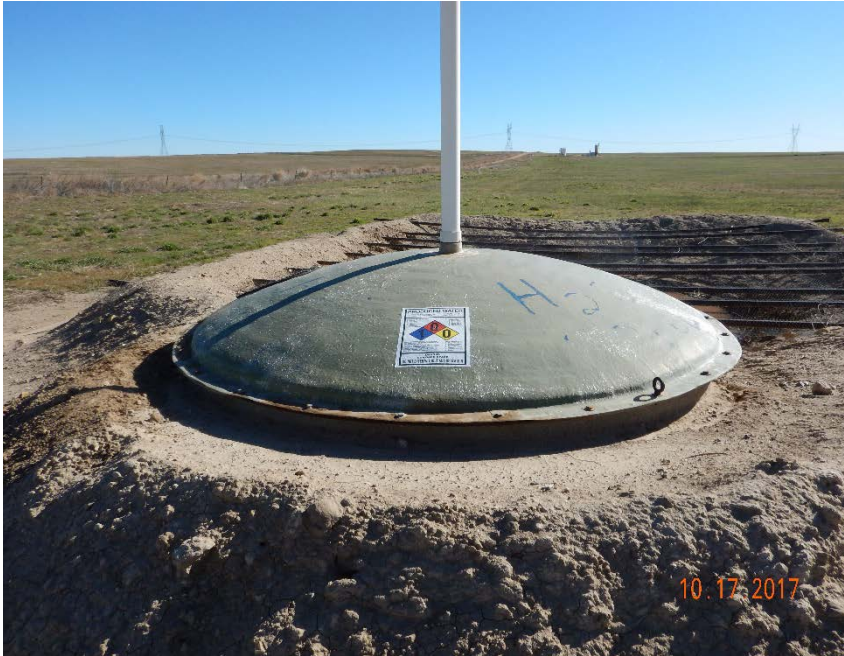
Photo #29 – Skim tank inside of pit berm at NE corner of production facility lacks berms of its own.

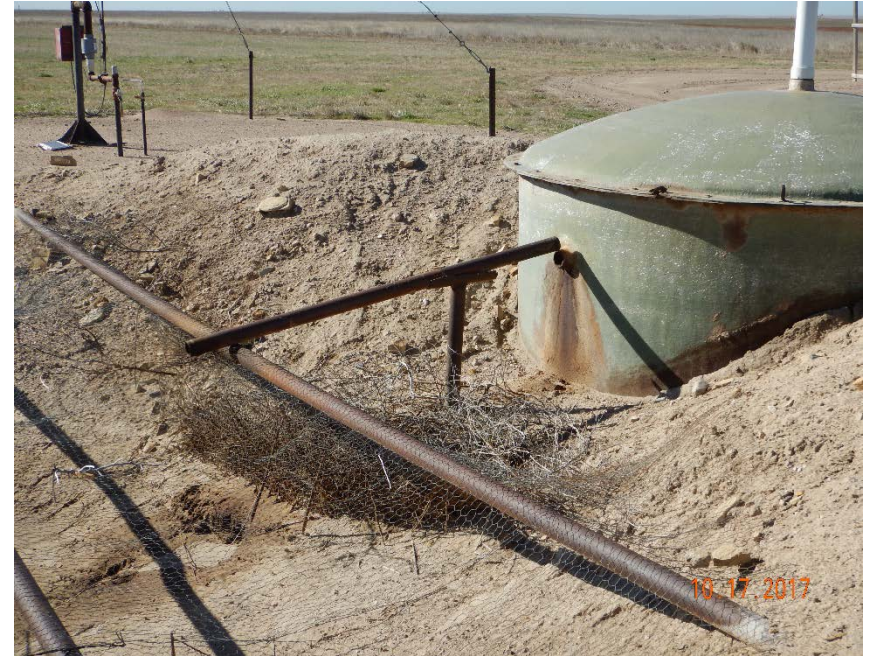
Photo #30 – Skim tank outlet to pit is disassembled. Note: oil-stained soil and weeds at skim tank outlet.

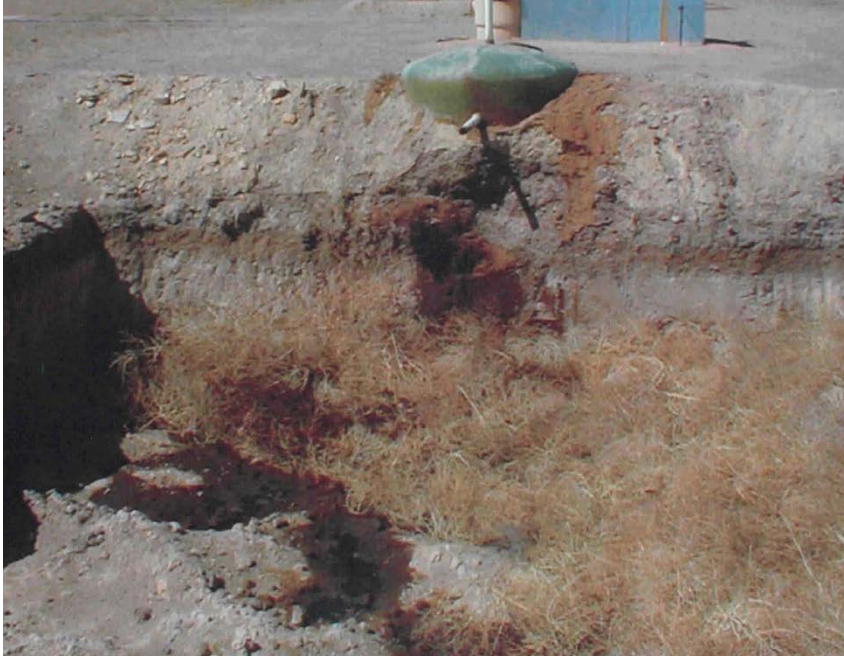
Photo #31 – Historical photo of produced water pit (Facility ID #273445) taken from document #1490137, dated 4/6/2004, predates Remediation Project #1834 and indicates that pit has been partially backfilled since photo was taken.

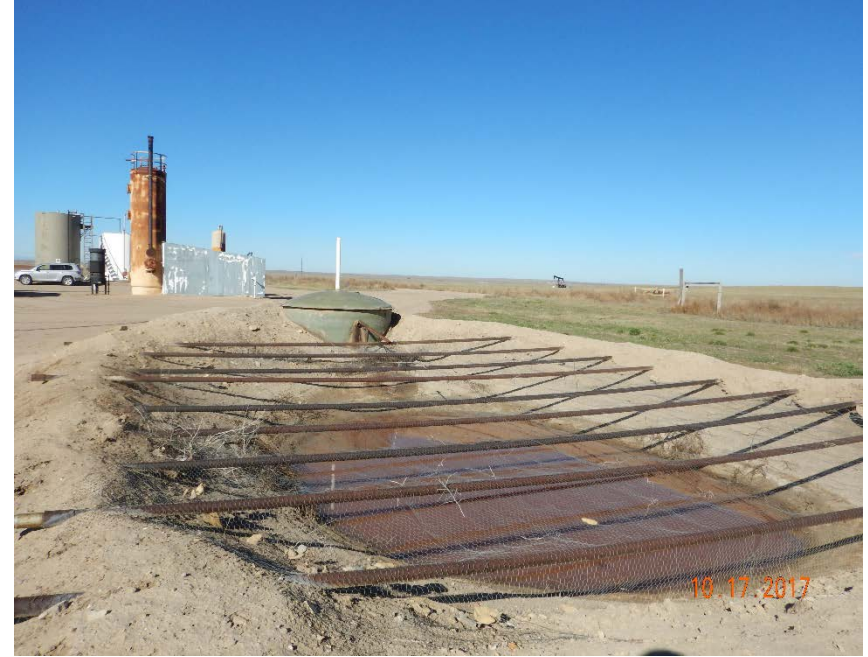
Photo #32 – View from SE corner of produced water pit on date of inspection.

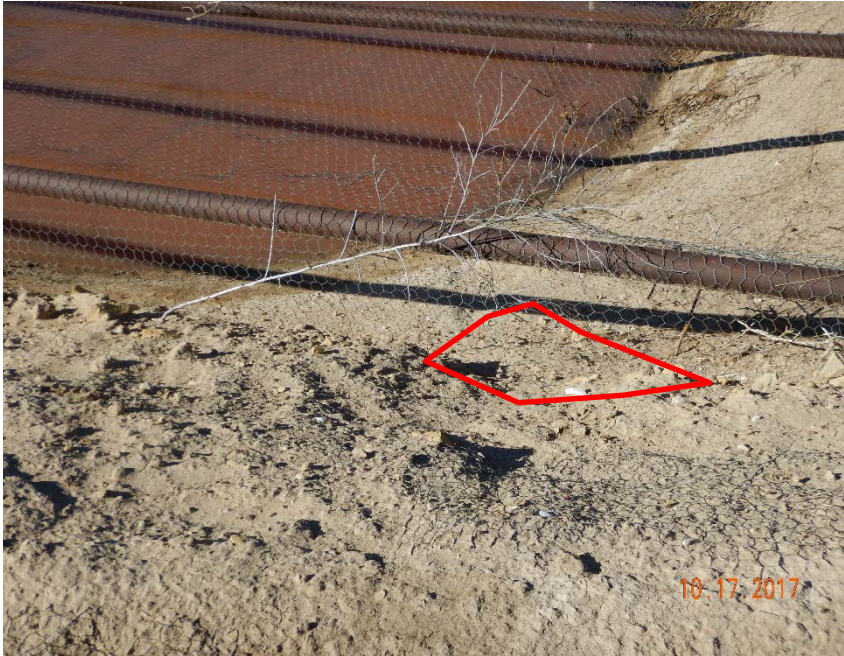
Photo #33 – Gaps in mesh cover for produced water pit (1).

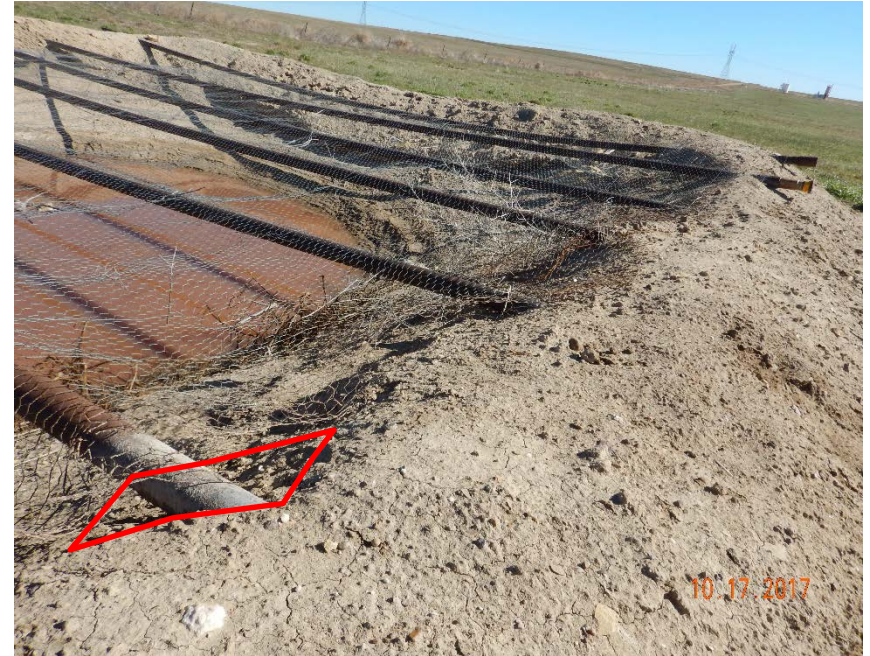
Photo #34 - Gaps in mesh cover for produced water pit (2).

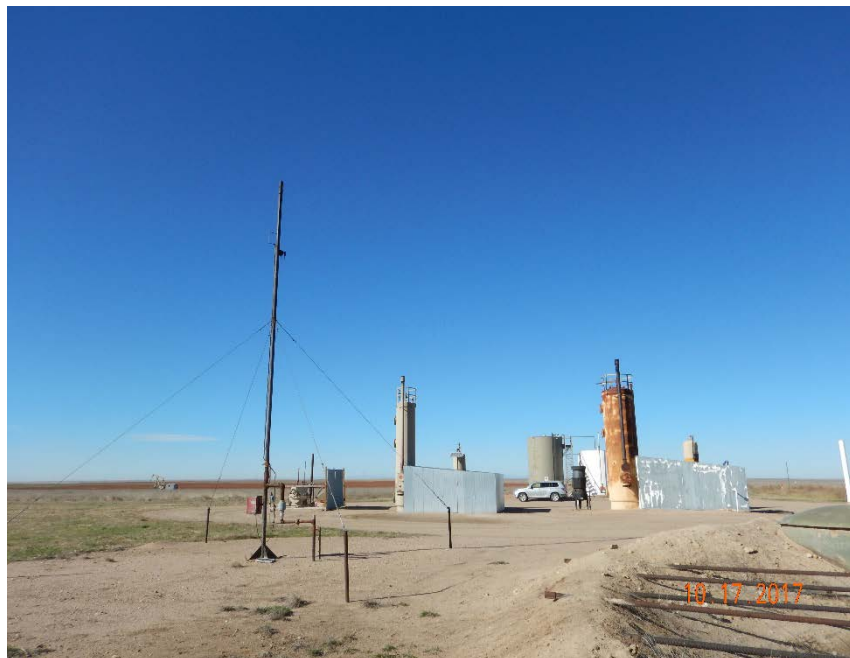
Photo #35 – View of gas flare, separator sheds, and tank battery from SE corner of pit.

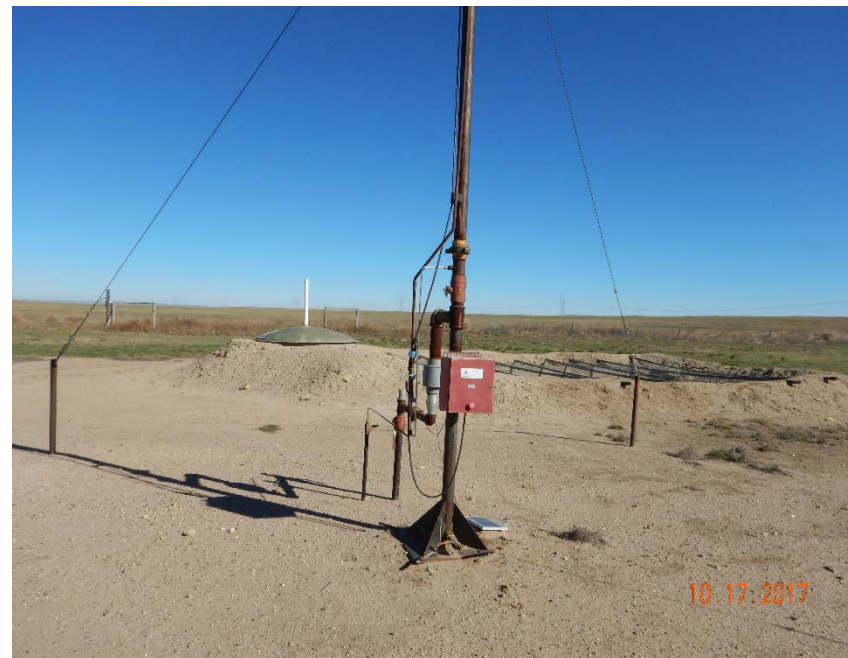
Photo #36 – Close-up view of flare control box and associated flowlines.
