Construction and Stormwater Inspection

October 25, 2017

Operator: EXTRACTION OIL & GAS INC - #10459

Inspection Photos
Location Name: Launer /26-M Pad
Location ID: 451686

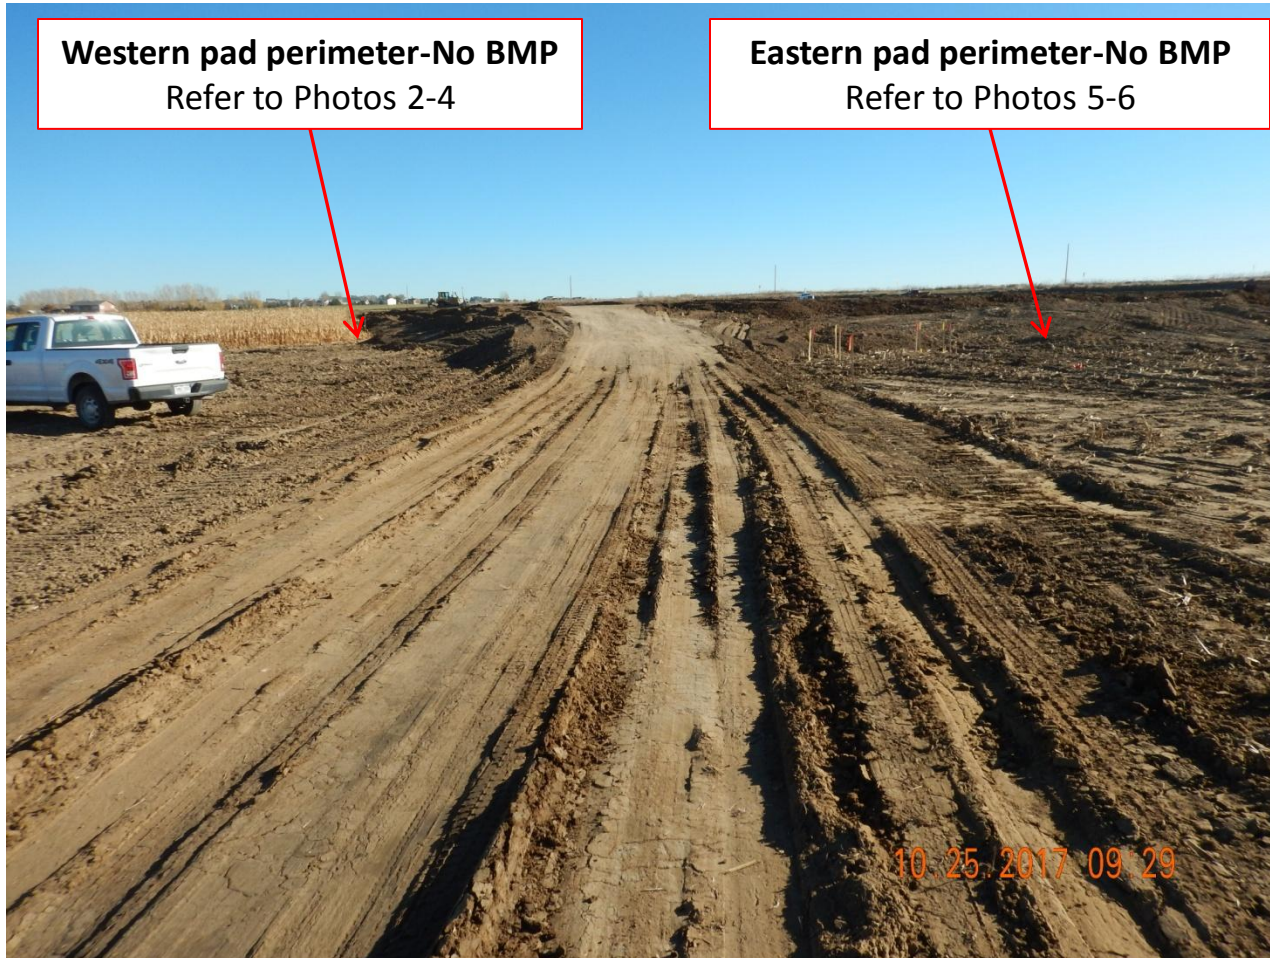
Photo 1. Photo taken from the entrance of the location, facing Northeast. No stormwater or erosion control BMPs were observed throughout any portion of the location. Per Form 42 (Notice of construction), construction activities commenced on September 18, 2017. Operator has failed to install stormwater and erosion control BMPs prior to, or at, the start of construction.

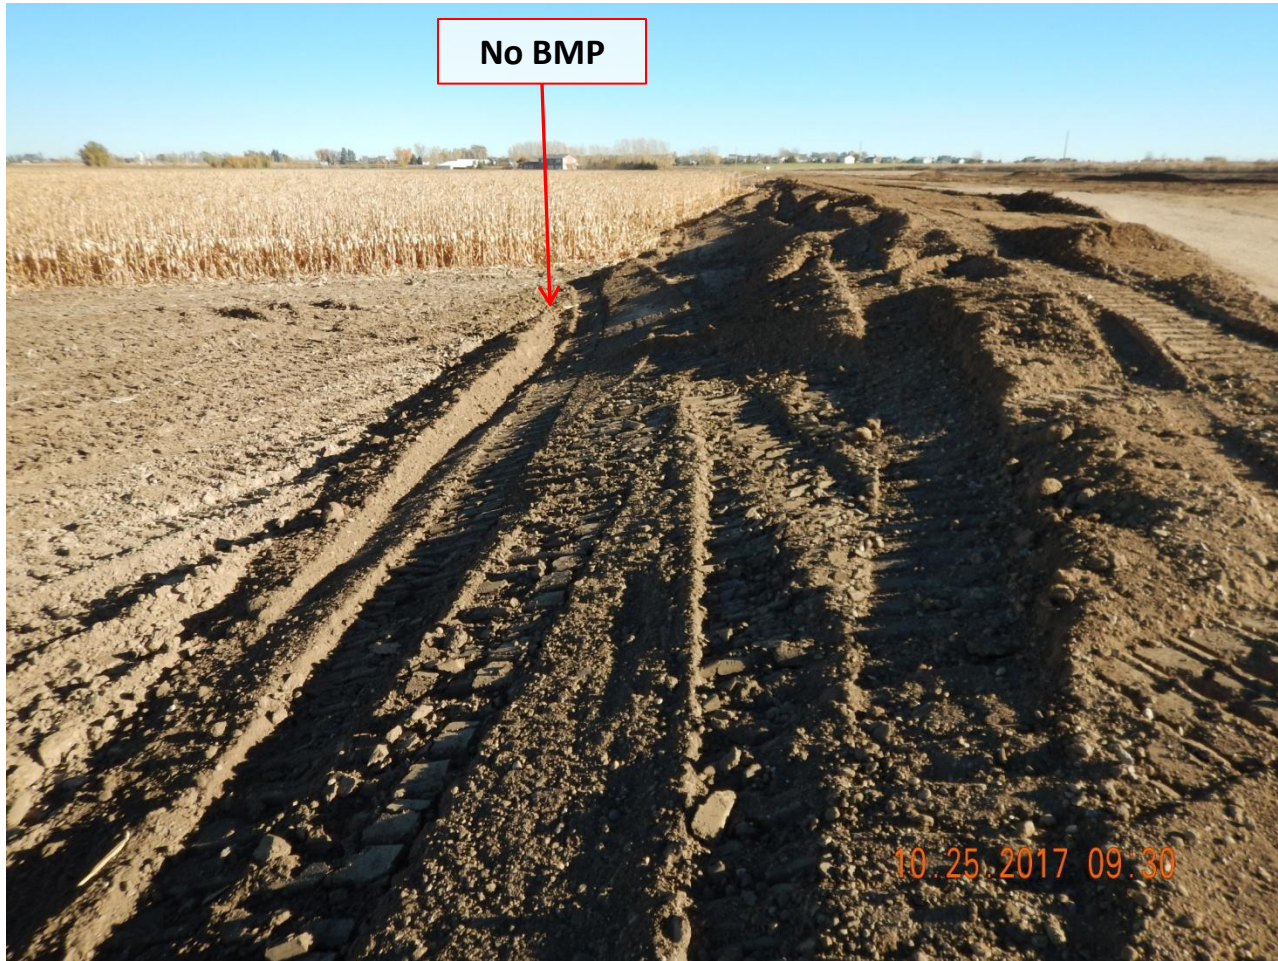
Photo 2. Photo taken from the southwest location, facing North. See comments under Photo 1.

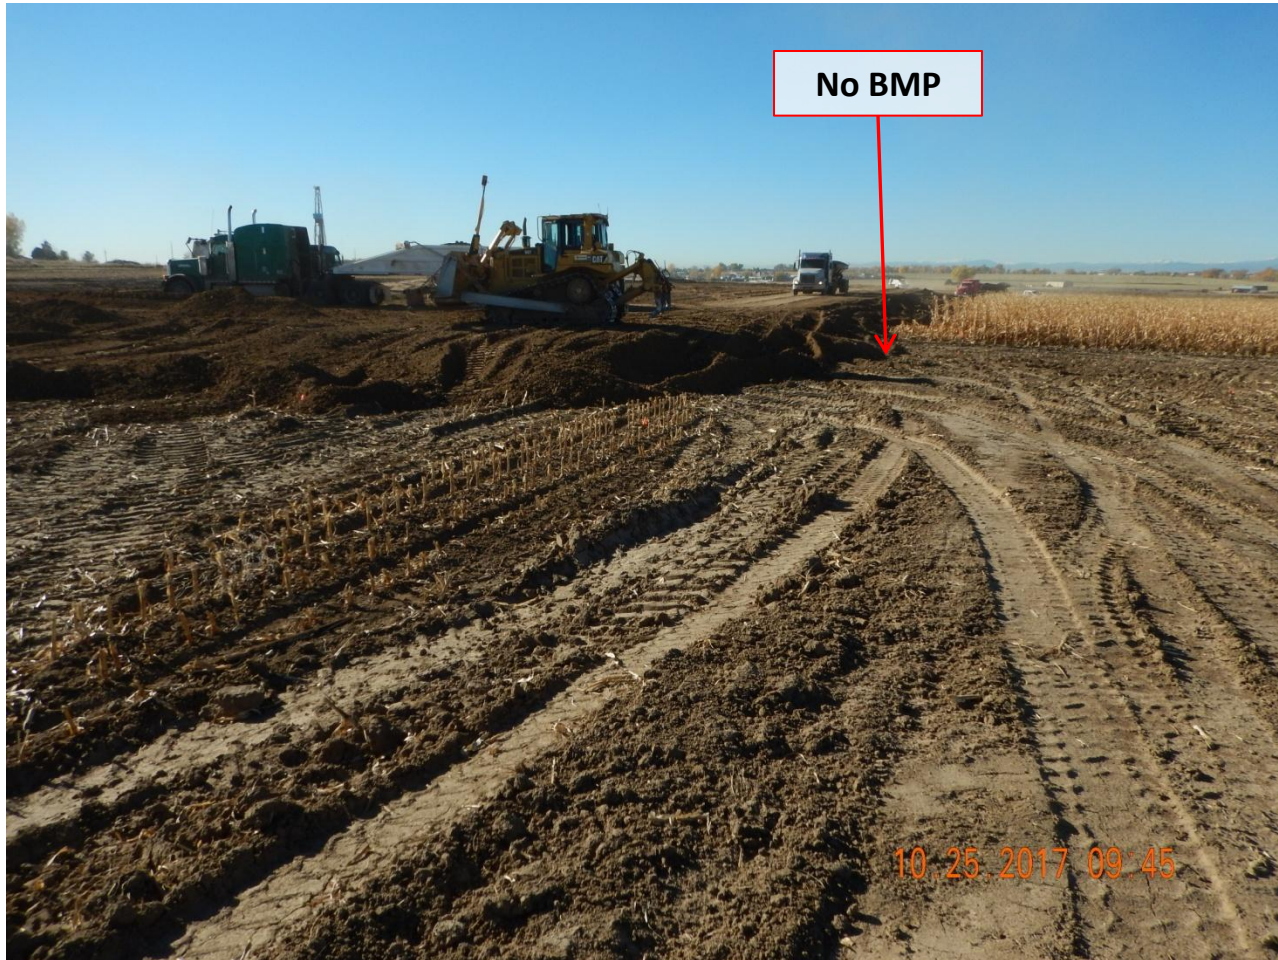
Photo 3. Photo taken from the northwest location, facing South. See comments under Photo 1.

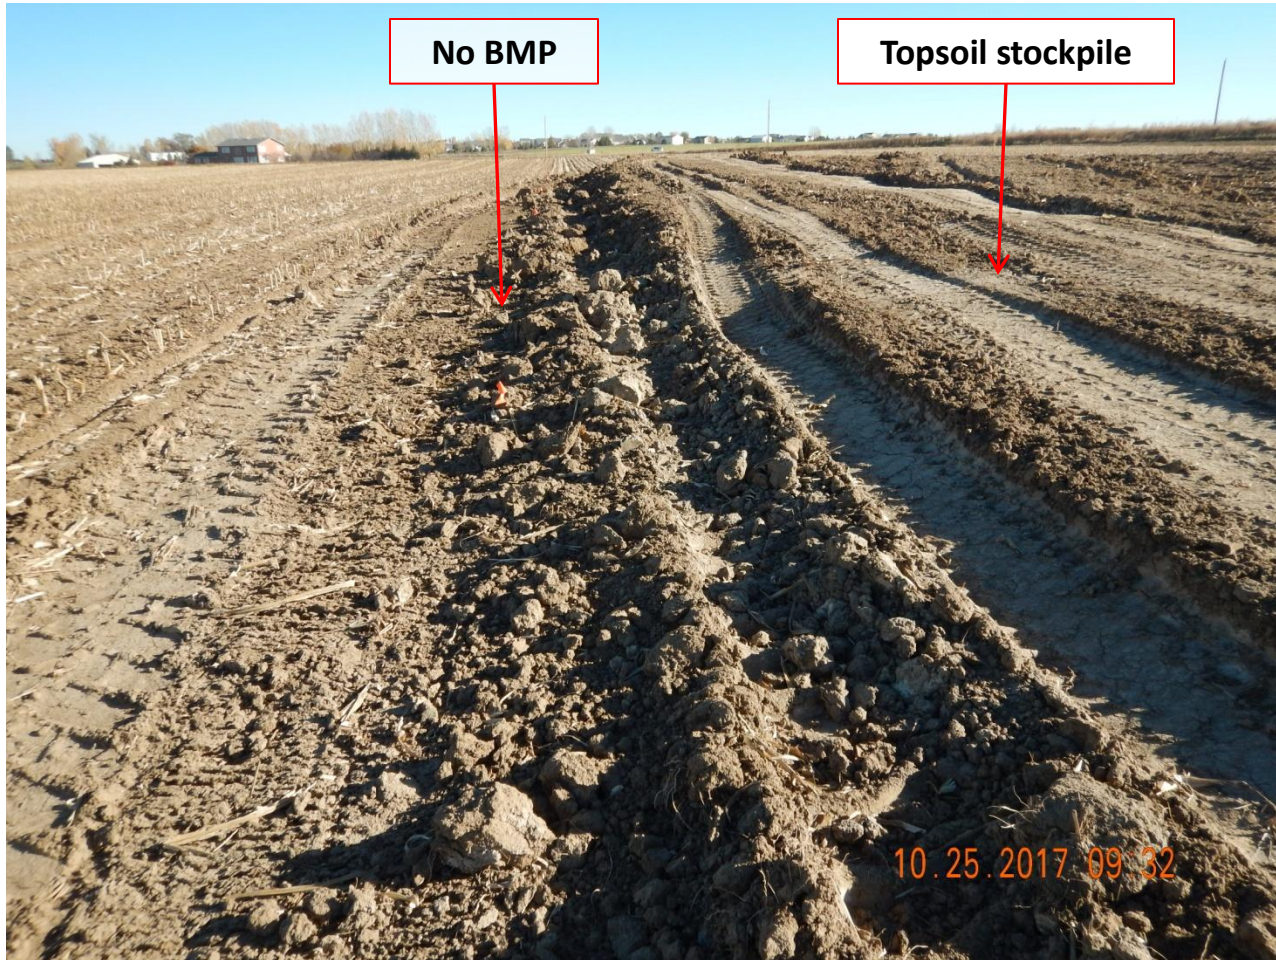
Photo 4. Photo taken from the northwest location, facing North. See comments under Photo 1. Does not appear the Operator has salvaged a sufficient amount of topsoil. The adjacent location to the south (Hergert well pad- Location ID 440396) has the approximate same disturbance area of the Launer location but has significantly more topsoil salvaged.

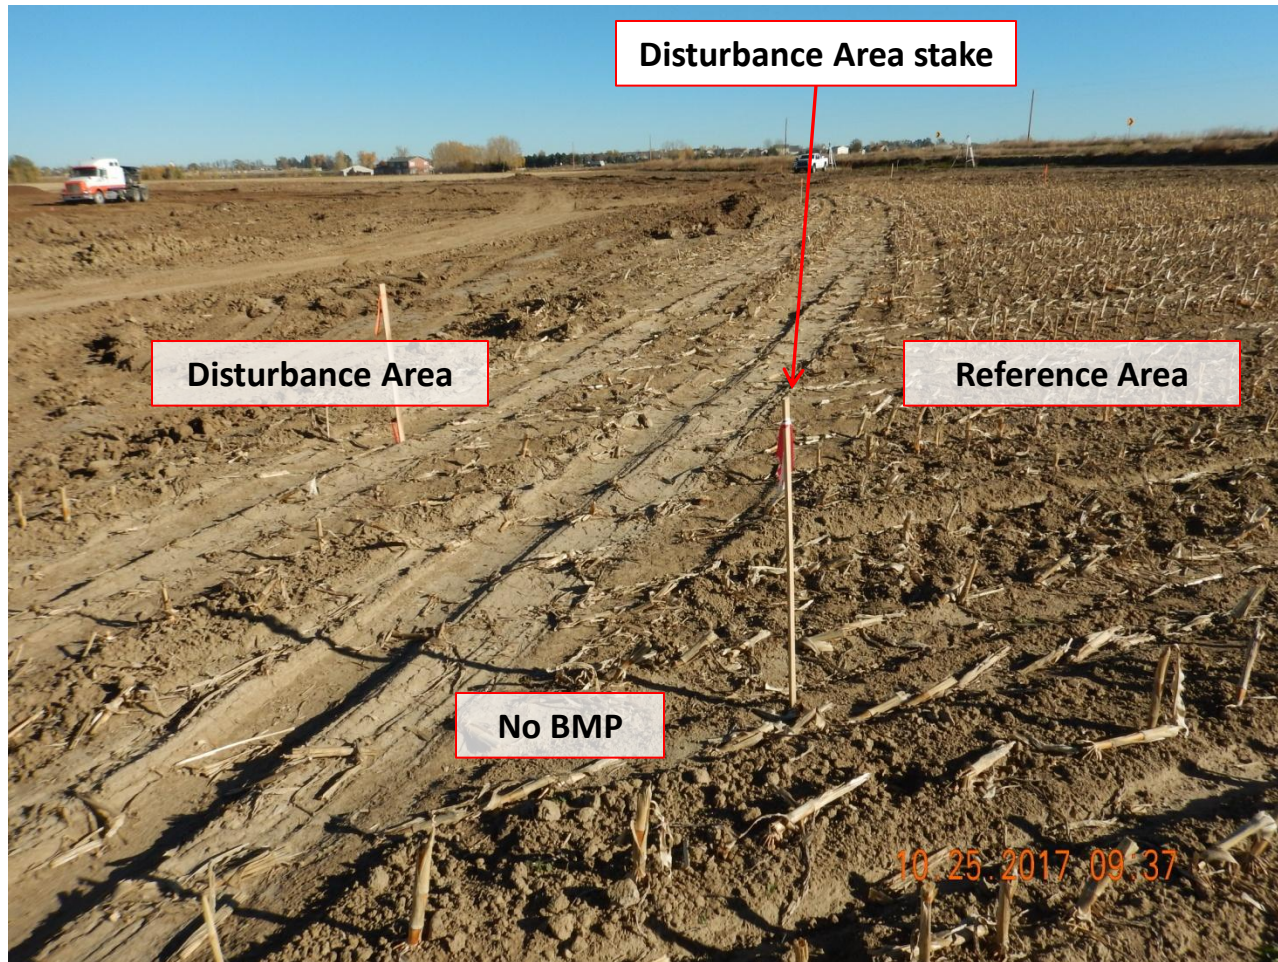
Photo 5. Photo taken from the eastern location, facing Northeast. See comments under Photo 1.

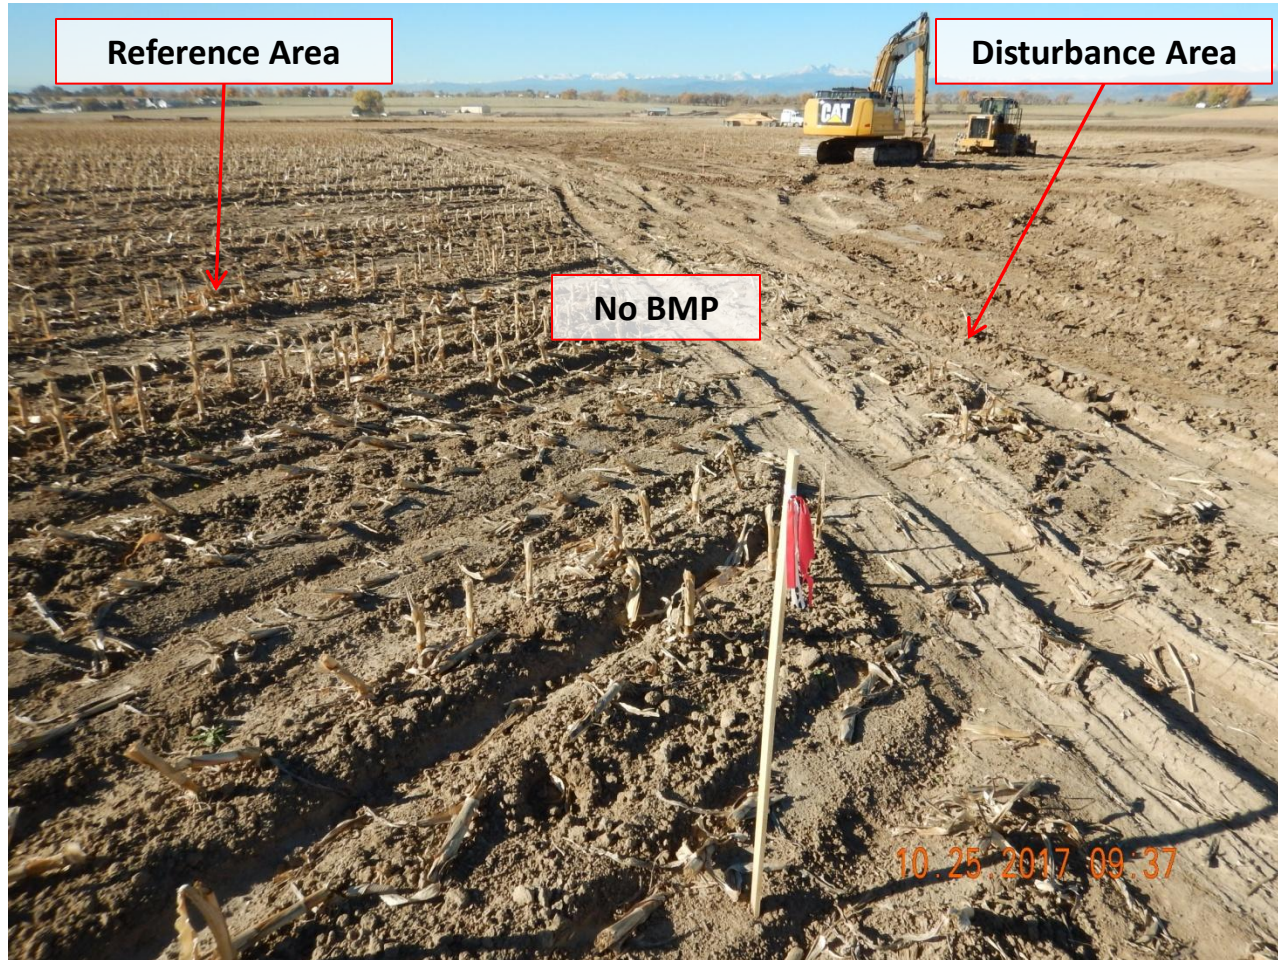
Photo 6. Photo taken from the eastern location, facing Northeast. See comments under Photo 1.

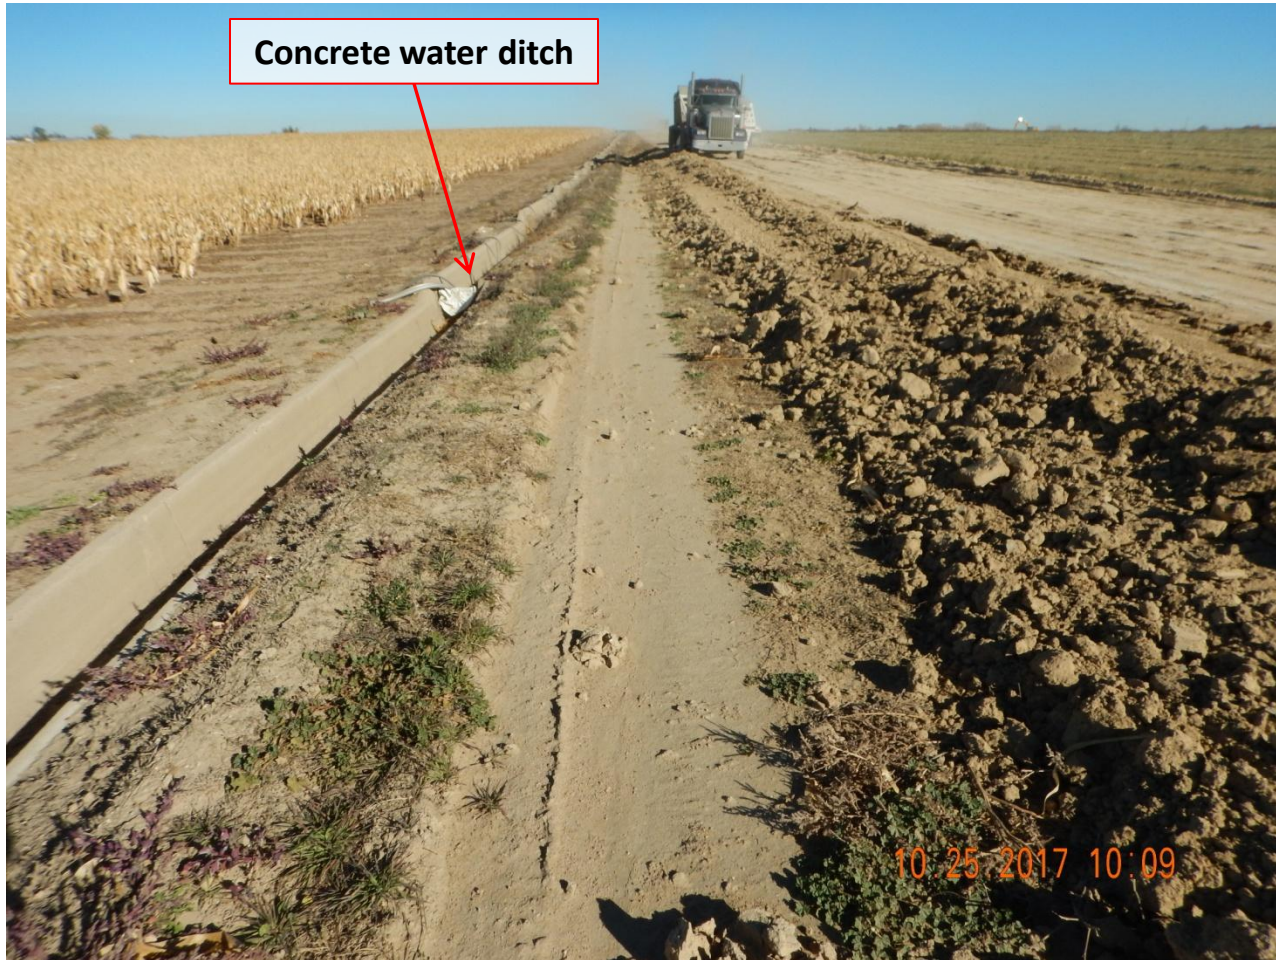
Photo 7. Photo taken from the access road, facing North. Operator shall stabilize unconsolidated soil material along the access road.
