Inspection Photos
Location Name: Marick #1061-41
API: 05-123-30239

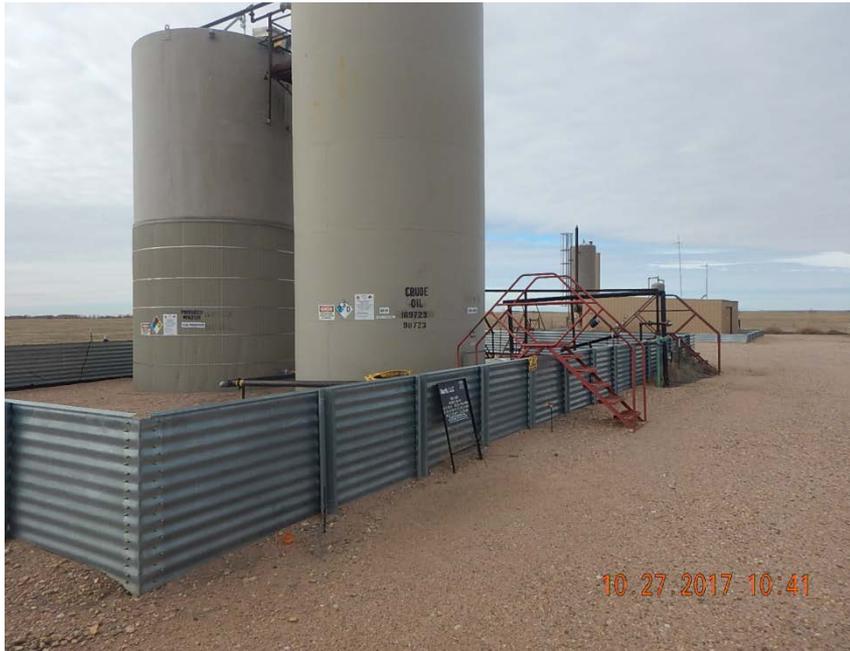
Photo 1: Location, looking SW

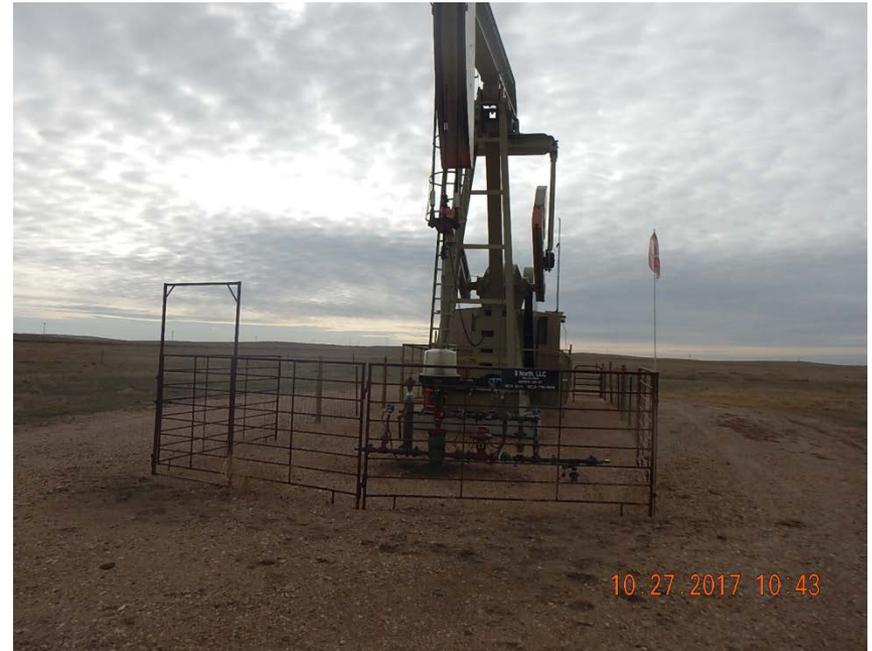
Photo 2: Wellhead, looking S

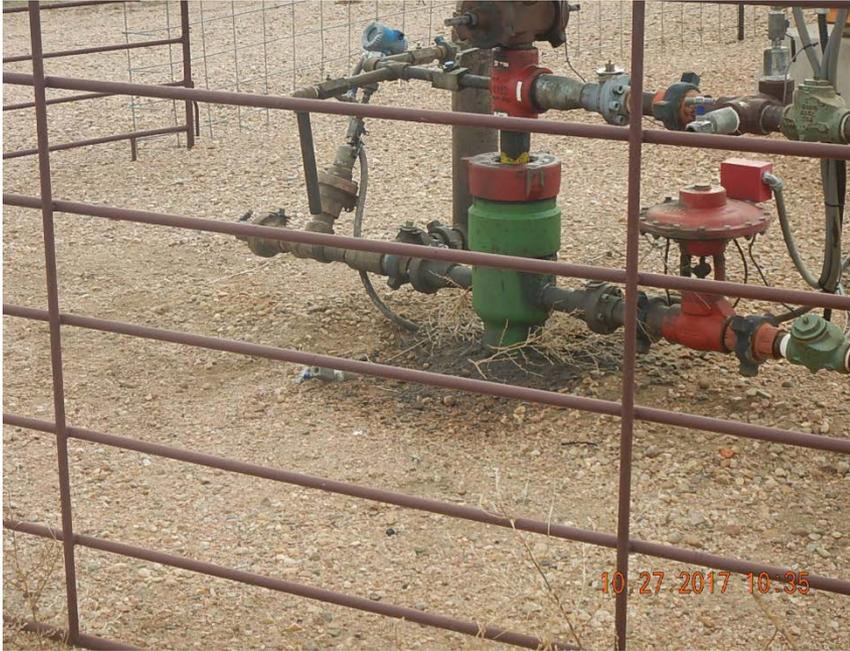
Photo 3: Stained soil at wellhead

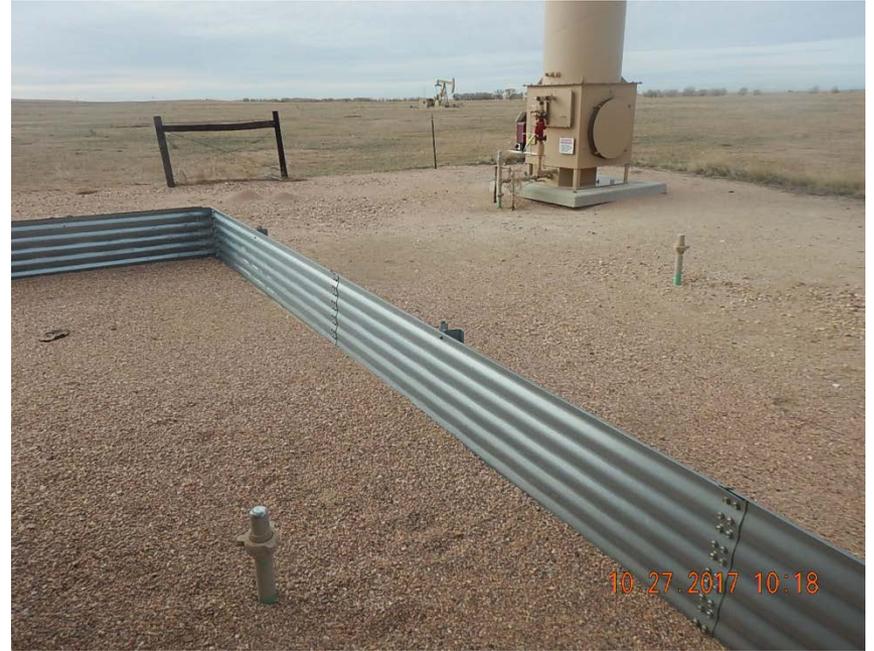
Photo 4: Risers at ECD

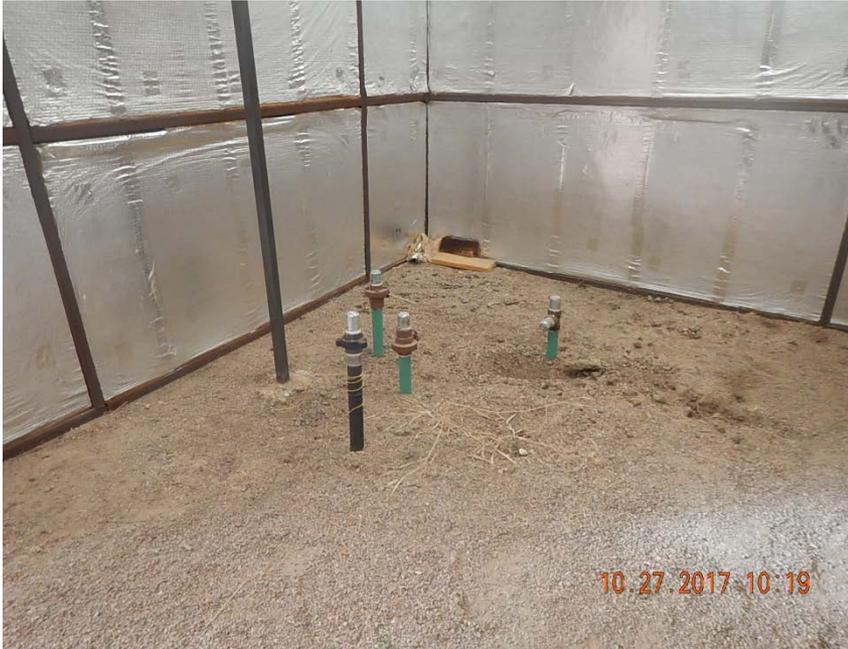
Photo 5: Risers in treater house

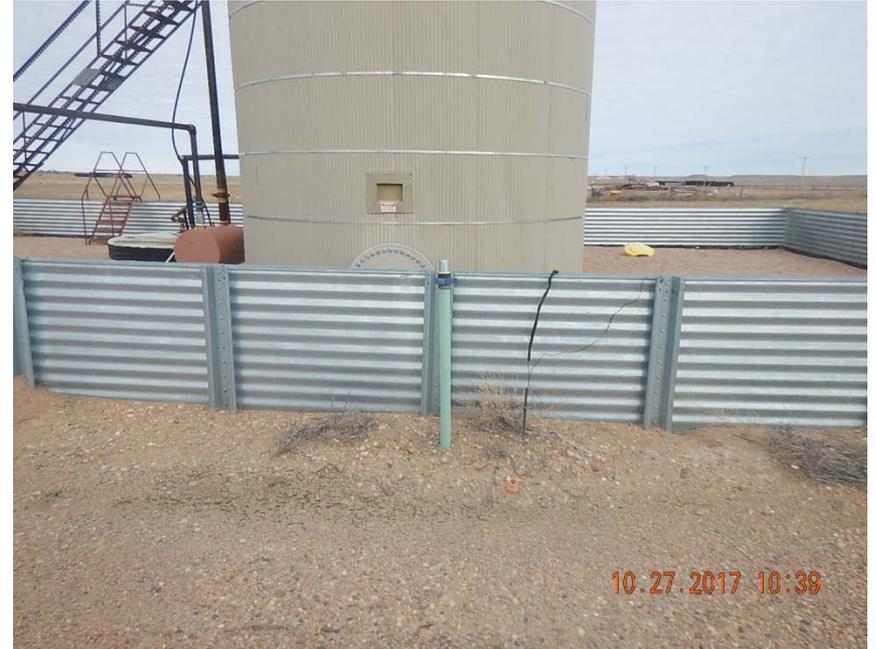
Photo 6: Riser next to tank battery
