Construction and Stormwater Inspection

October 25, 2017

Operator: EXTRACTION OIL & GAS INC - #10459

Inspection Photos
Location Name: Hergert /35-D Facility
Location ID: 426721

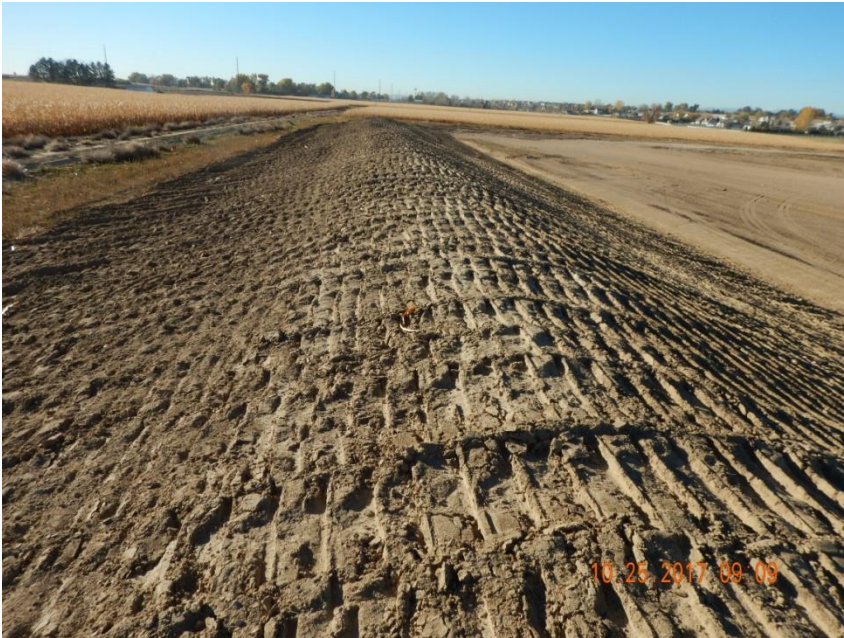
Photo 1. Overview photo taken from the eastern location, facing South. Topsoil salvaged and stored along the eastern perimeter of the location.

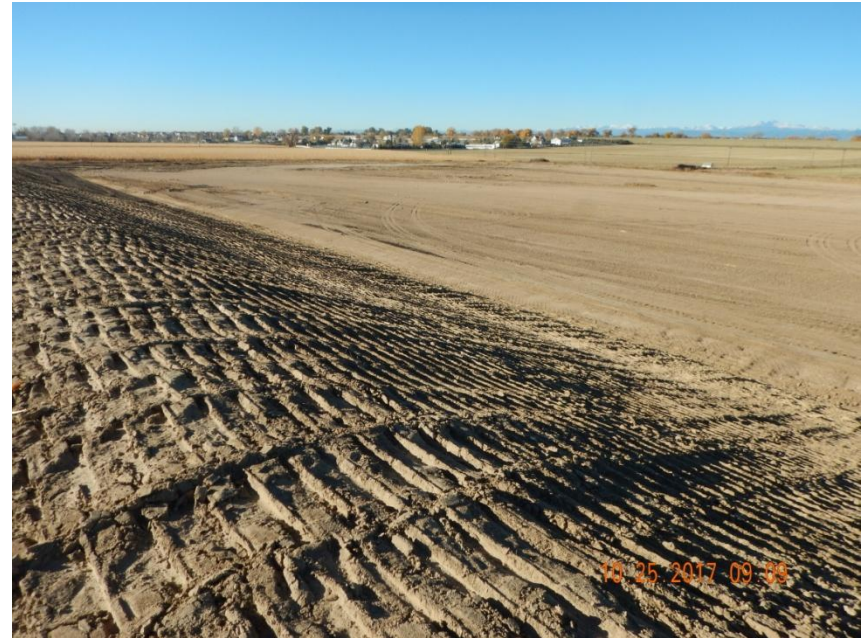
Photo 2. Overview photo taken from the eastern location, facing Southwest. See comments under Photo 1.

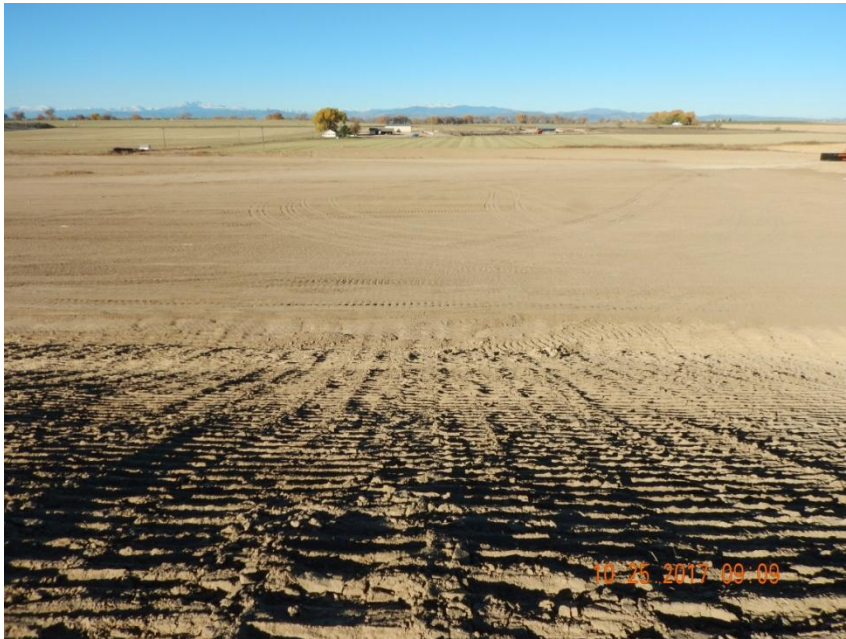
Photo 3. Overview photo taken from the eastern location, facing West. See comments under Photo 1.

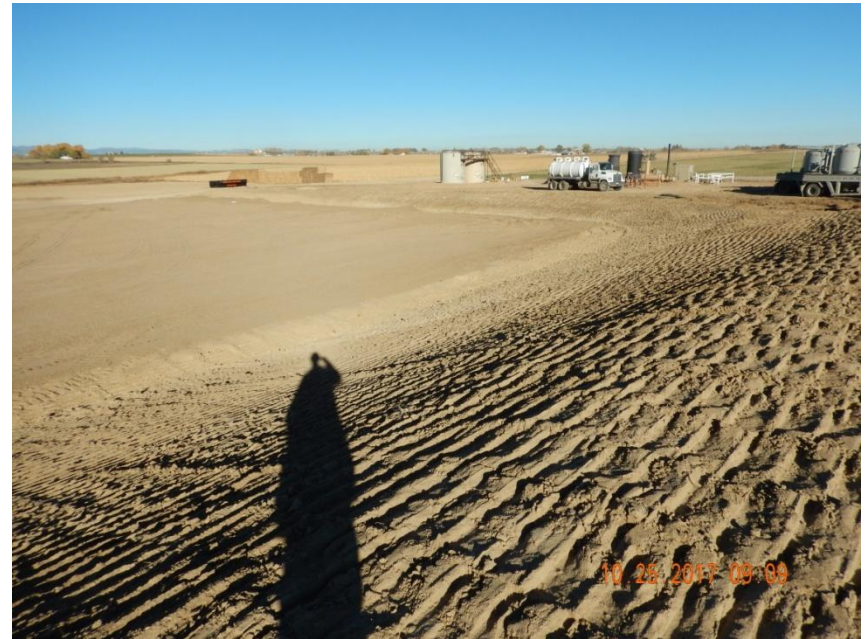
Photo 4. Overview photo taken from the eastern location, facing Northwest. See comments under Photo 1.

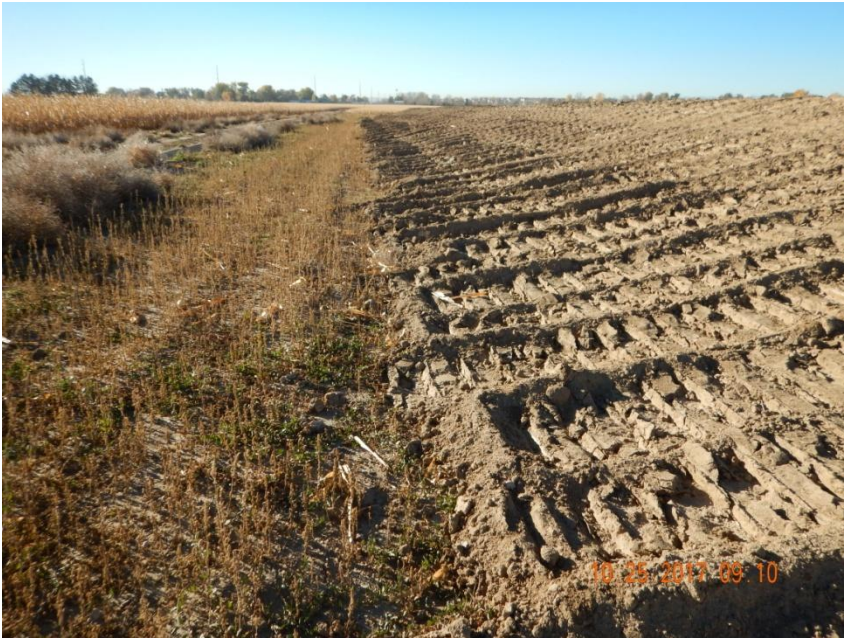
Photo 5. Photo taken from the eastern location, facing South. No stormwater and erosion control BMPs observed along the outer perimeter of stockpile.

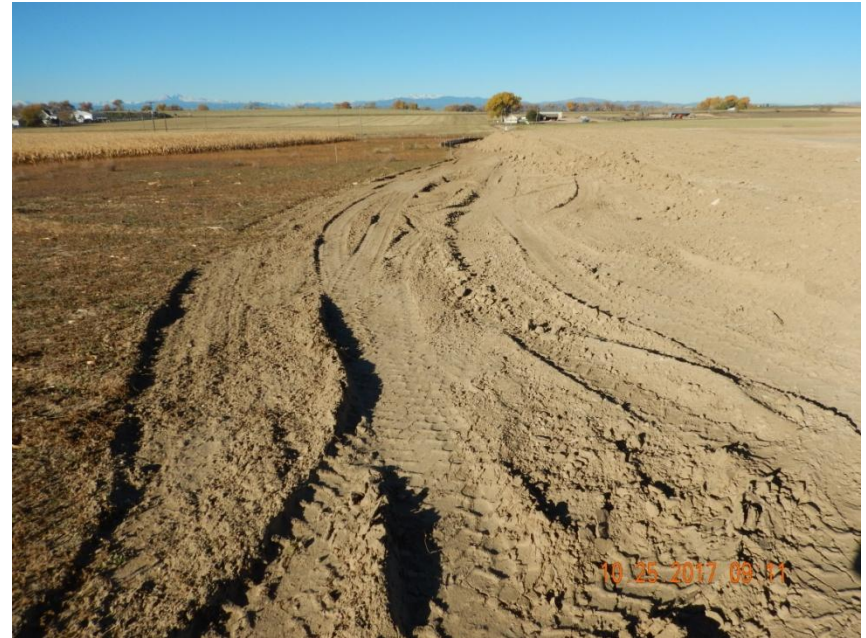
Photo 6. Photo taken from the southeastern location, facing West. No stormwater and erosion control BMPs observed along this portion of the location. Operator plans to install ditch that will be directed to the sediment basin which has already been constructed.

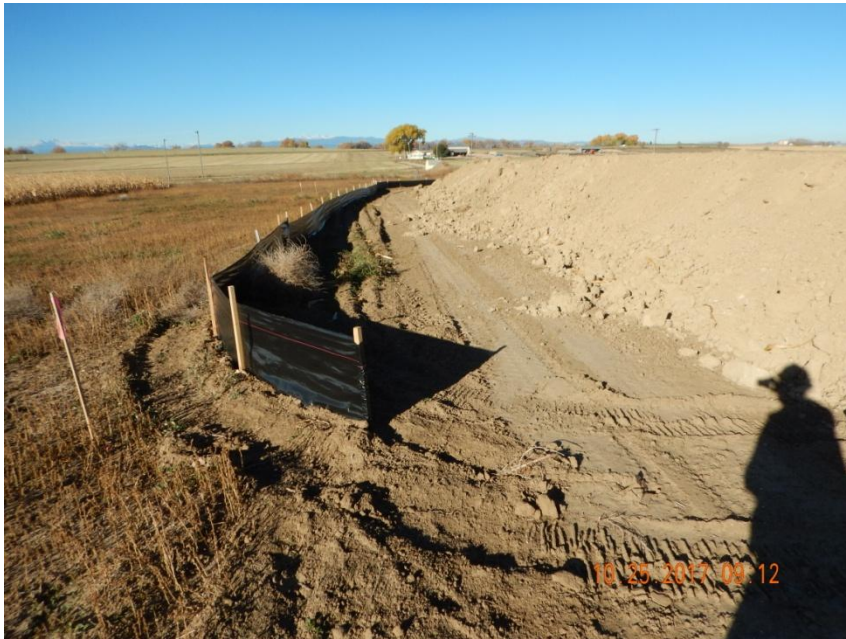
Photo 7. Photo taken from the southwestern location, facing West. Silt fence BMP has been installed along the southwest, west, and northwest perimeter of location. Fill slopes need to be stabilized.

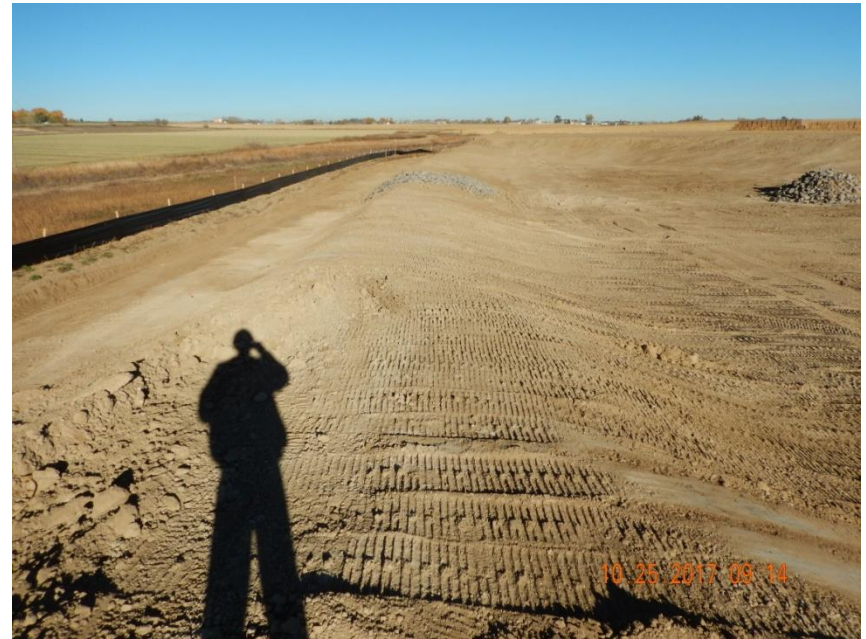
Photo 8. Photo taken from the southwestern location, facing North. Sediment basin has been constructed in conjunction with a silt fence BMP.

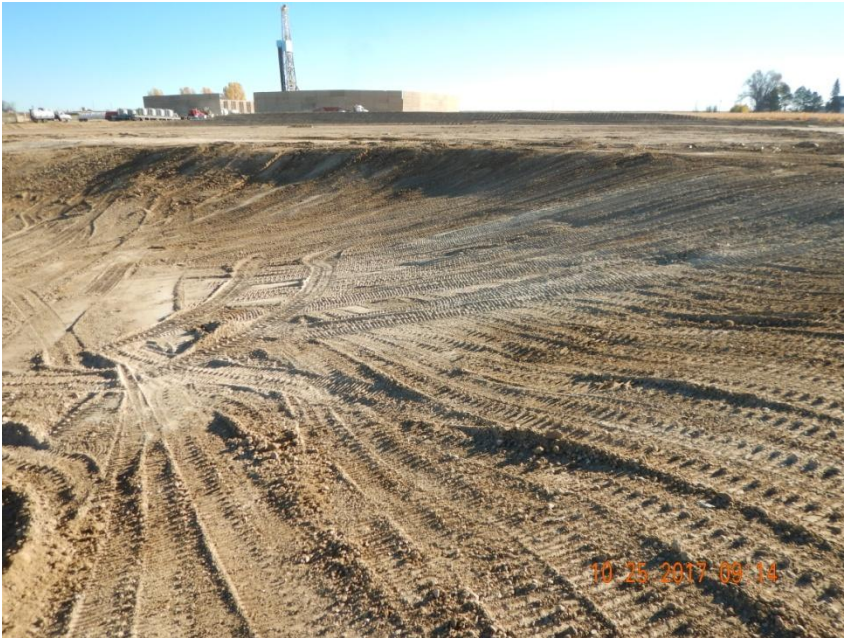
Photo 9. Photo taken from the southwestern location, facing East. See comments under Photo 8.

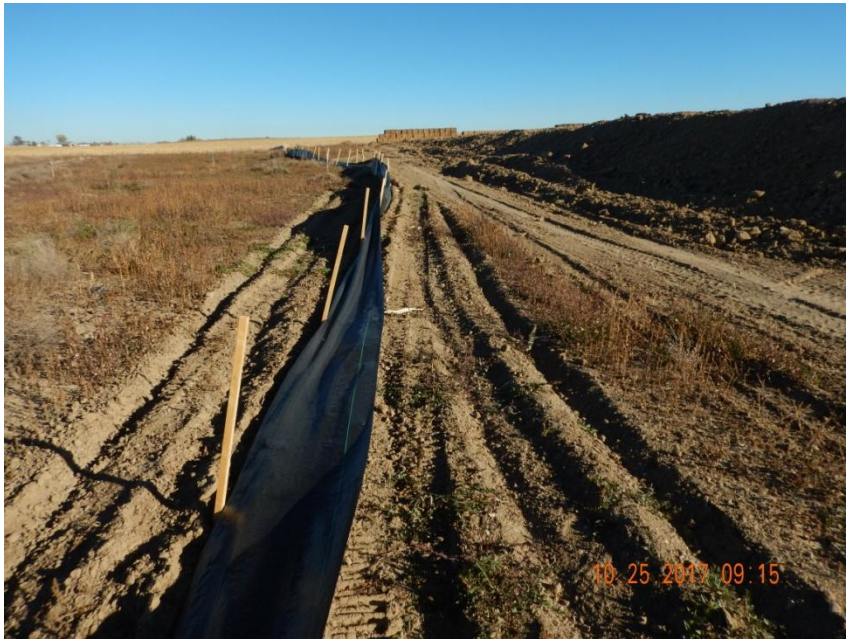
Photo 11. Photo taken from the western location, facing North. Silt fence BMP in need of maintenance.

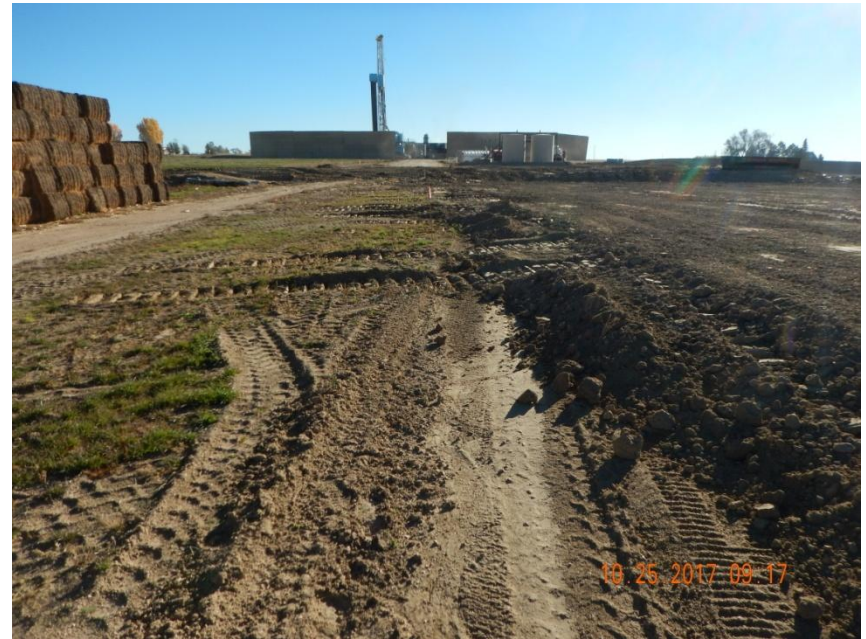
Photo 12. Photo taken from the northern location, facing East. See comments under Photo 6.
