Inspection Photos

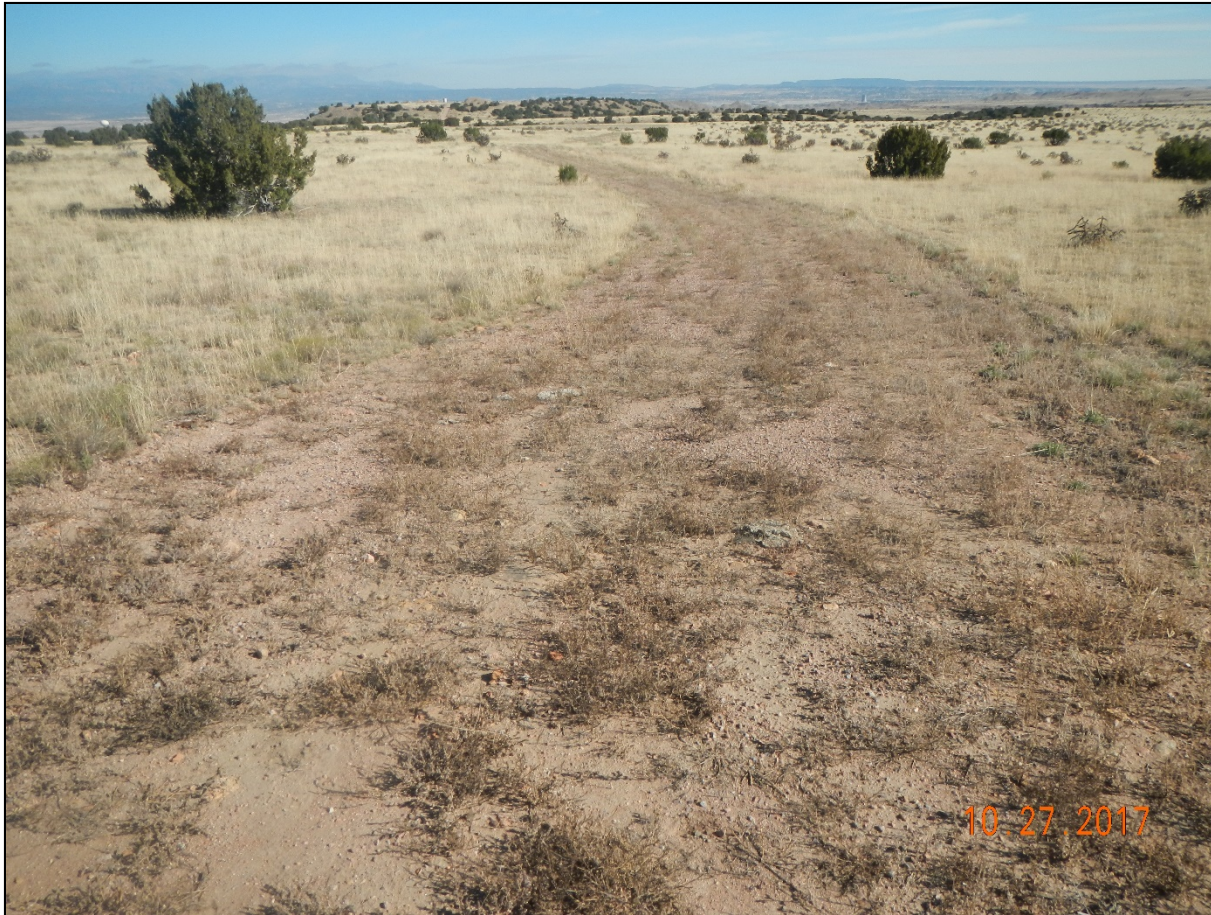
Photo 1. Facing northeast at the beginning of the former access road.

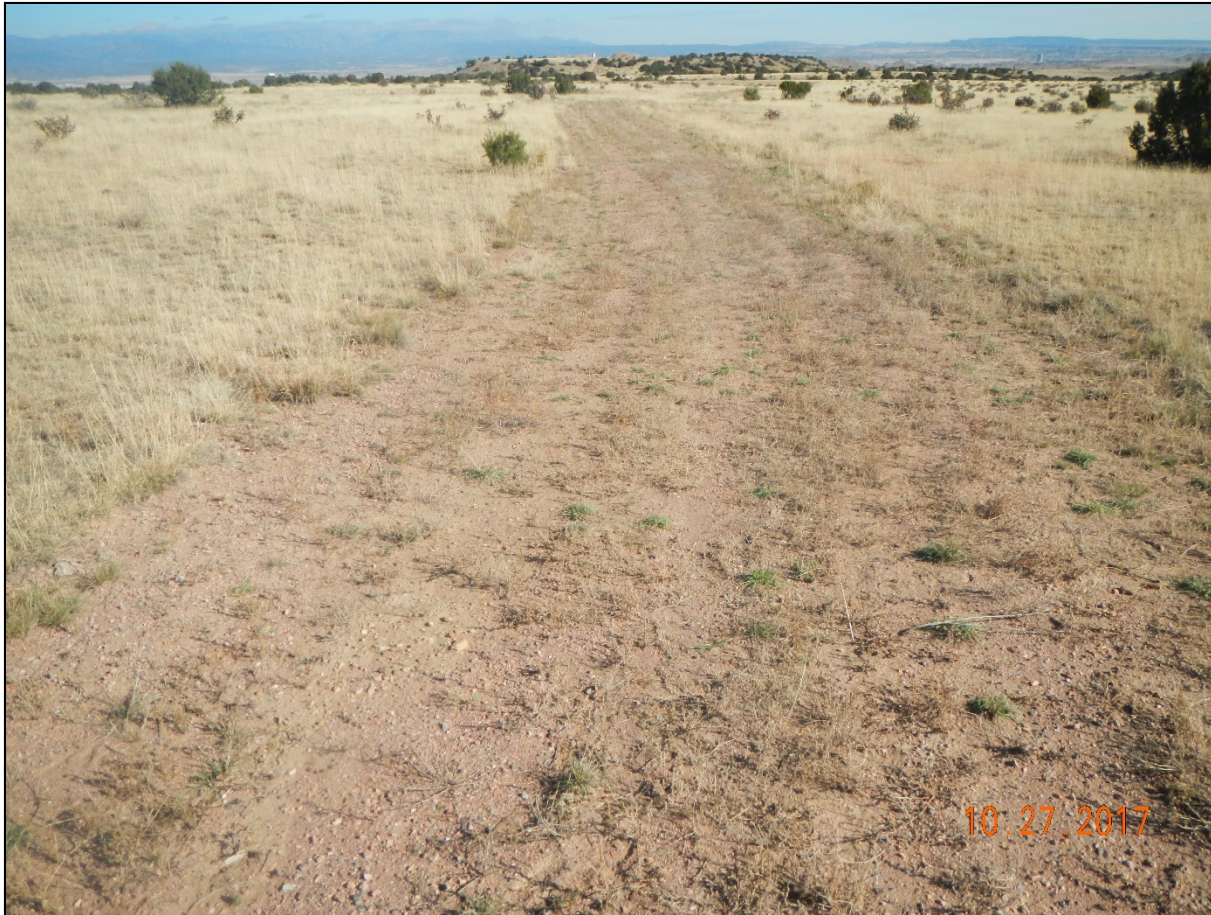
Photo 2. Facing northeast further along the former access road.

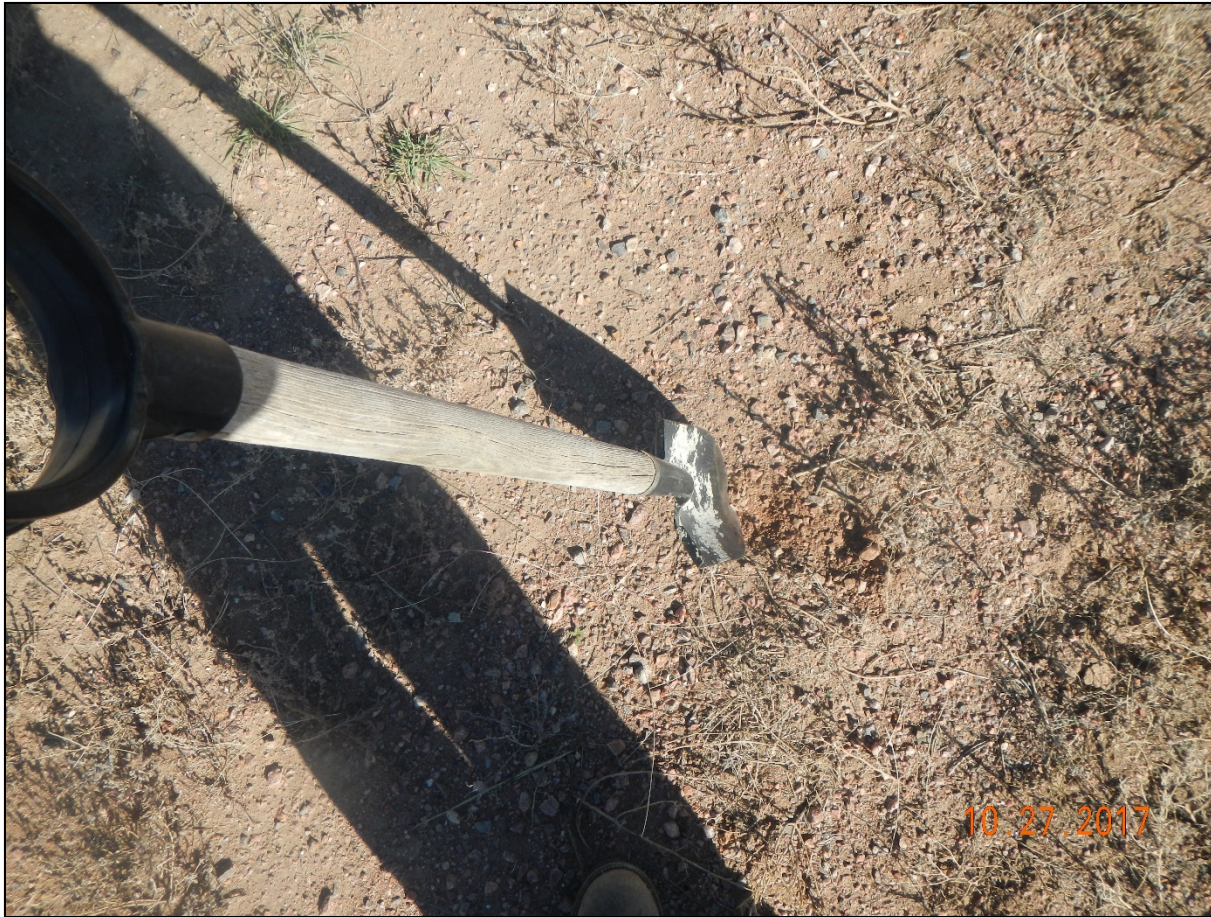
Photo 3. There are areas along the access road that gravel remains and soils are compacted.

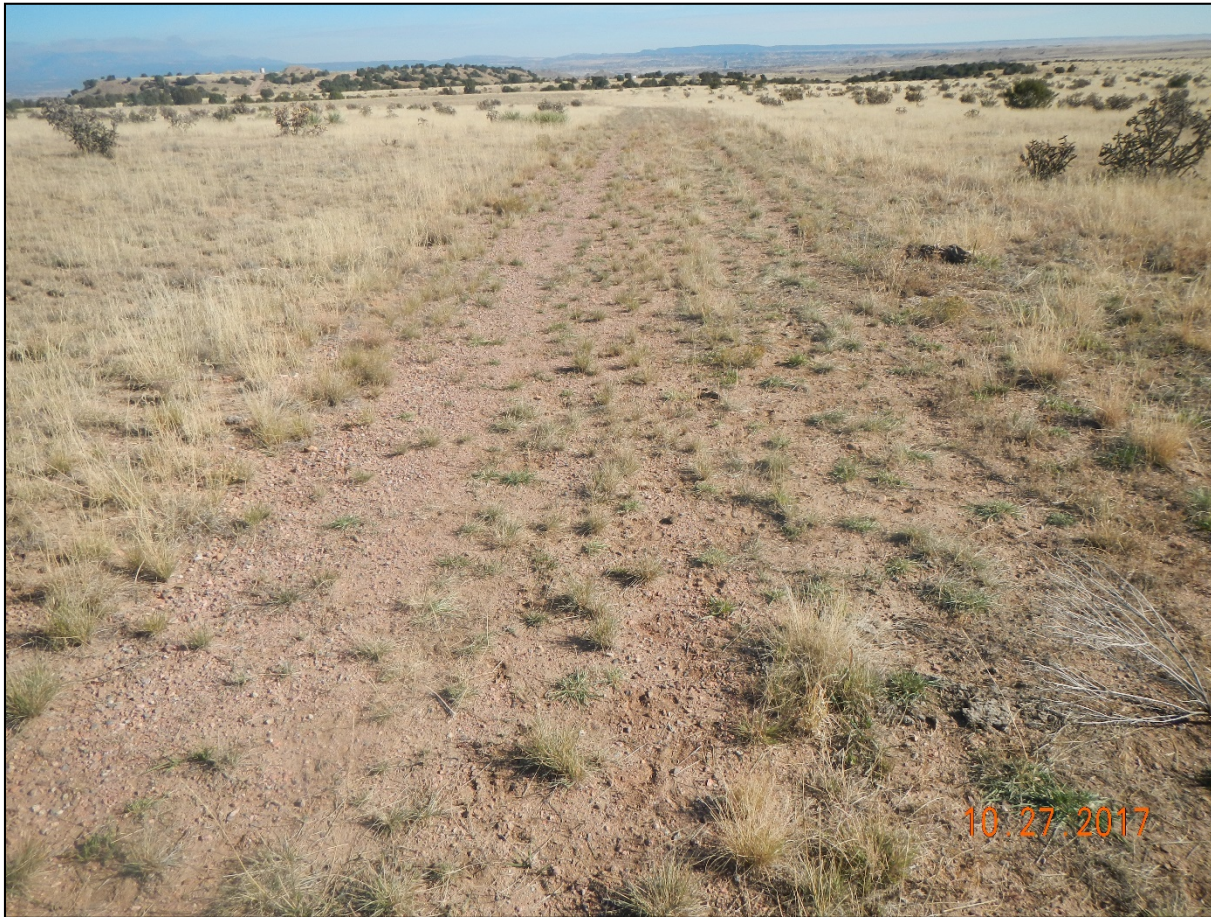
Photo 4. Facing northeast further along the former access road.

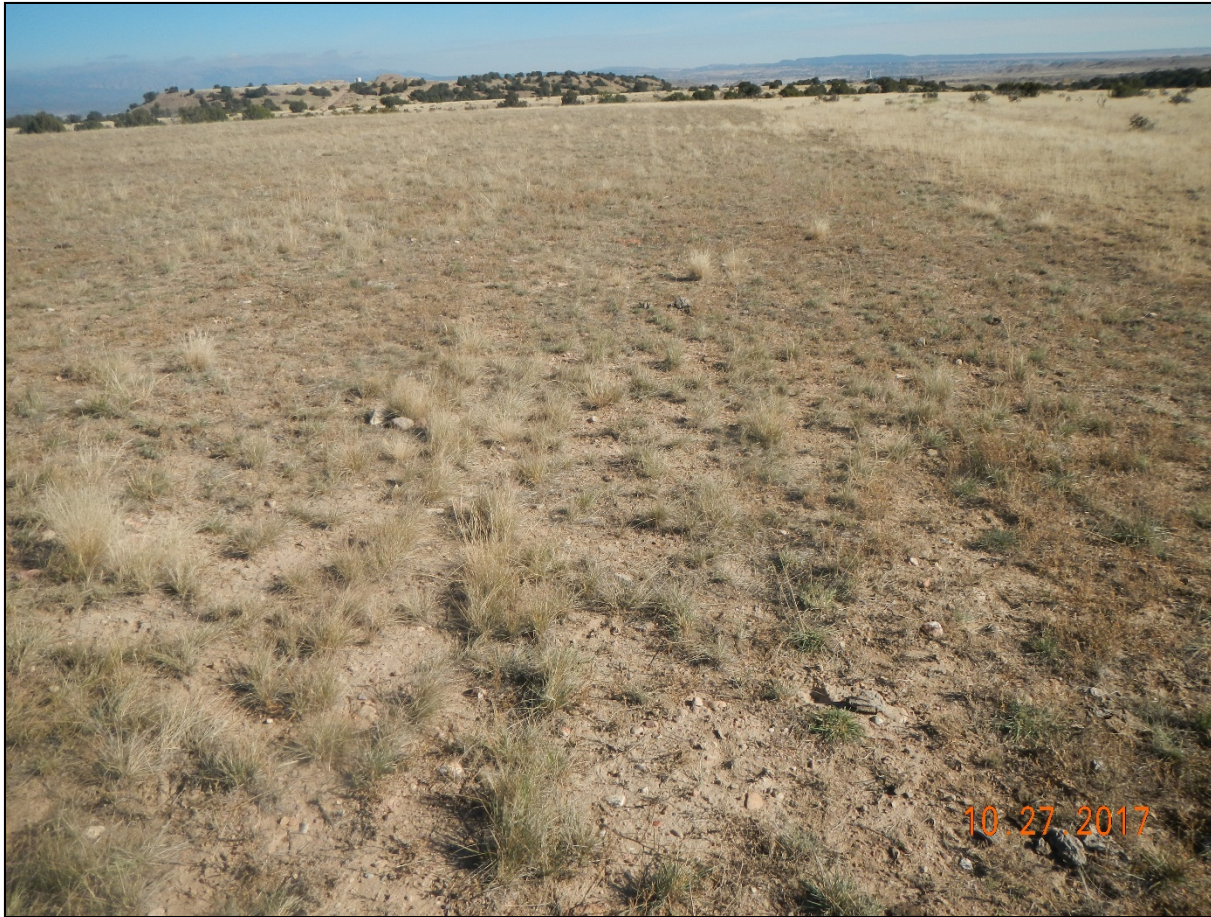
Photo 5. Facing north toward the location.

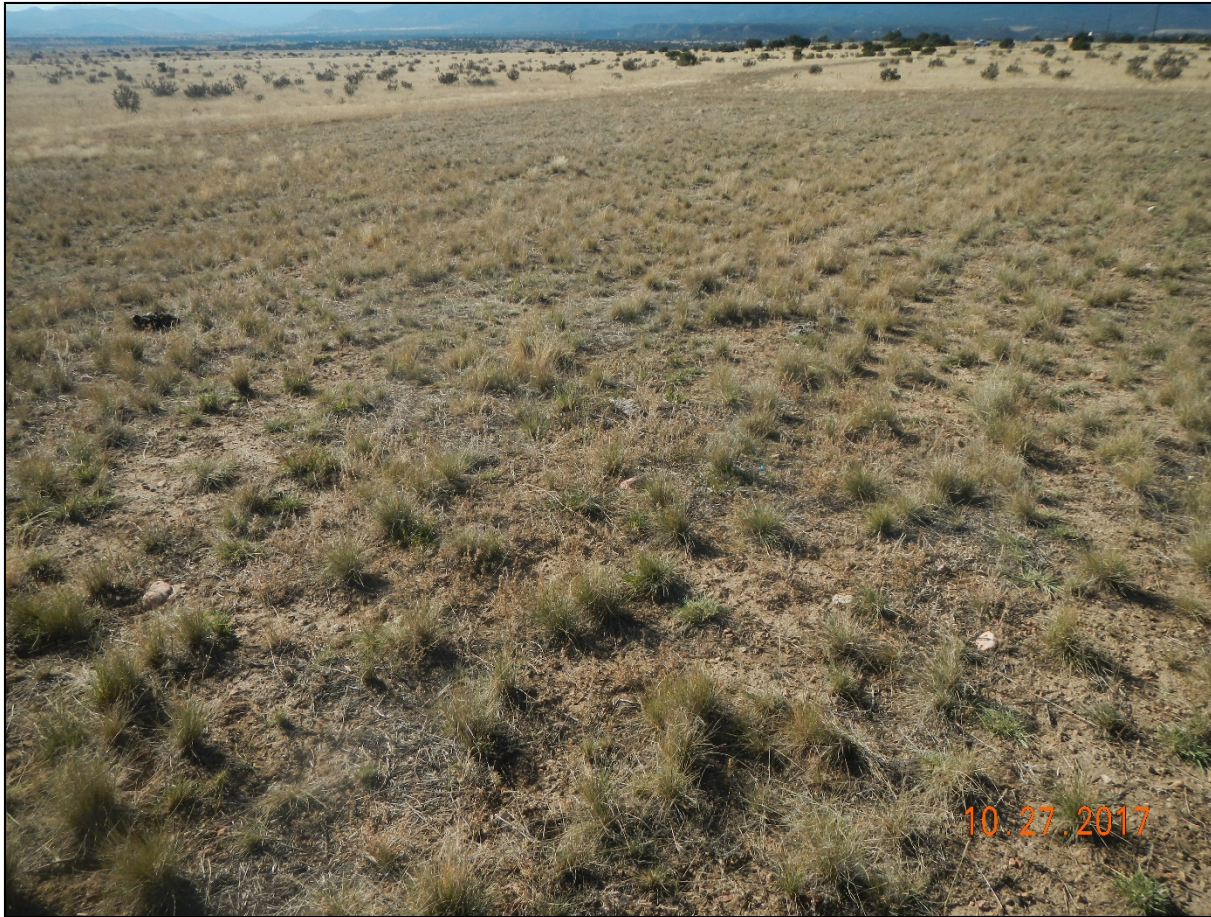
Photo 6. Facing south at the location. There is some desirable vegetation establishment at the location.

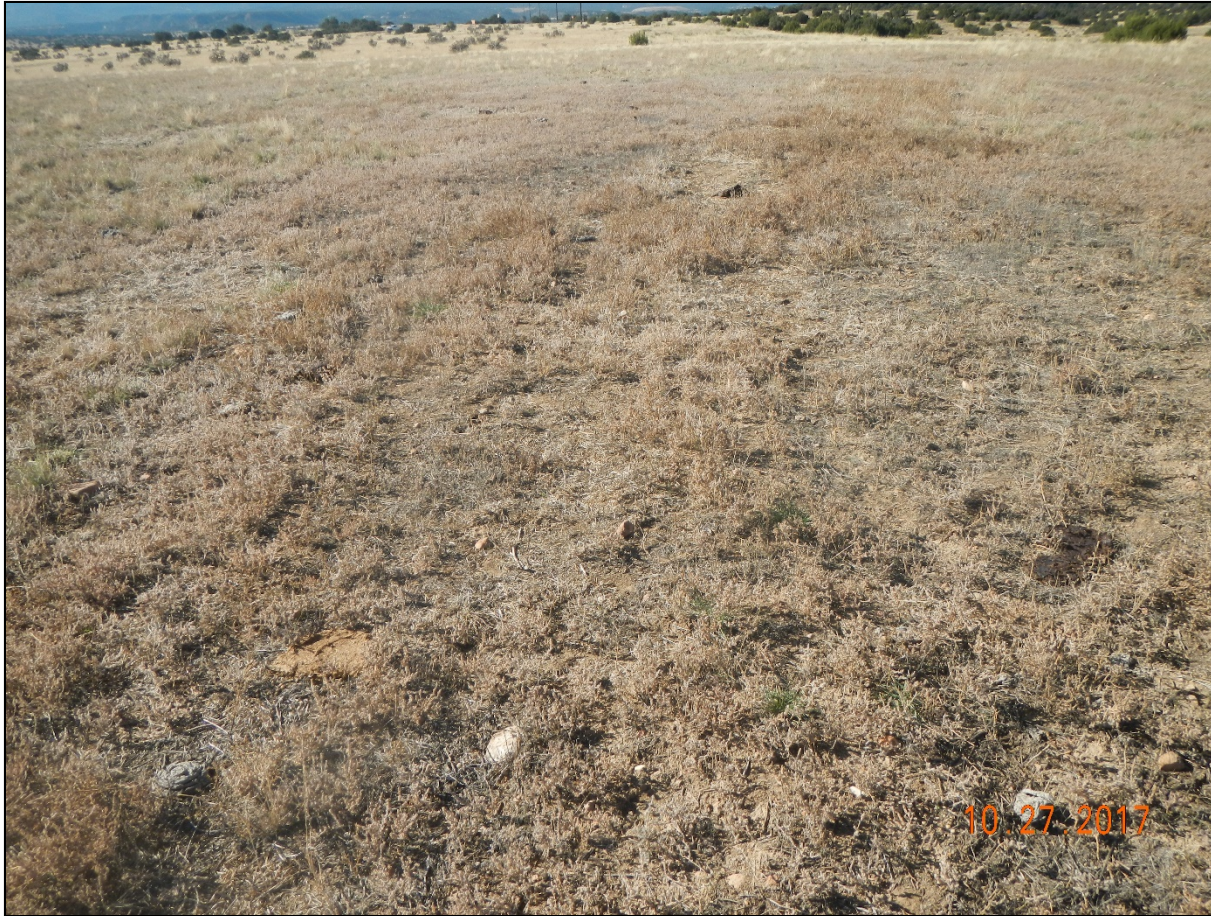
Photo 7. West side of the location facing south. There is predominately undesirable vegetation at this side of the location.

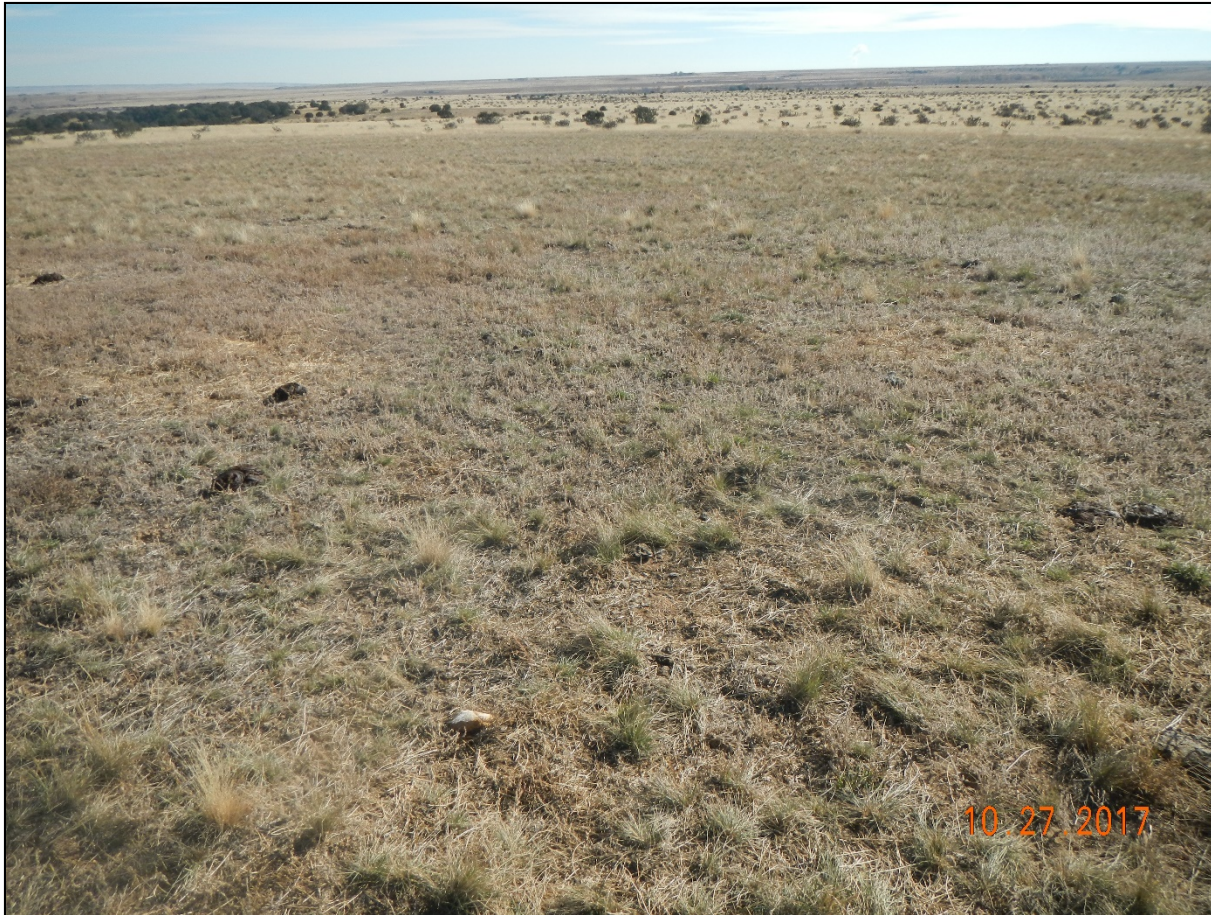
Photo 8. West side of the location facing east.

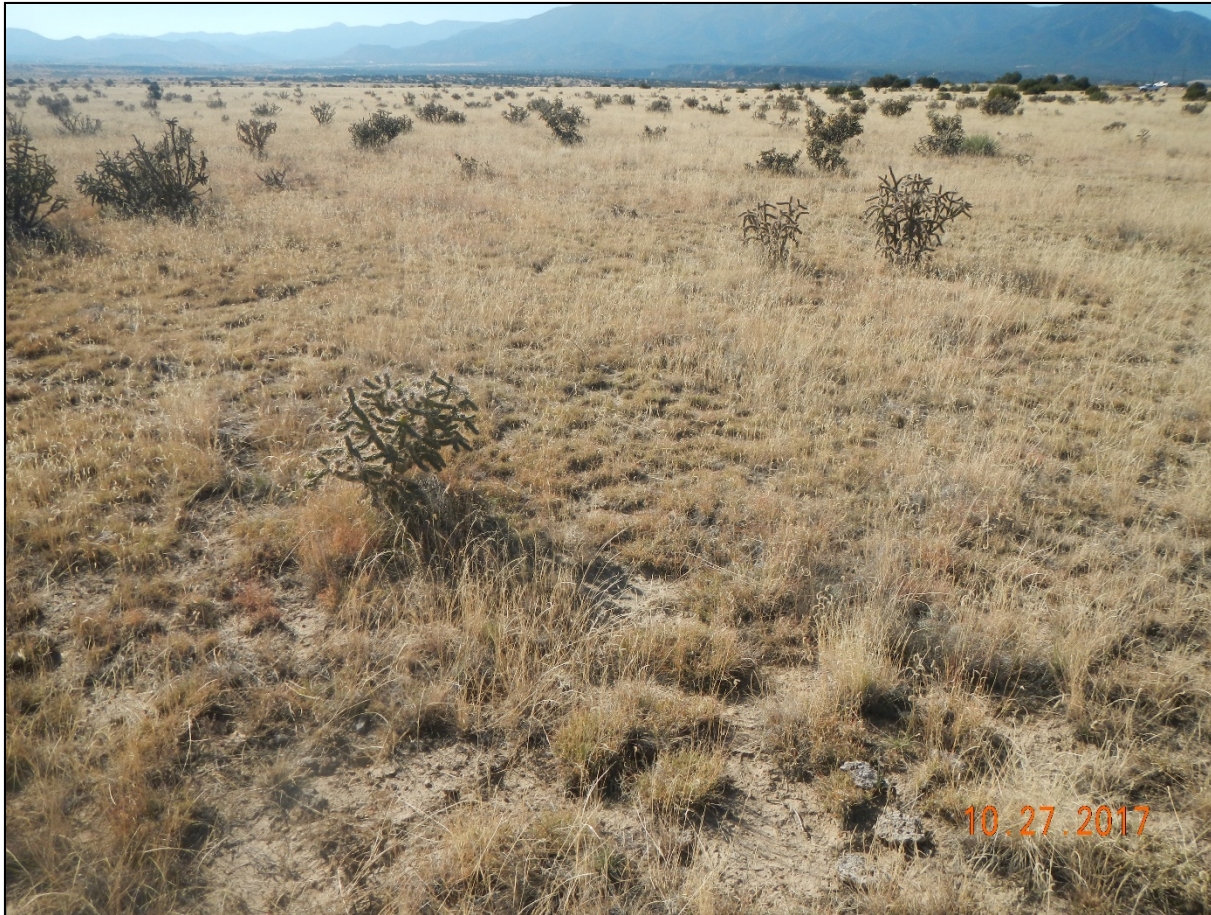
Photo 9. Facing south toward the surrounding undisturbed pasture.
