Inspection Photos

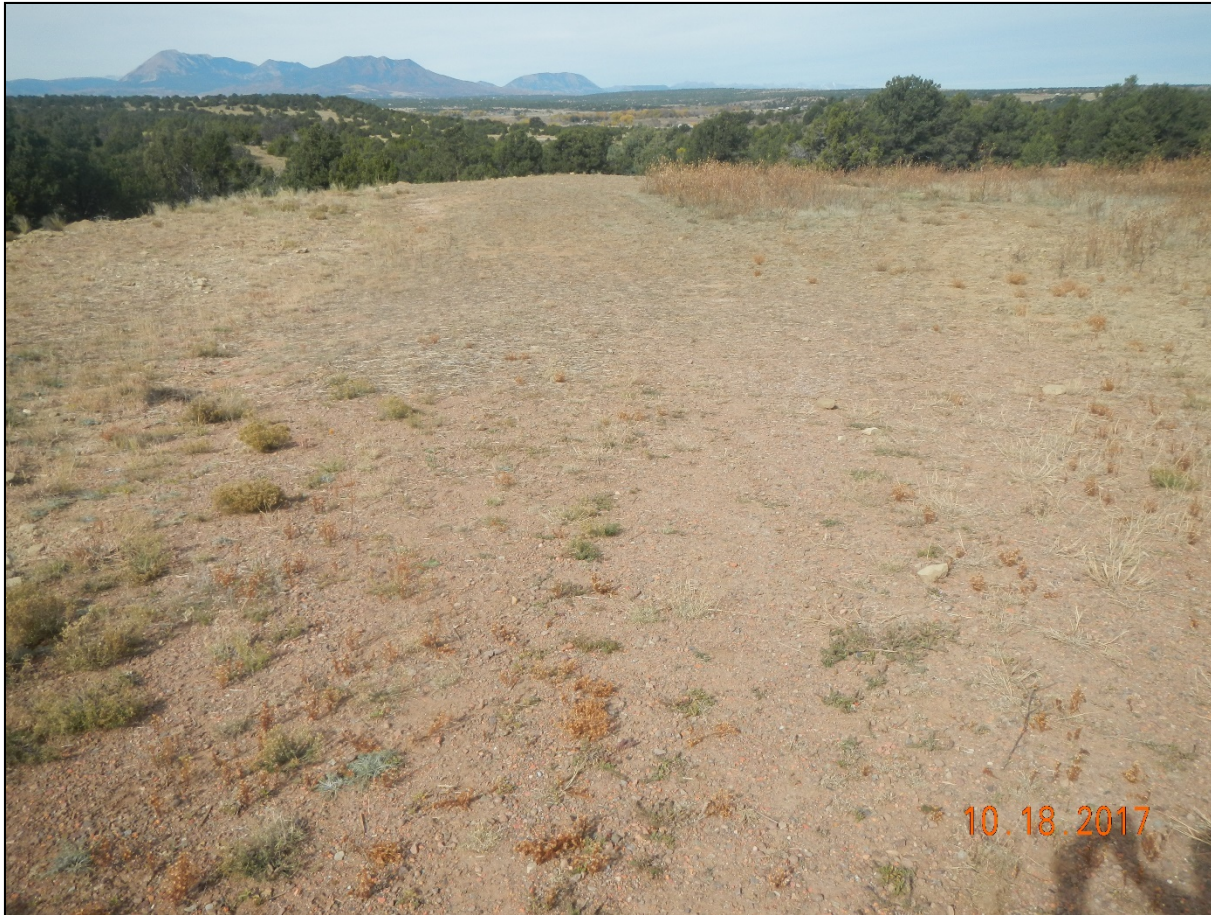
Photo 1. Facing northwest toward the location.

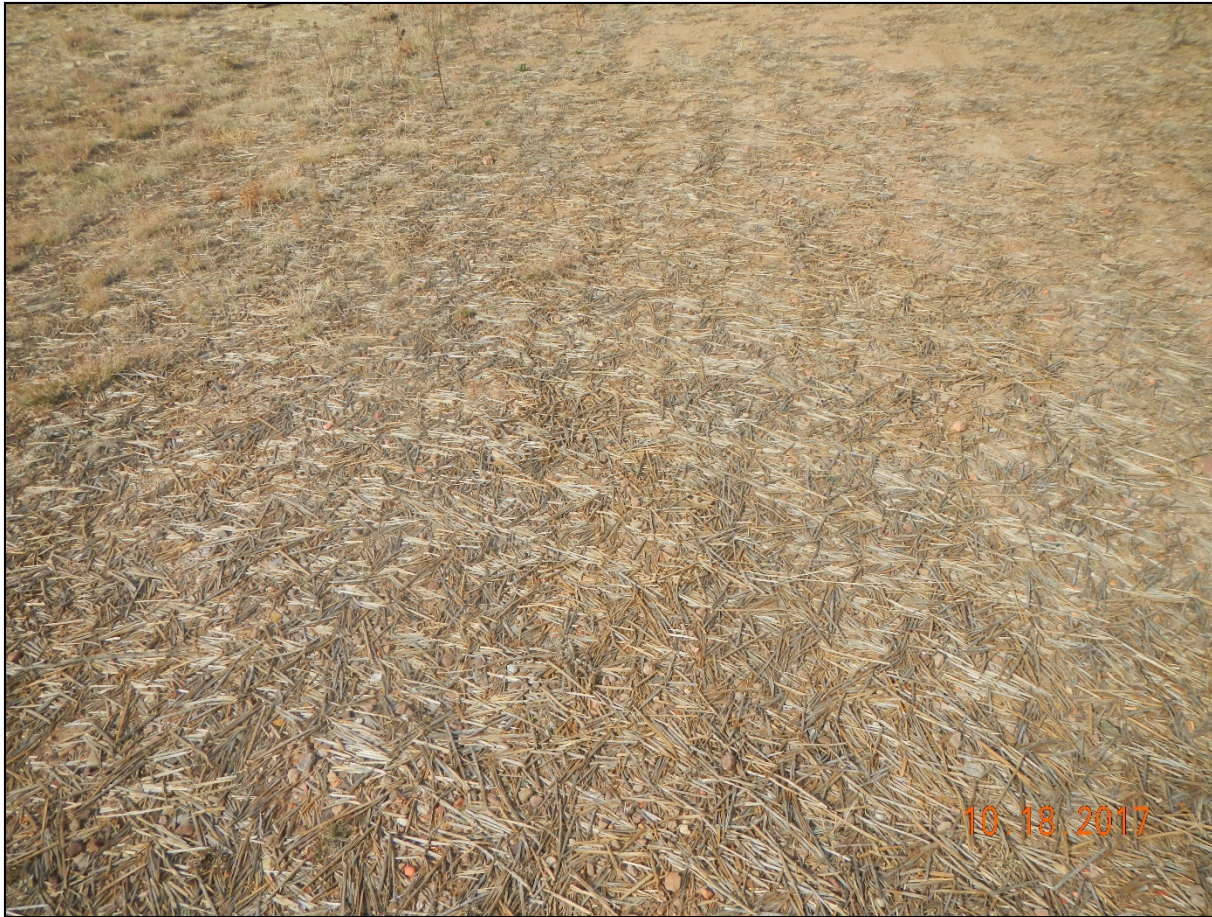
Photo 2. There are areas of the location that are covered with wood mulch.

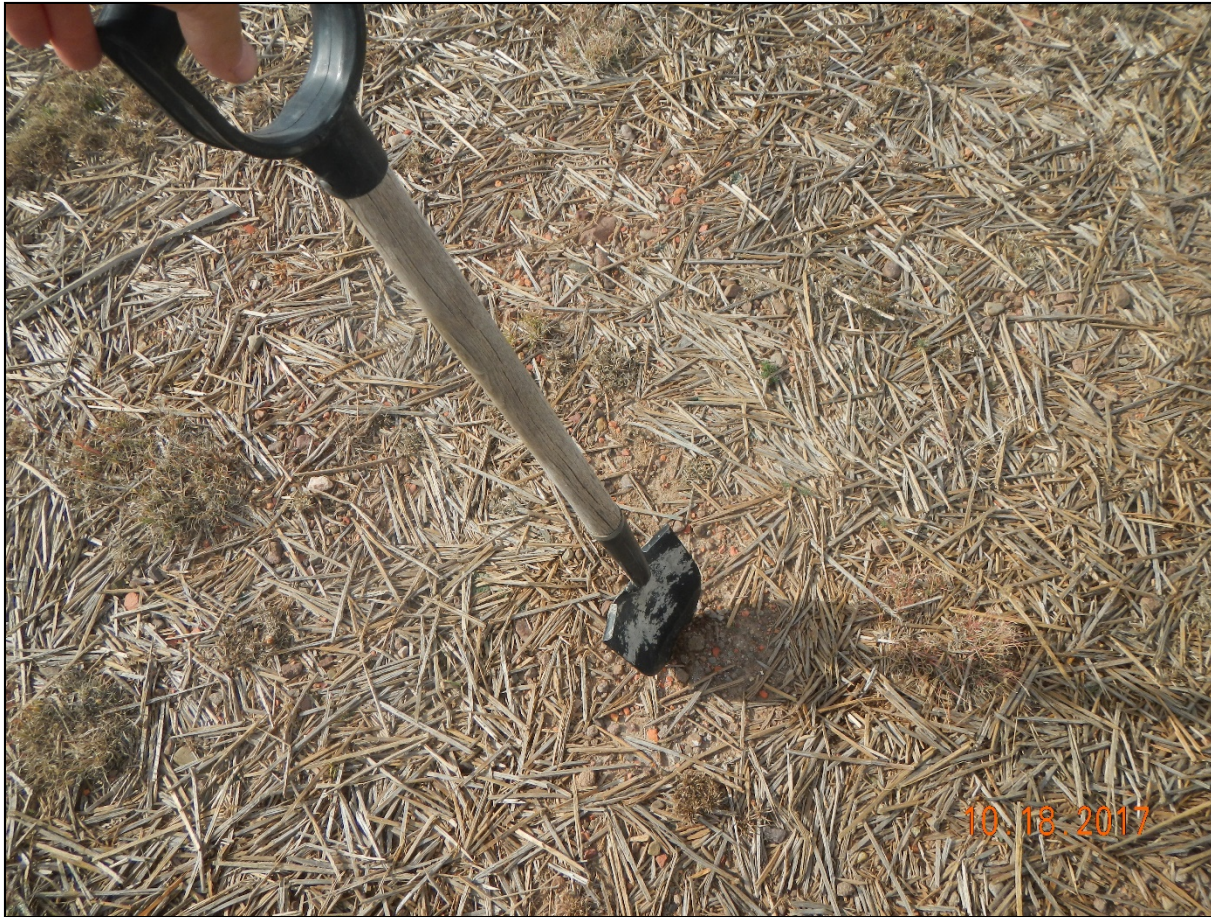
Photo 3. Some of the areas where there is wood mulch appear to have compacted soils. There is minimal vegetation establishment in these areas.

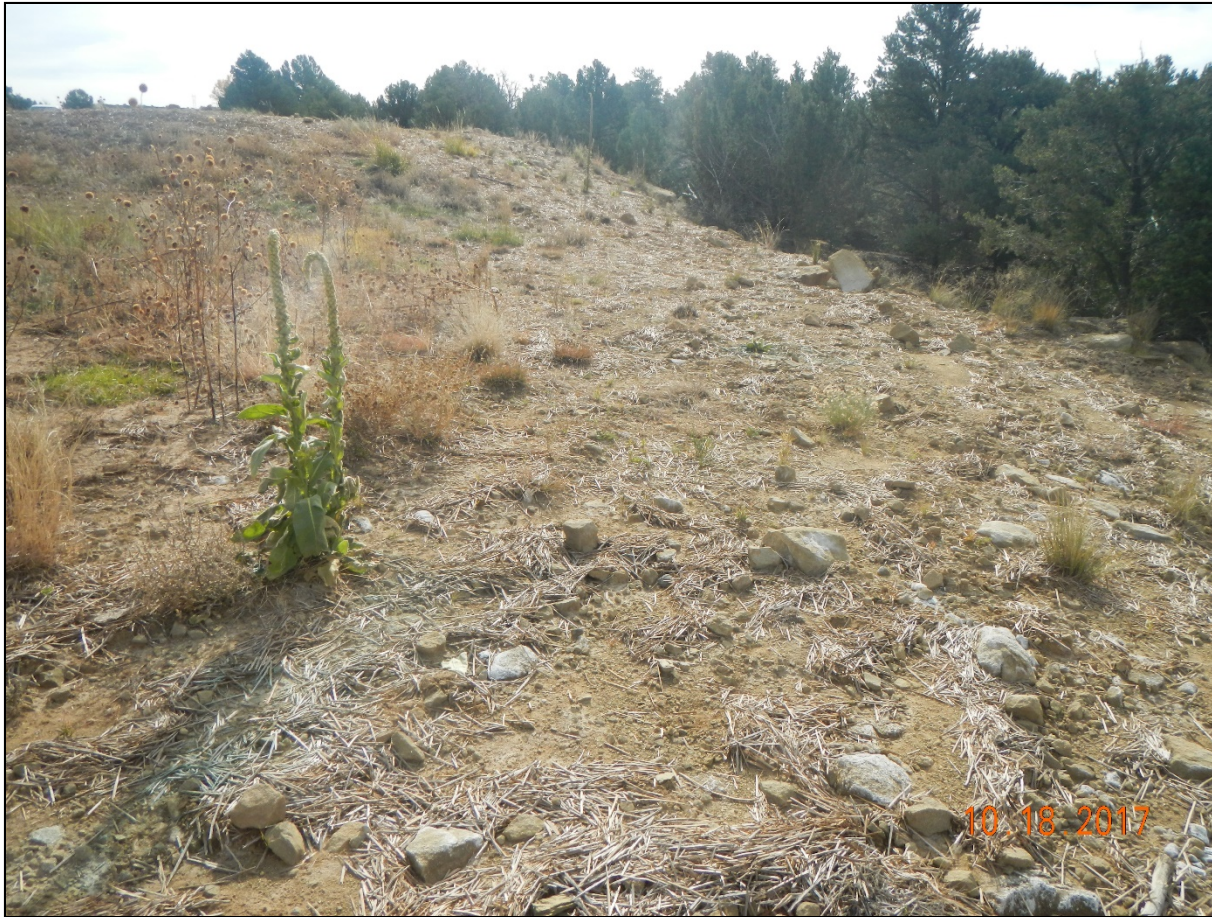
Photo 4. Facing south along the west side of the location.

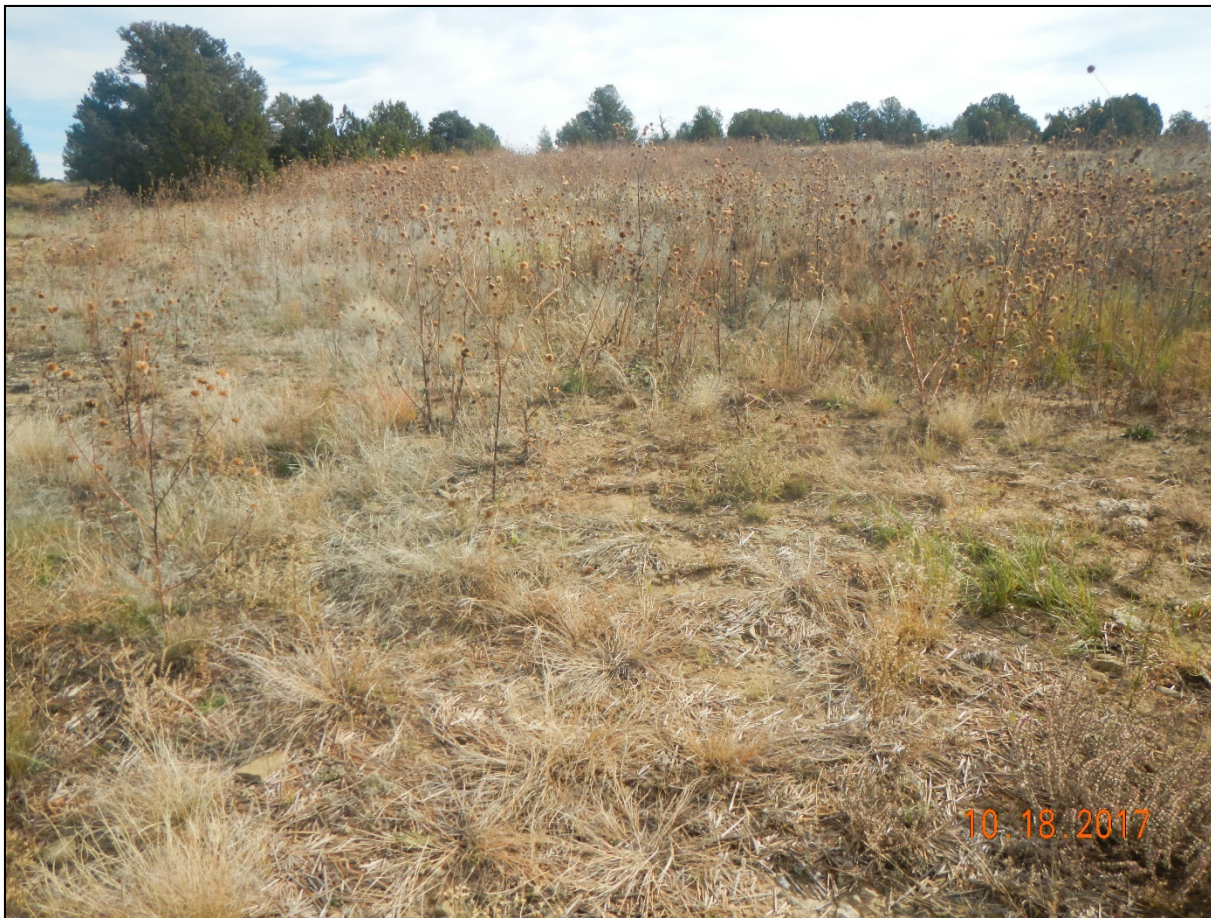
Photo 5. Northwest side of the location facing east.

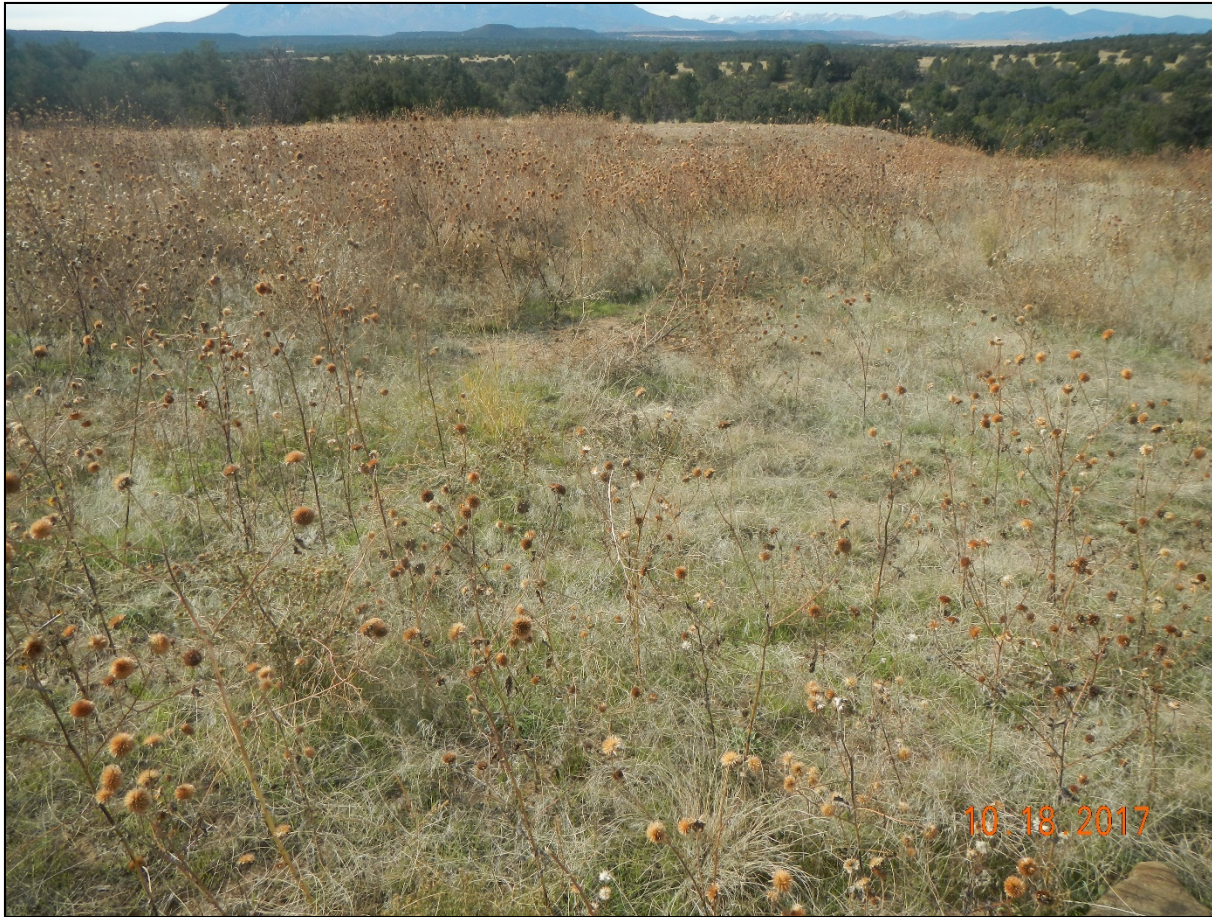
Photo 6. Northeast side of the location facing southwest.

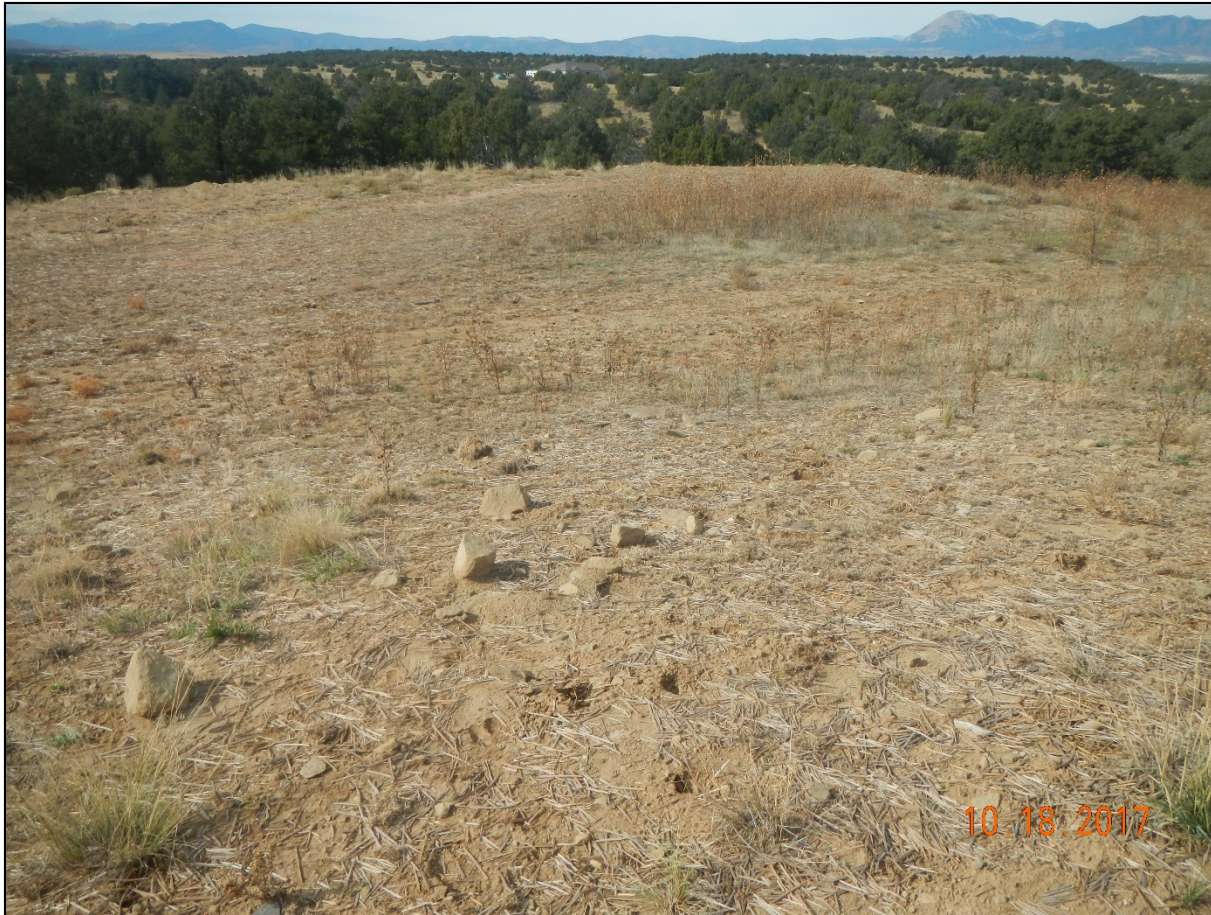
Photo 7. East side of the location facing west.
