Inspection Photos

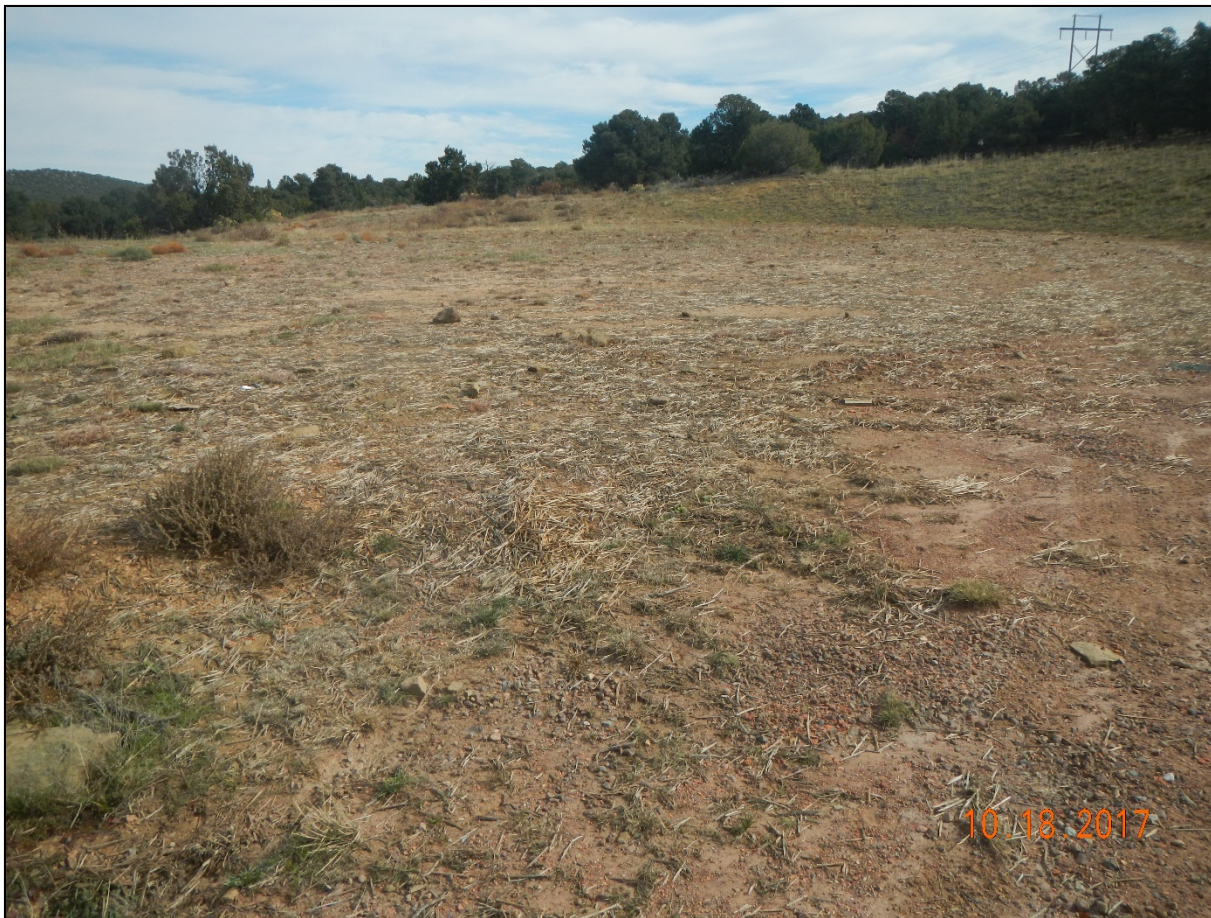
Photo 1. Facing east toward the location.

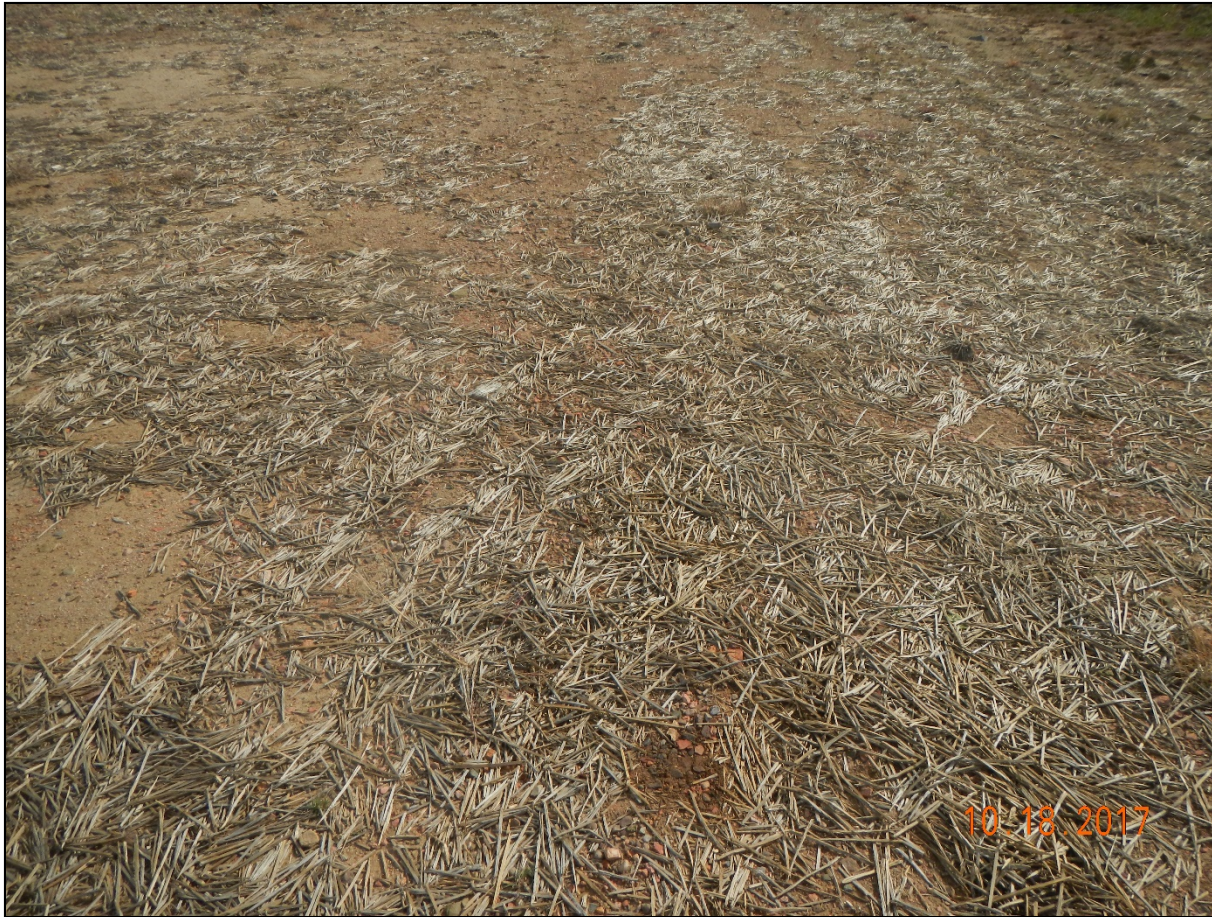
Photo 2. There is wood mulch applied to the soil surface.

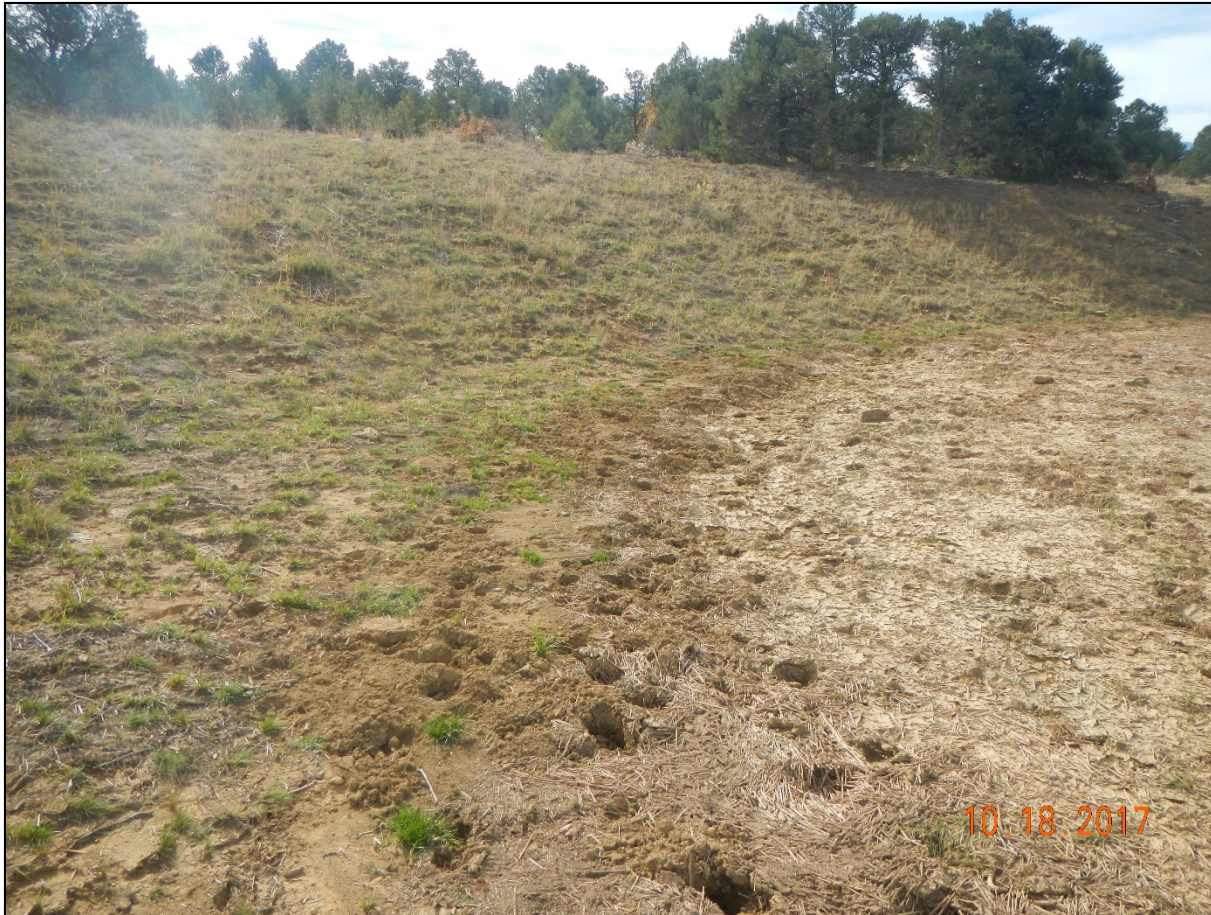
Photo 3. Facing toward the east cut slope.

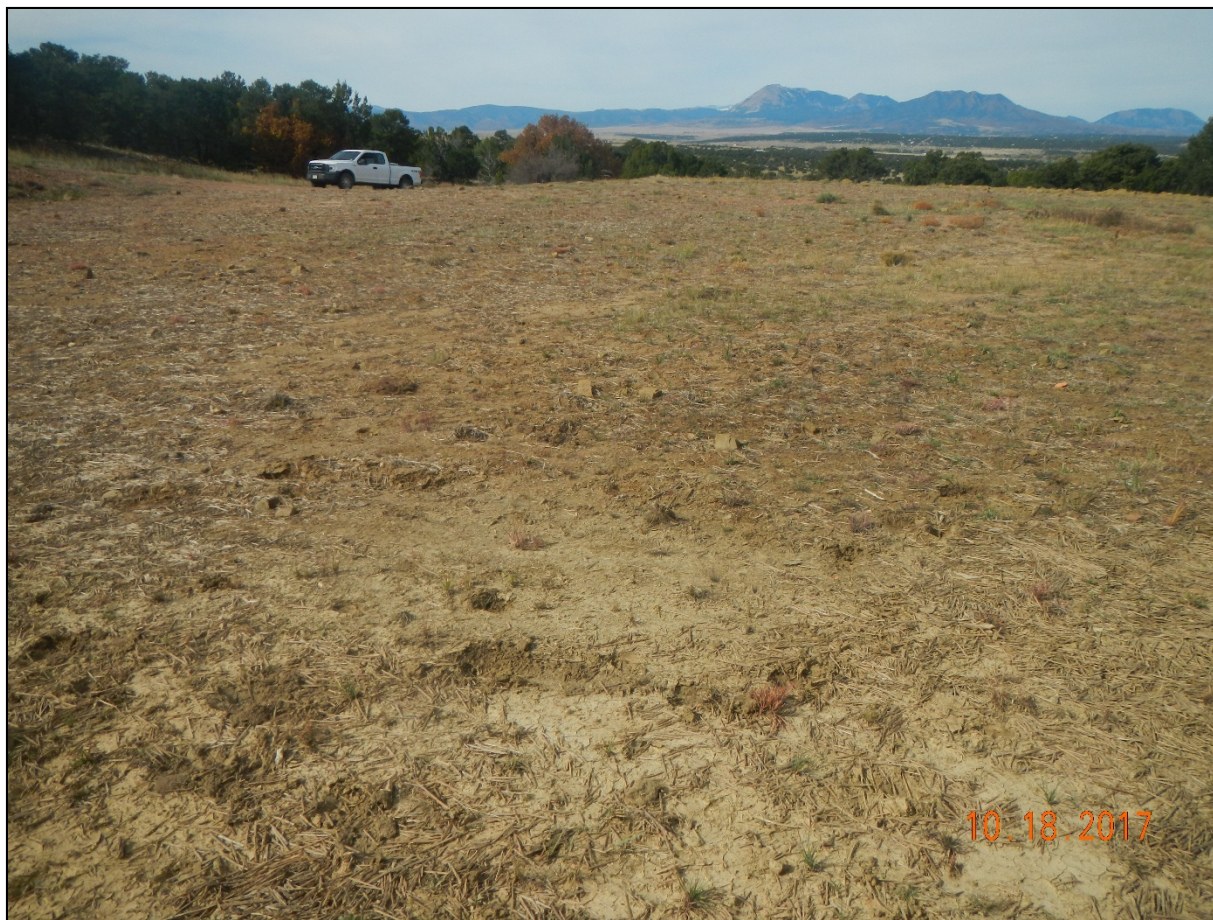
Photo 4. Facing west at the location.

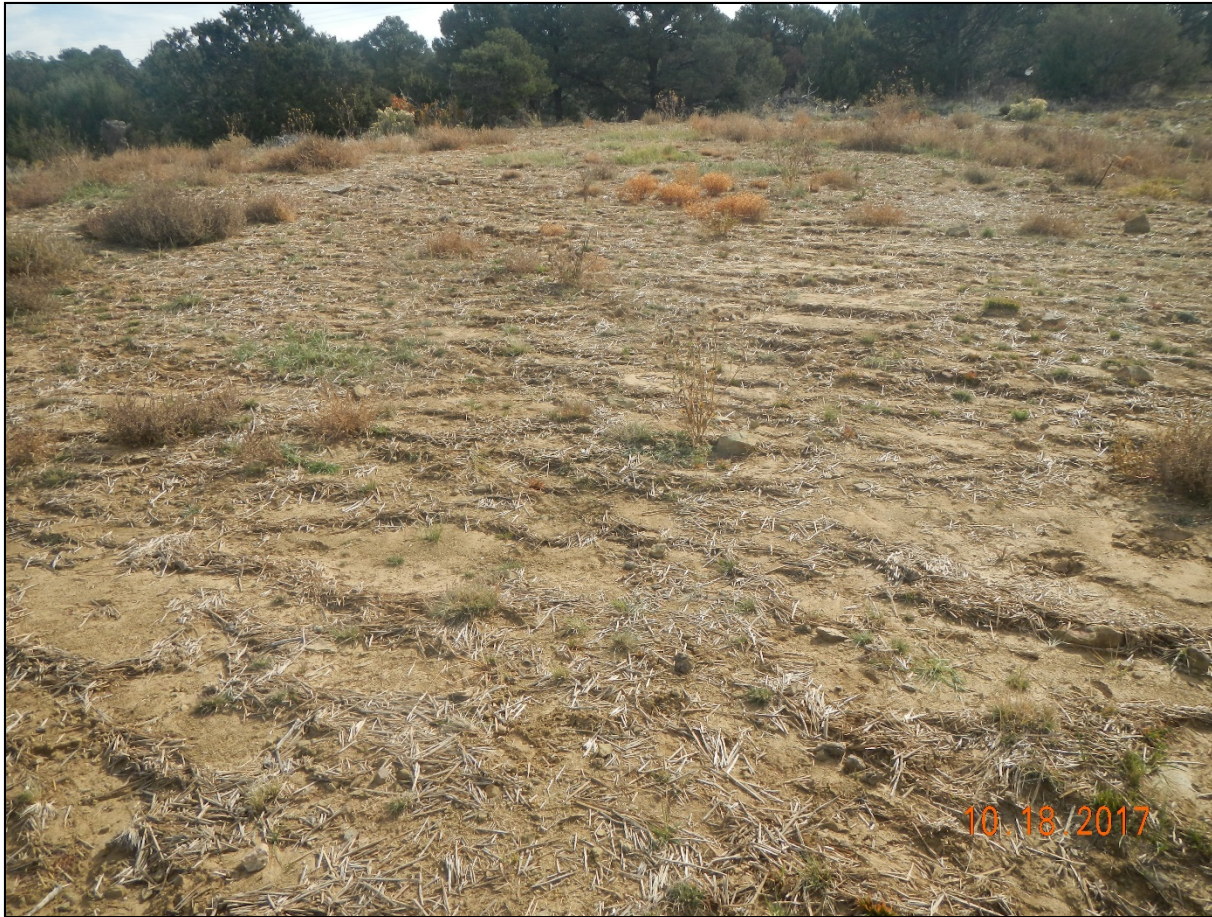
Photo 5. Facing toward the northeast side of the location. There is signs that stormwater has displaced the wood mulch.

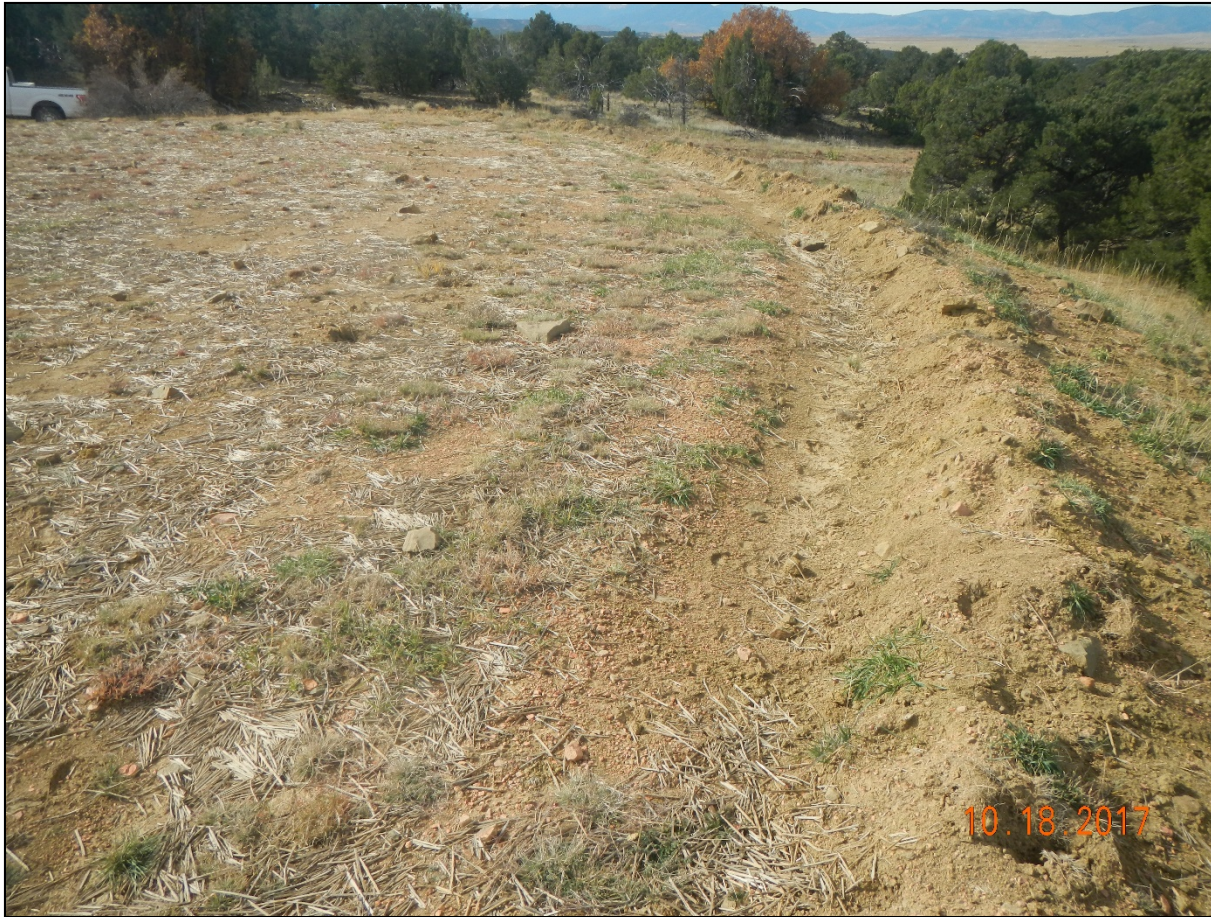
Photo 6. Facing west along the cut slope. A berm has been placed at the edge of the pad.

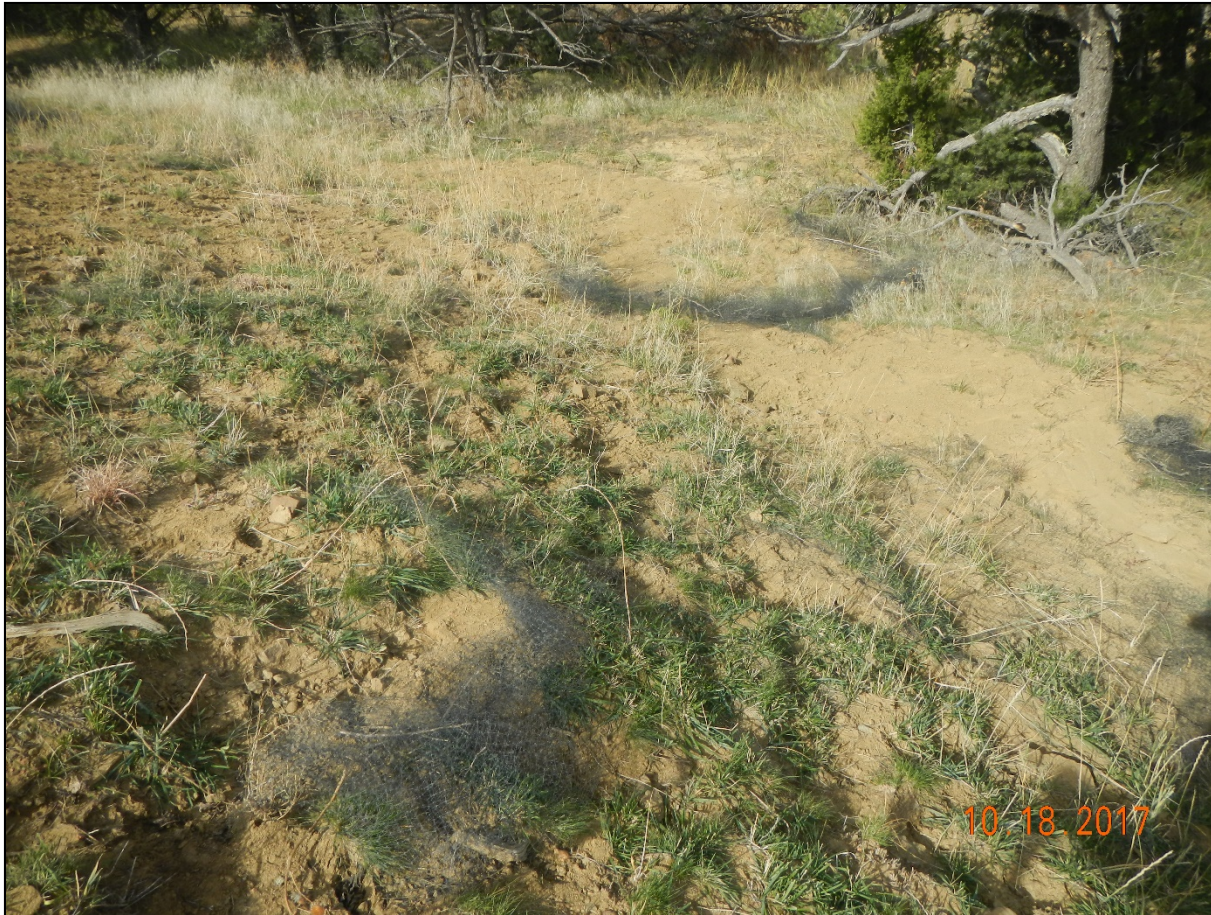
Photo 7. The plastic netting debris remains and has not been removed.

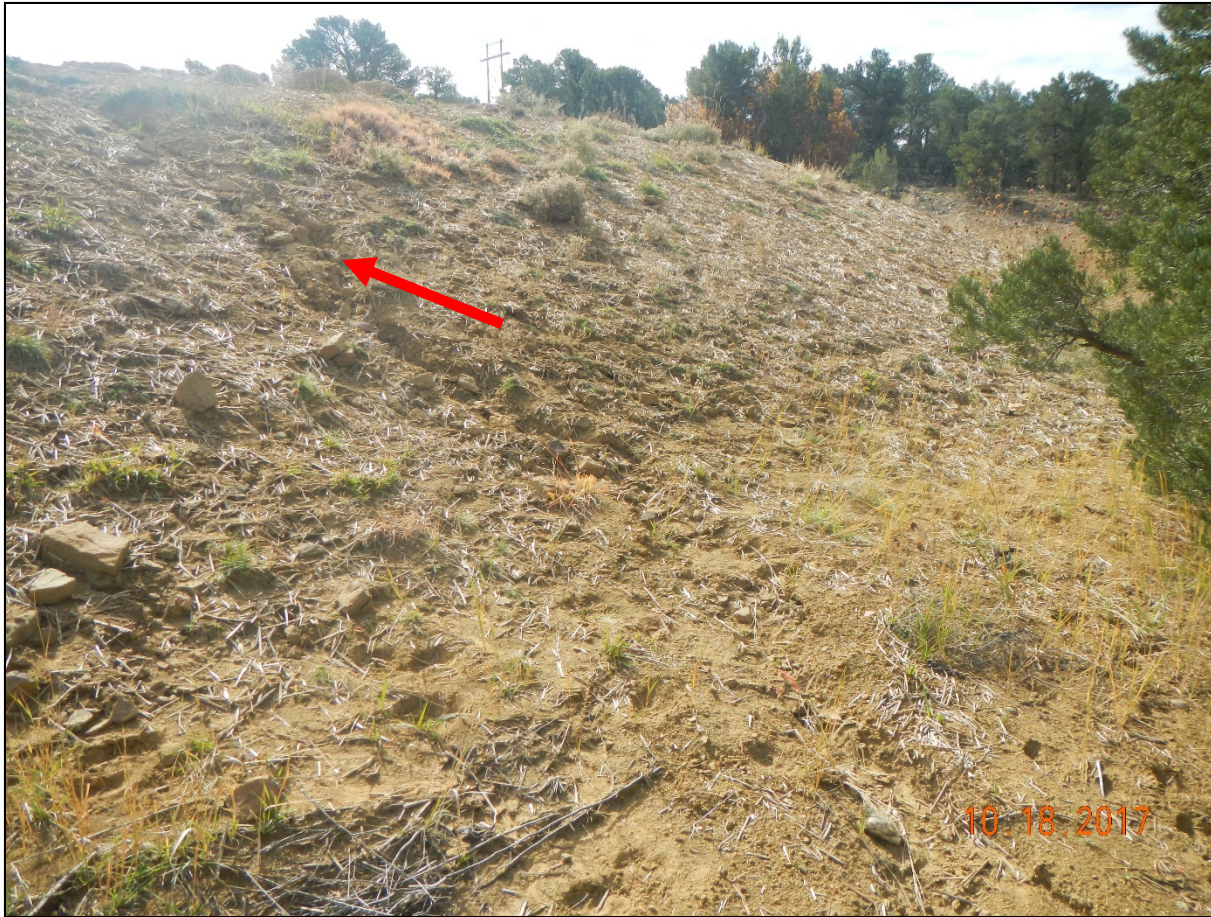
Photo 8. Facing toward the fill slope. There is signs of erosion occurring off the fill slope.

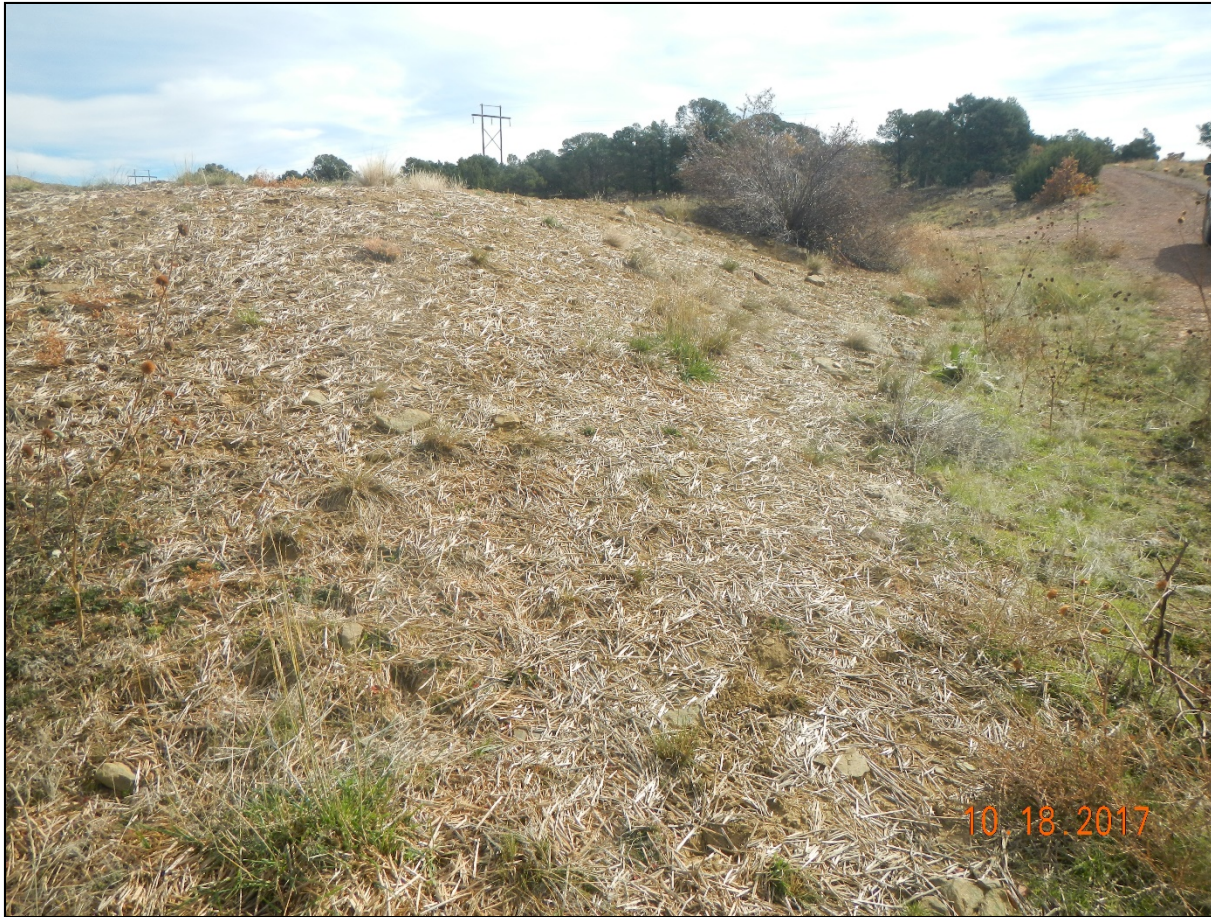
Photo 9. Facing southeast along the fill slope. Wood mulch has been applied along the fill slope.
