Inspection Photos

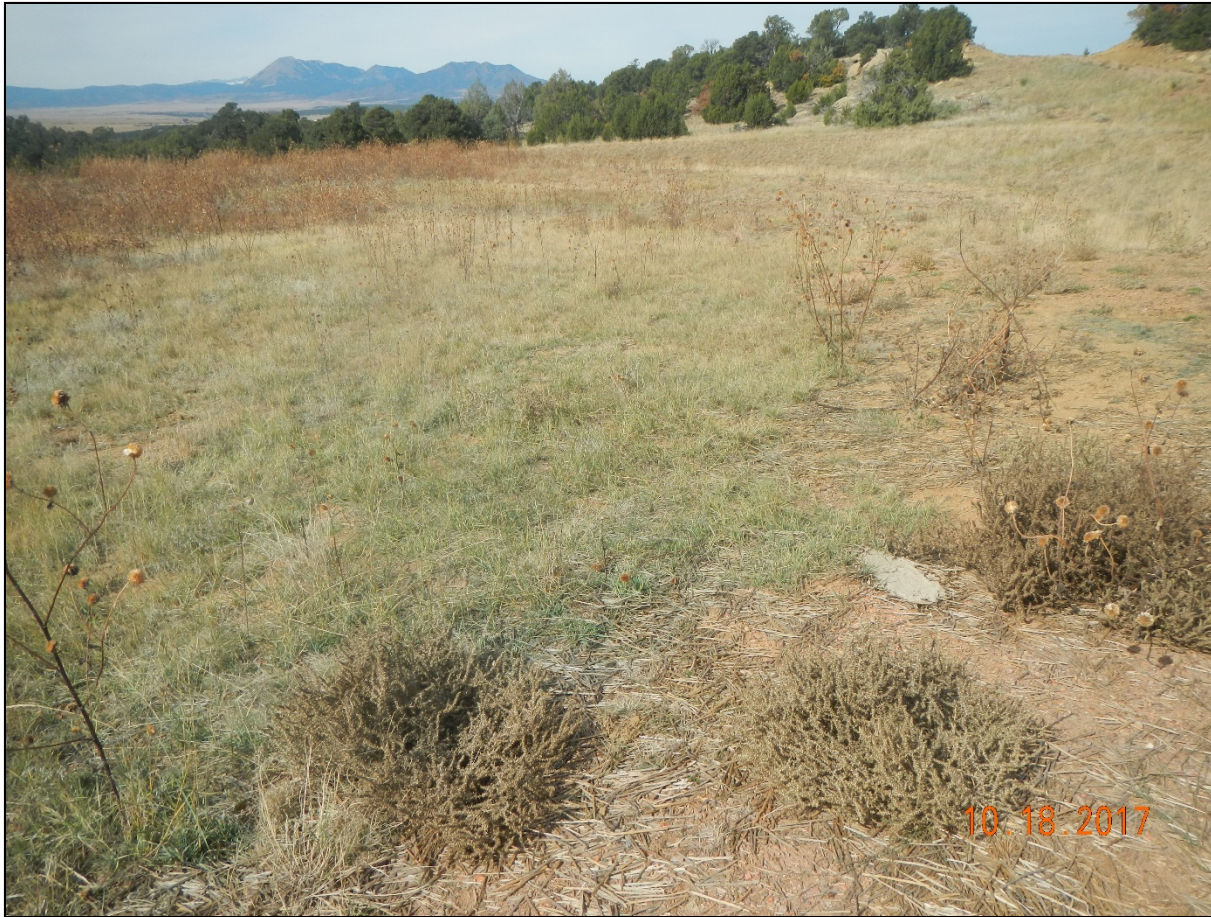
Photo 1. Facing northwest toward the location.

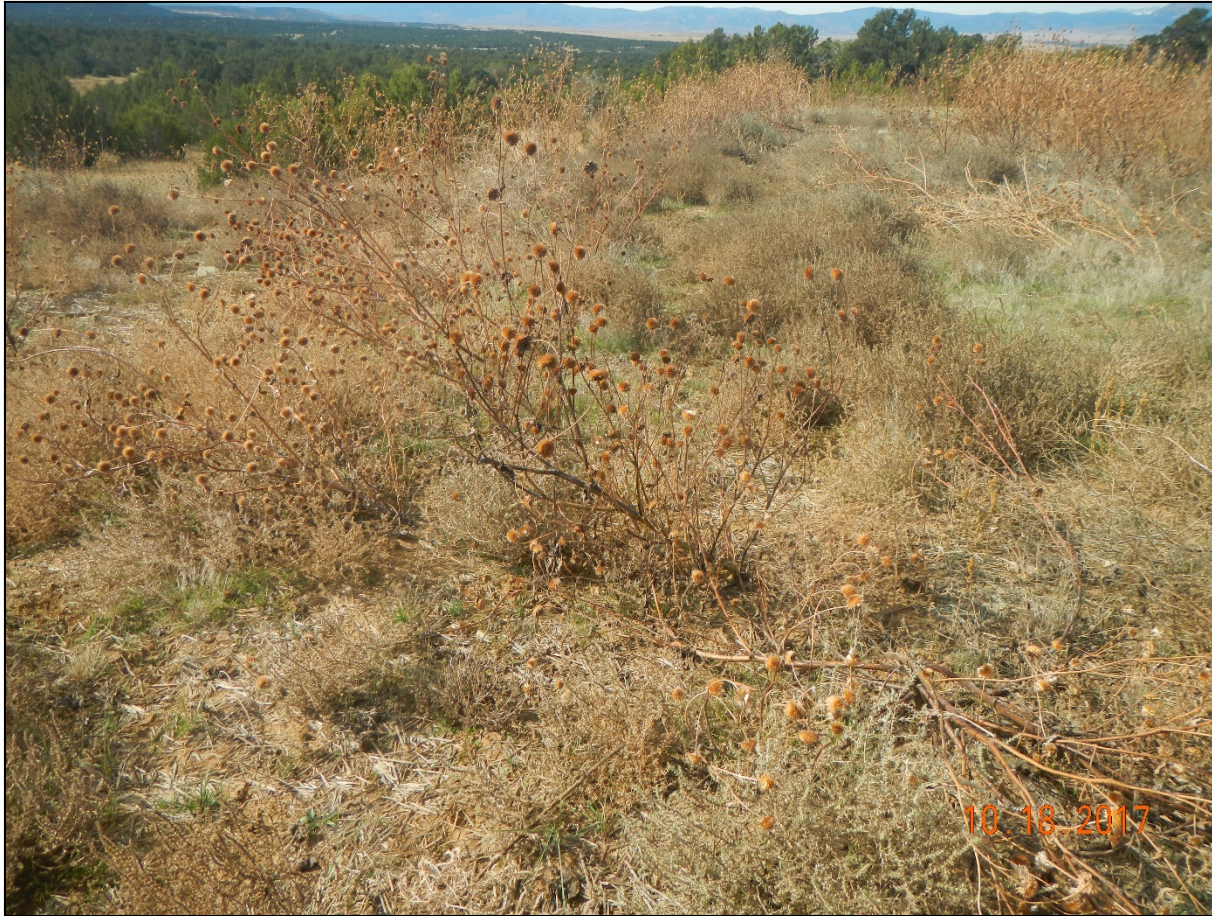
Photo 2. Facing southwest along the south side of the location. There is some undesirable weed debris and some desirable vegetation growth in this area.

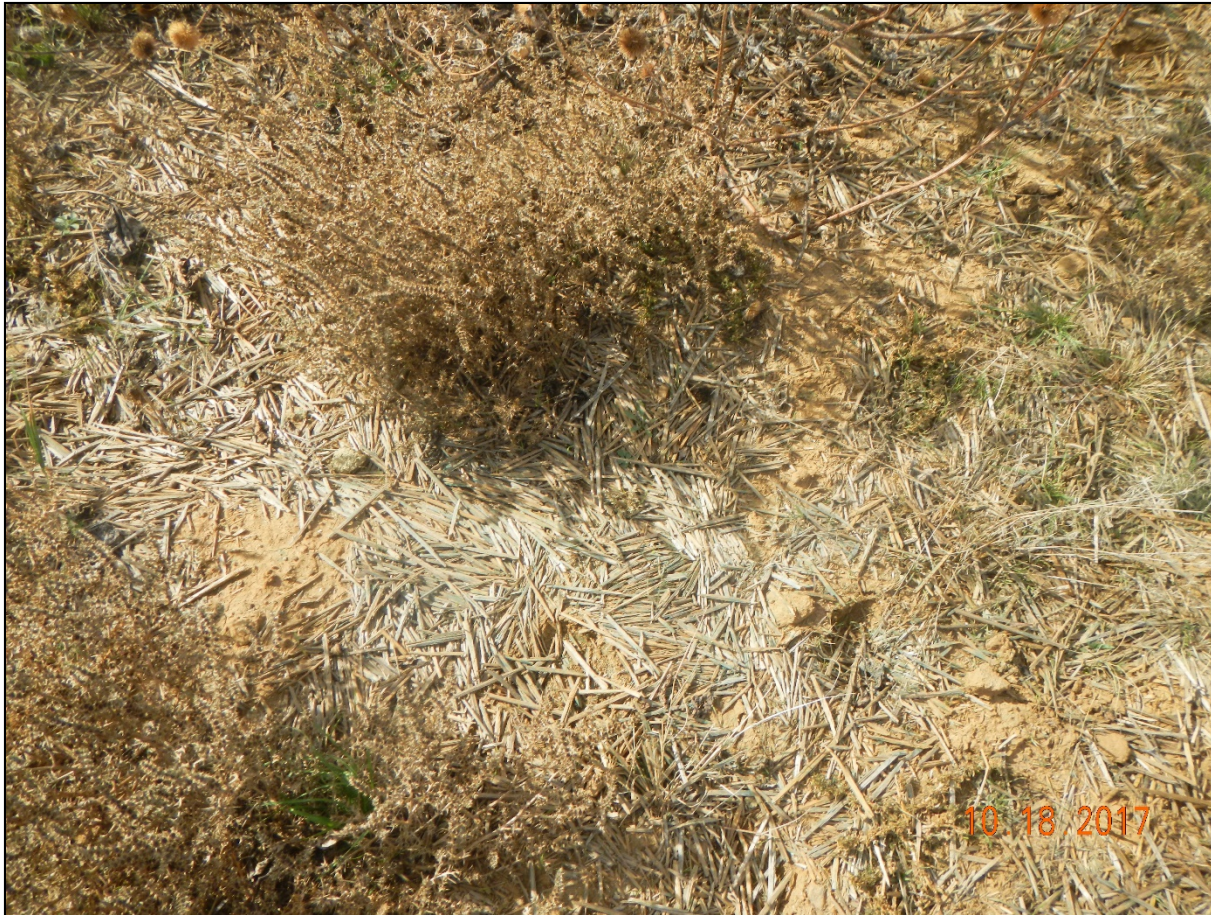
Photo 3. There is wood straw mulch applied to bare areas of the location.

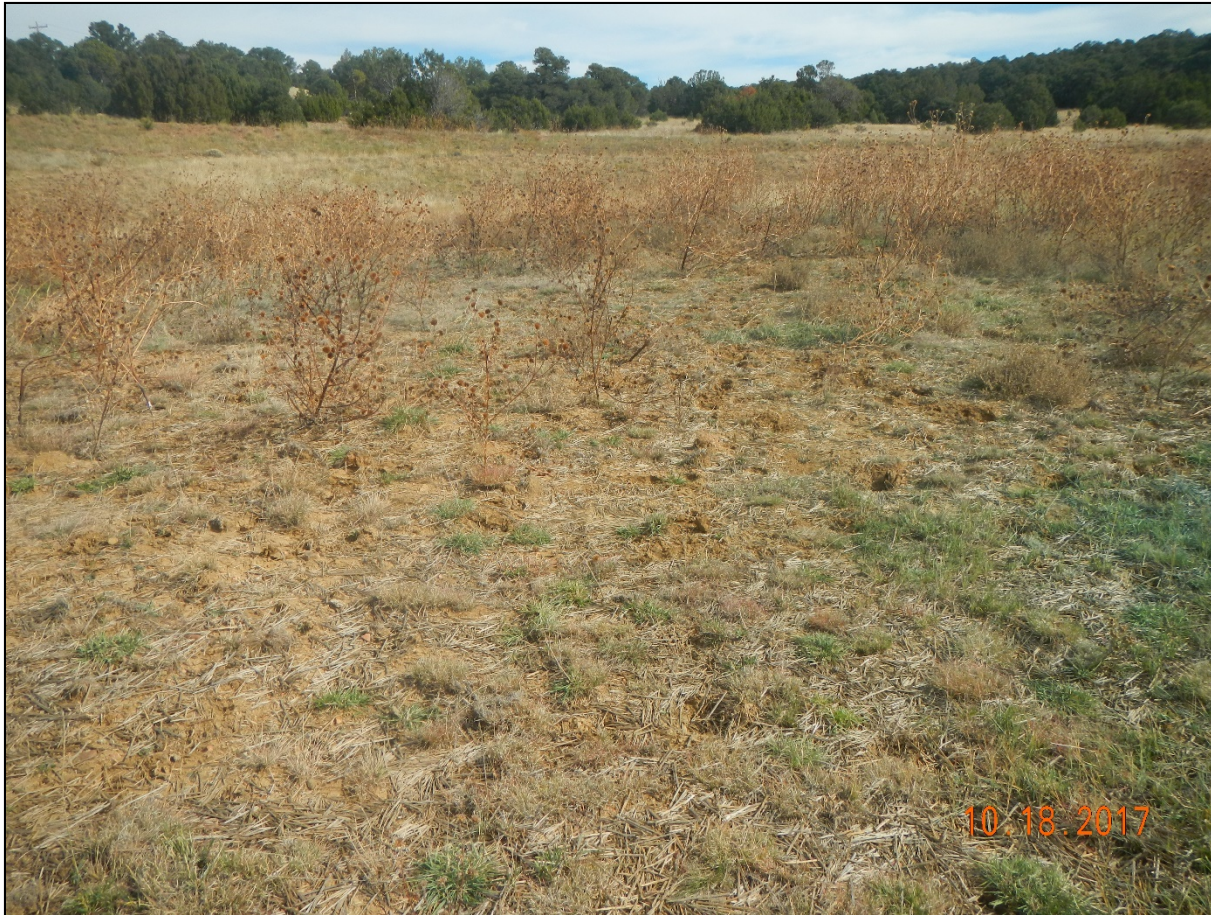
Photo 4. West side of the location facing east.

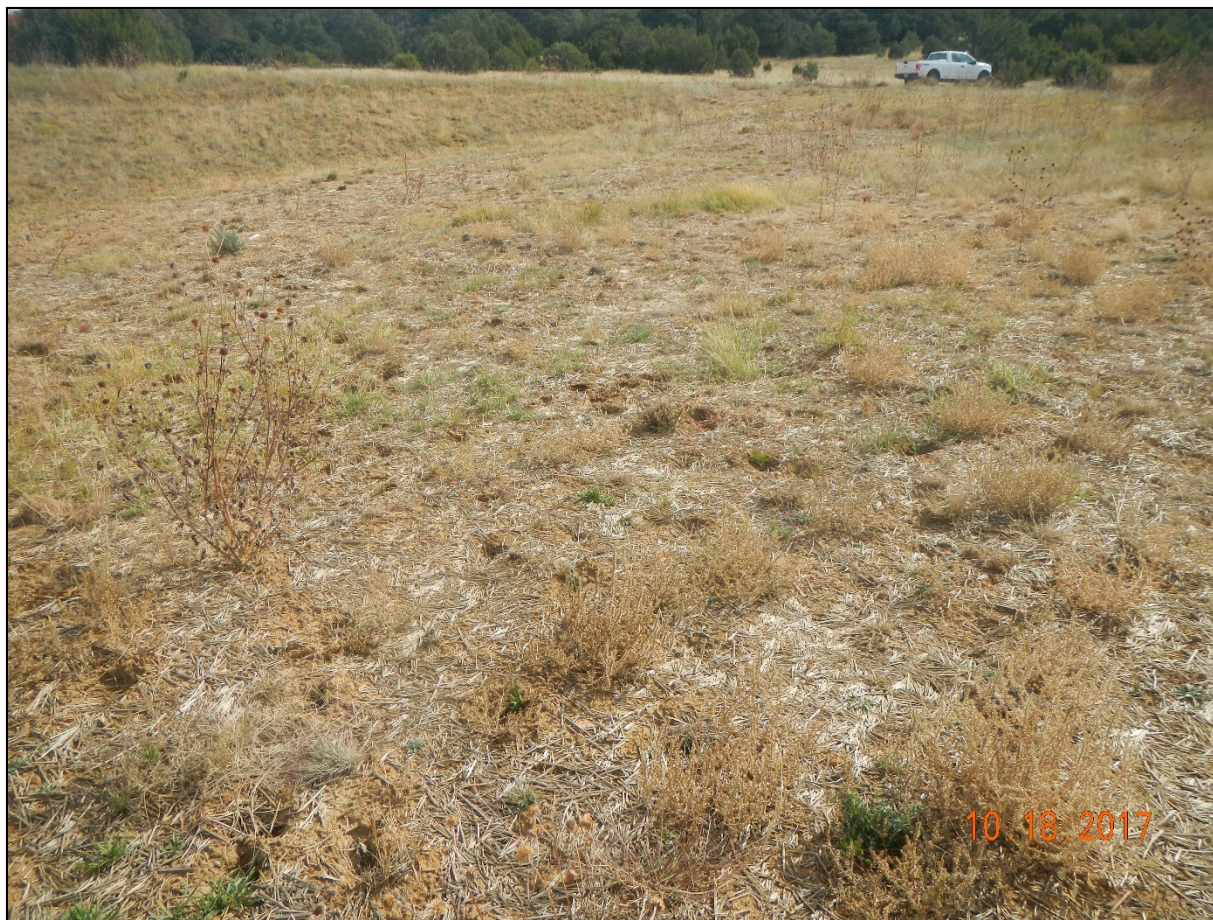
Photo 5. Facing southeast at the location.
