Inspection Photos

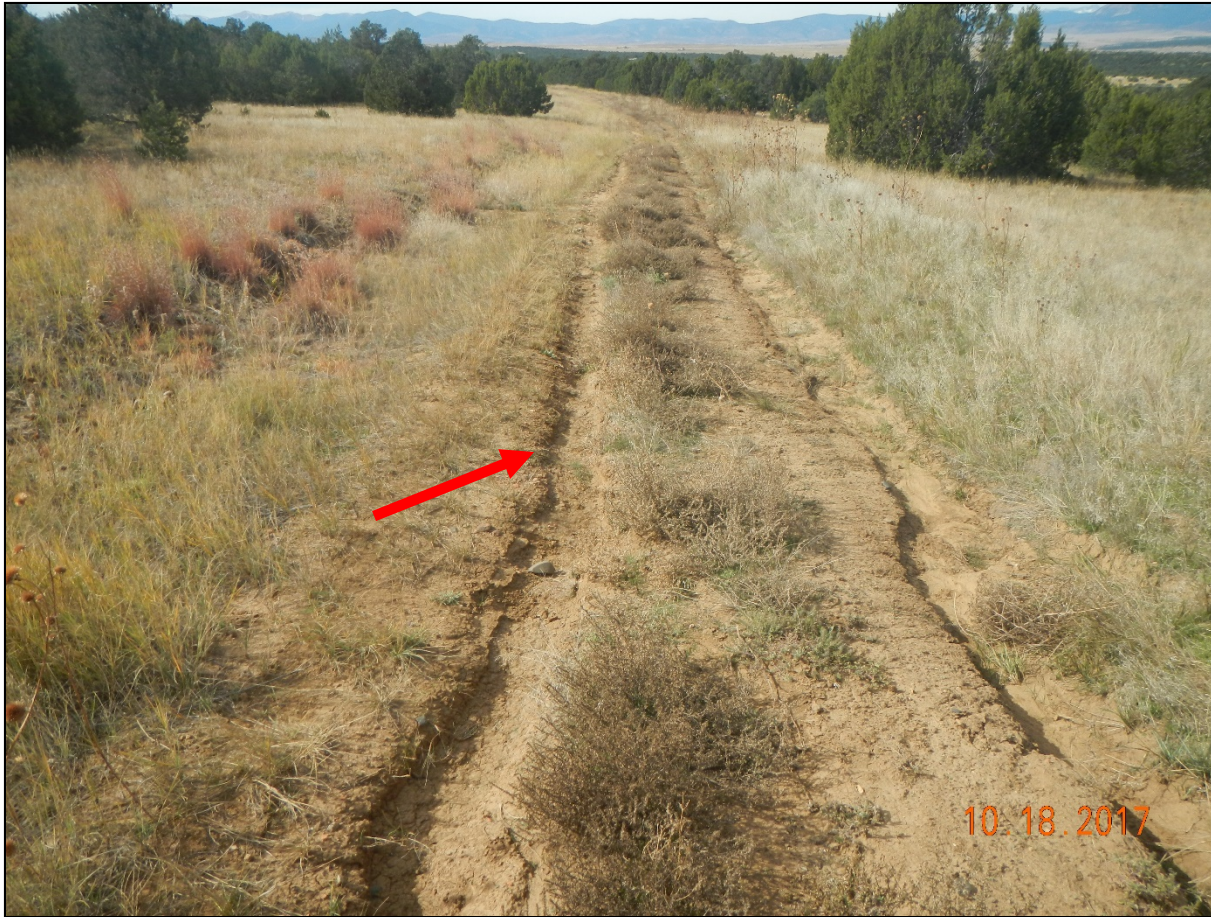
Photo 1. Facing southwest along the access road. There are signs of erosion occurring down the road.

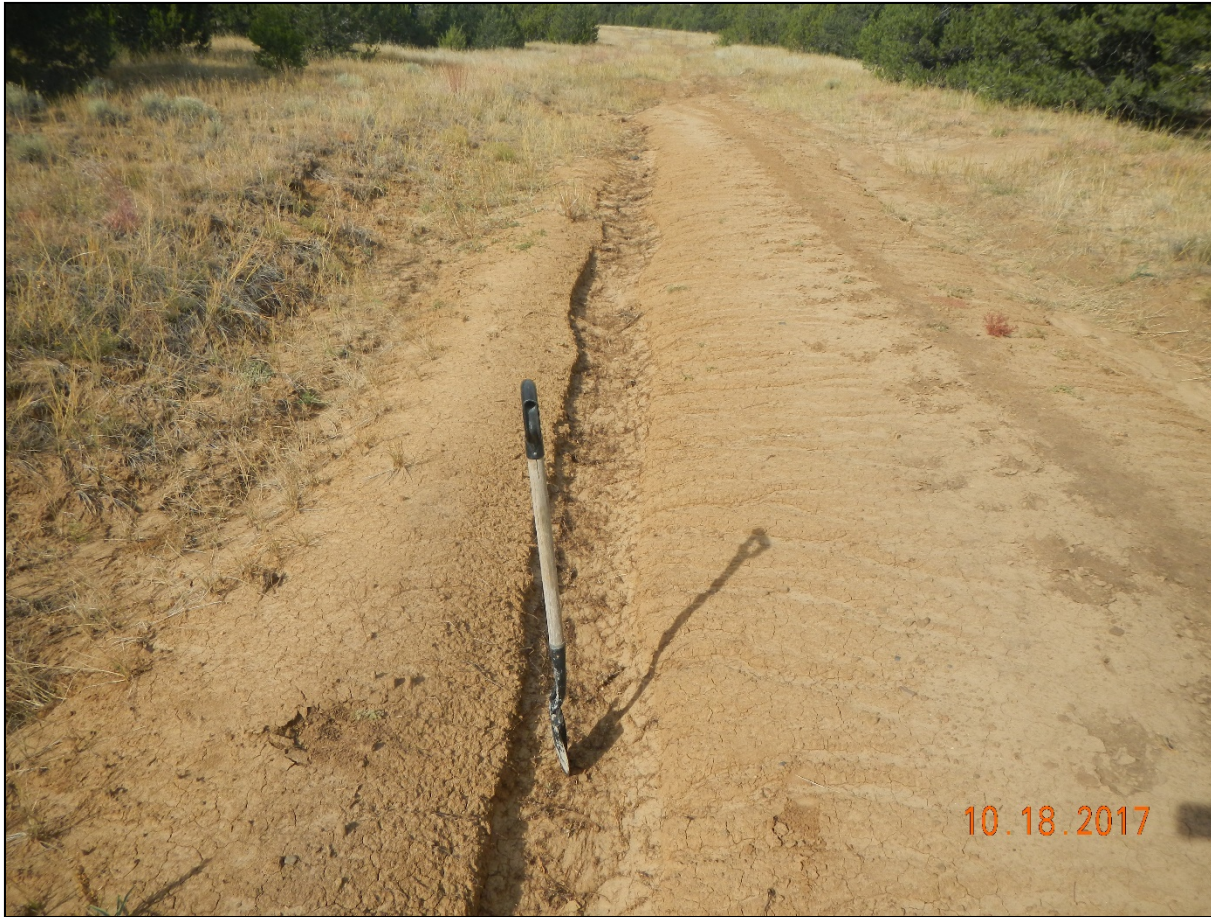
Photo 2. Facing northwest along the access road. There is stormwater erosion occurring along the road. A 3.5 ft. shovel is placed into the erosion rill for scale.

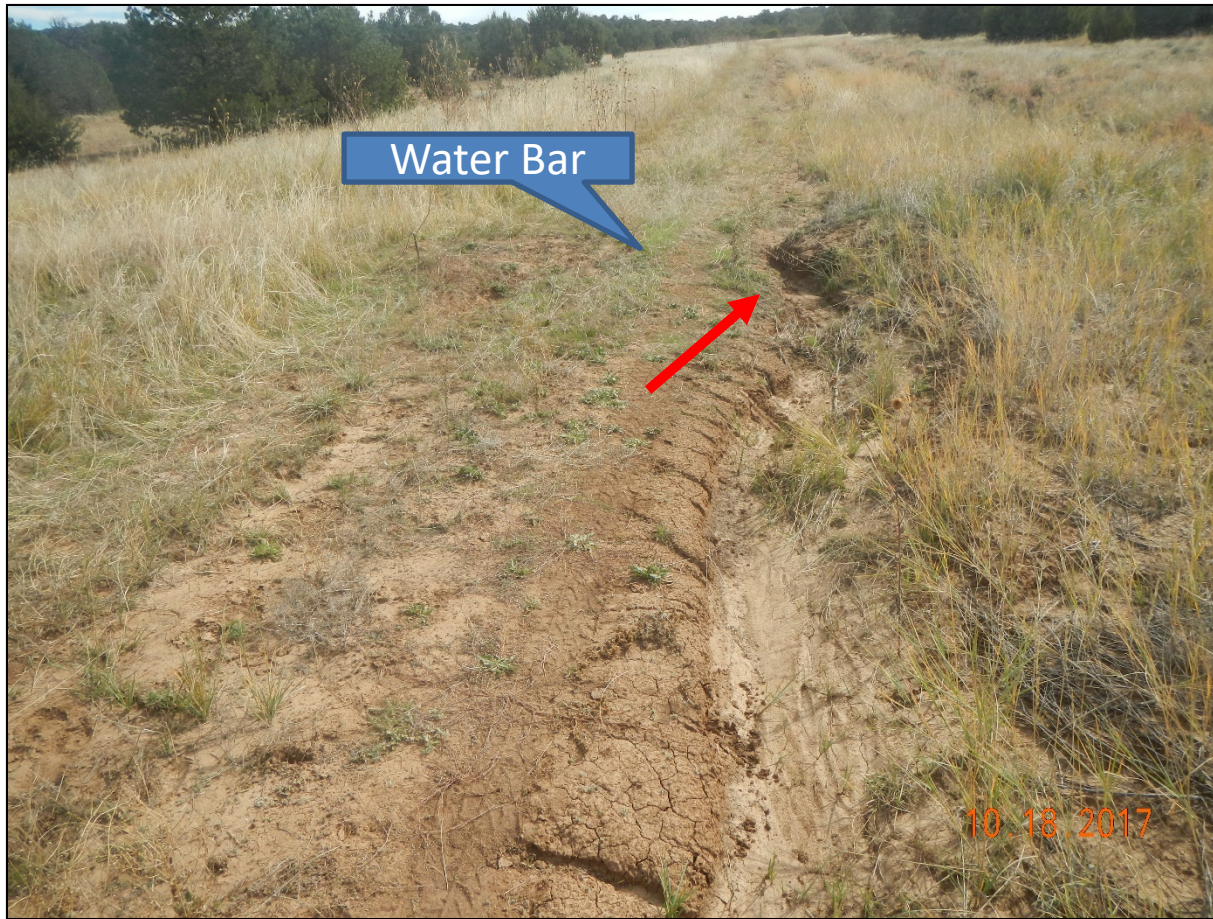
Photo 3. There is a water bar installed at this point in the road however, stormwater has eroded thru the water bar and down the road.

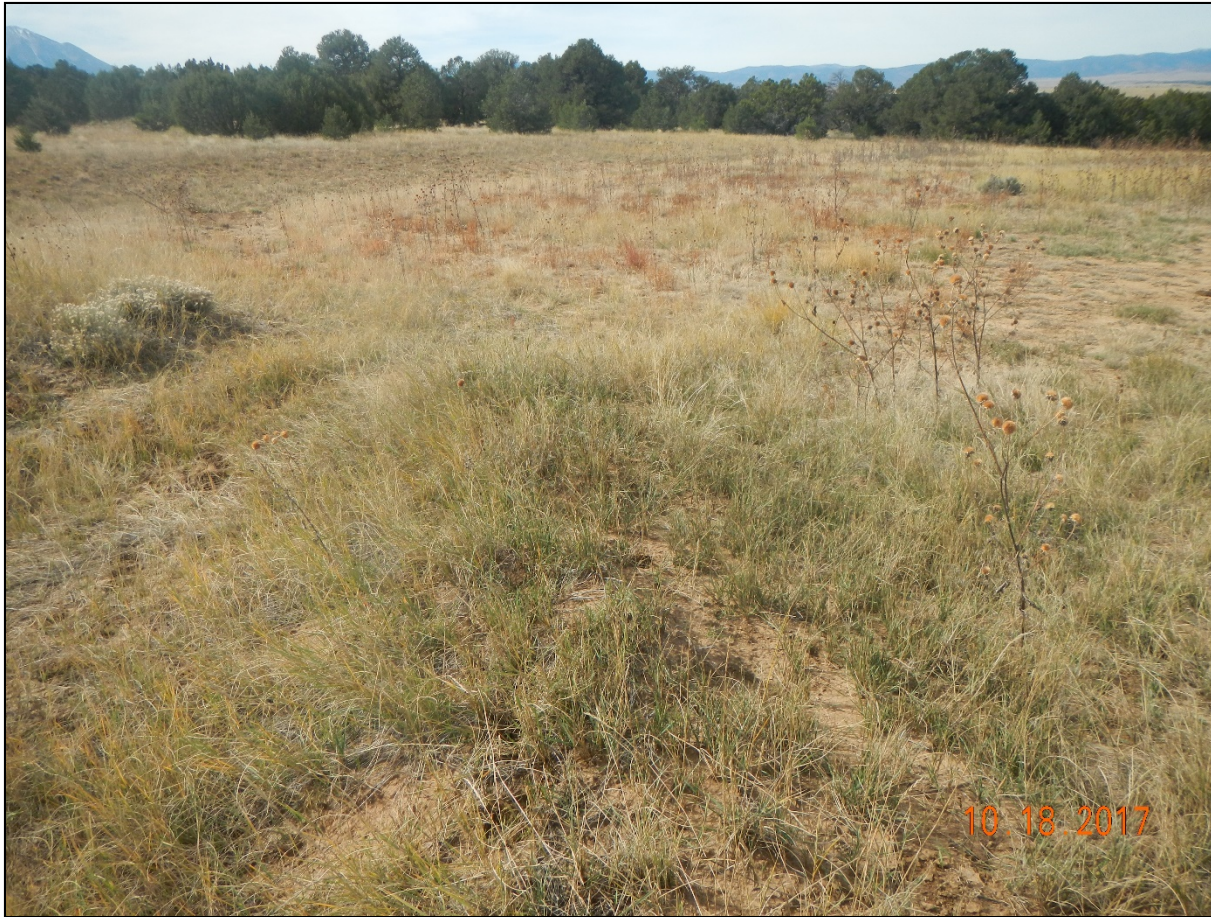
Photo 4. Facing southwest toward the location. The vegetation is well established throughout the location.

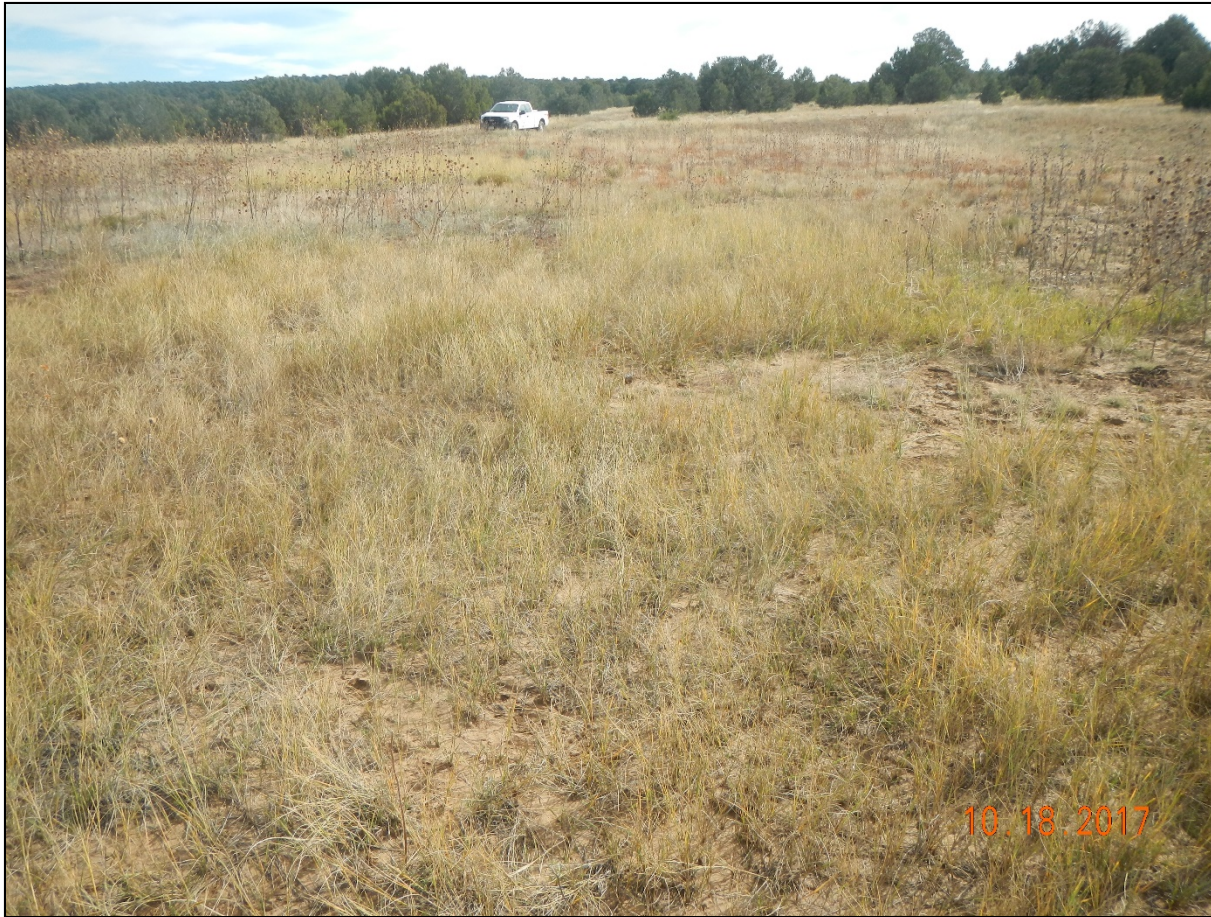
Photo 6. West side of the location facing east. The vegetation is well established throughout the location.
