Inspection Photos
Location Name: Argo 33-16
API: 05-081-07089

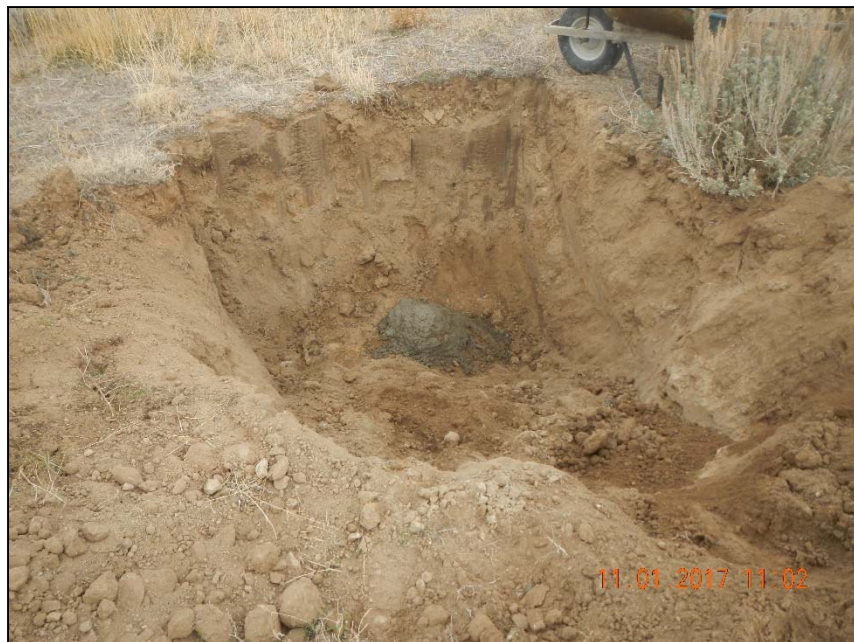
Photo 1. Surface of cement plug.

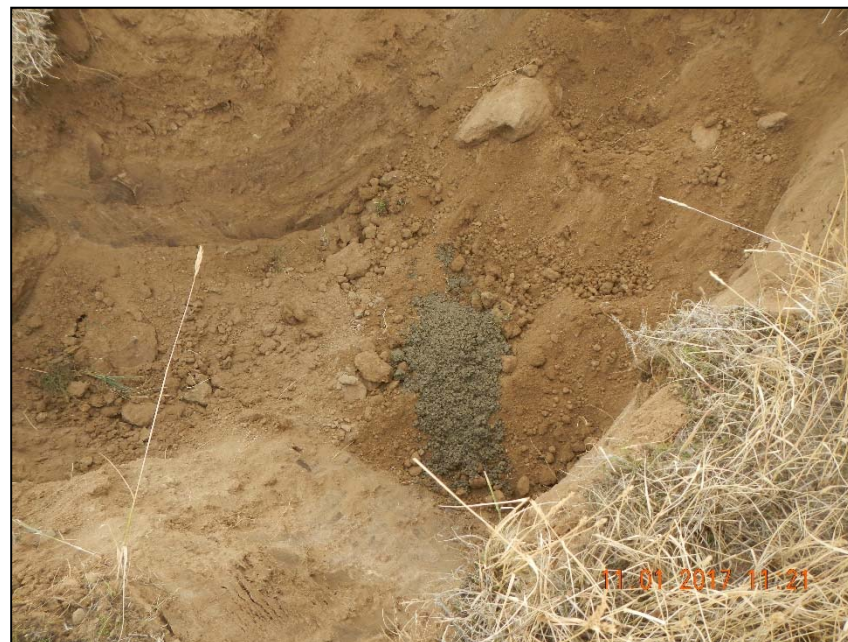
Photo 2. Surface of cement plug.

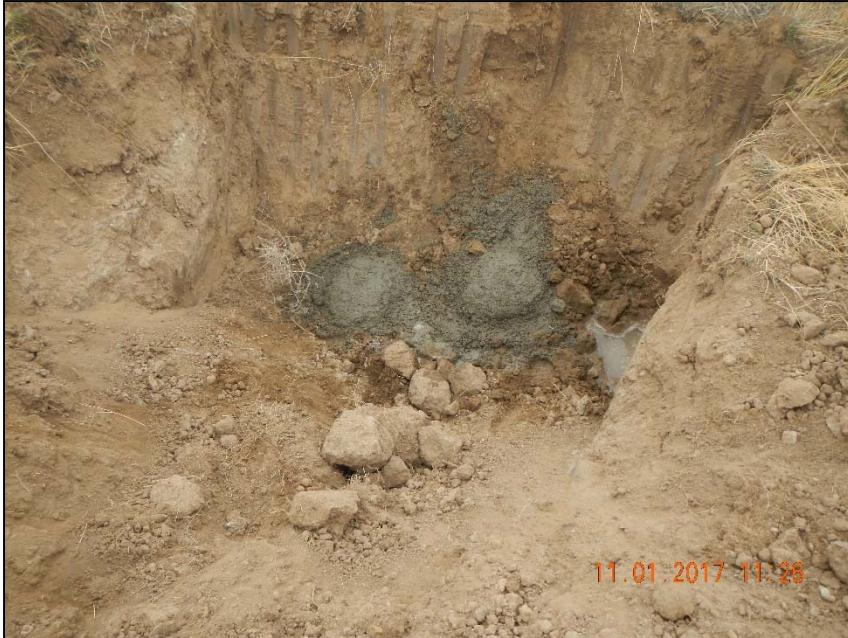
Photo 3. Surface of cement plugs.

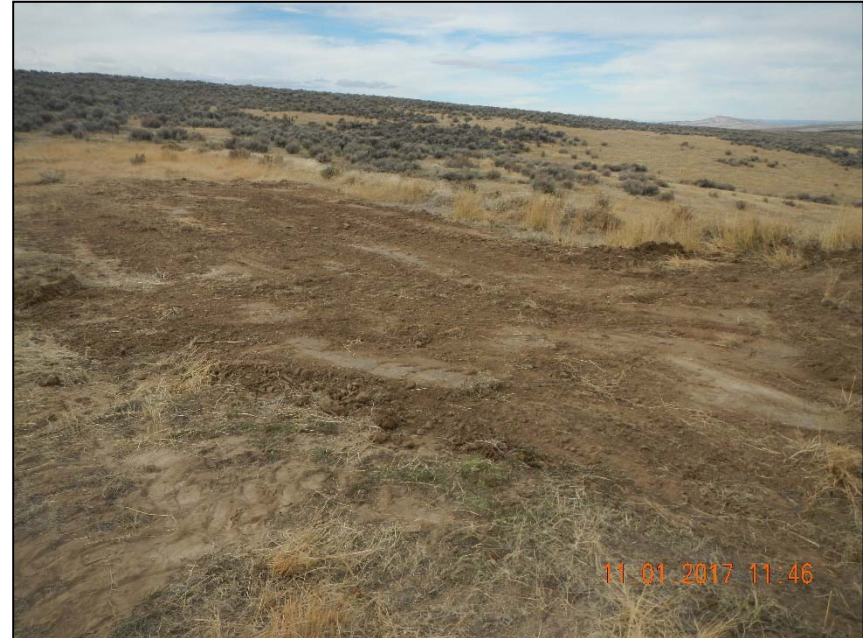
Photo 4. Backfilled area.

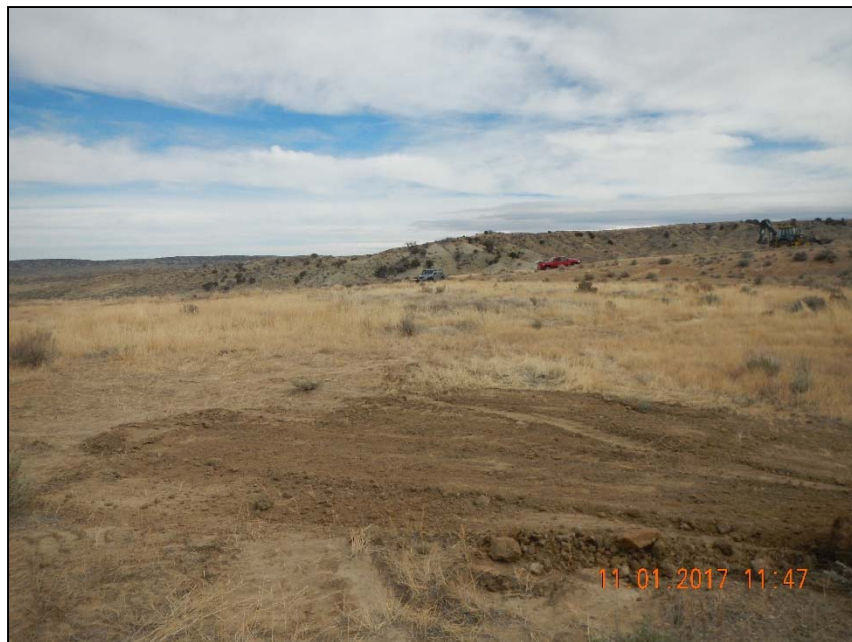
Photo 5. Overview of location taken from southwest corner facing northeast.

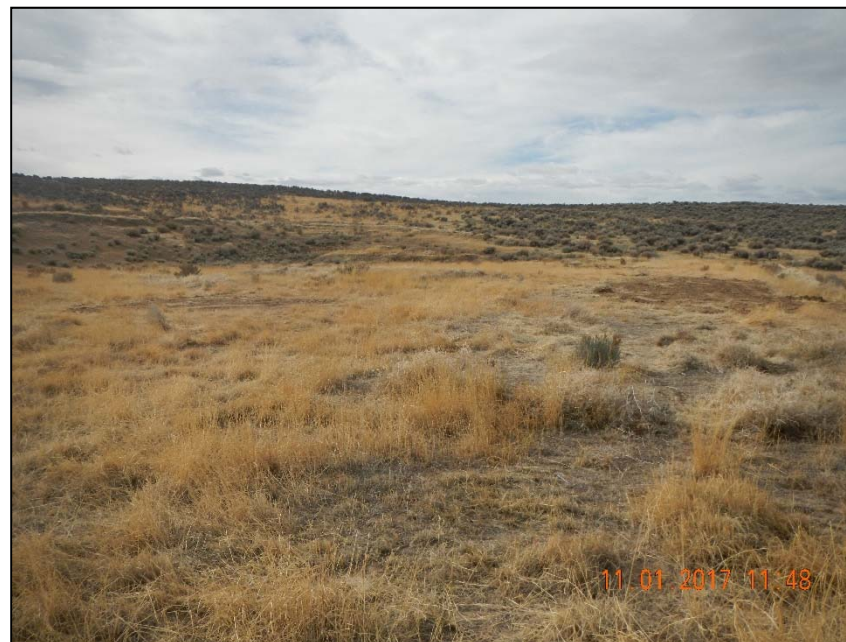
Photo 6. Overview of location taken at entrance facing west.
