Inspection Photos

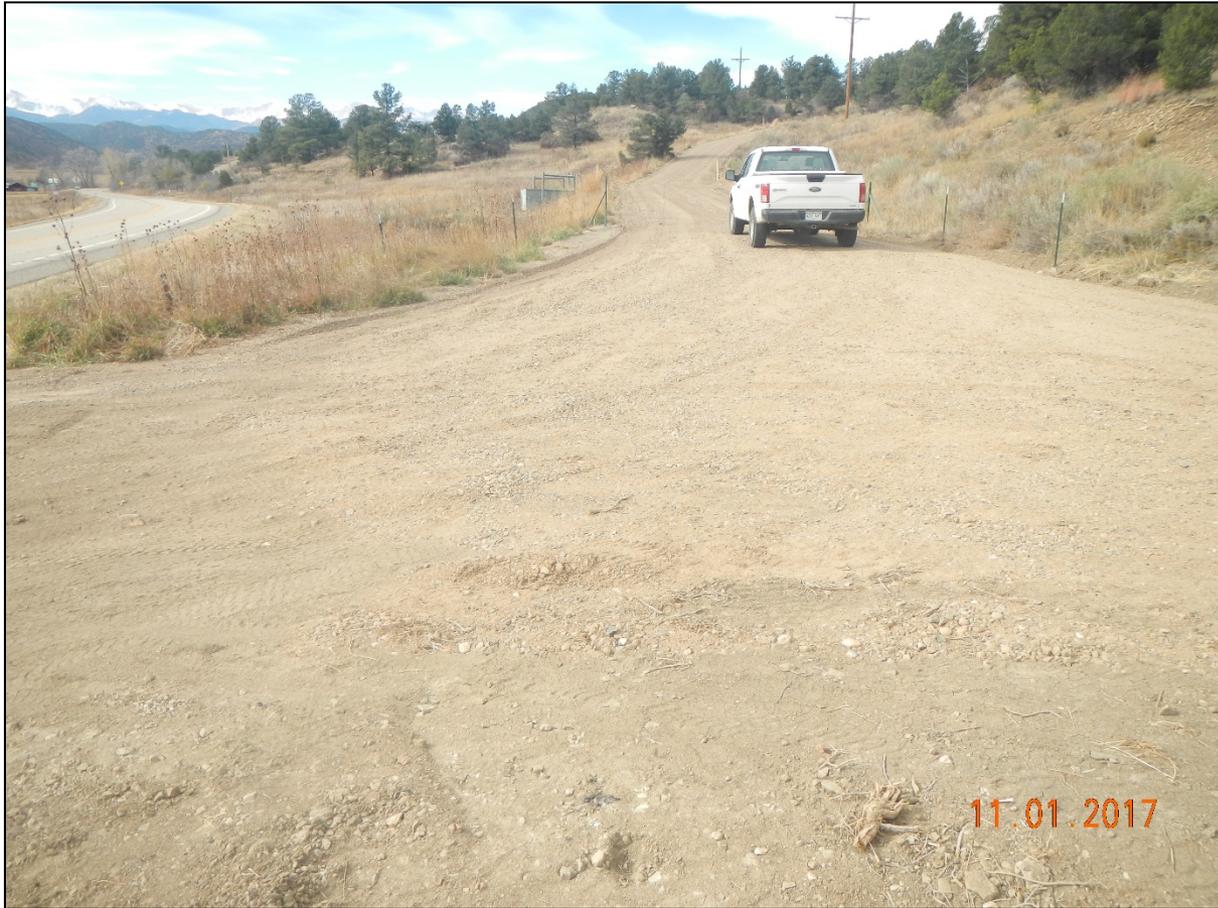
Photo 1. Facing northwest at the beginning of the access road standing near Hwy 12. Gravel has been applied and compacted to the surface to prevent vehicle tracking..

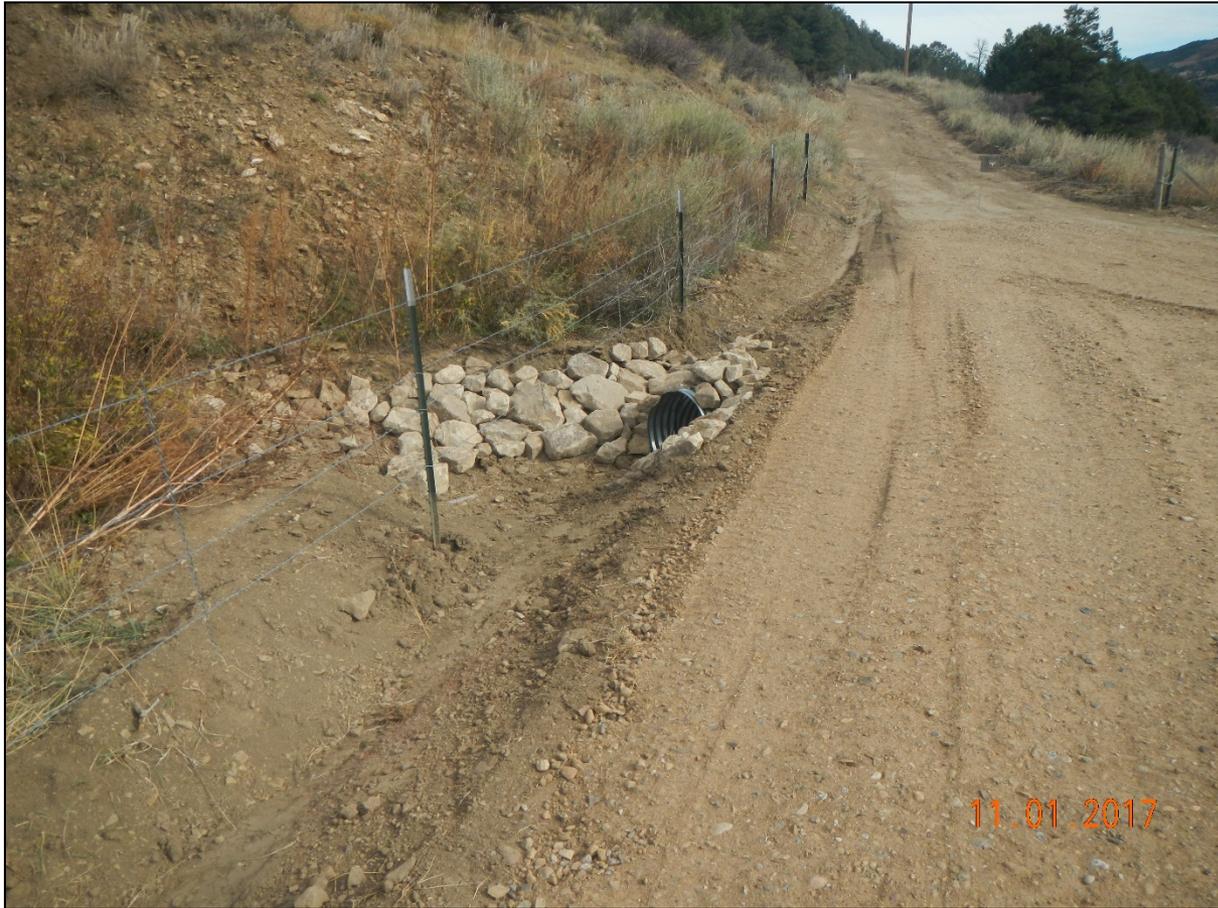
Photo 2. A culvert was installed to direct stormwater away from the access road and highway.

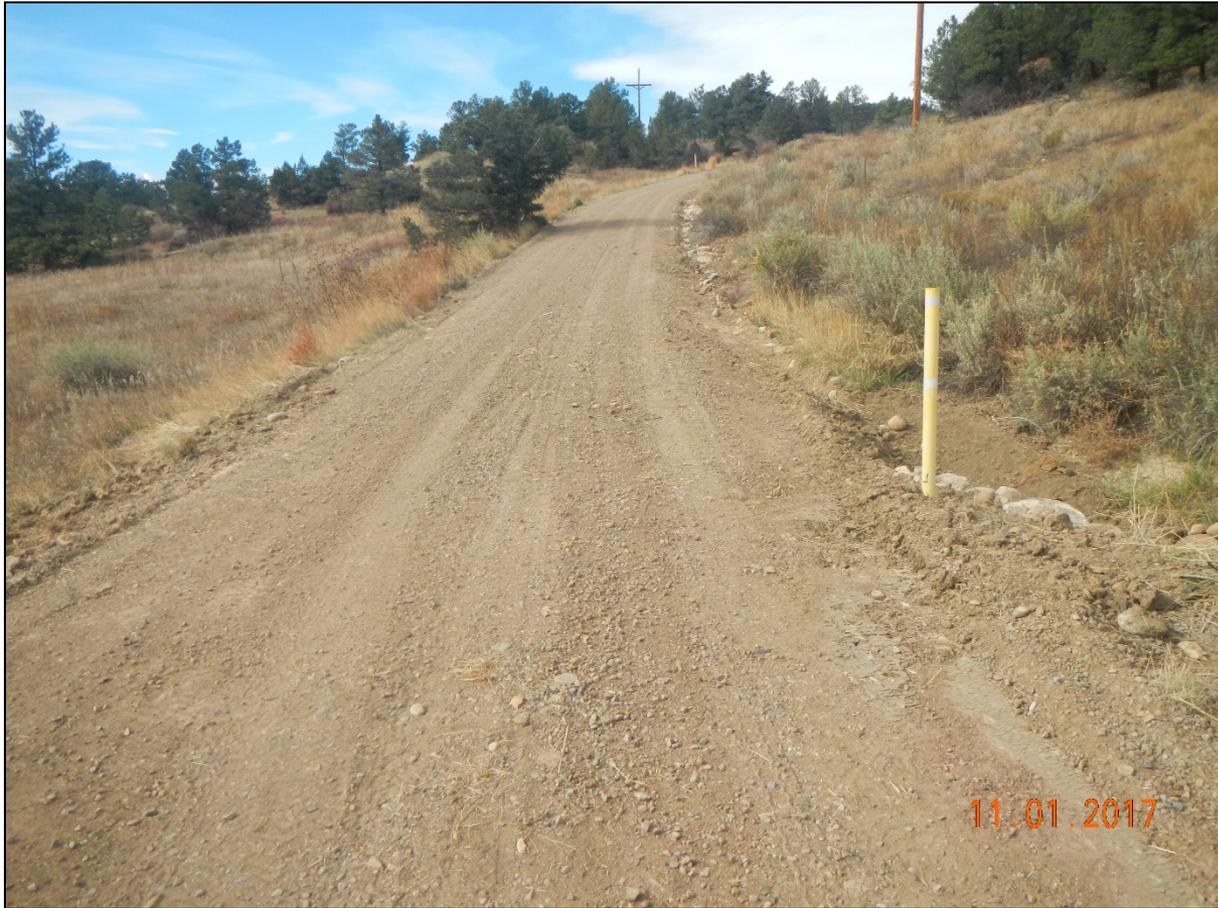
Photo 3. Facing northwest along the access road. A culvert was installed to prevent stormwater from flowing across the road.

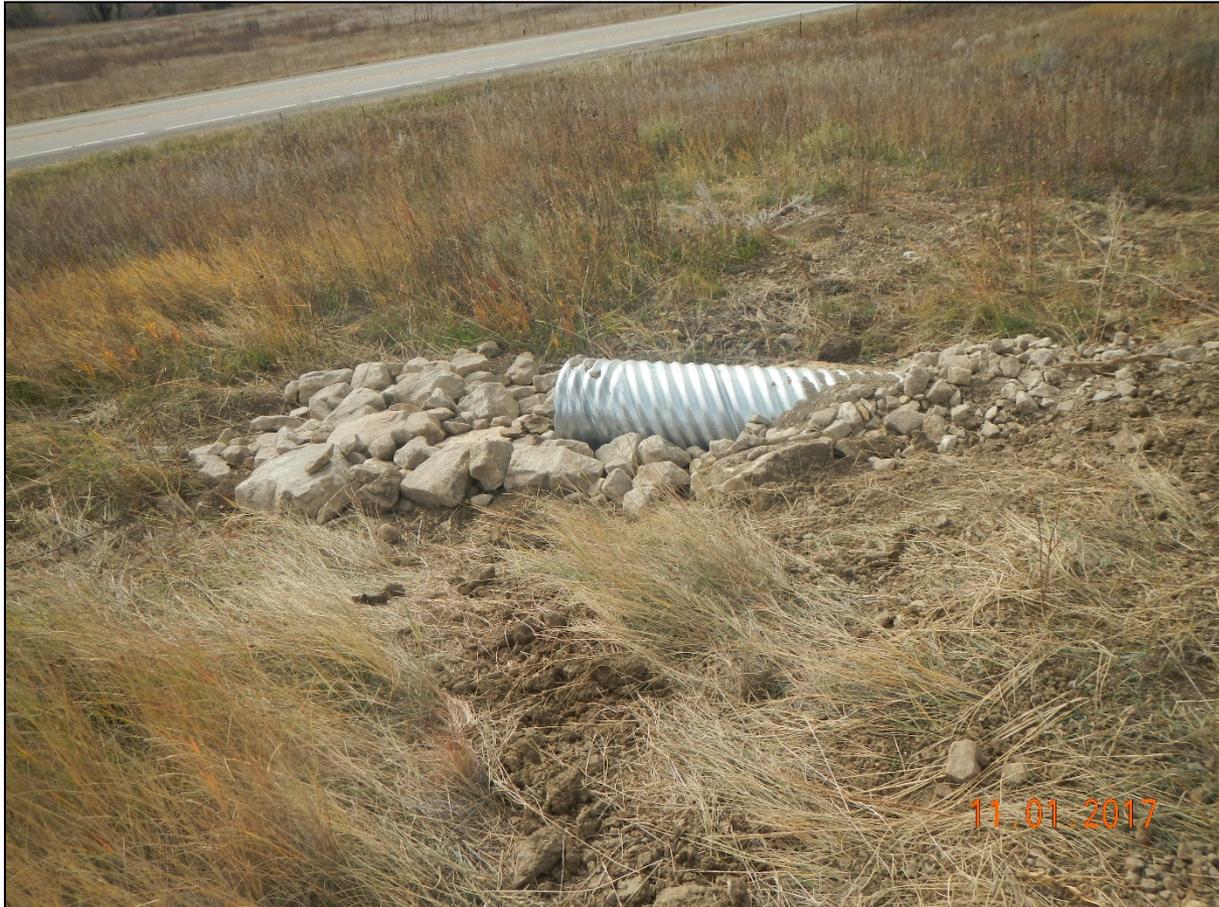
Photo 4. The culvert was installed with rock rip/rap outlet protection.

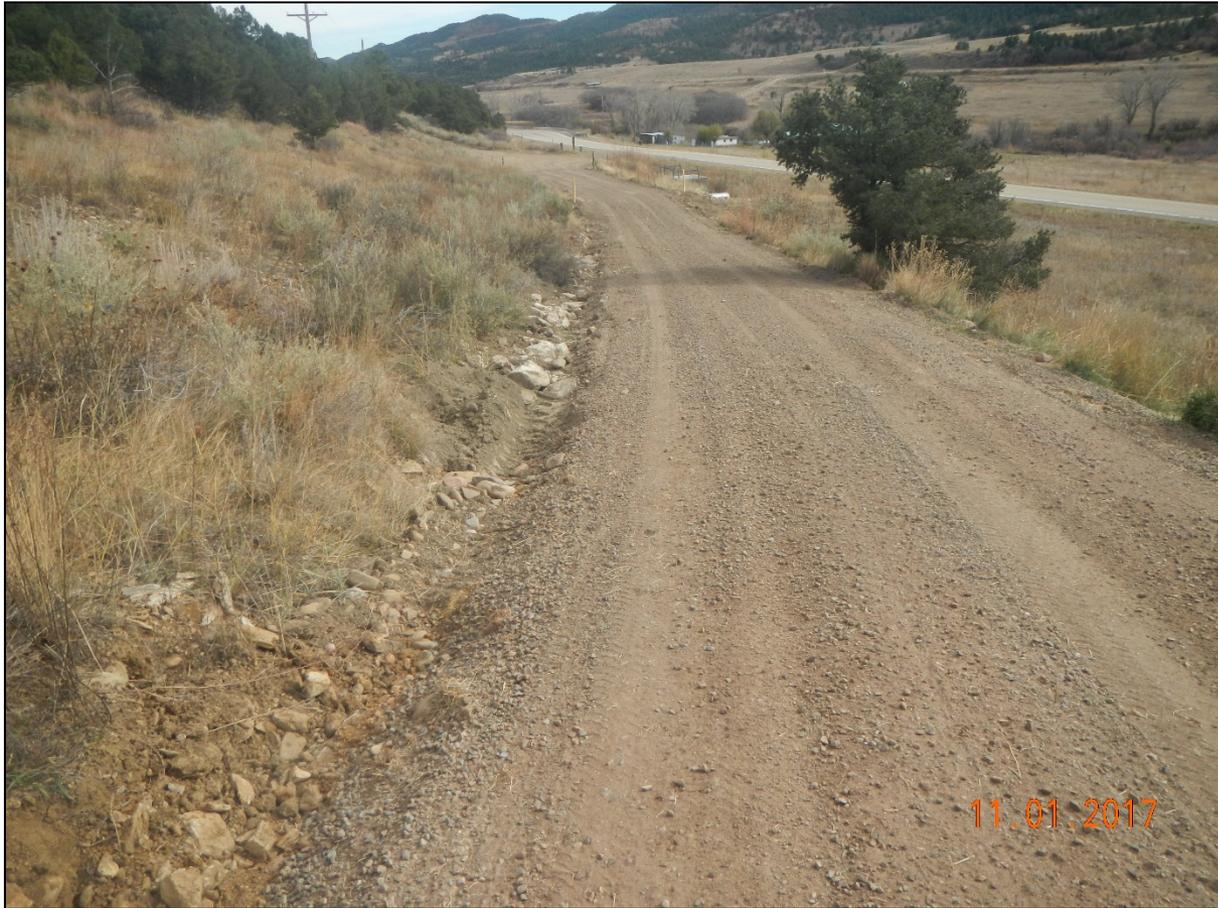
Photo 5. The side of the access road has been filled in where it was eroded. Some rock rip/rap has been placed to prevent erosion.

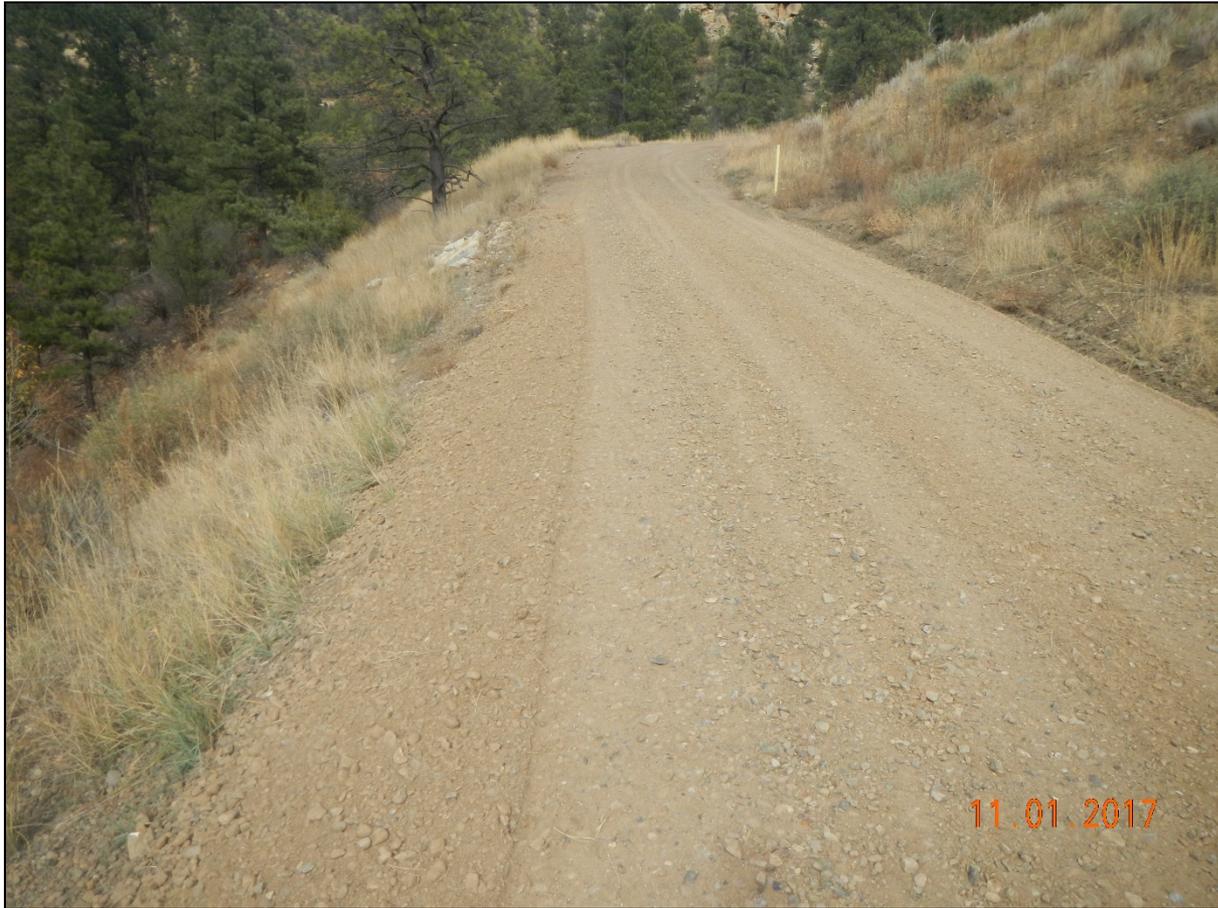
Photo 6. Facing north along the access road. Gravel material has been applied to areas along the road.

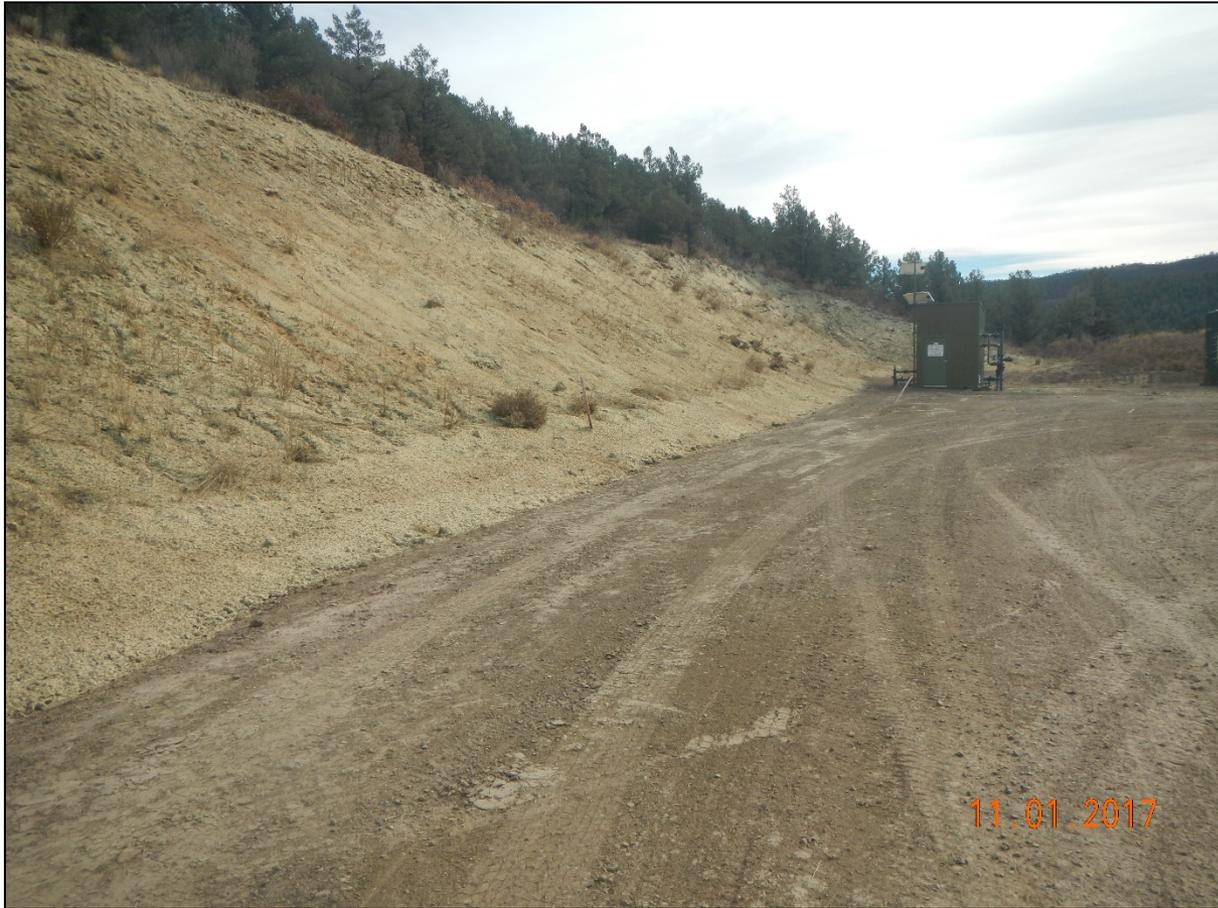
Photo 7. Facing southeast at the location toward the cut slope. The cut slope is temporarily stabilized with hydro-mulch.
