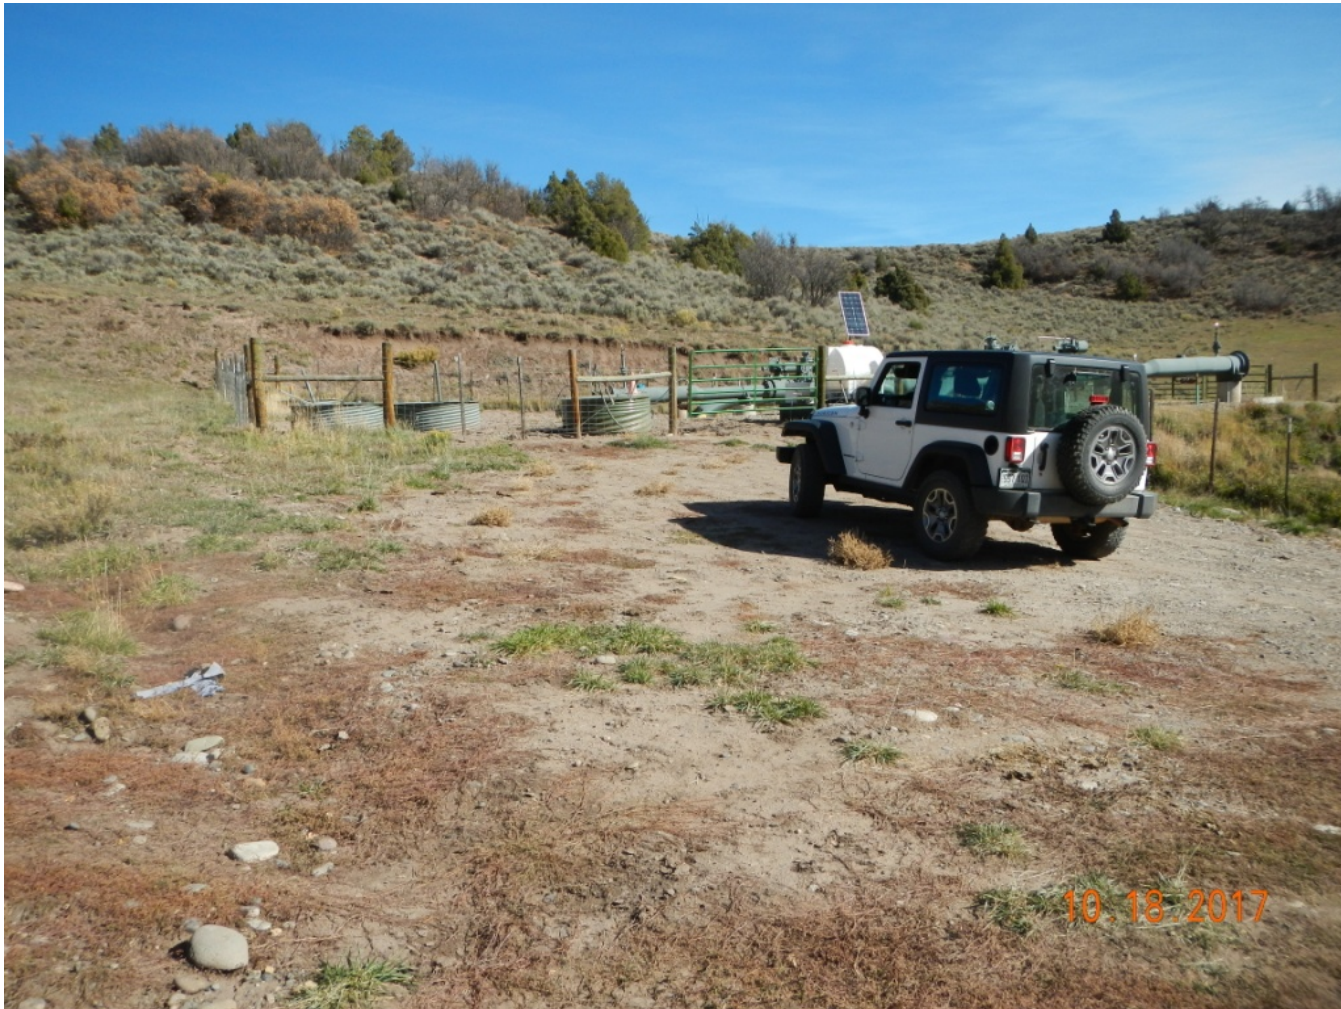
Photo 1. View of tank area west of the working area for the well. Small pieces of debris is present.

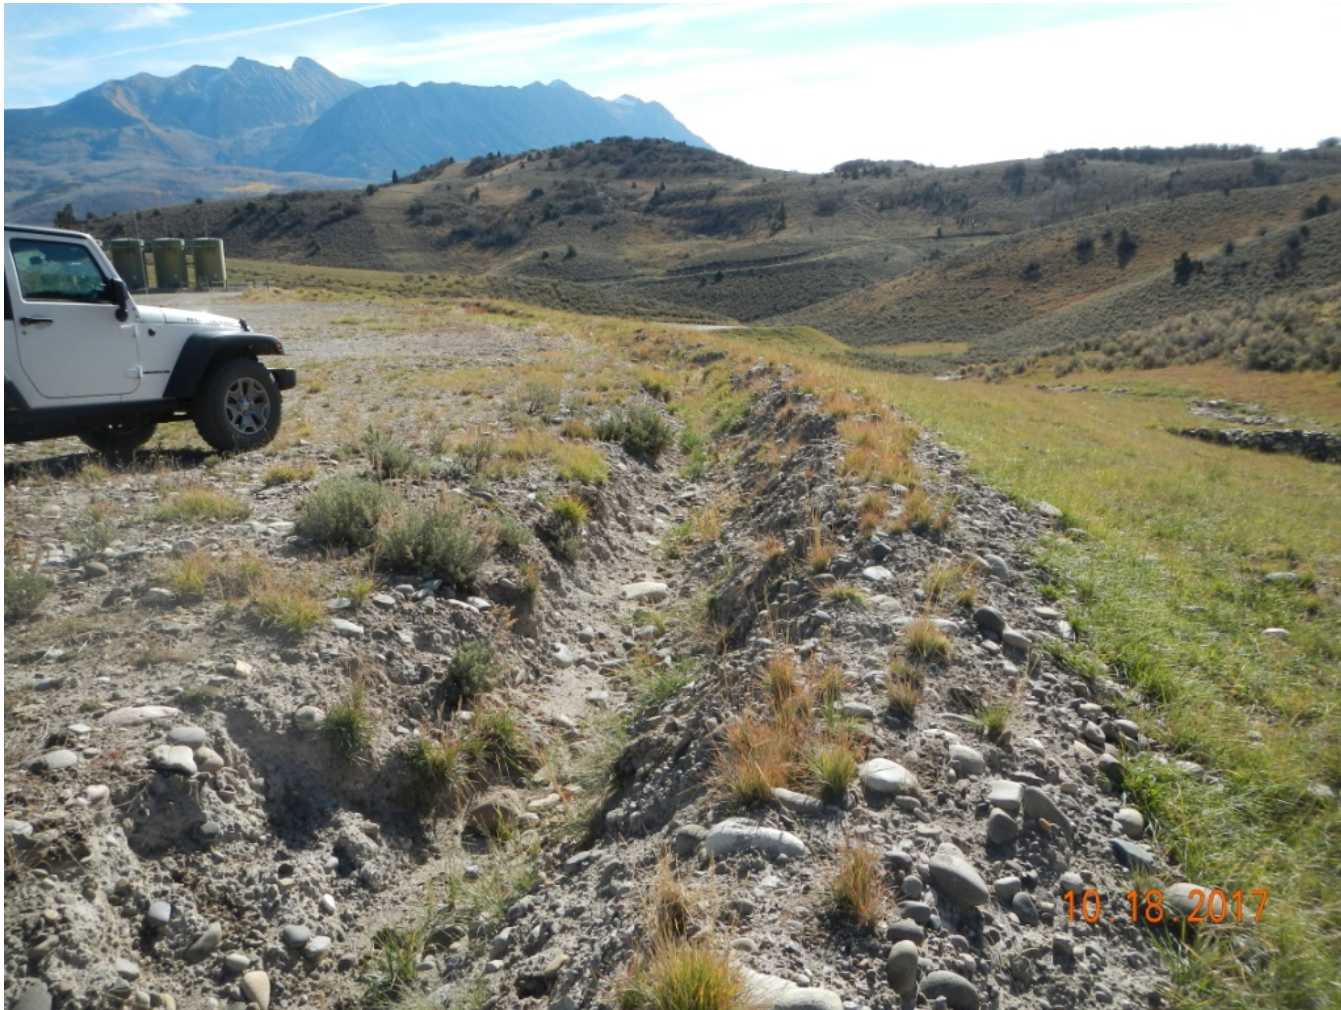
Photo 2. View of the southern edge of the working area facing eastward.

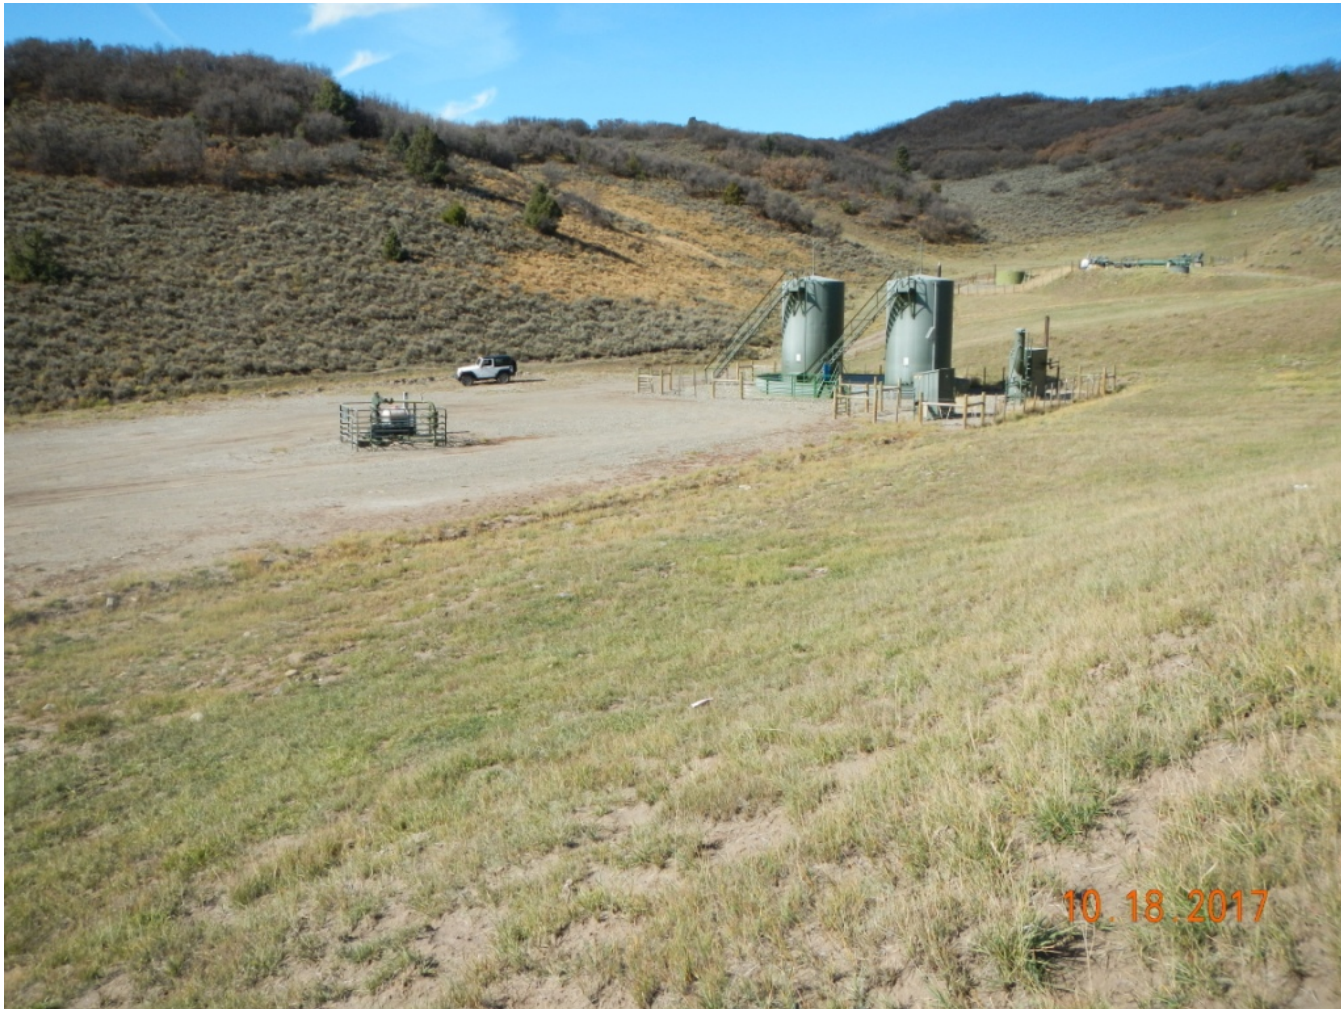
Photo 3. View of the project area from the northeastern corner facing center. Revegetation is progressing with grasses such as western wheatgrass (*Pascopyrum smithii*).

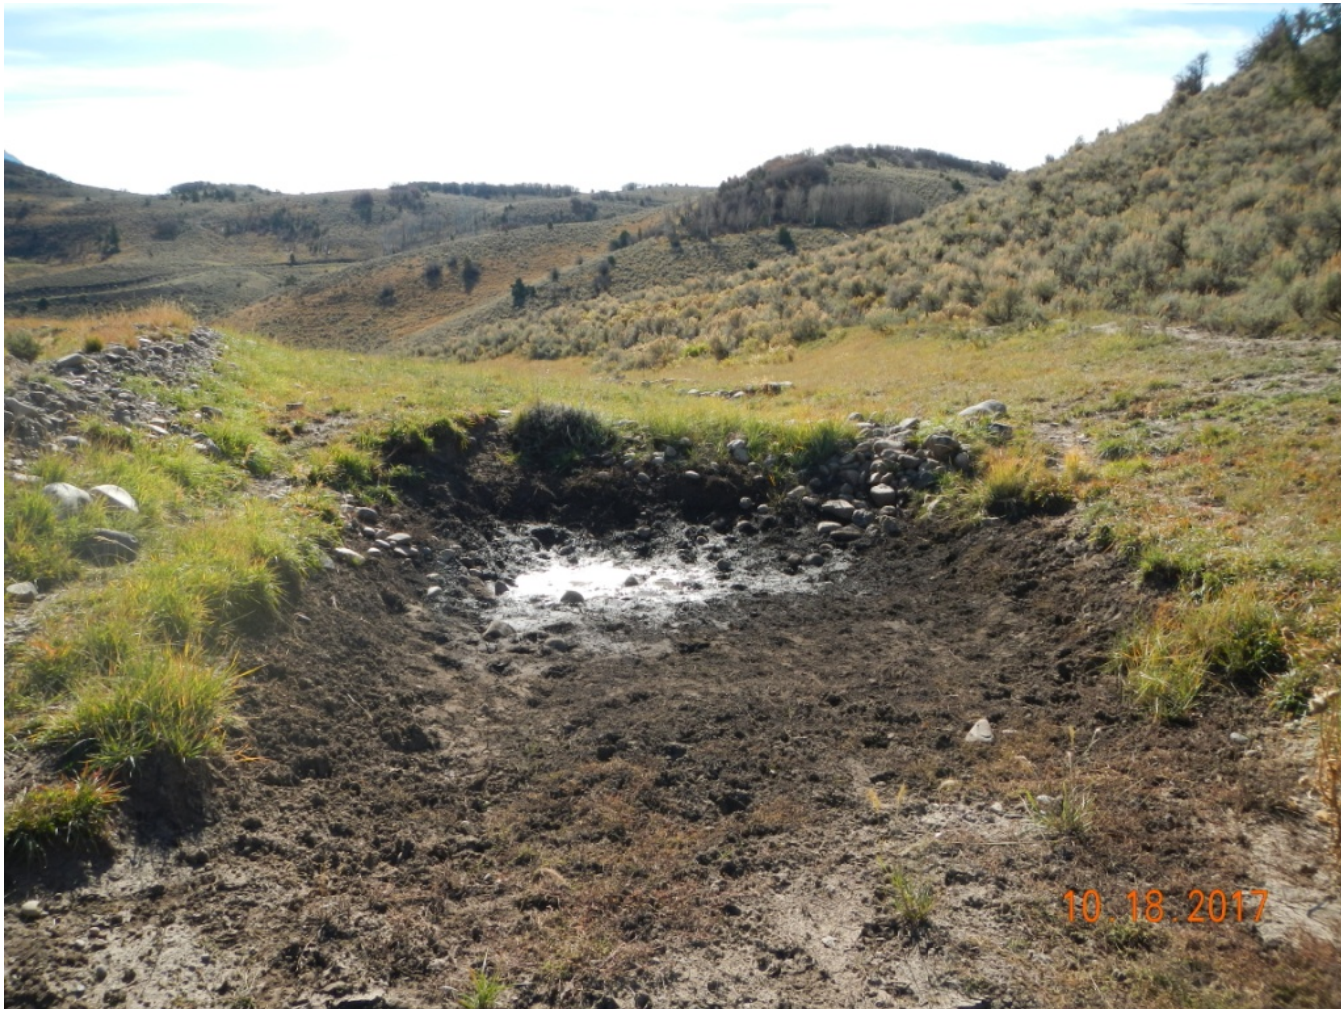
Photo 4. View of silt trap in the southern portion of the project area that appears to recently have been maintained.

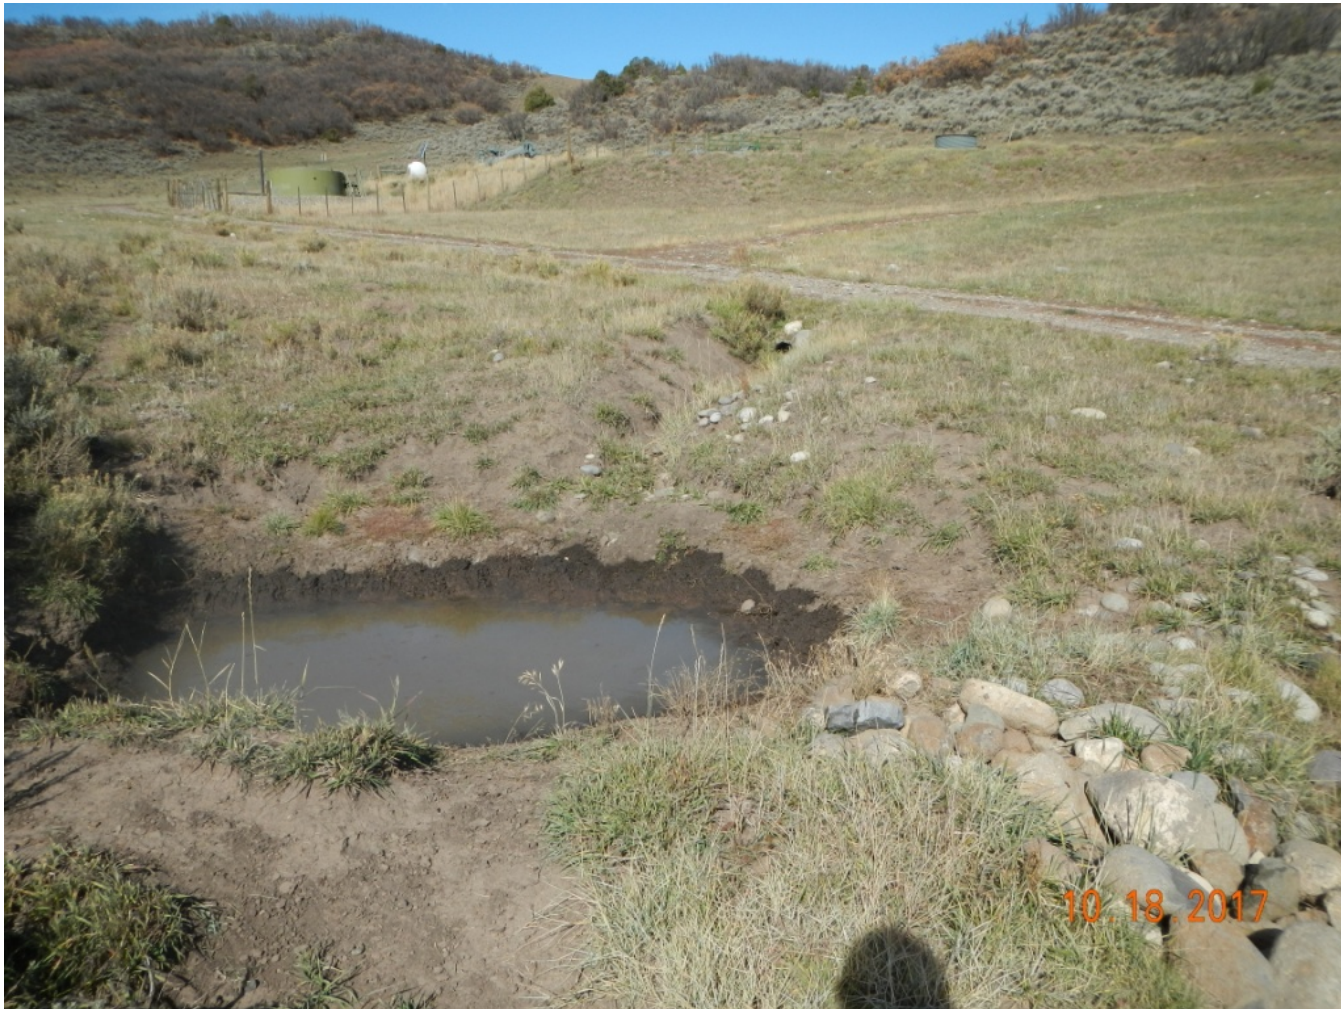
Photo 5. View of another silt trap at the southwestern edge of the project area, appears to be functioning.
