Photo log for Response to October 5, 2017 Inspection

Document 689300253

Name: Schank J

Location ID: 336706

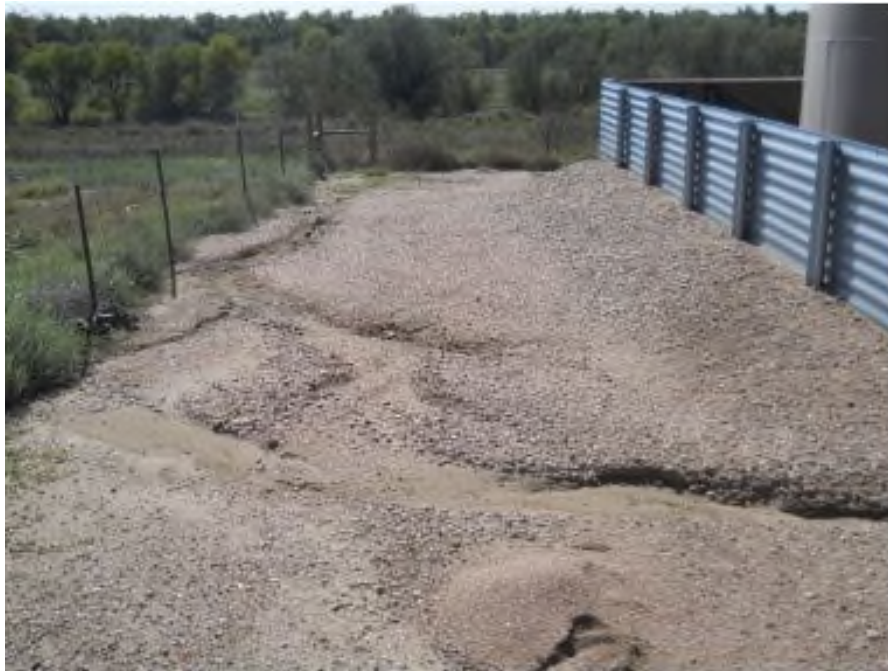
Stormwater: Location is washing out northeast of tank battery and running along east side of tank battery, discharging at southeast edge of location. Sediment is carrying off into field. Location is also starting to wash out between tank battery and separators.

Photo 5: Location washing out from northeast edge of tank battery and running along the east side of tank battery, discharging sediment off of location

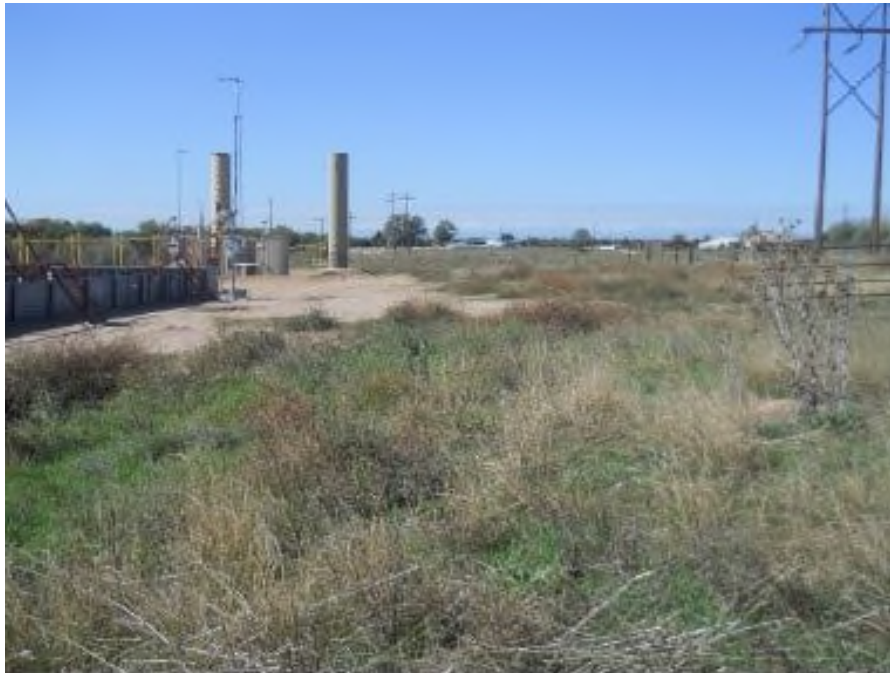
Actively growing weeds on location, need to be controlled.

Photo 6: Actively growing weeds on location need to be controlled
