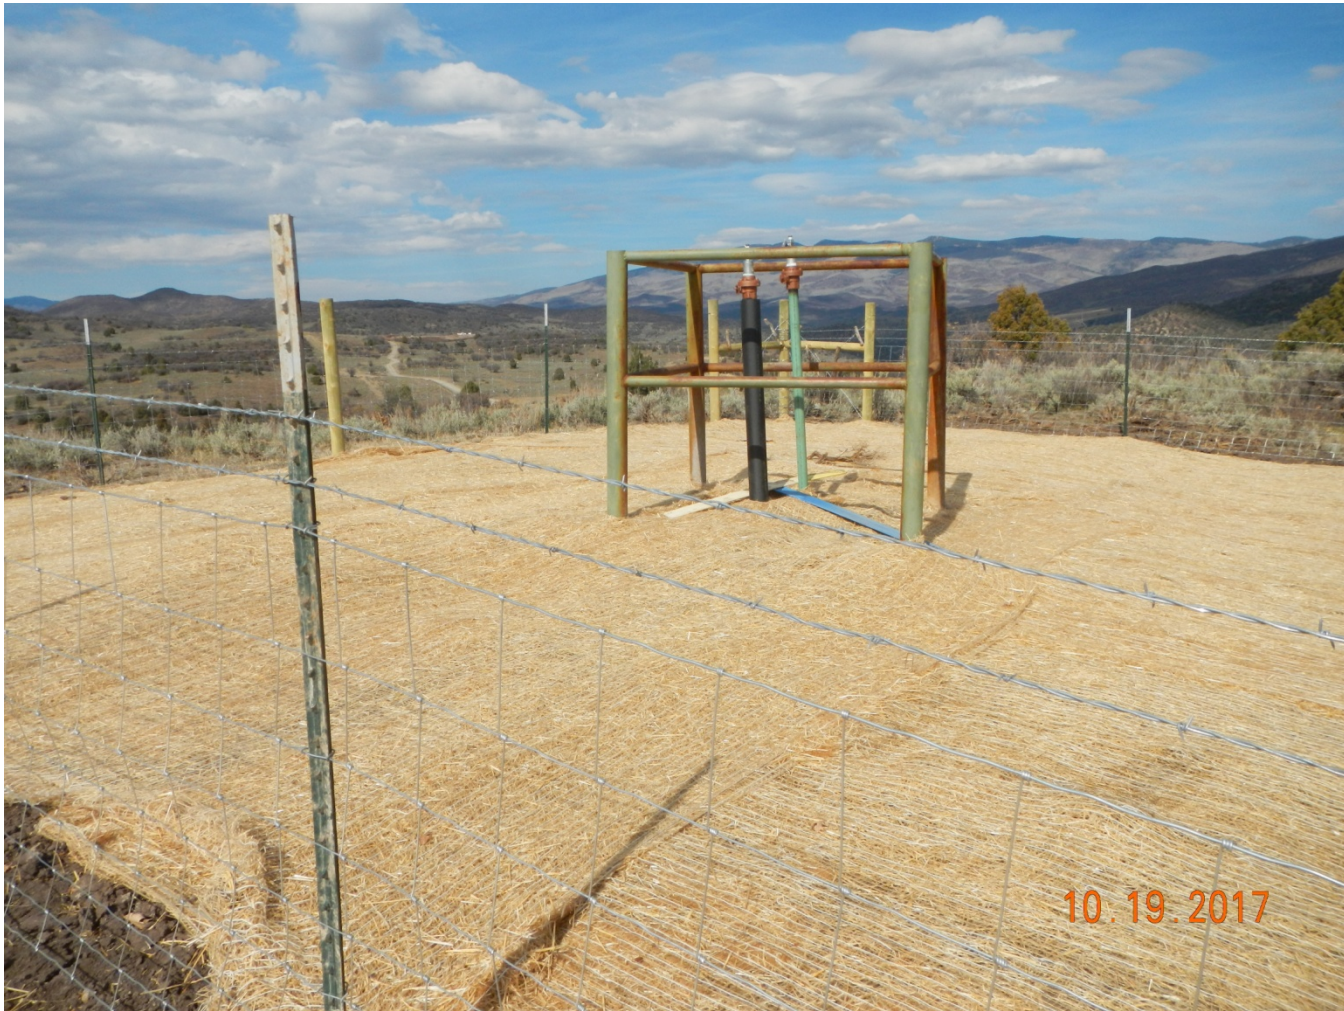
Photo 1. View of area recently reclaimed around pipeline riser. Area is recently reclaimed.

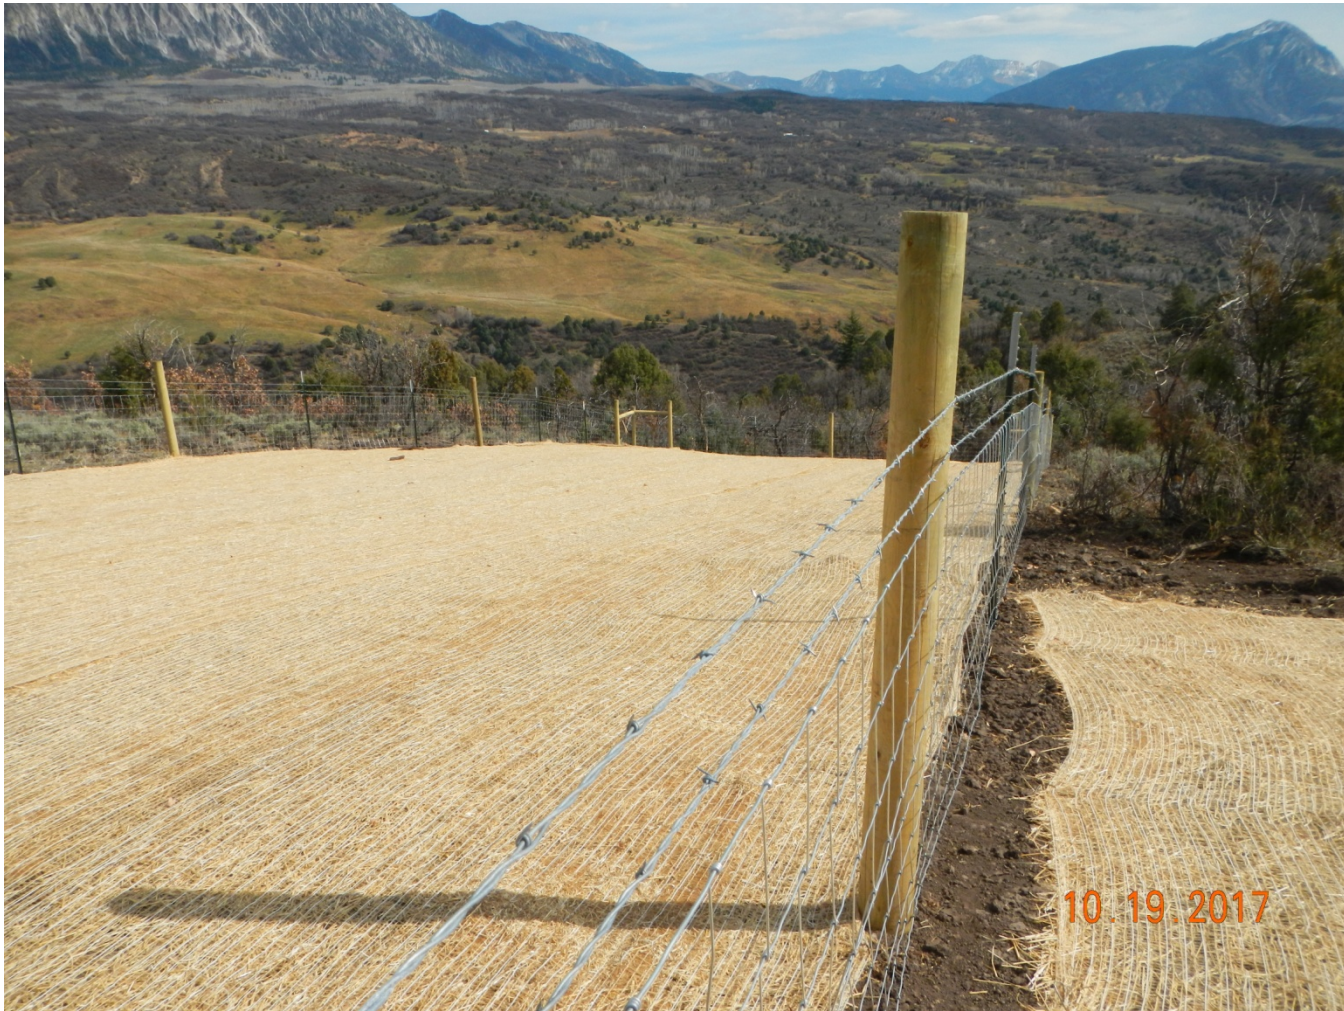
Photo 2. View of area west of repaired riser. This area is reclaimed with straw blanket and fencing.

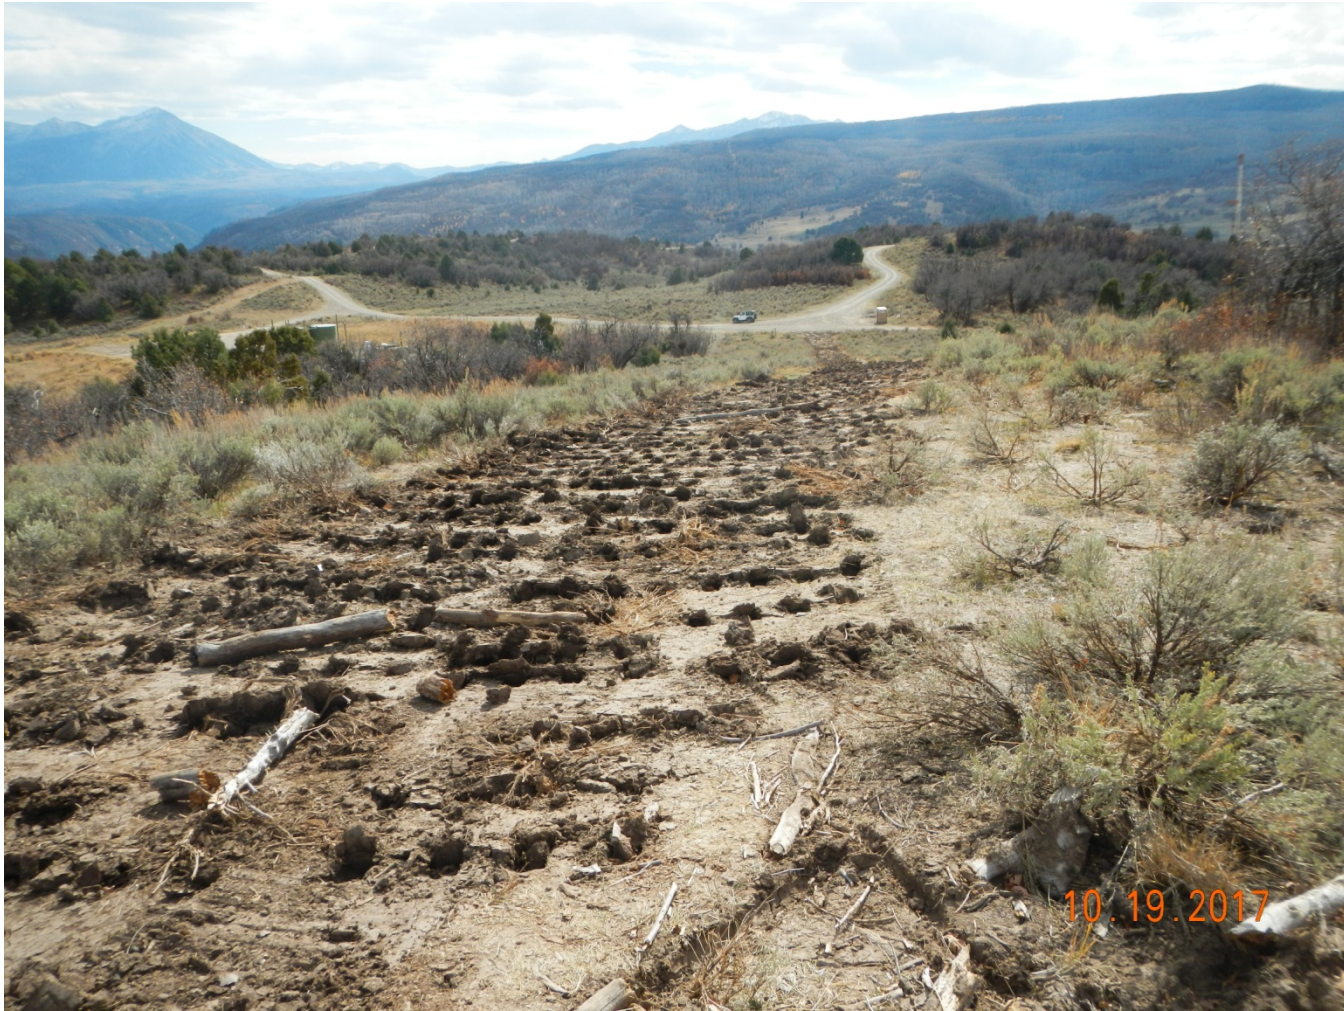
Photo 3. View of area south of repaired riser that was recently reclaimed. Area is surface roughened and appears to be seeded.
