- Federal 2 - 19
- 05-033-06071

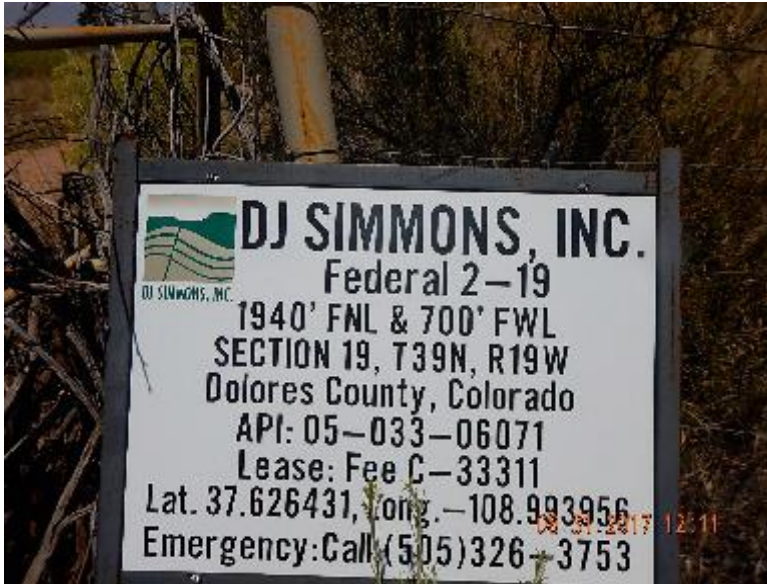
Photo 1: Wellhead sign. Previous inspection.

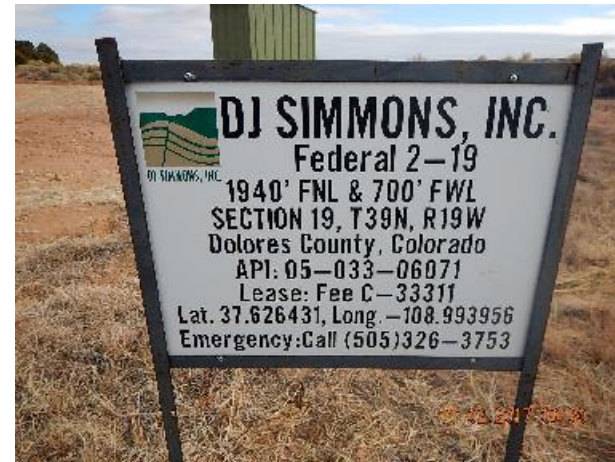
Photo 2: Wellhead sign. Follow-up inspection.

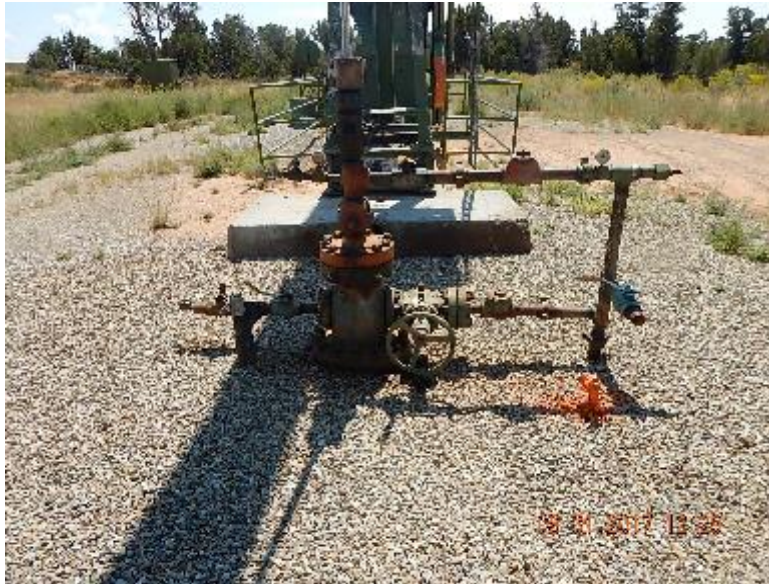
**Photo 3: Wellhead and riser. Previous inspection.**

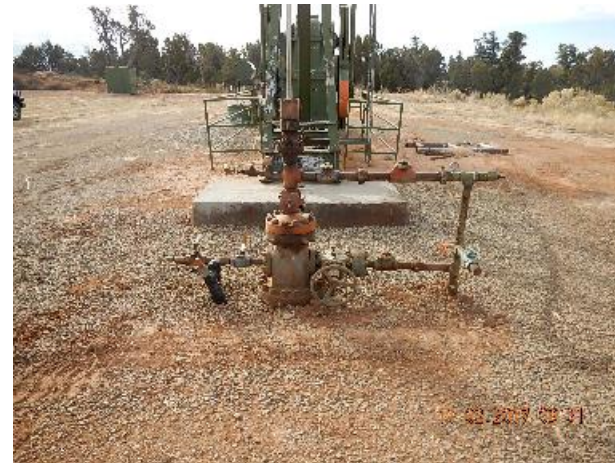
**Photo 4: Wellhead. Follow-up inspection.**

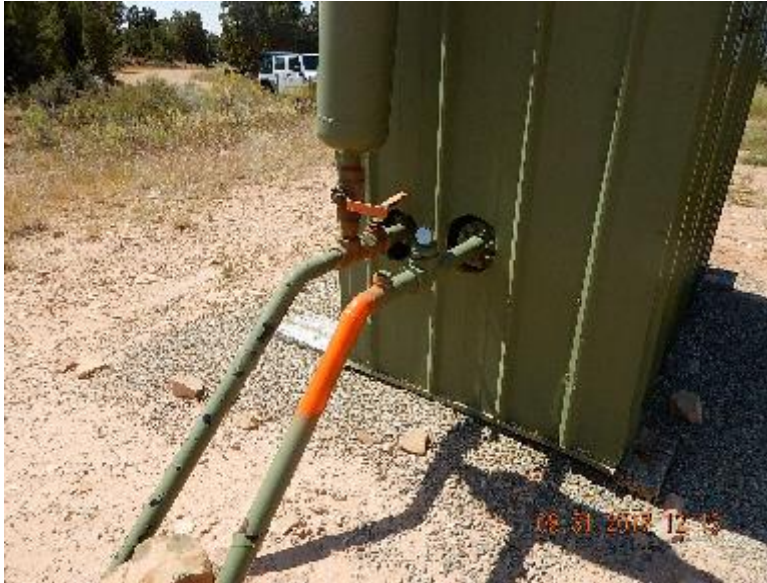
**Photo 5: Flowline riser at meter house open to atmosphere. Previous inspection.**

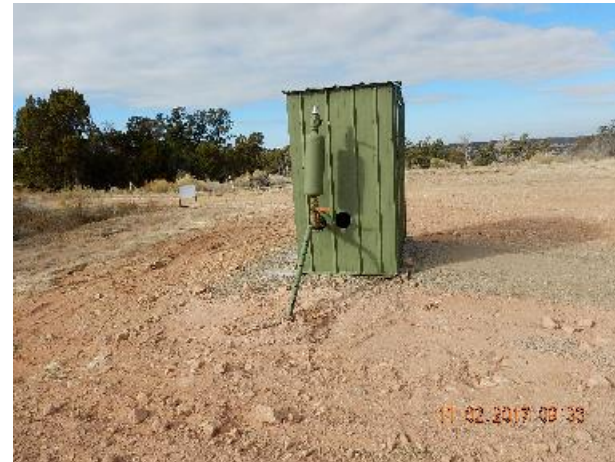
**Photo 6: Removed riser at meter house. Follow-up inspection.**

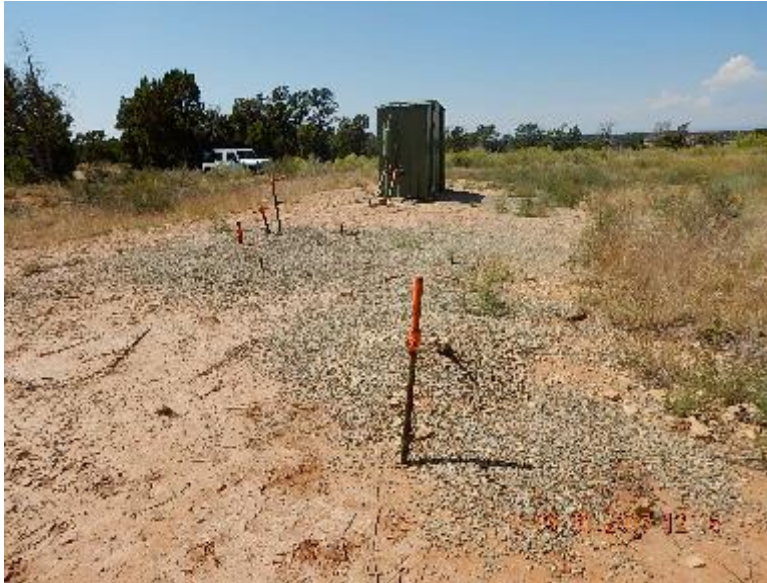
**Photo 7: (4) risers off backside of gas meter run shed. Previous inspection.**

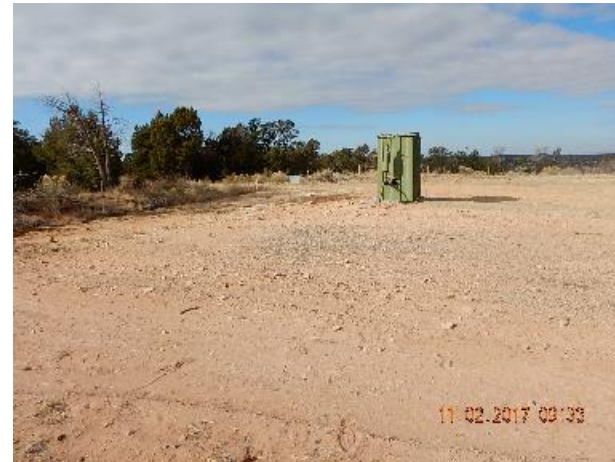
**Photo 8: Removed risers off backside of gas meter run. Follow-up inspection.**

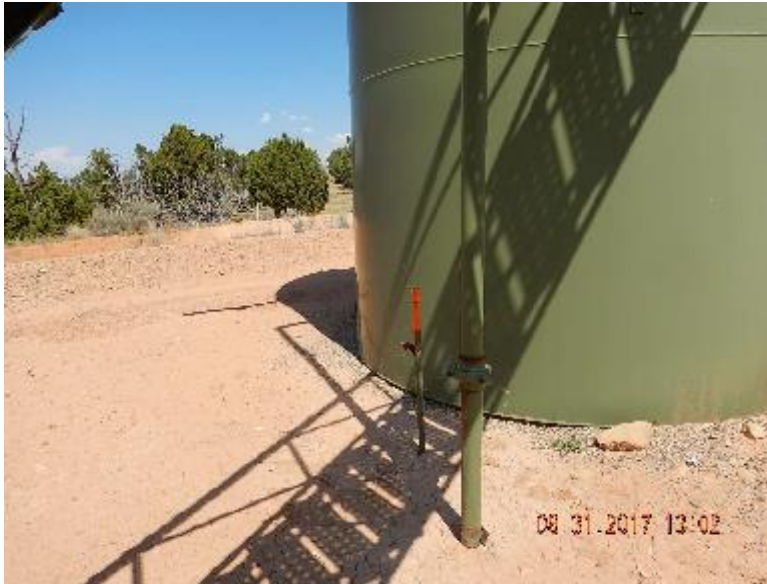
**Photo 9: Riser in production tank battery. Previous inspection.**

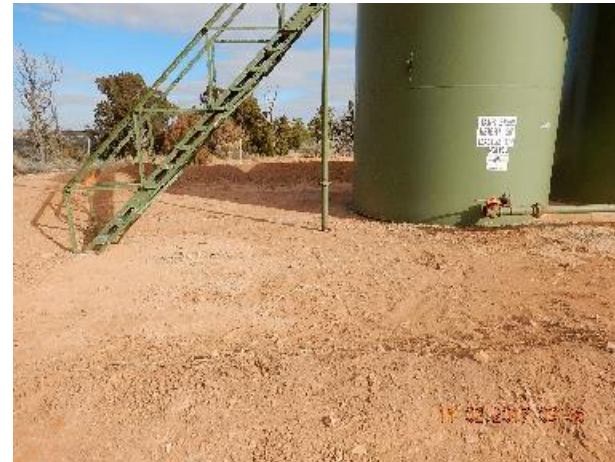
**Photo 10: Removed riser at tank battery. Follow-up inspection.**

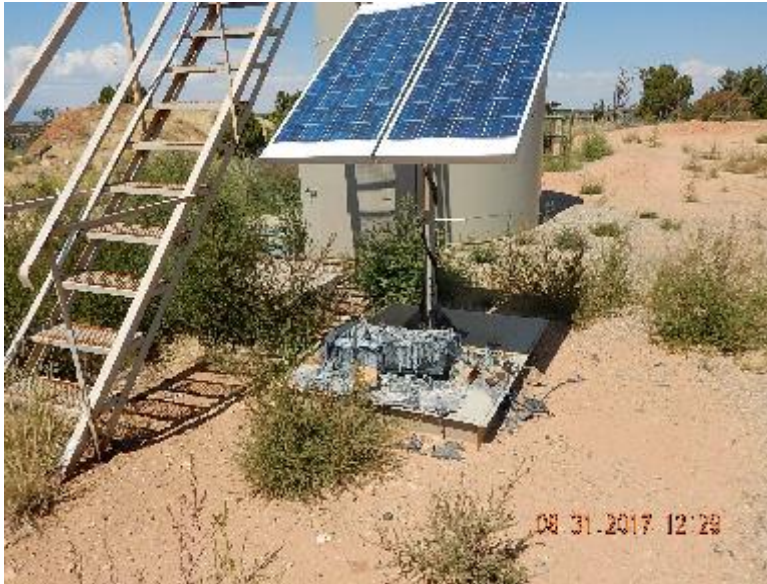
**Photo 11: Burnt batteries under solar panel. Previous inspection.**

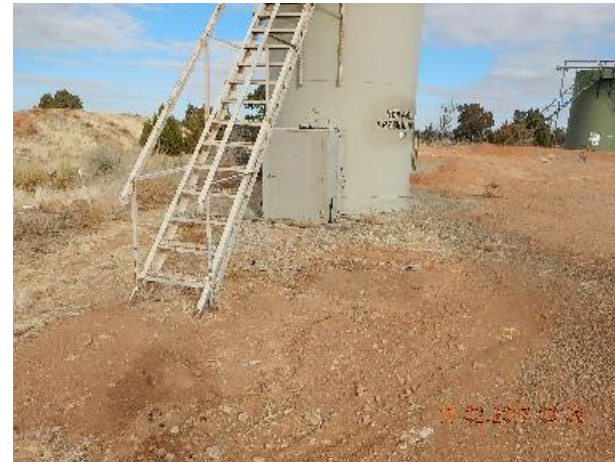
**Photo 12: Removed batteries and solar panel. Follow-up inspection.**

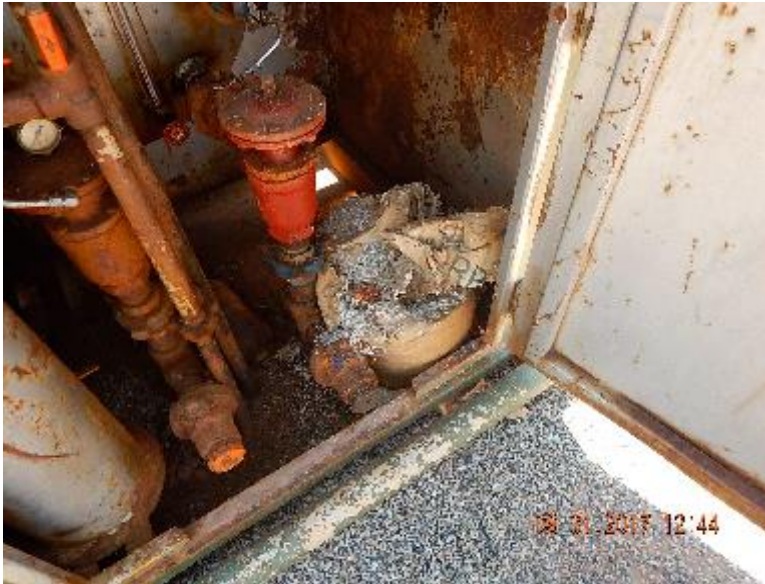
**Photo 13: Deteriorated bag of material inside separator box. Previous inspection.**

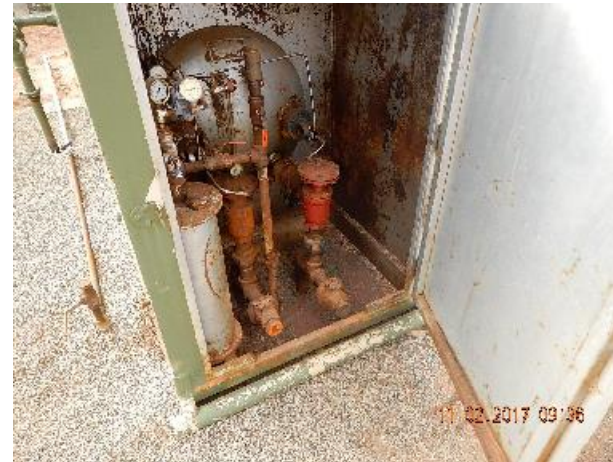
**Photo 14: Cleaned up and removed material from separator. Follow-up inspection.**

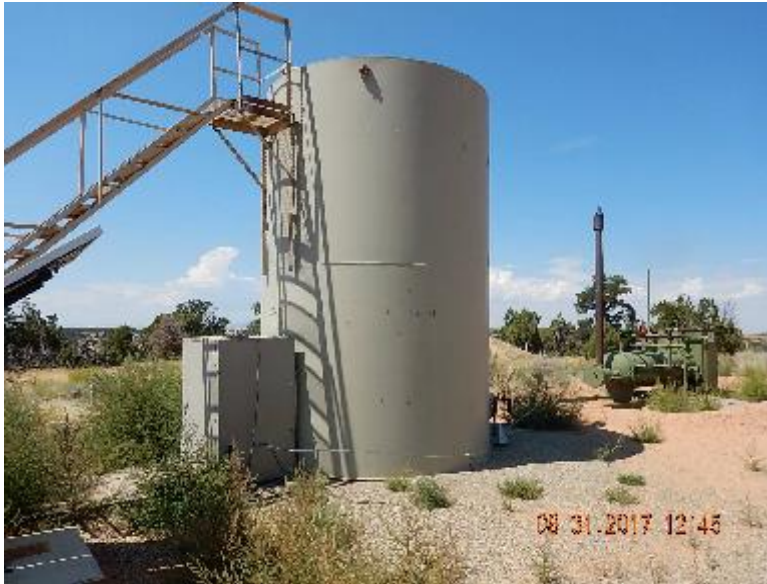
Photo 15: Unlabeled 210 BBL steel tank. Previous inspection.

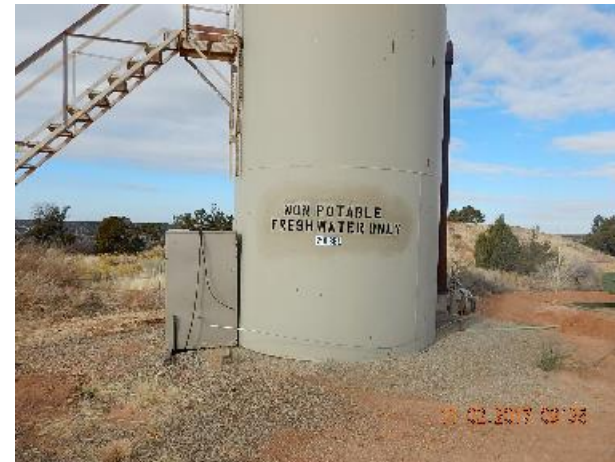
Photo 16: Labeled 210 BBL tank. Follow-up inspection.

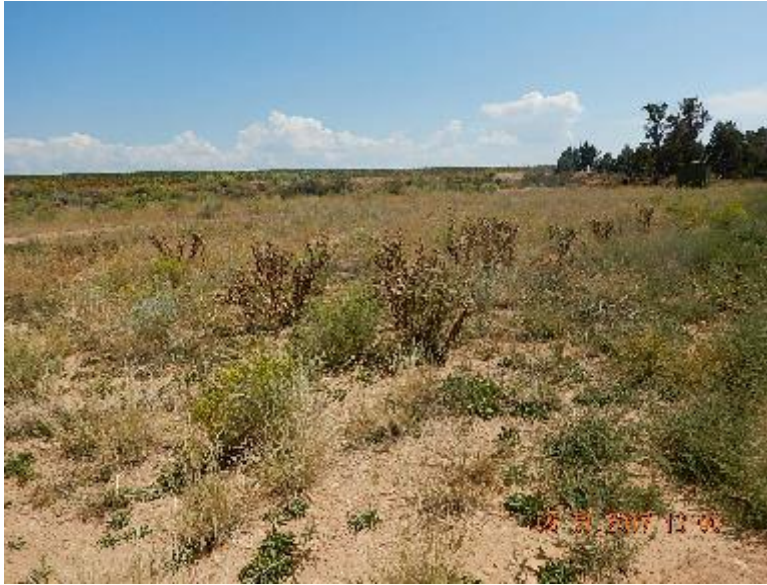
**Photo 17: Thistle and weeds growing on location. Previous inspection.**

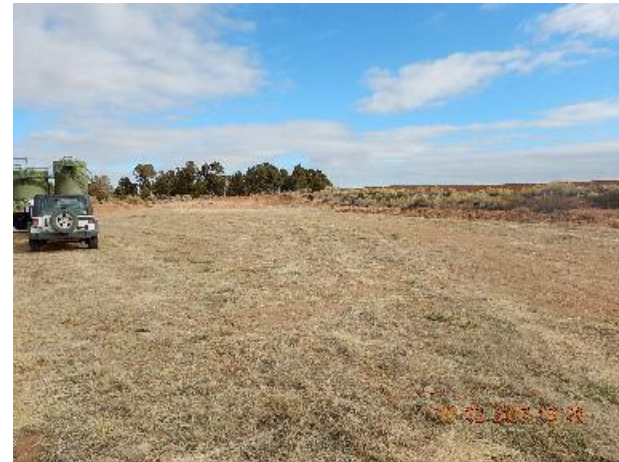
**Photo 18: Cleaned up and mowed location overview. Follow-up inspection.**

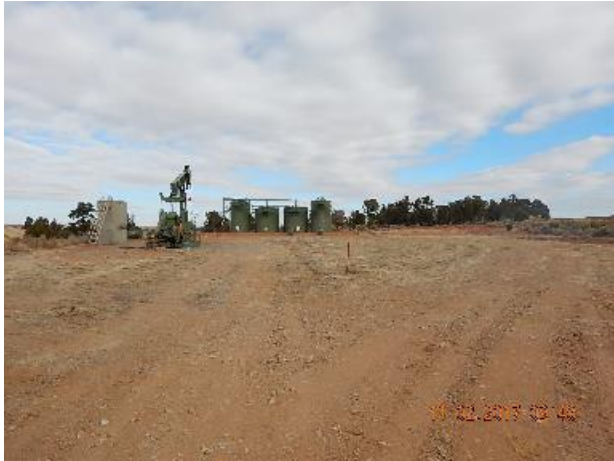
**Photo 19: Location overview from entry point. Follow-up inspection.**

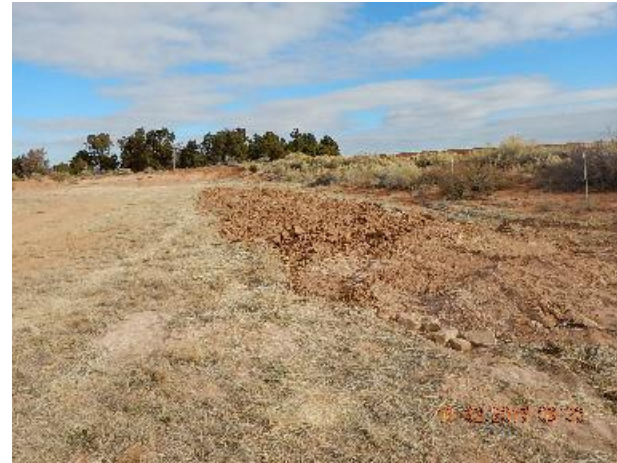
**Photo 20: Recently turned land farm area. Follow-up inspection.**
