- Federal #1 - 19
- 05-033-06060

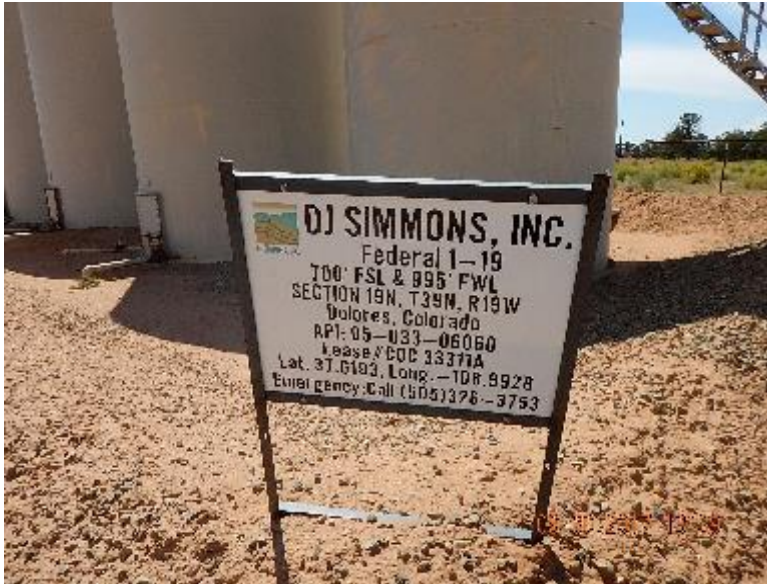
Photo 1: Wellhead sign. Previous inspection.

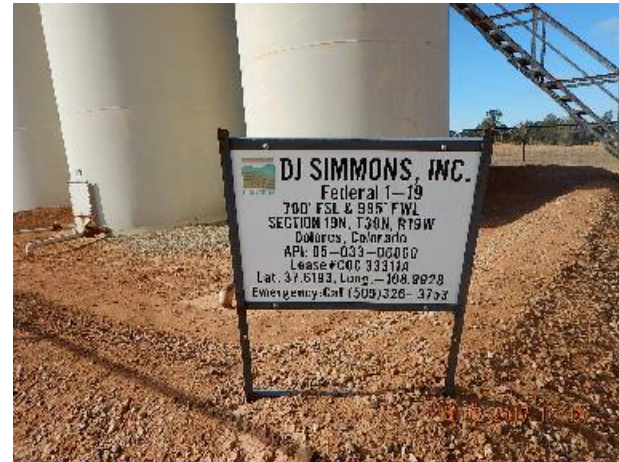
Photo 2: Wellhead sign. Follow-up inspection.

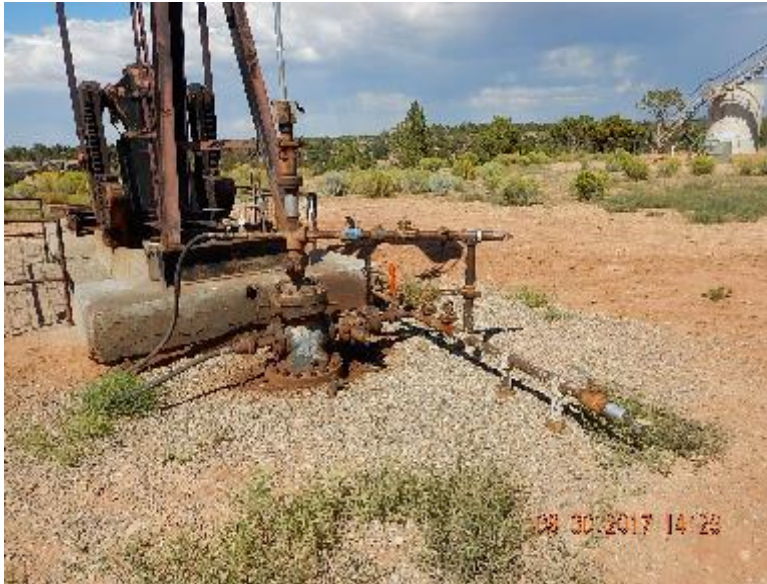
Photo 3: Wellhead with impacted soil around base of wellhead and 1" steel riser. Previous inspection.

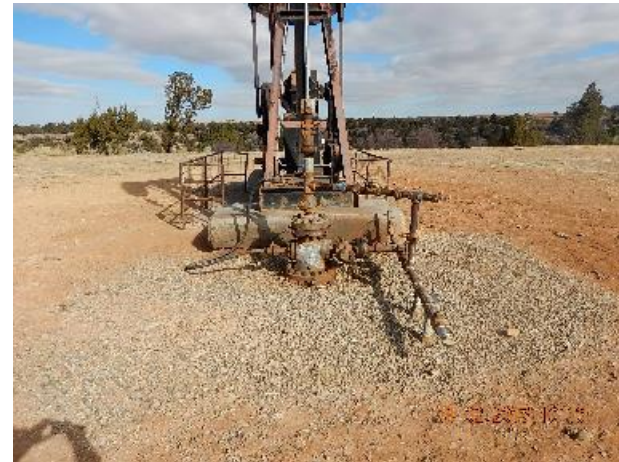
Photo 4: Cleaned up impacted soil and removed riser. Follow-up inspection.

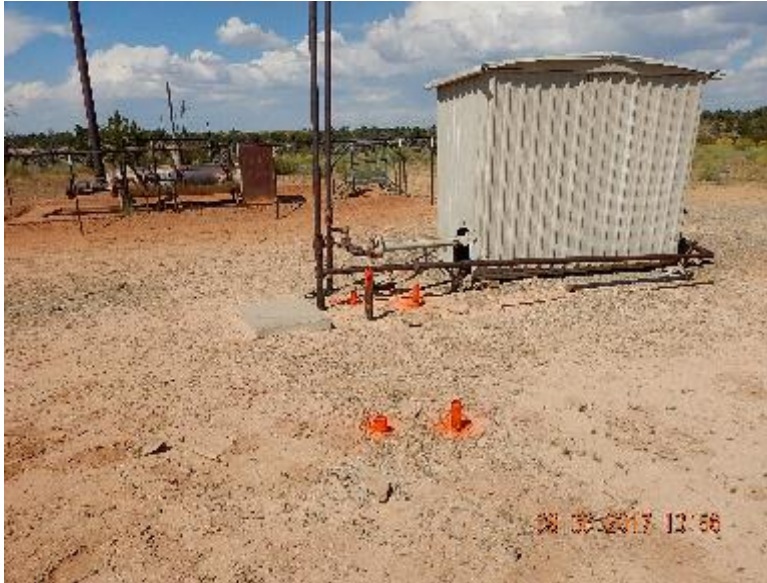
Photo 5: Risers (5) beside gas meter shed. Previous inspection.

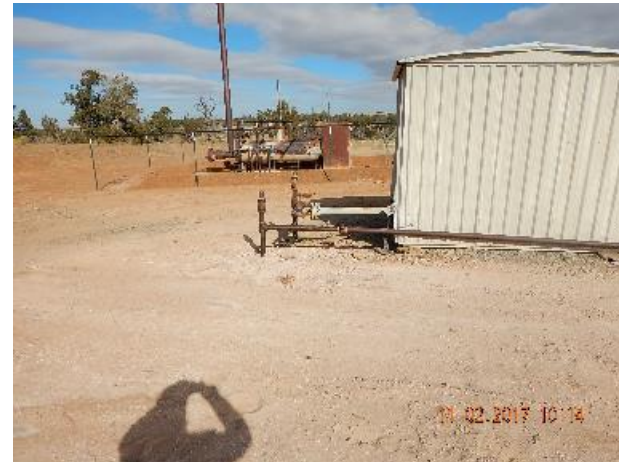
Photo 6: Removed risers by meter run shed. Follow-up inspection.

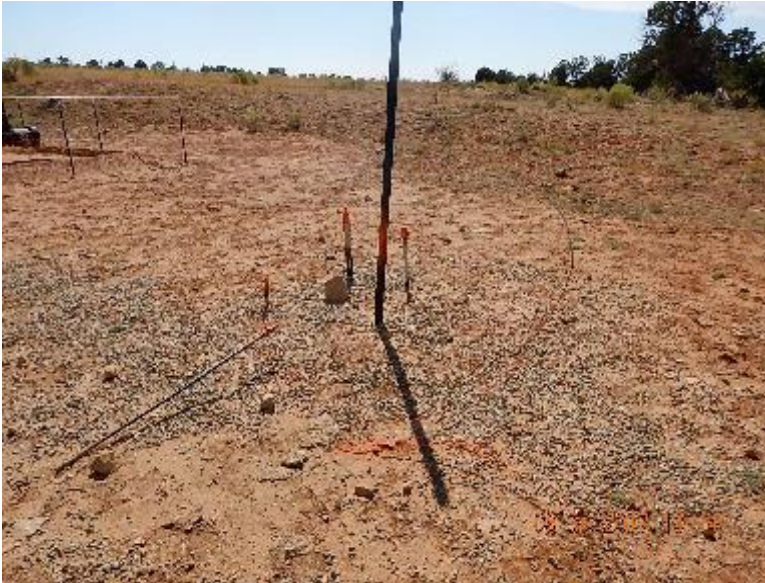
Photo 7: Risers (6) outside separator fencing. Previous inspection.

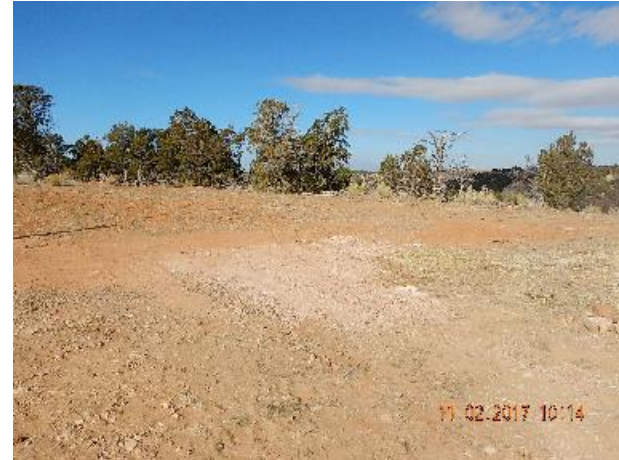
Photo 8: Removed risers outside separator fencing. Follow-up inspection.

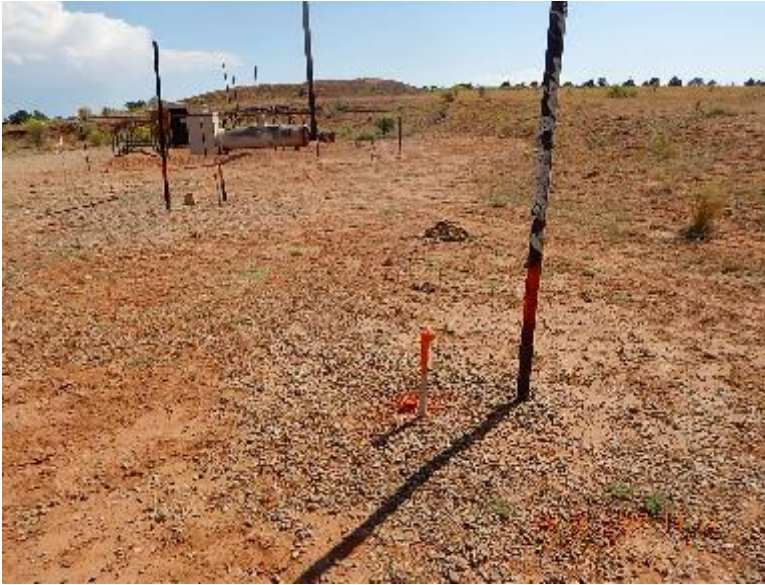
Photo 9: Risers (3) outside separator fencing out from first set of (6). Previous inspection.

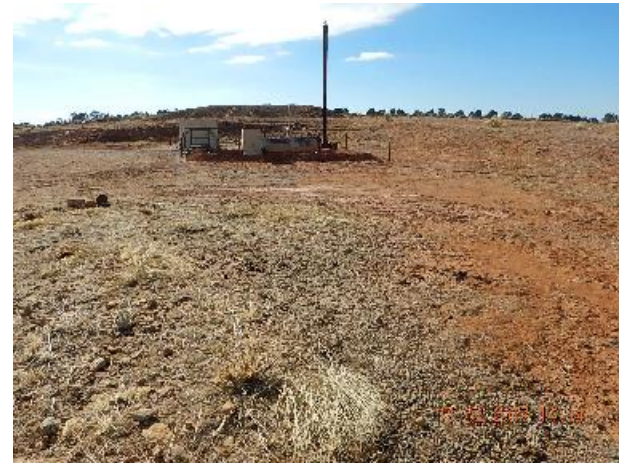
Photo 10: Removed risers outside separator fencing. Follow-up inspection.

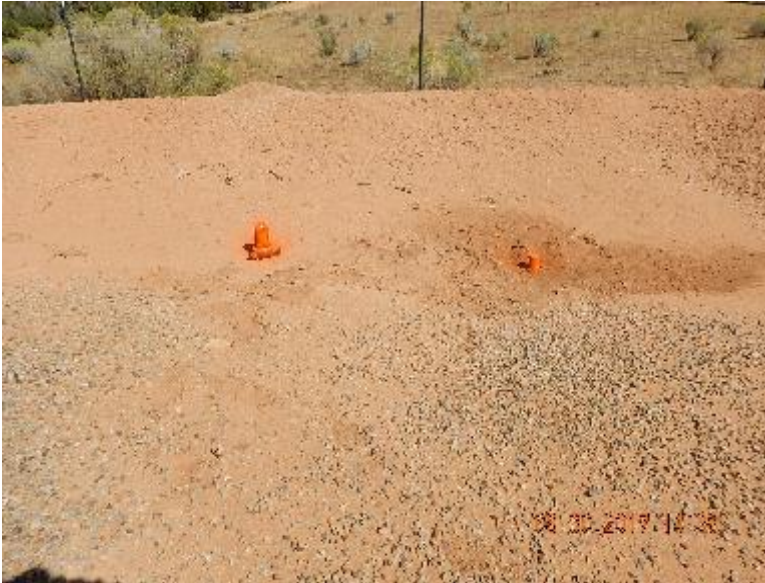
Photo 11: Risers inside production tank battery fencing. Previous inspection.

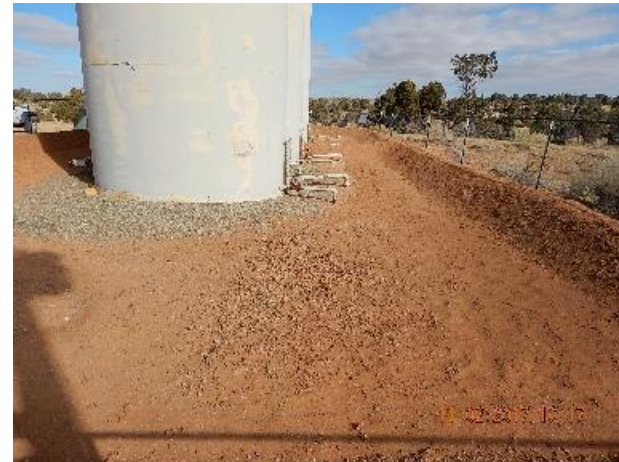
Photo 12: Removed risers inside tank battery fencing. Follow-up inspection.

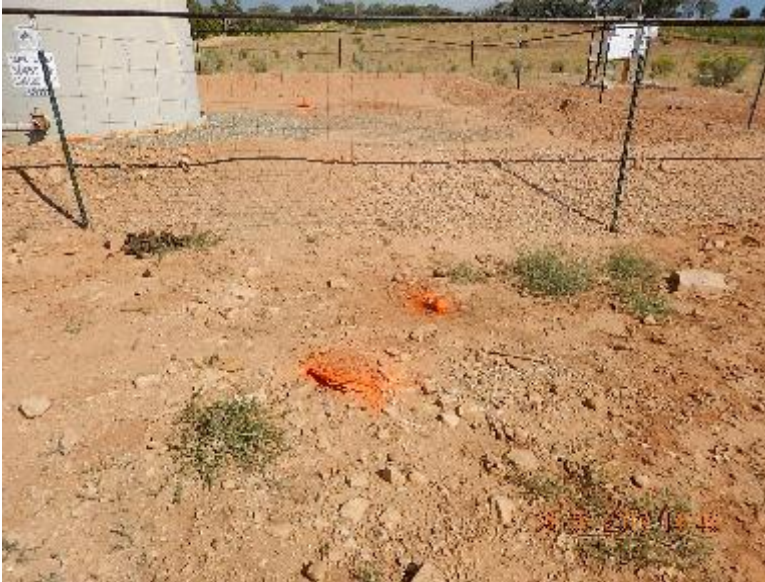
Photo 13: Riser and heavy gauge wiring outside production tank fencing. Previous inspection.

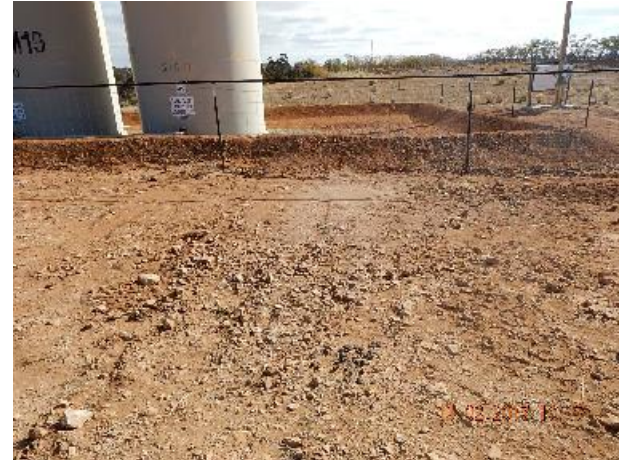
Photo 14: Removed risers outside tank battery fencing. Follow-up inspection.

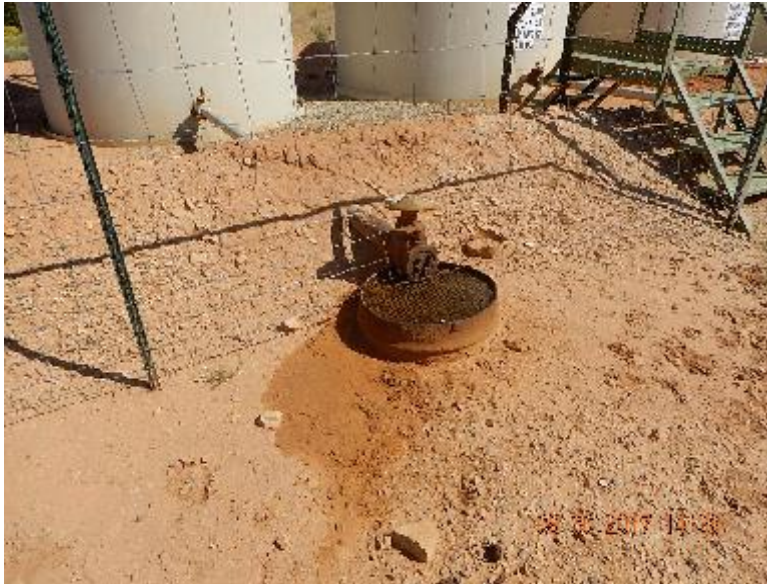
Photo 15: Water tank load out spill prevention full and impacted soil from overflow. Previous inspection.

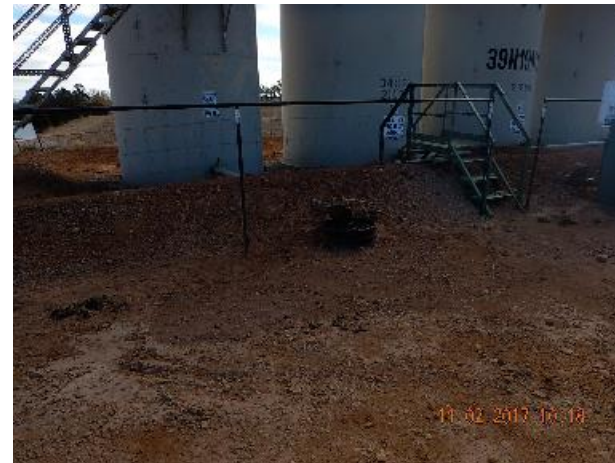
Photo 16: Cleaned up area around water tank load out. Previous inspection.

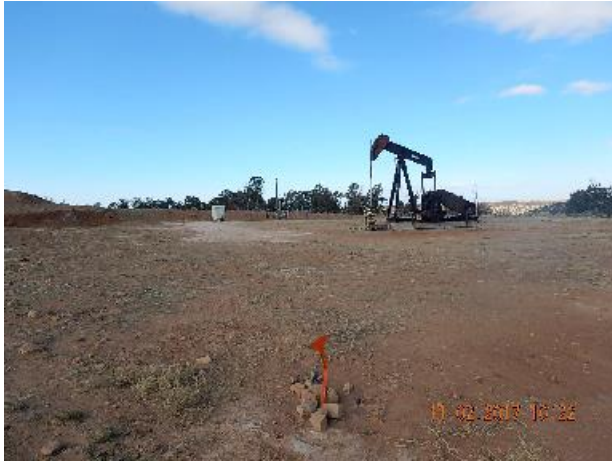
Photo 17: Location overview. Follow-up inspection.

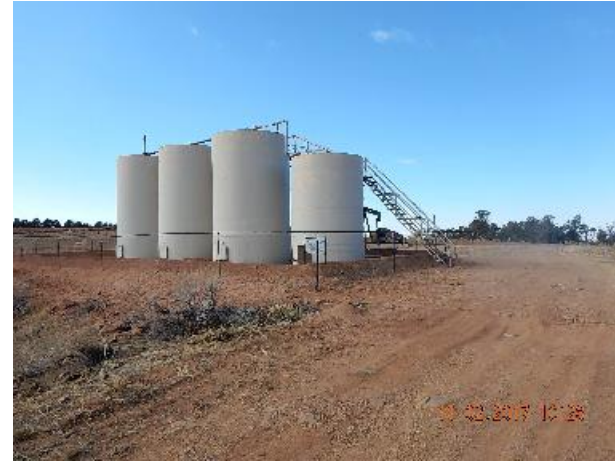
Photo 18: Location overview outside entry point. Follow-up inspection.
