- Cross Canyon Unit 1
- 05-033-06012

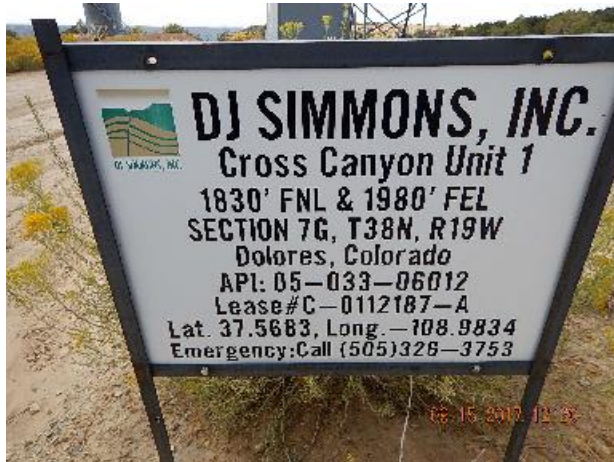
Photo 1: Wellhead sign. Previous inspection.

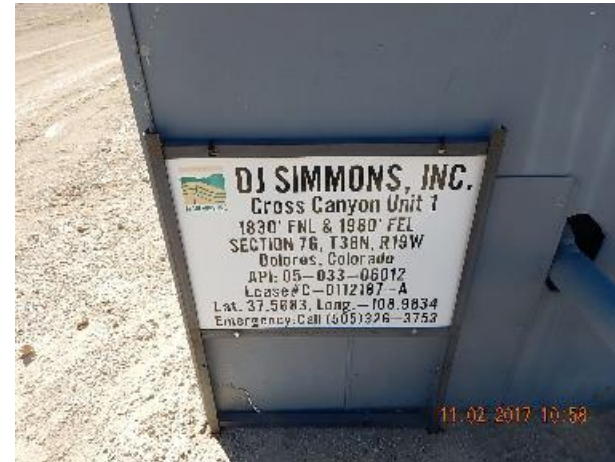
Photo 2: Wellhead sign. Follow-up inspection.

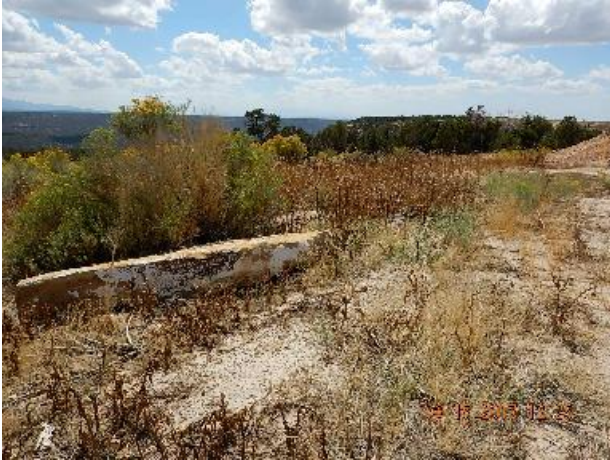
Photo 3: Thistle. Previous inspection.

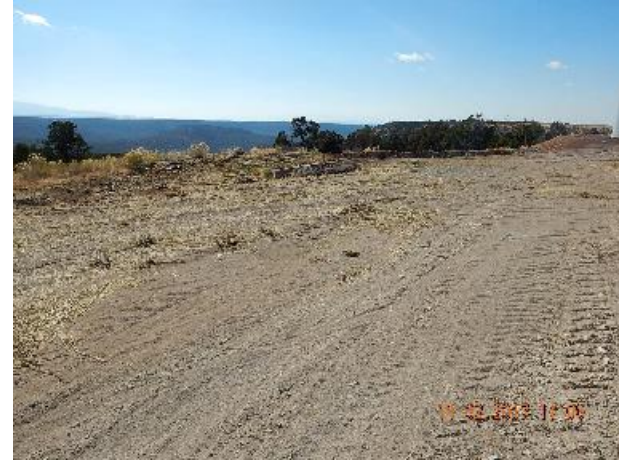
Photo 4: Removed steel cable and Thistle. Follow-up inspection.

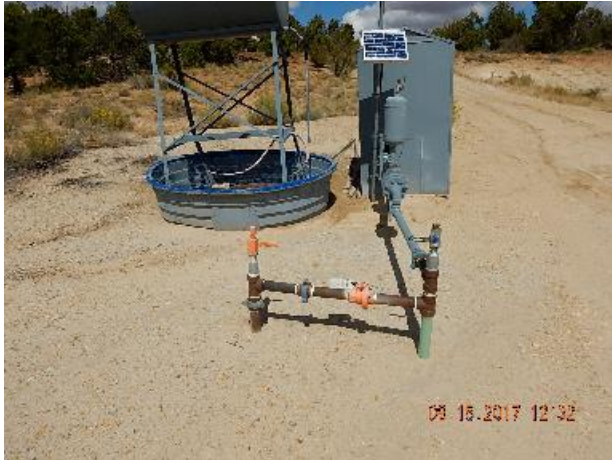
Photo 5: Line into meter and low point stub up and valve. Previous inspection

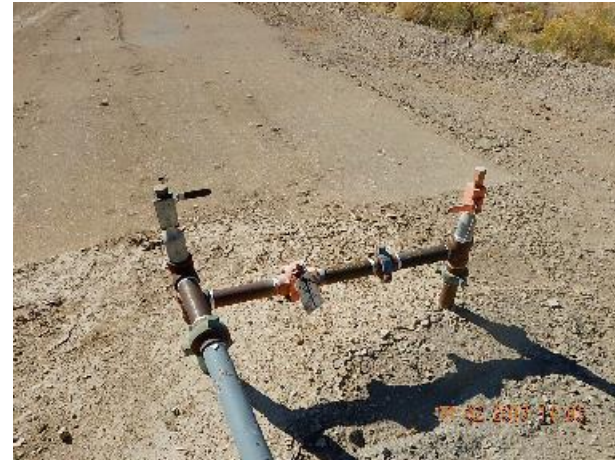
Photo 6: Line into meter and low point stub up with locked and tagged valve. Follow-up inspection.

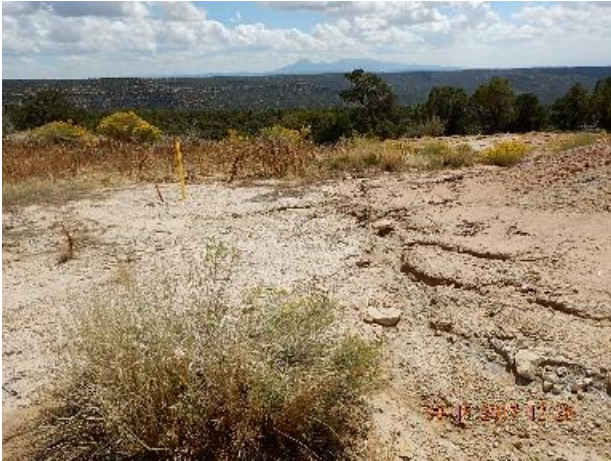
Photo 7: Stormwater erosion channel off front of production tank berm. Previous inspection.

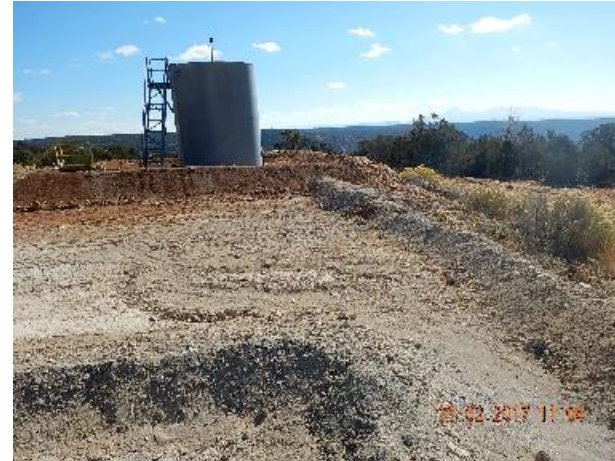
Photo 8: Repaired surface area and new berm. Follow-up inspection.

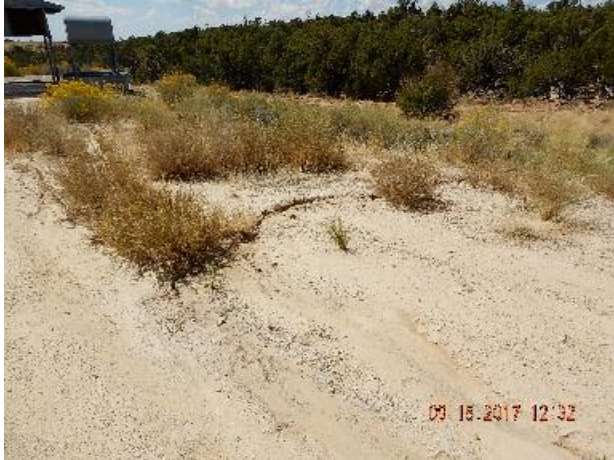
Photo 9: Stormwater flow coming down access road grade at entrance. Previous inspection.

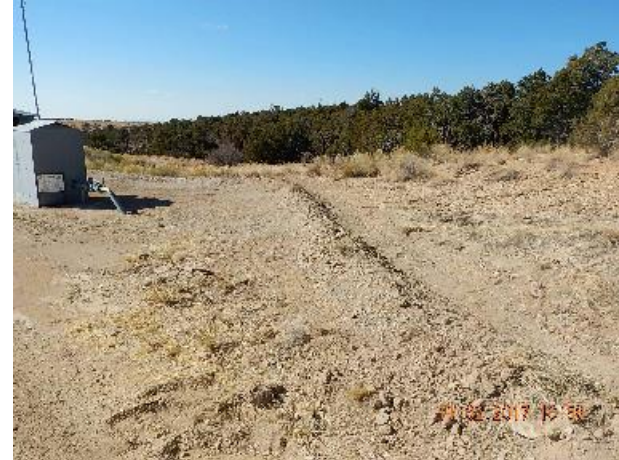
Photo 10: New diversion berm for stormwater coming off access road. Follow-up inspection.

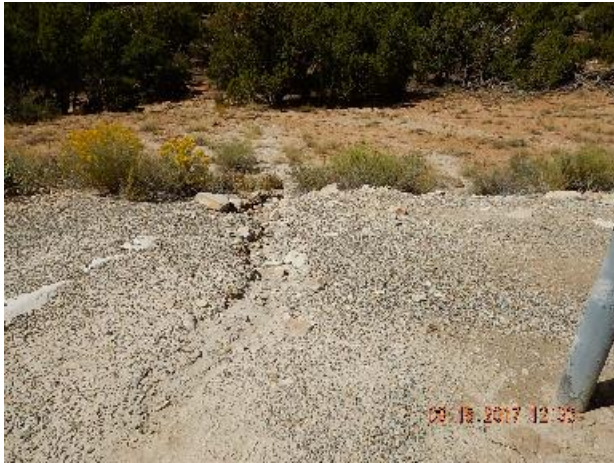
Photo 11: Erosion channel on SW corner beside carport shelter. Previous inspection.

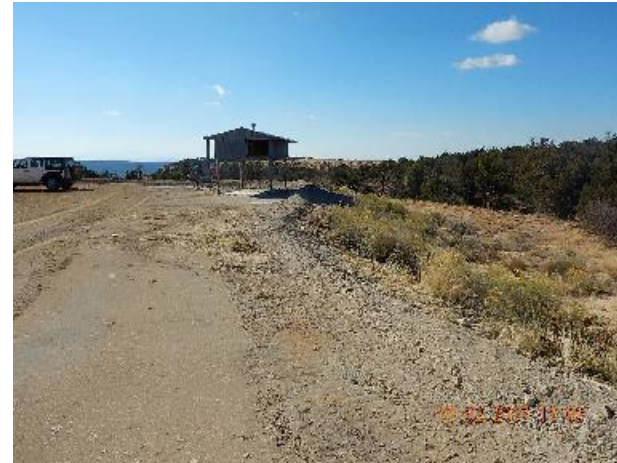
Photo 12: New berm along perimeter to divert/control stormwater. Follow-up inspection.

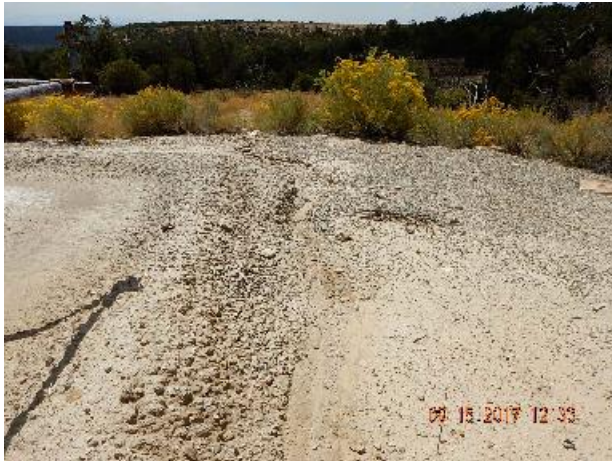
Photo 13: Erosion channel on SW corner along separator berms. Previous inspection.

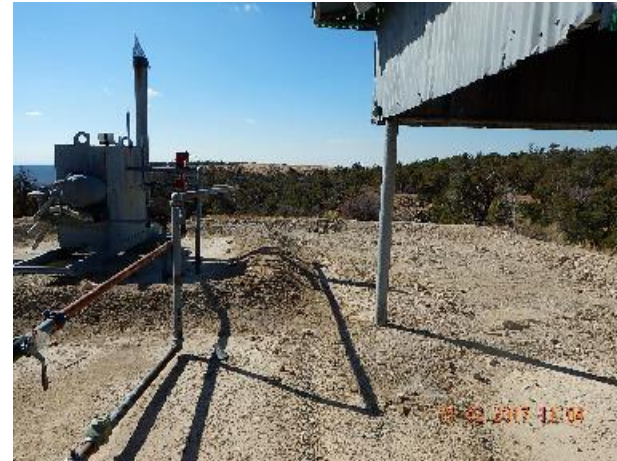
Photo 14: Repaired surface area and new berm to control stormwater. Follow-up inspection.
