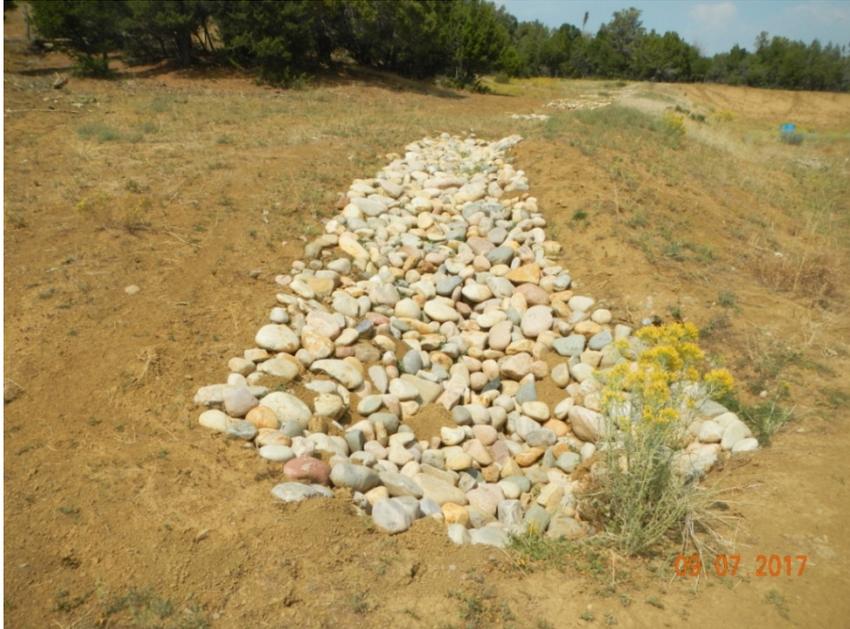
Photo 1: View of cobble stormwater controls installed in the western portion of the project area.

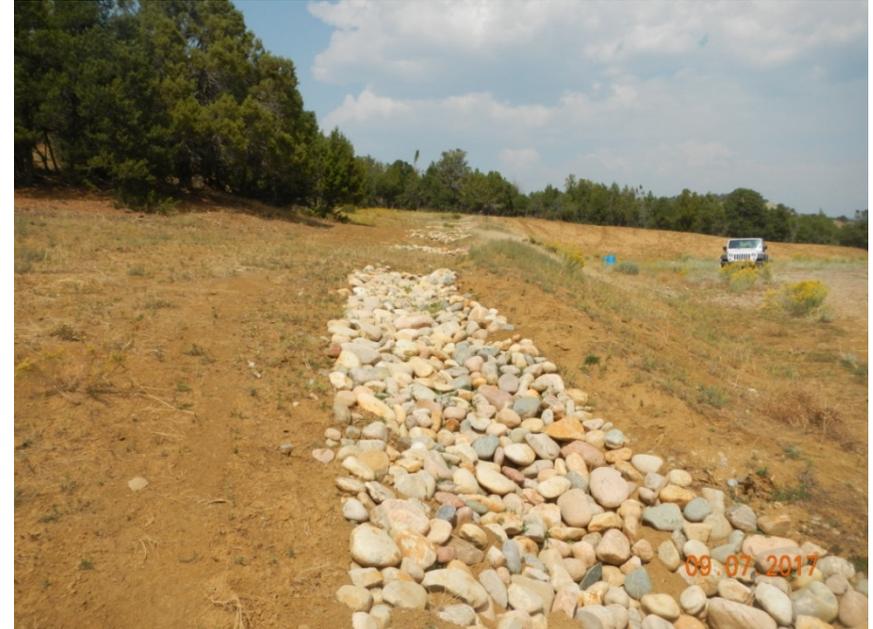
Photo 2: Another view of stormwater controls within the western portion of the project area. Cobble check dams visible in background.

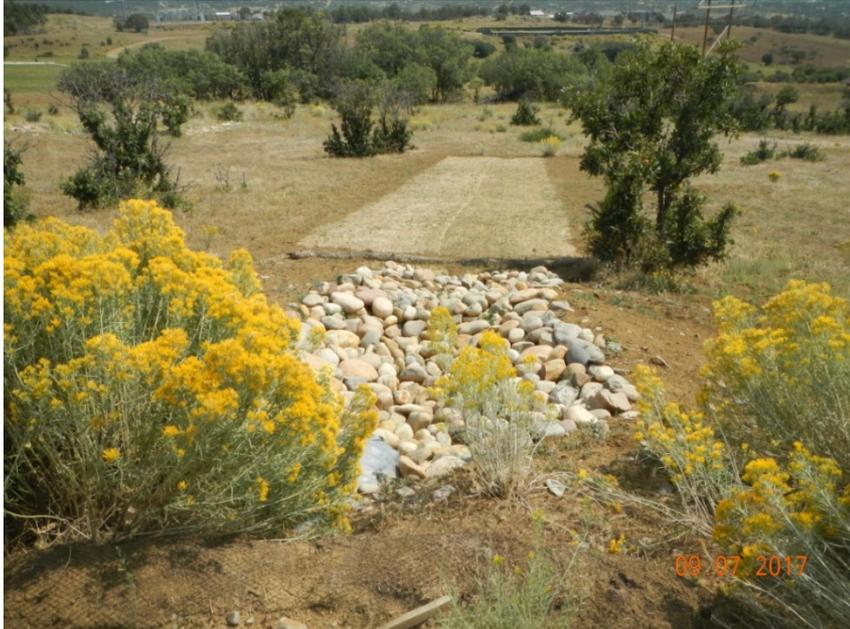
Photo 3: View of stormwater controls and erosion repair downstream from culvert outlet near the entrance of the well pad.

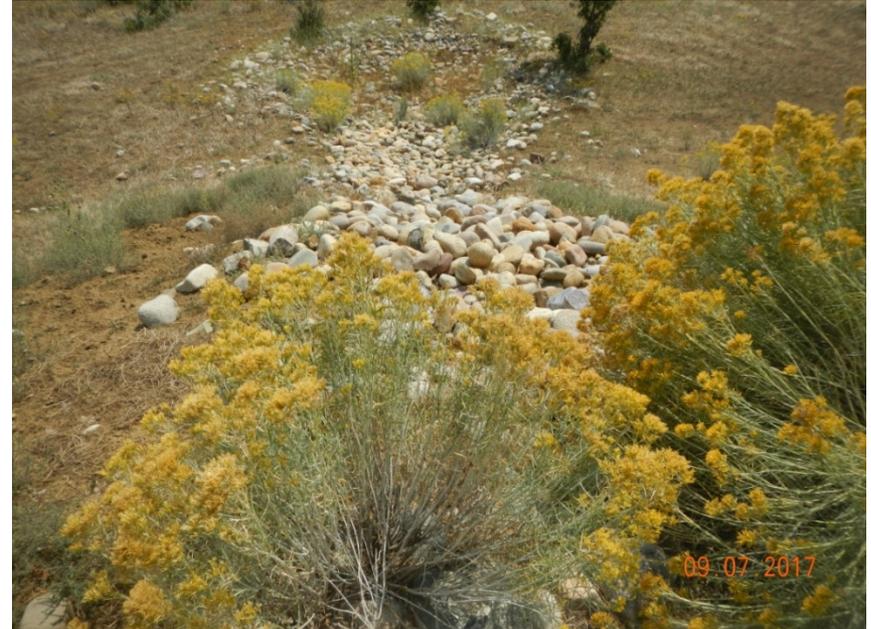
Photo 4: View of cobble run down and silt trap in the southeastern corner of the project area.

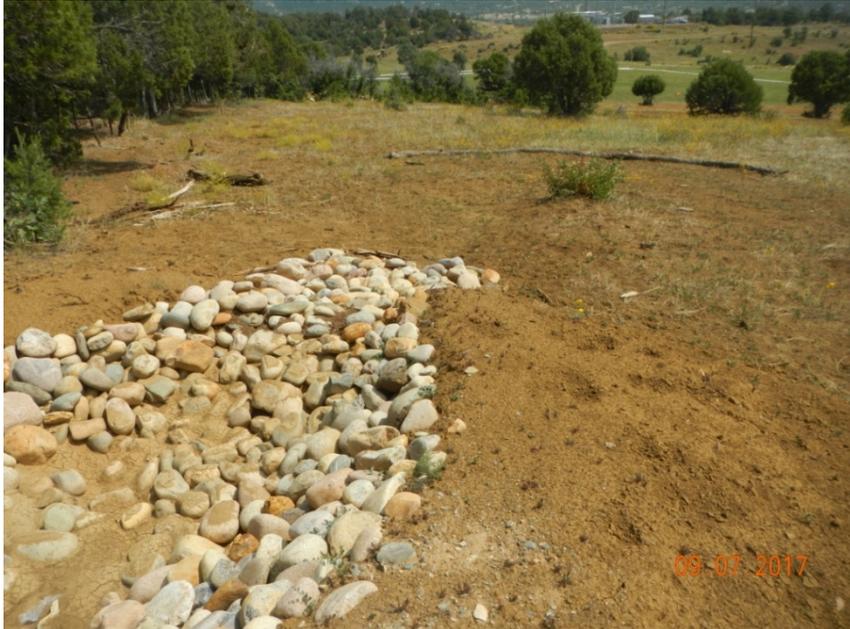
Photo 5: View of stormwater controls in the northeastern portion of the project area where stormwater flows eastward (toward the upper right-hand corner of the photo).

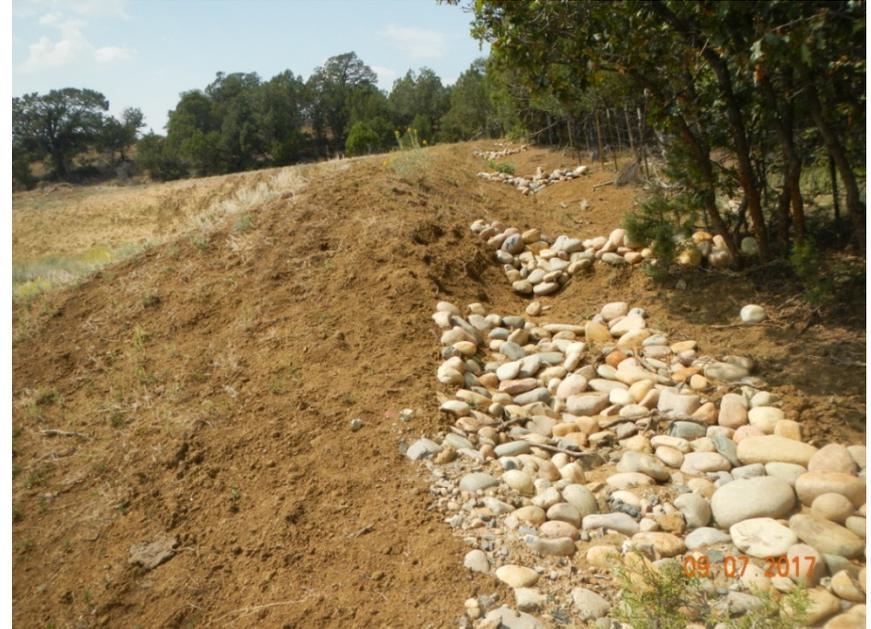
Photo 6: View of cobble stormwater controls in the northern portion of the project area, upstream of Photo 5.

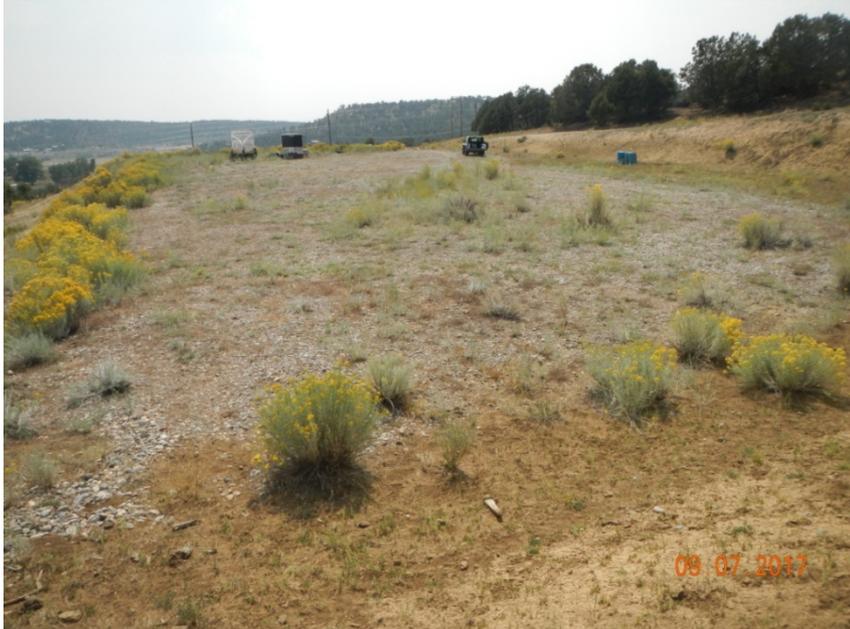
Photo 7: View of the project area from the northeastern corner facing center. Cut slopes were recently seeded and hydromulched.

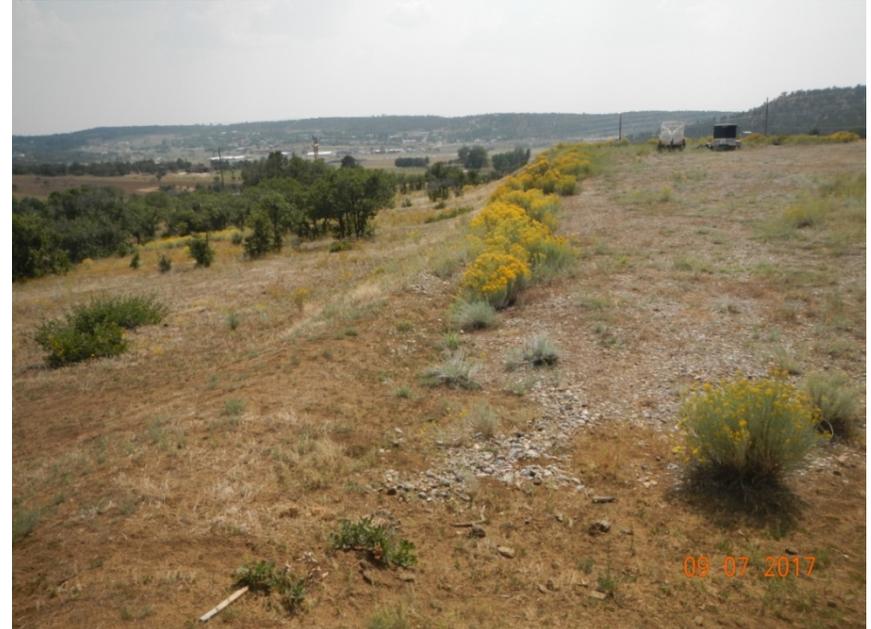
Photo 8: View of the eastern portion of the project area from the northeastern corner facing southward.

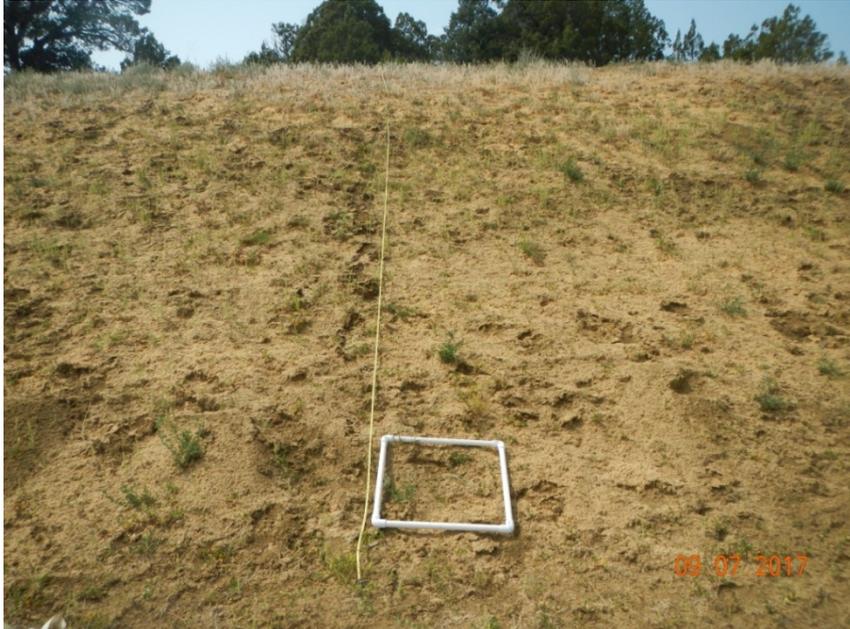
Photo 9: View of germination Transect 1, within the western portion of the project area. Area was recently seeded, and this study provides baseline data.

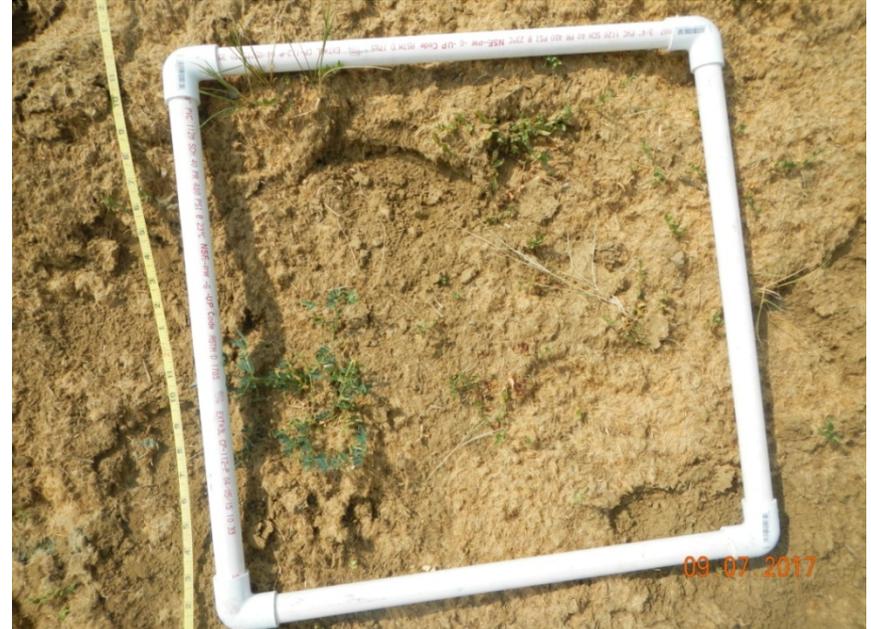
Photo 10: Birdseye view of typical quadrat along germination Transect 1.

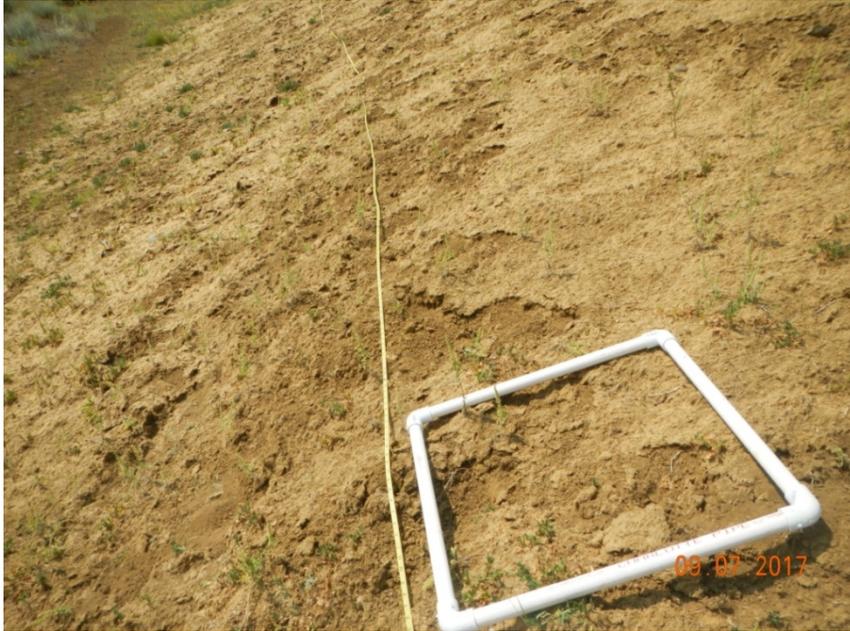
Photo 11: View of germination Transect 2, within the western portion of the project area. Area was recently seeded, and this study provides baseline data.

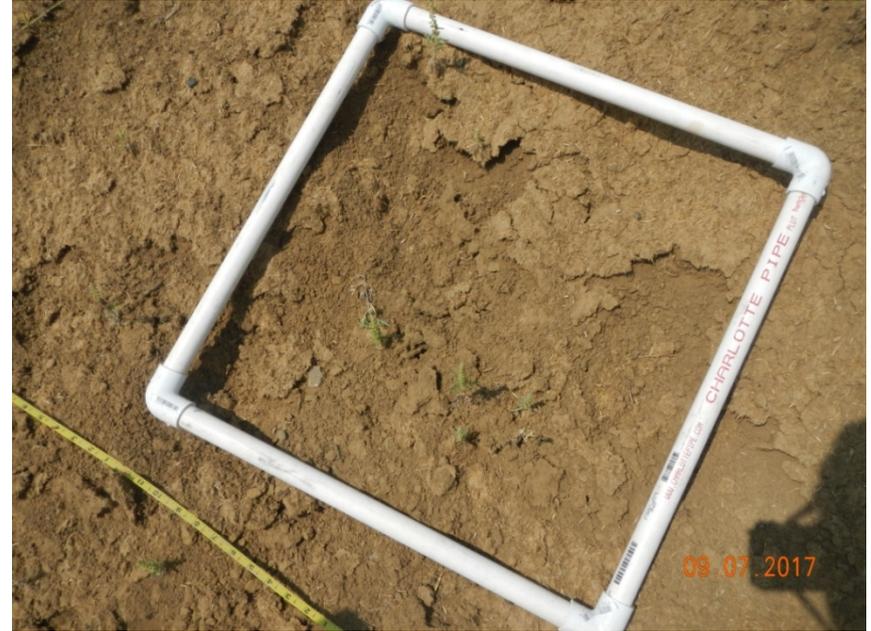
Photo 12: Birdseye view of typical quadrat along germination Transect 2.
