Inspection Photos  
Well Name: ECK 12-90-1 1  
Location ID: 428197

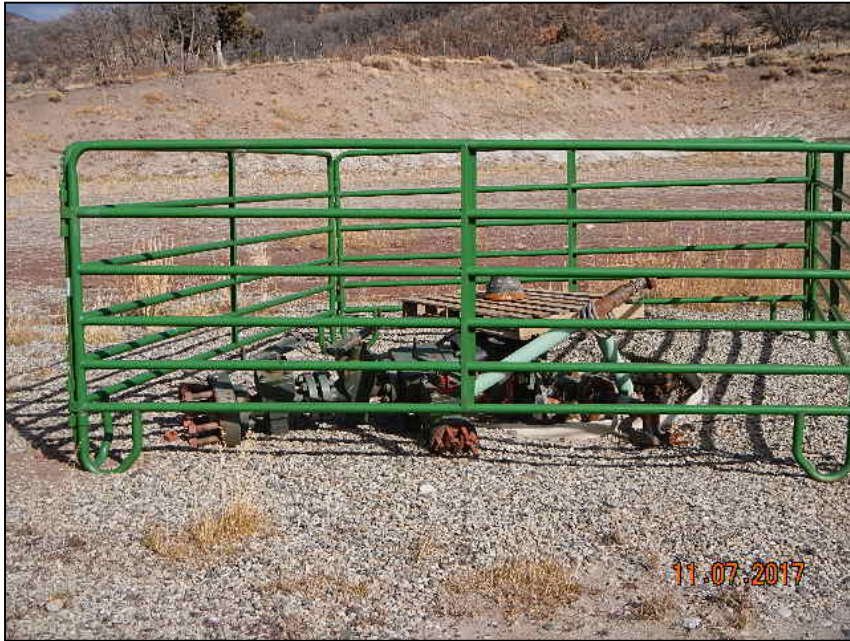
**Photo 1. Wellhead.**

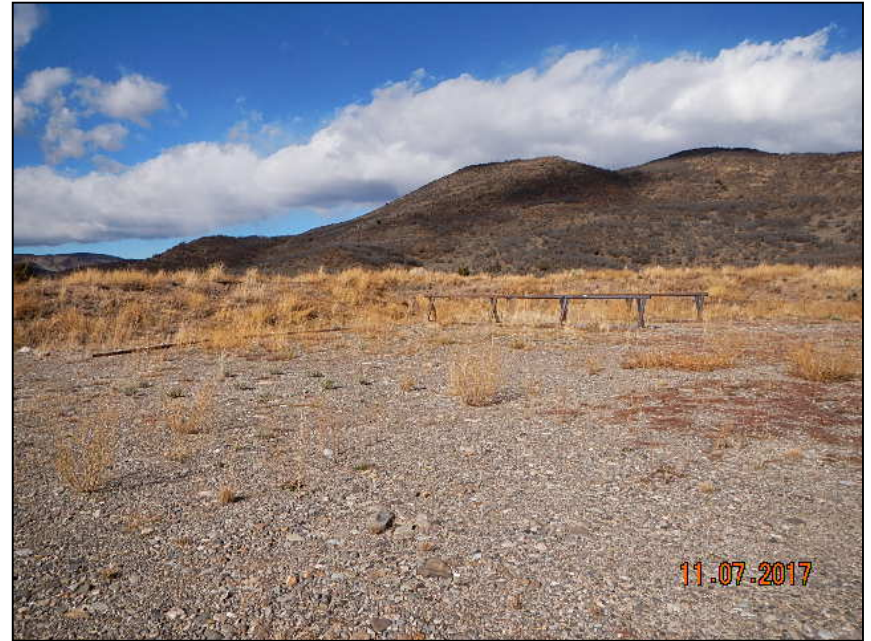
**Photo 2. Pipe racks still on location.**

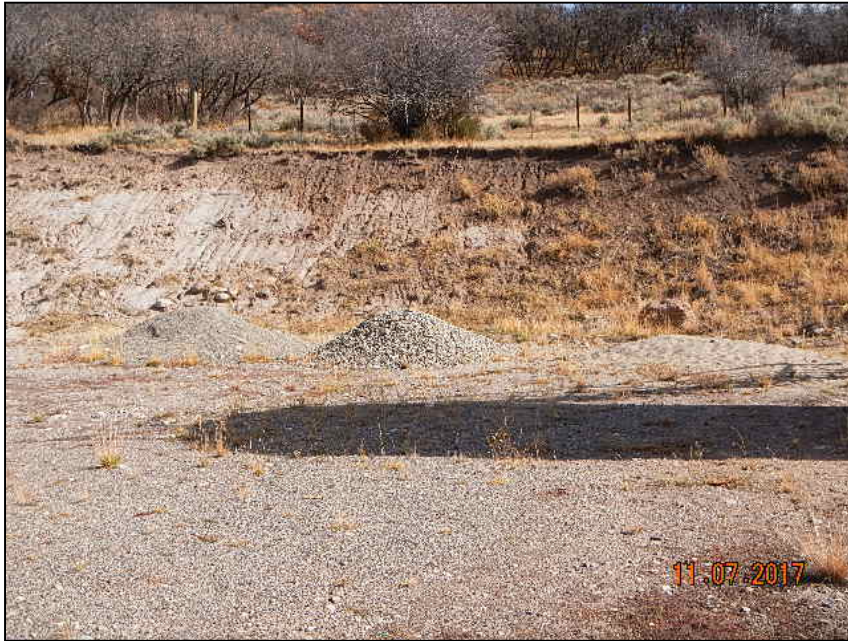
Photo 3. Stored gravel. Cut slope erosion.

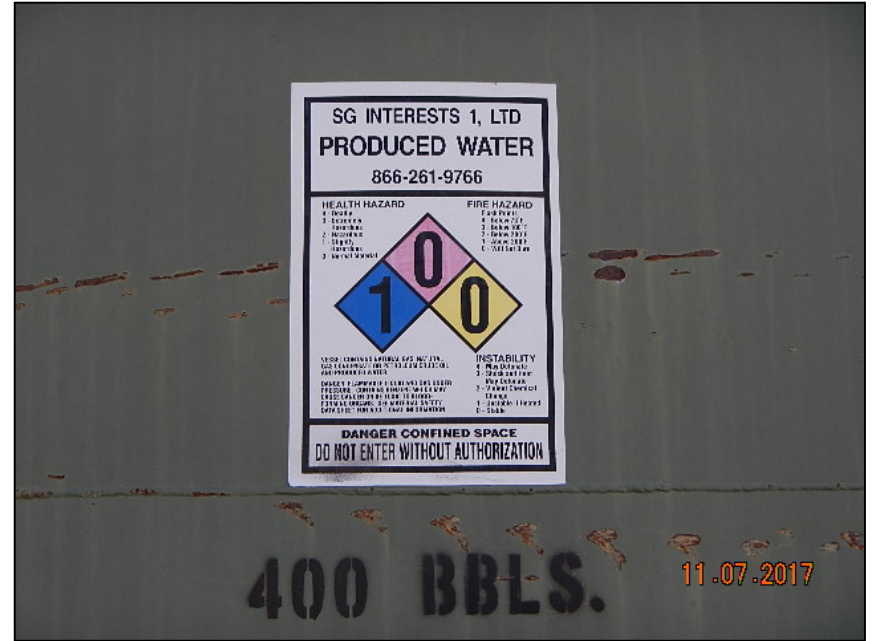
Photo 4. Update NFPA diamond for Produced Water or provide documentation for 0 fire hazard rating

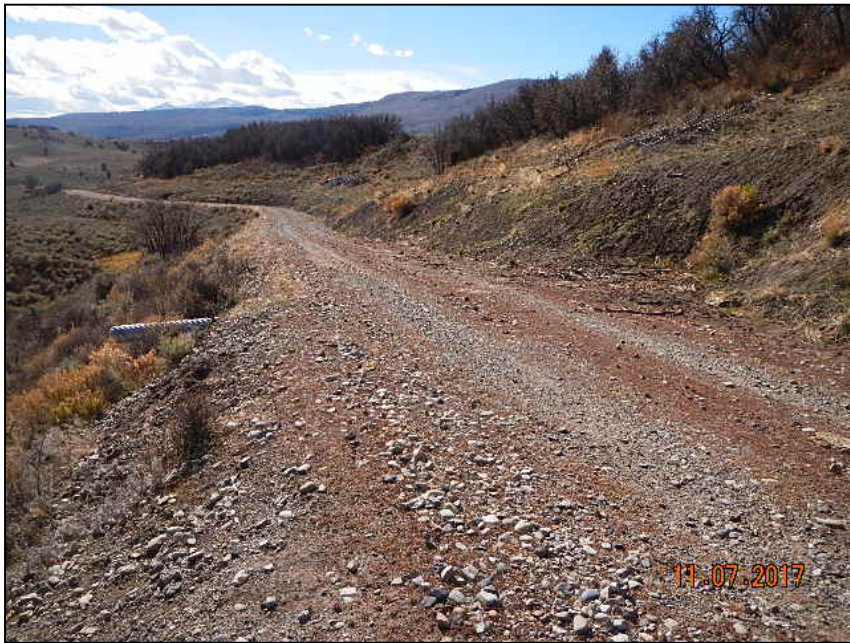
**Photo 5. one of two culverts with silted in inlet.**

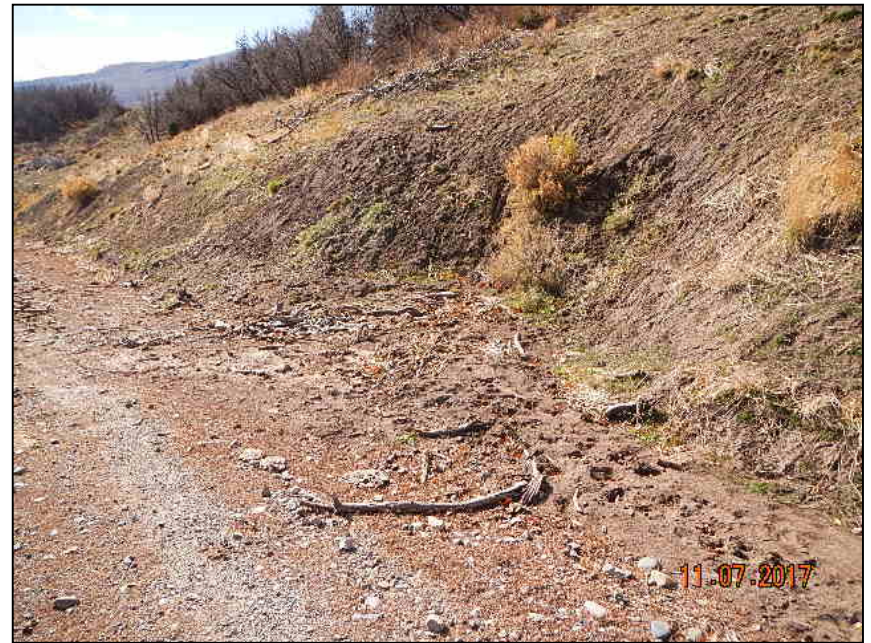
**Photo 6. Silted in inlet to culvert**
