Inspection Photos

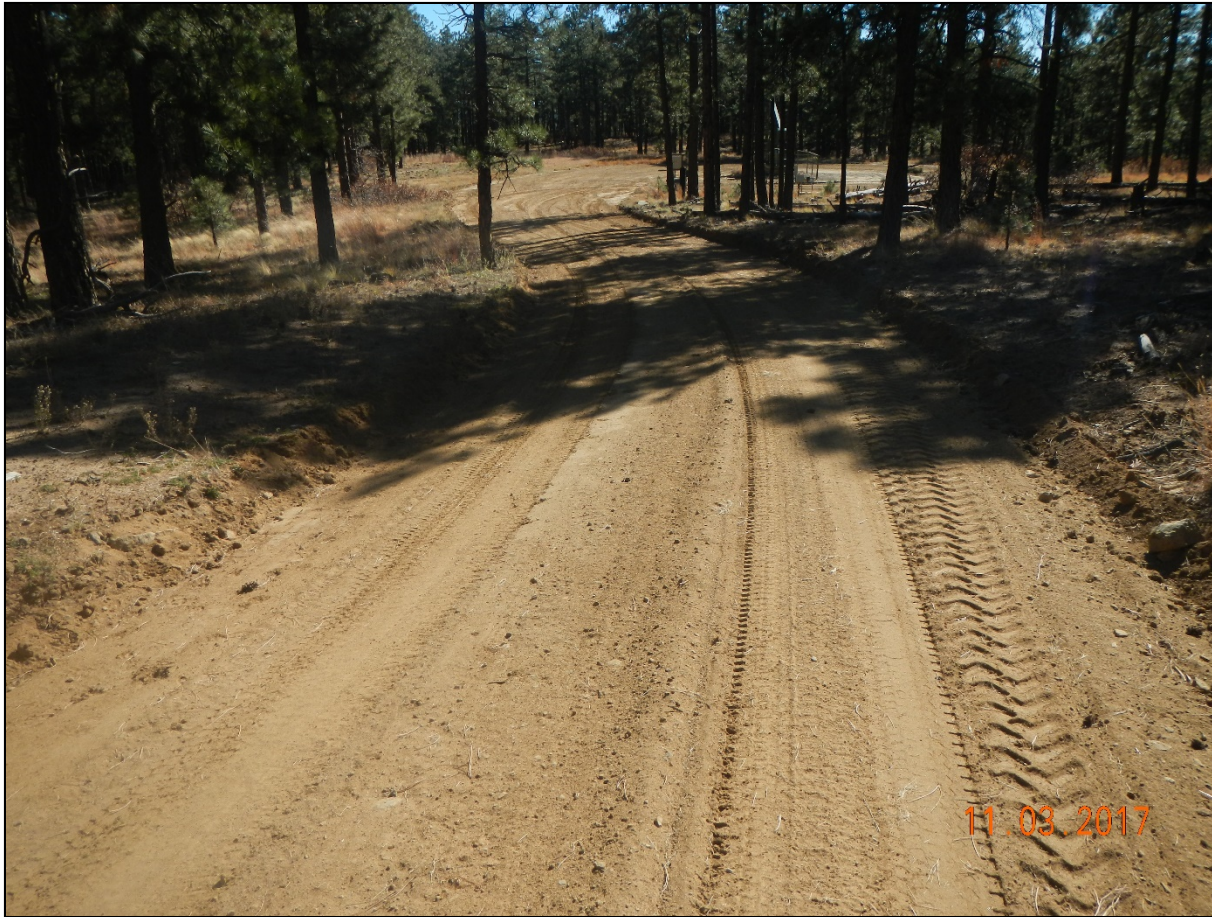
Photo 1. Facing southeast along the access road. The access road has recently been graded and soil was pushed onto the road.

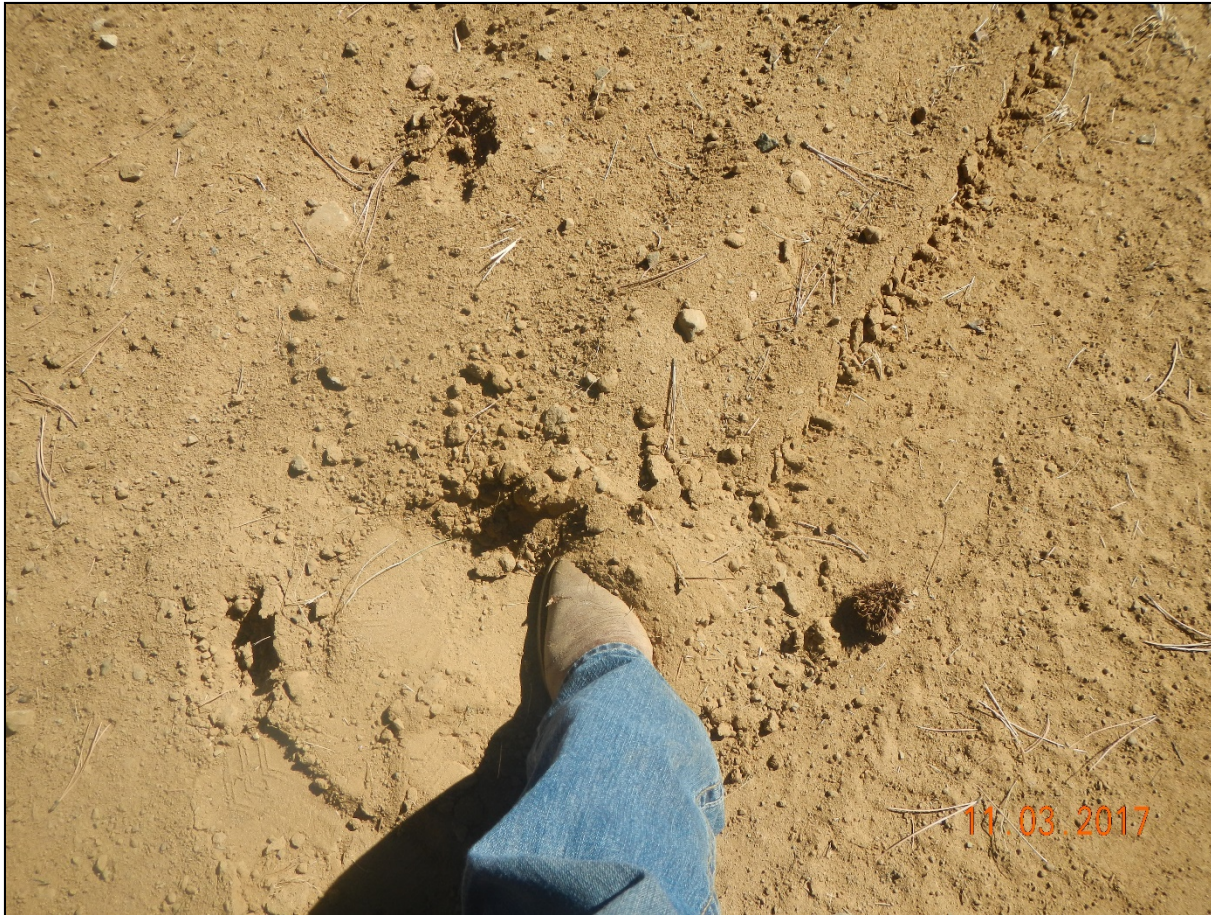
Photo 2. The soil pushed onto the road is loose and susceptible to erosion.

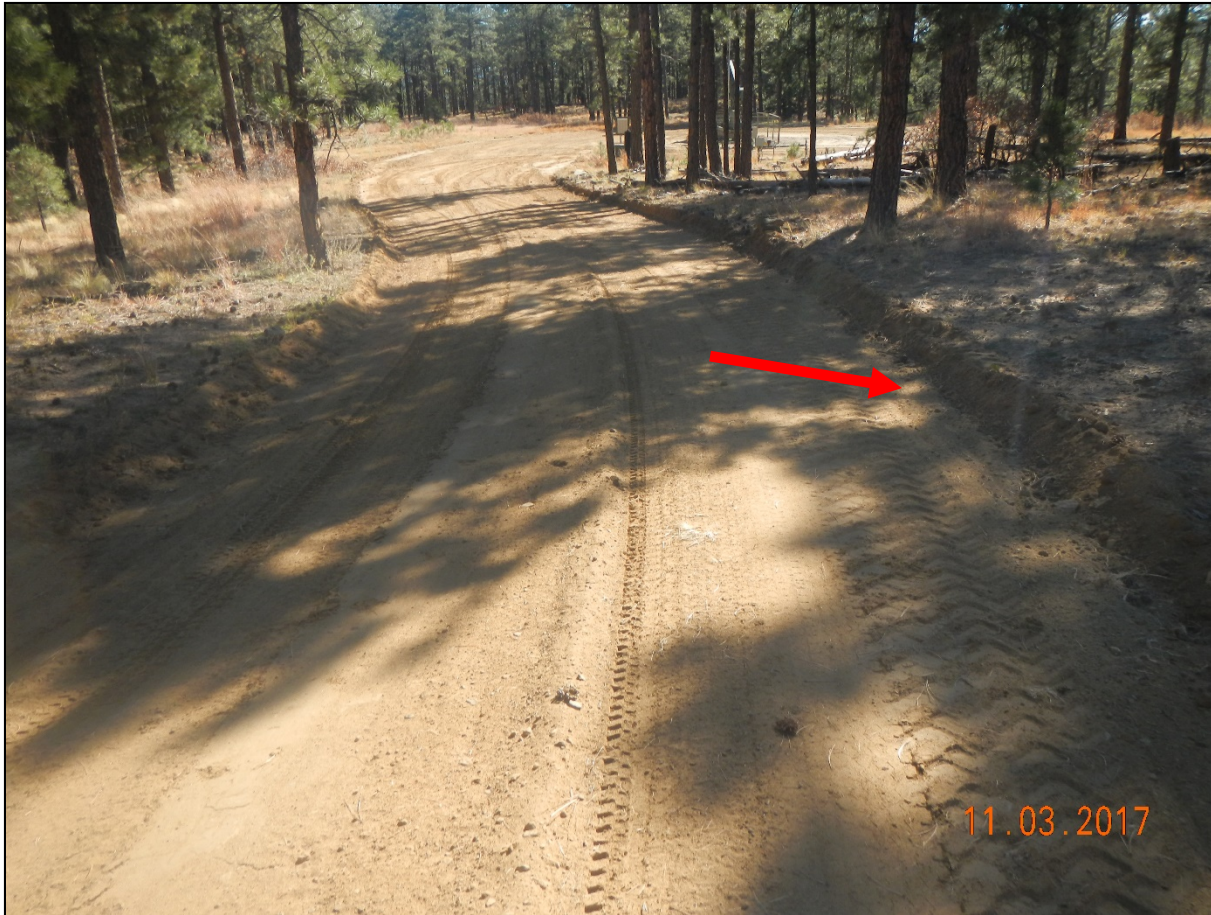
Photo 3. The arrow points to the side of the road cut where soil was pushed onto the road which is also causing the road to become widened. The grade of the road is being lowered by grading activities.

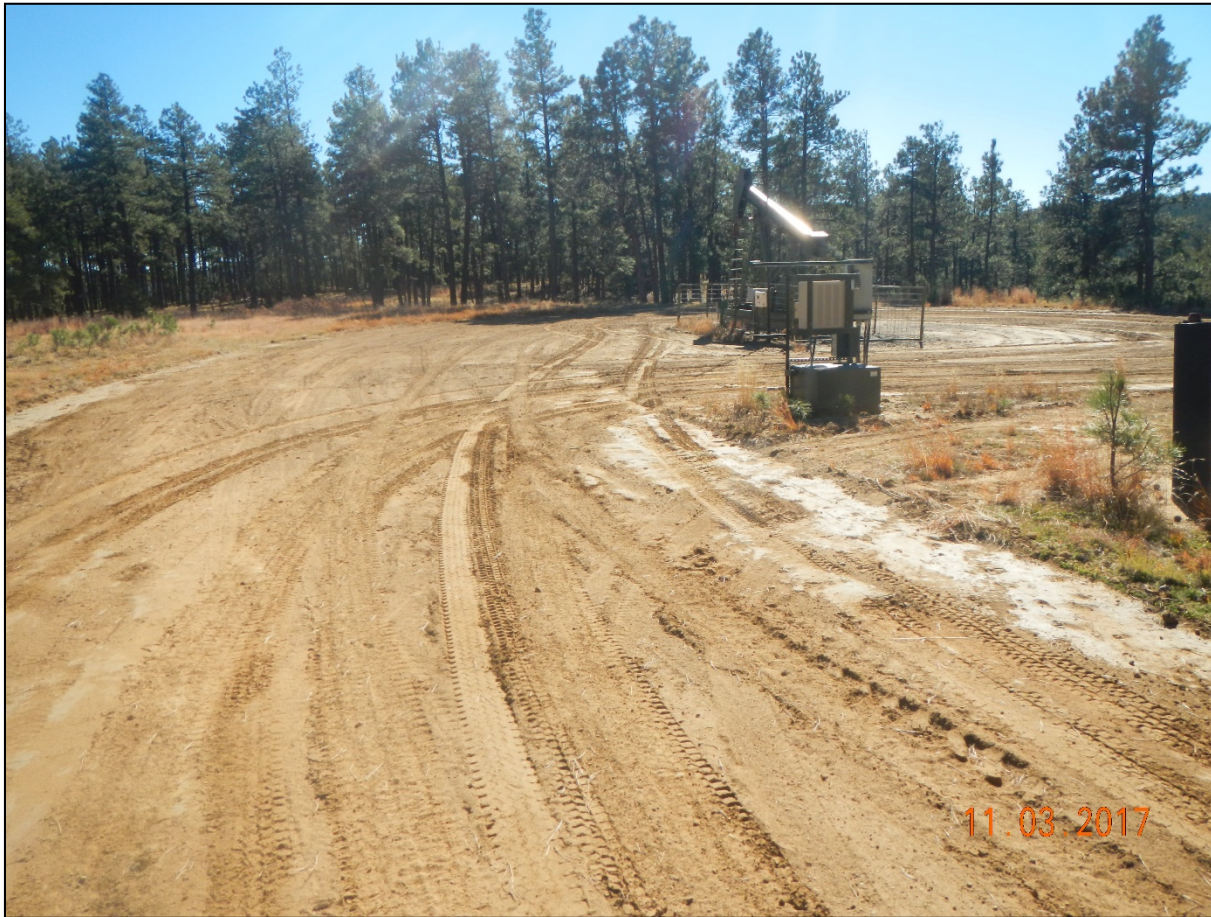
Photo 4. Facing southeast toward the location. The location was regraded. Some of the vegetation may have been disturbed.

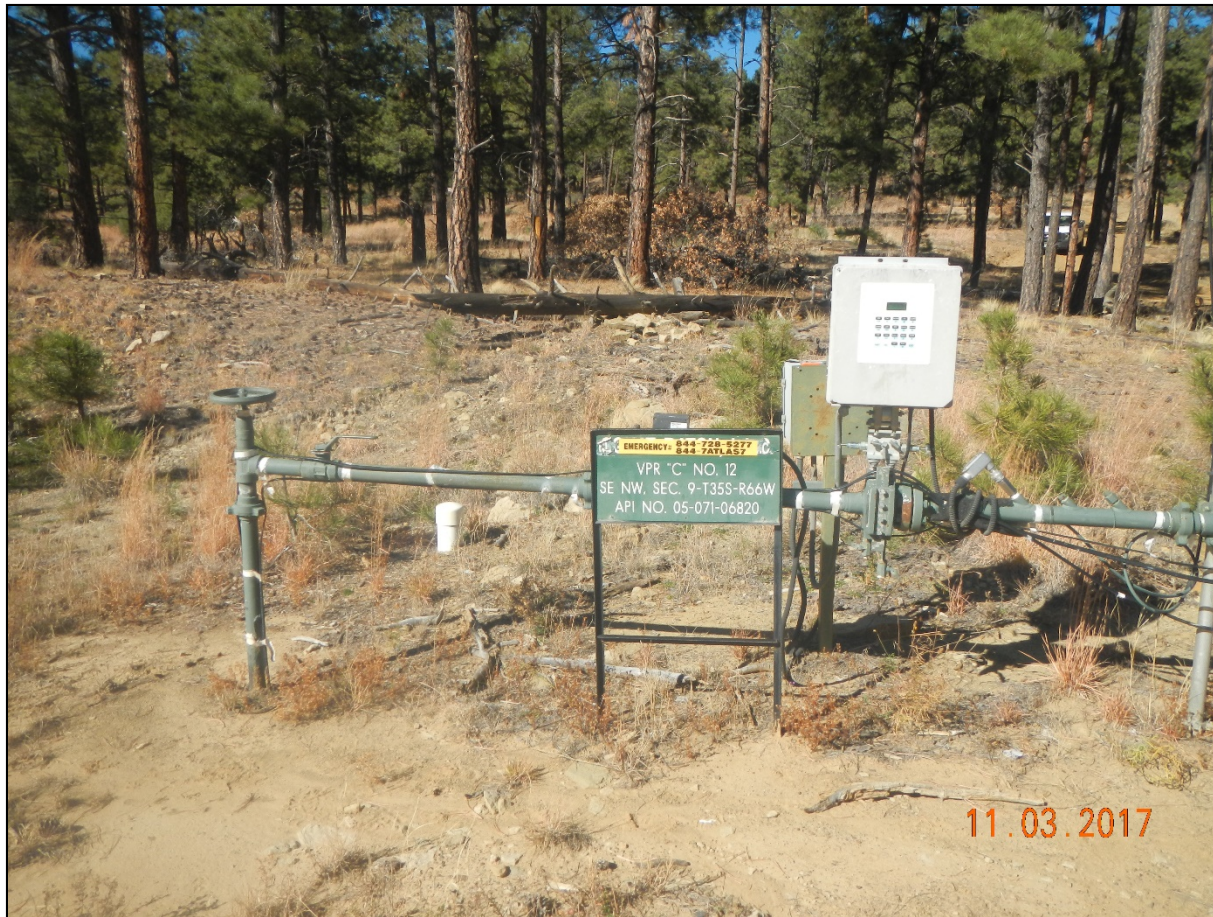
Photo 5. The well sign at the location does not have an operator name.

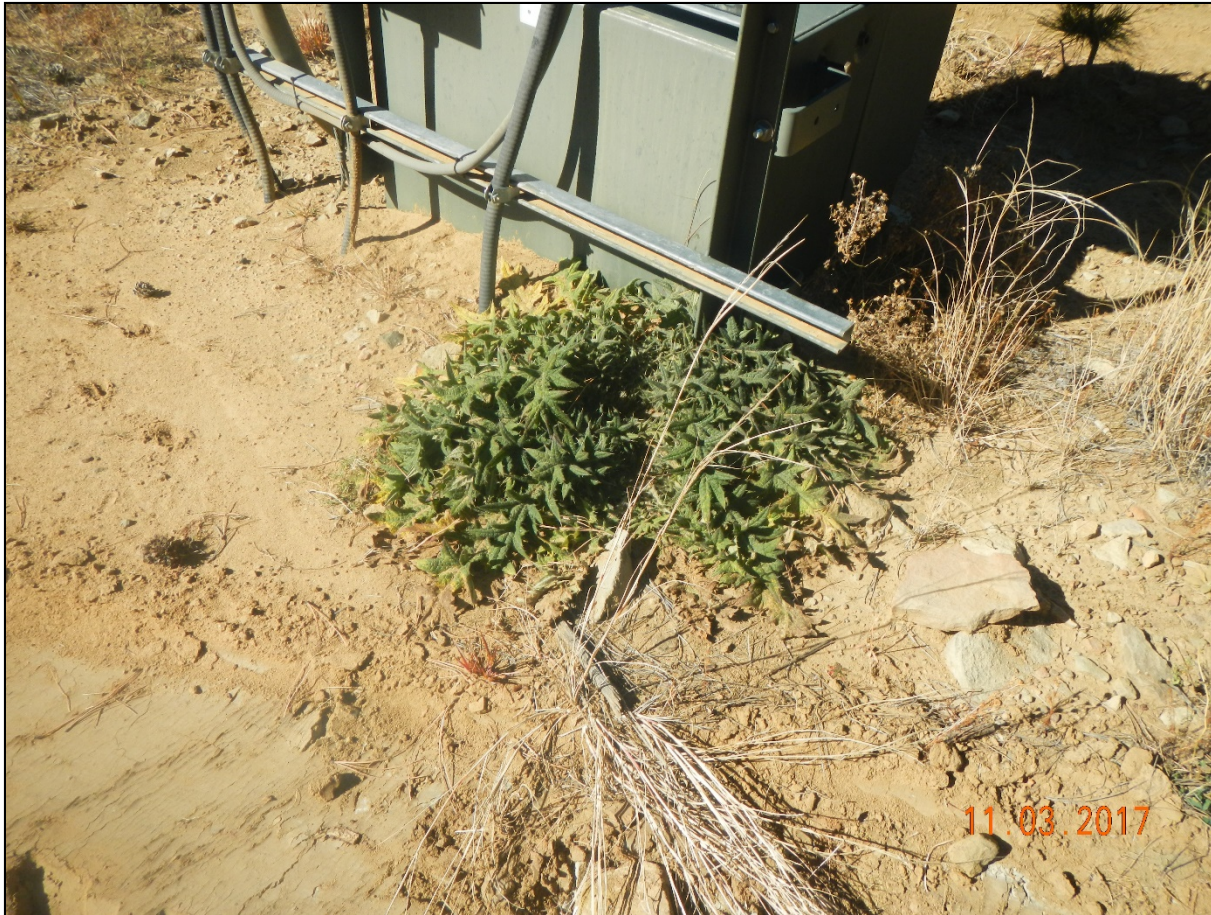
Photo 6. There is List B noxious weeds (Bull thistle) noticed at the location.

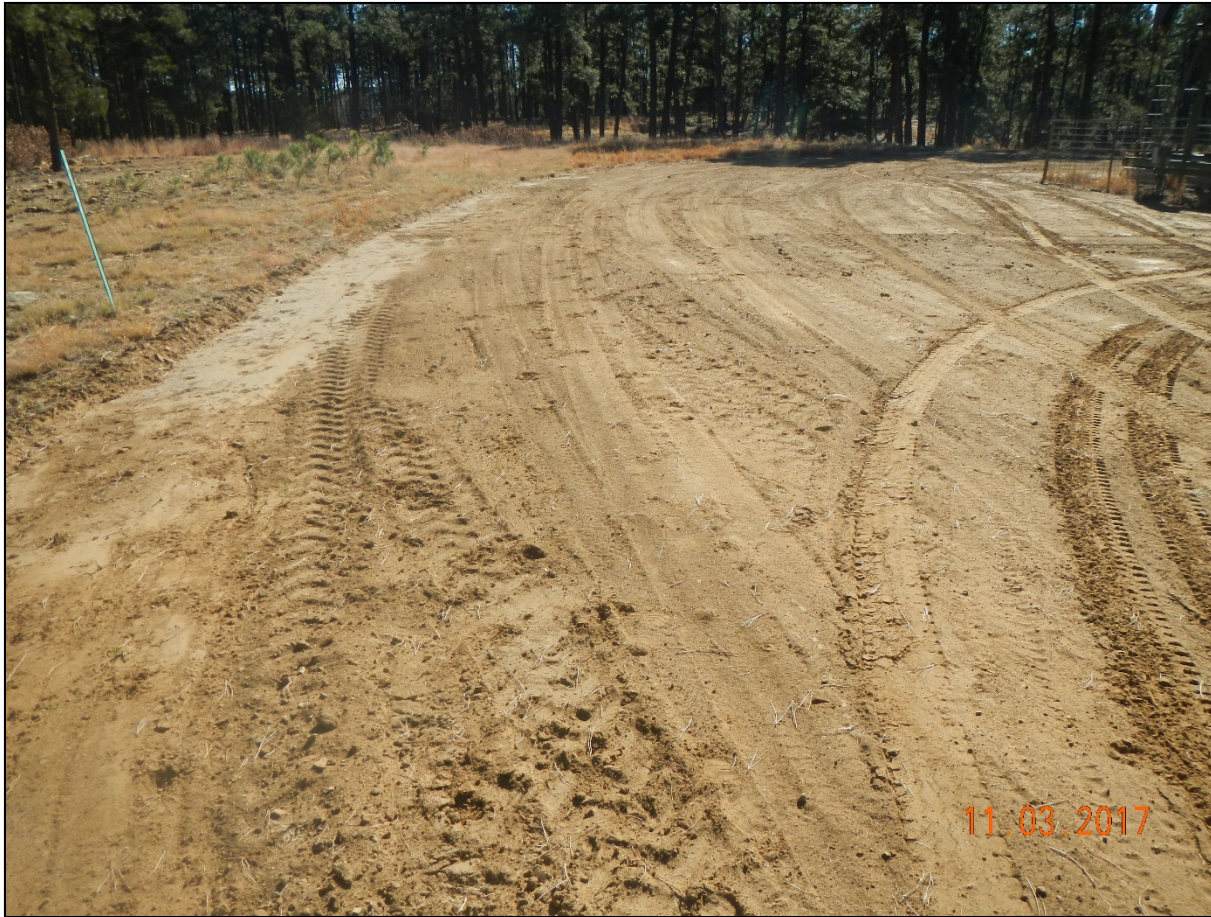
Photo 7. Facing southeast toward the location. The location was regraded. Some of the vegetation may have been disturbed.
