Inspection Photos

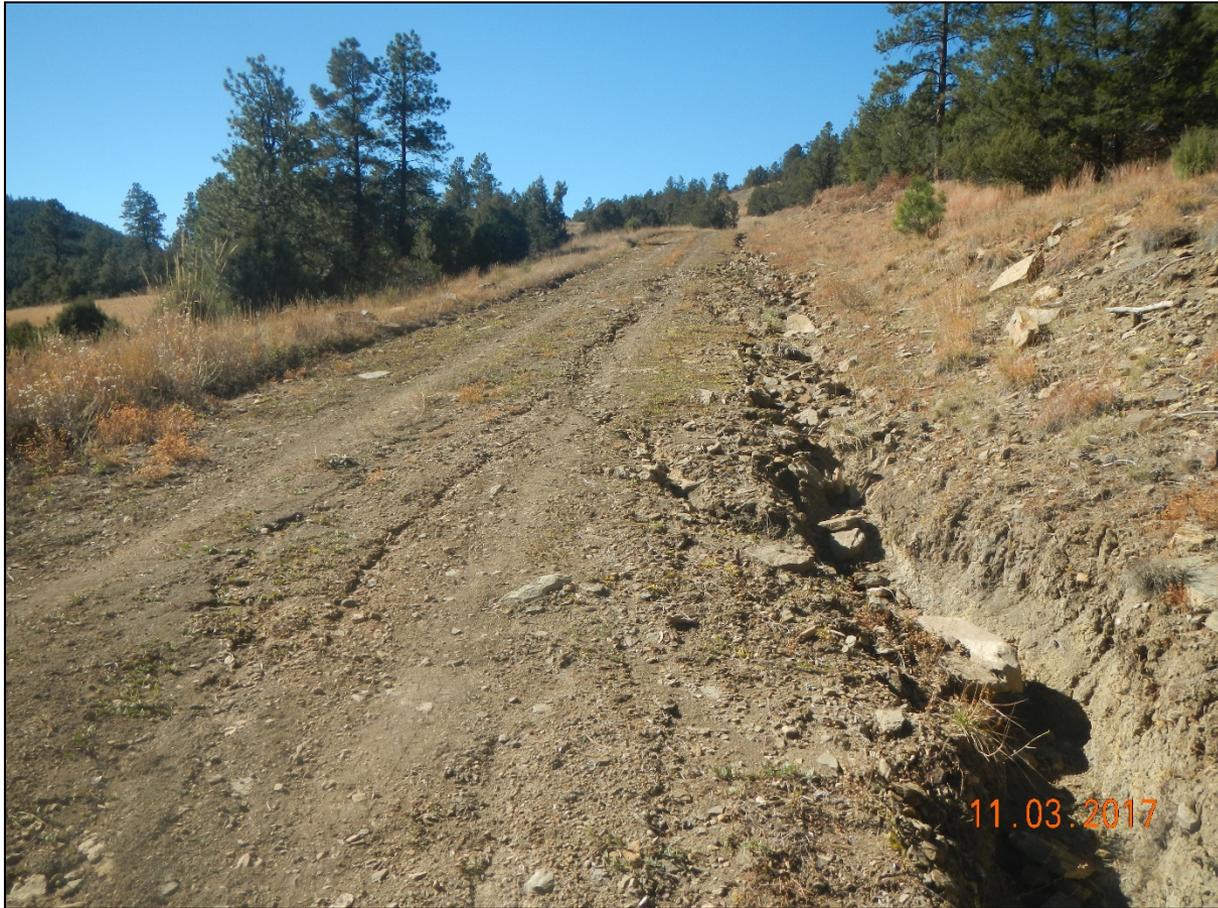
Photo 1. Facing southwest along the access road. There is stormwater erosion occurring down the access road. No BMP's are installed to prevent erosion.

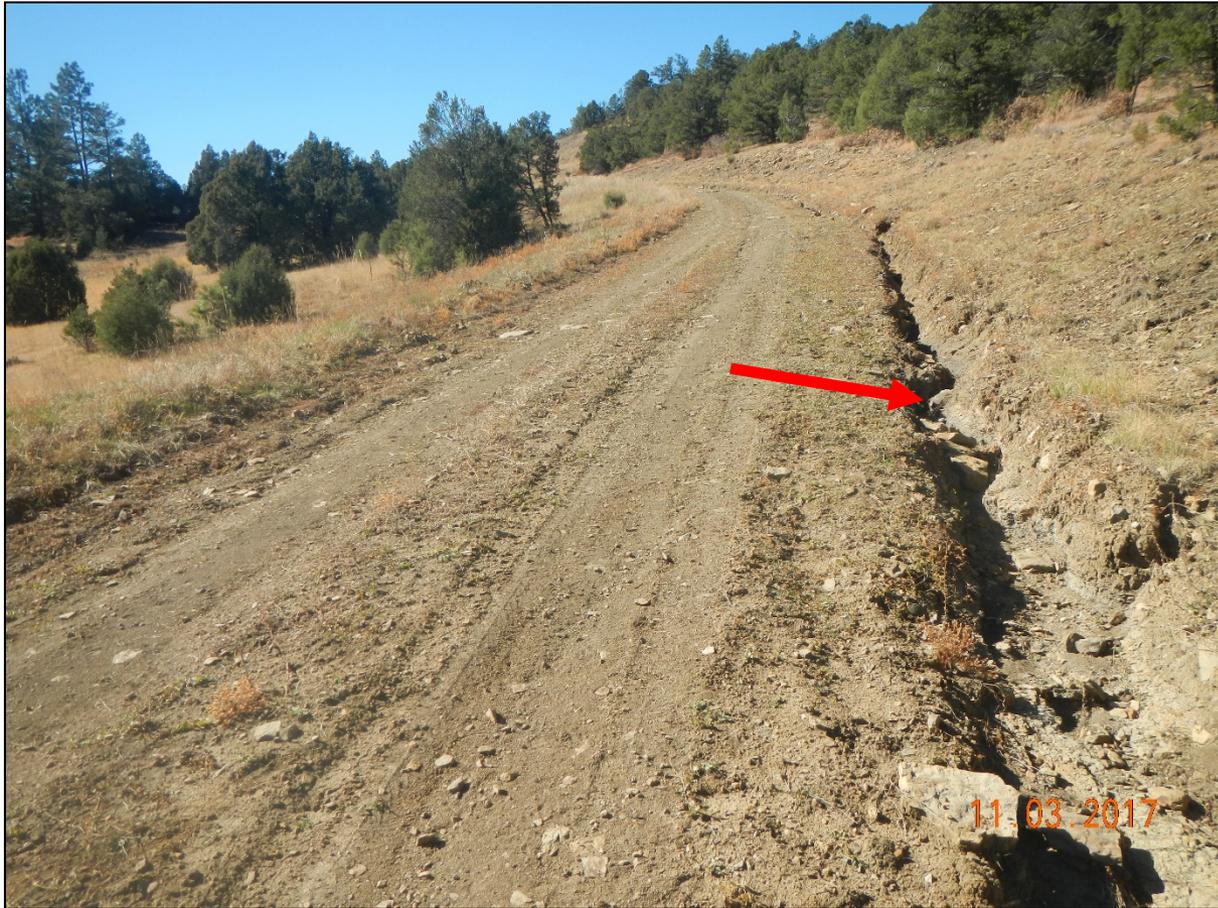
Photo 2. There are no BMP's installed along the access road. Stormwater erosion has incised the side of the road.

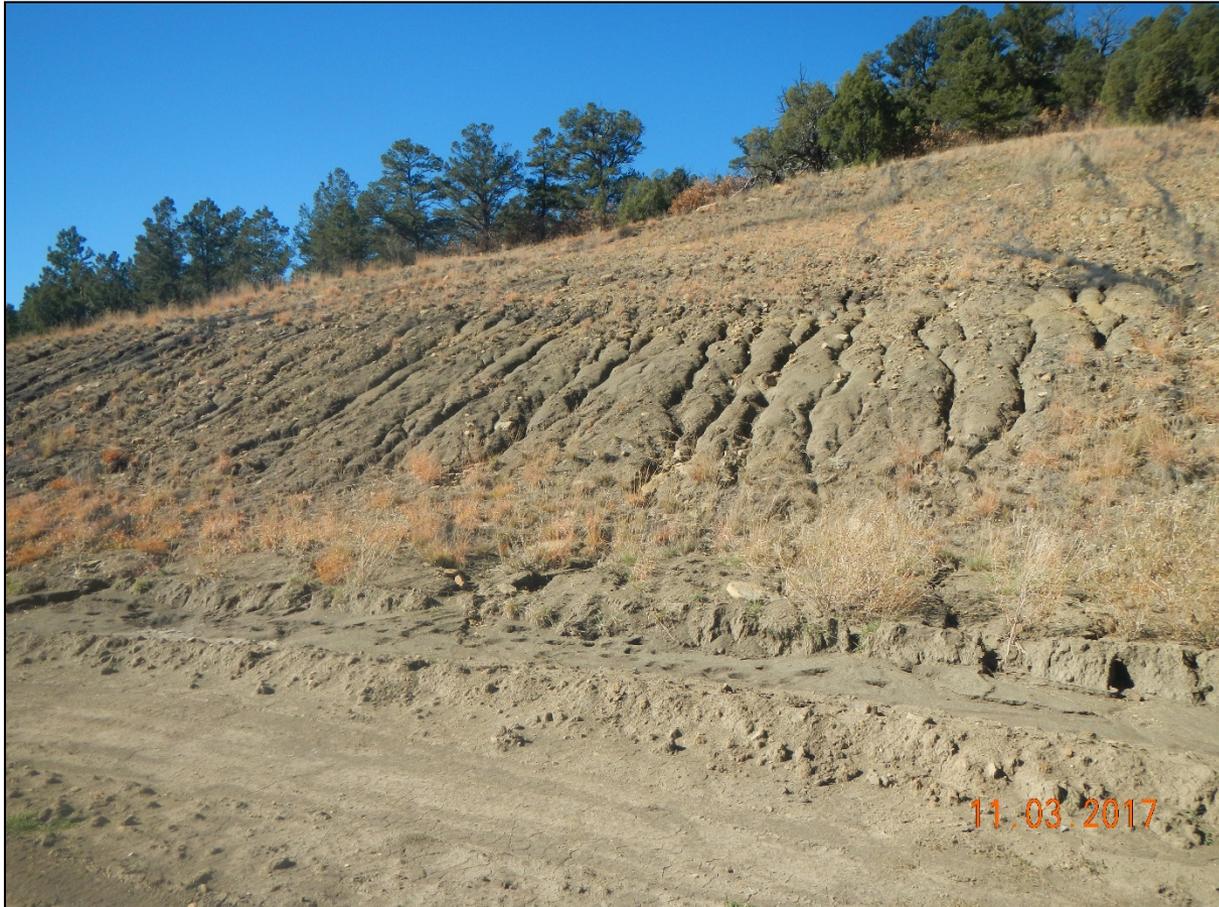
Photo 4. Facing toward the northwest cut slope which is not stabilized. Stormwater erosion is occurring along the cut slope.

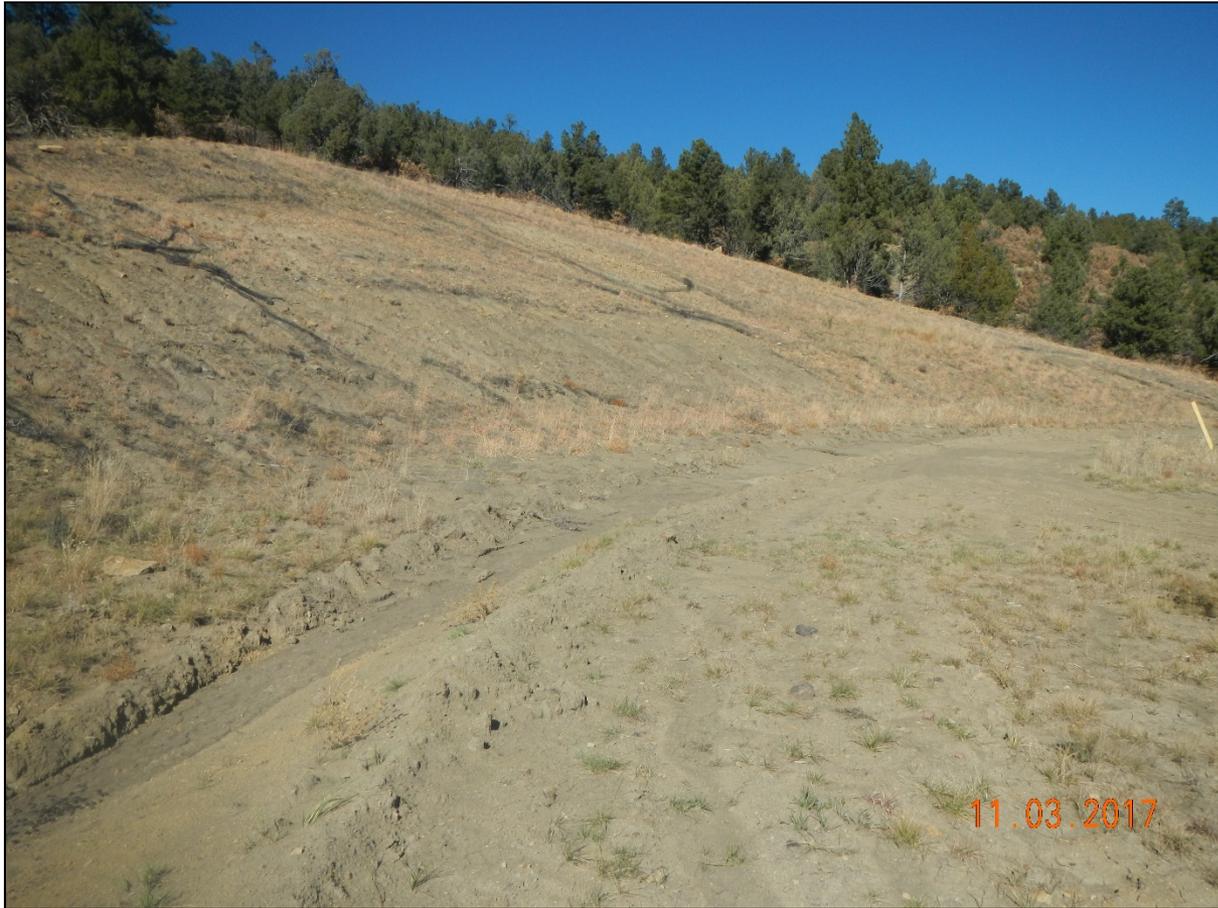
Photo 5. Facing north toward the cut slope. There is a ditch which has filled in with sediment at the base of the cut slope. The ditch divert stormwater toward the access road and southwest side of the location. No other BMP's are installed.

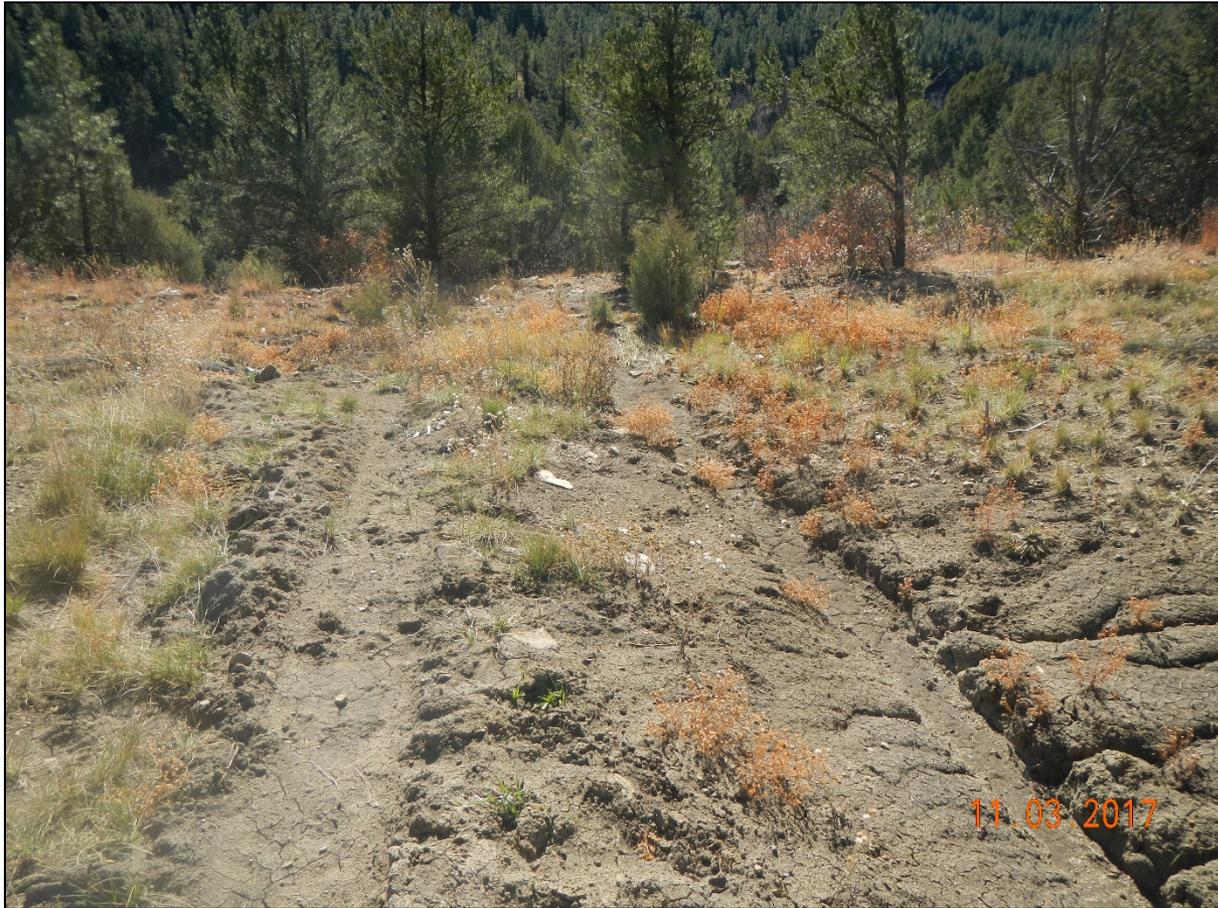
Photo 6. Facing toward the southwest side of the location. The ditch directs stormwater toward this direction however no other BMP's are installed to contain sediment and stormwater erosion.

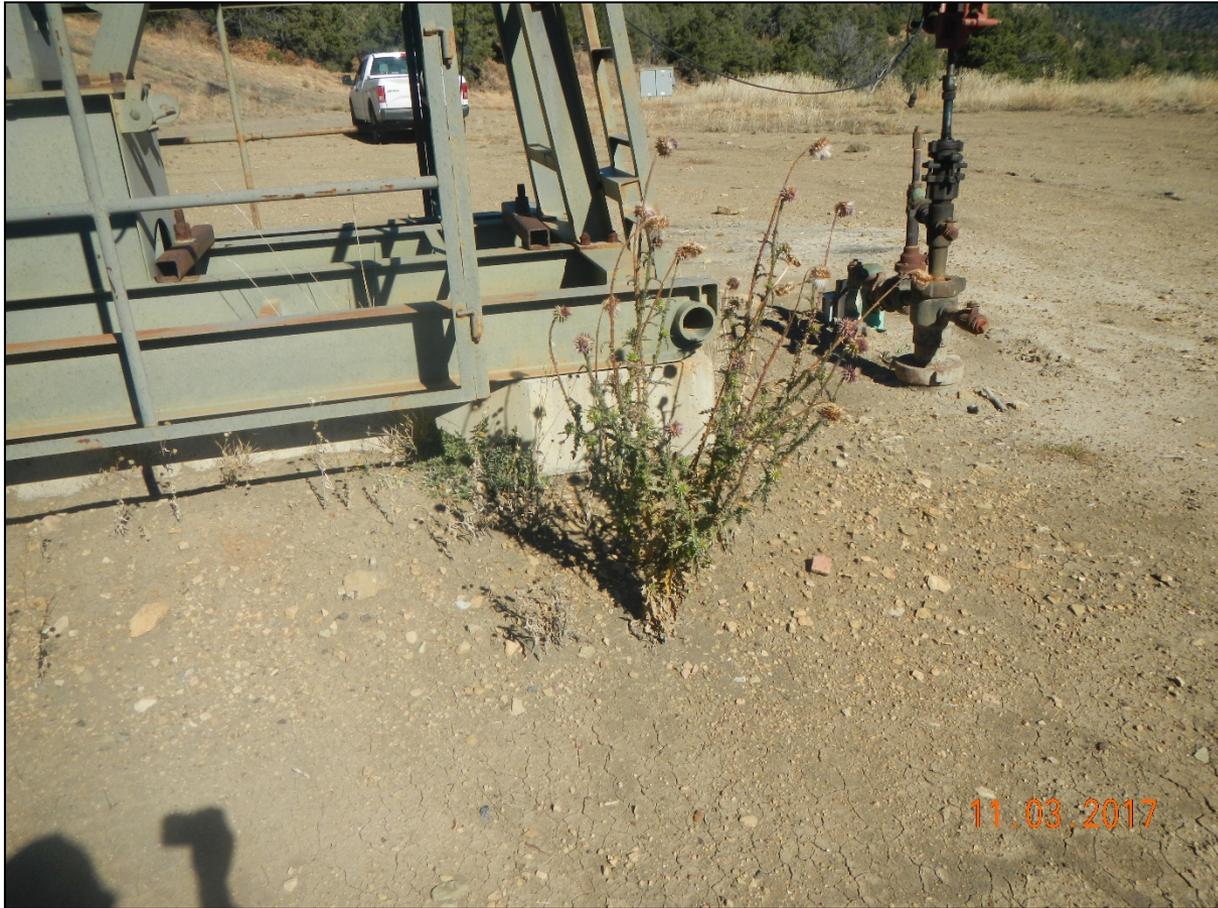
Photo 7. There is a few List B noxious weeds (Musk thistle) noticed at the location.
