# Inspection Photos

11/09/2017

Operator: ST CROIX OPERATING INC - 81490

Inspection Doc. Number: 682502777

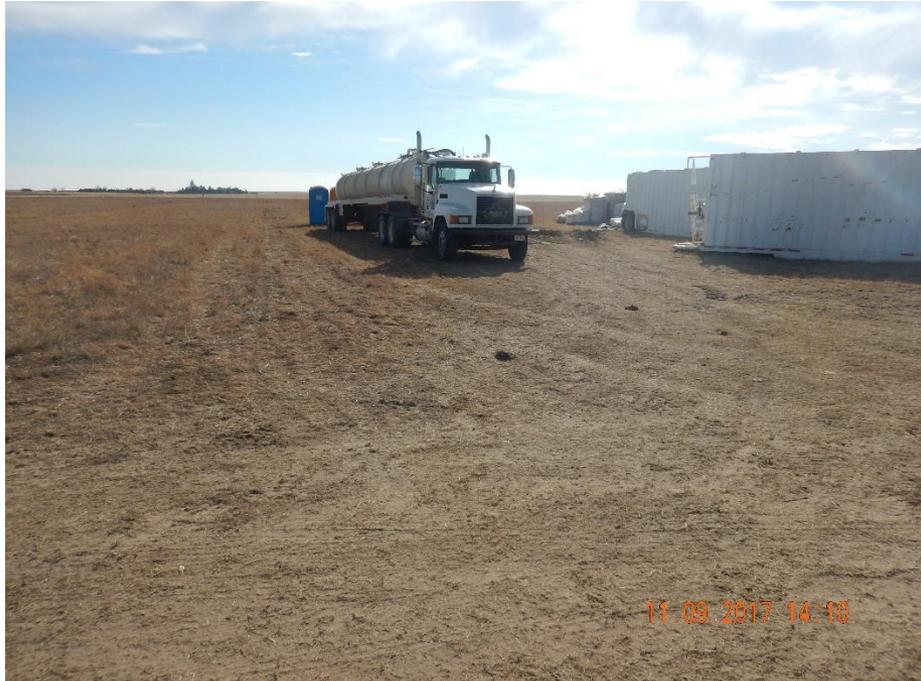
**Photo 1:** Photo taken from the east end of the location, facing south. Photos 1-3 provide a “panoramic” overview of the location. Photo shows that, with exception to the pit, no topsoil salvage has been conducted on the location. All equipment has been stored directly upon the soil surface/topsoil.

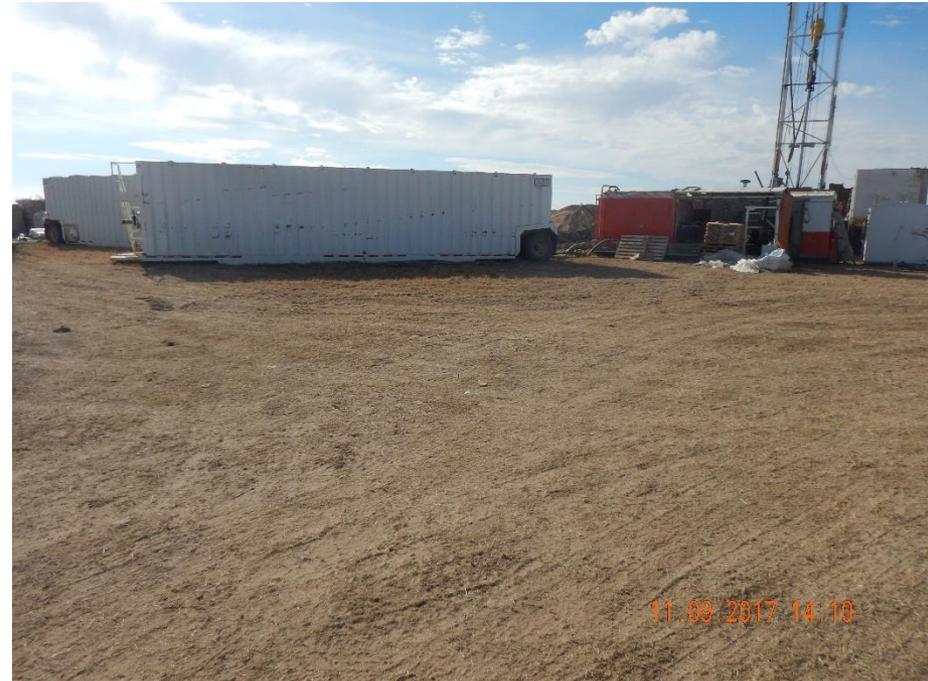
**Photo 2:** Photo taken from the east end of the location, facing southwest. See comments under photo 1.

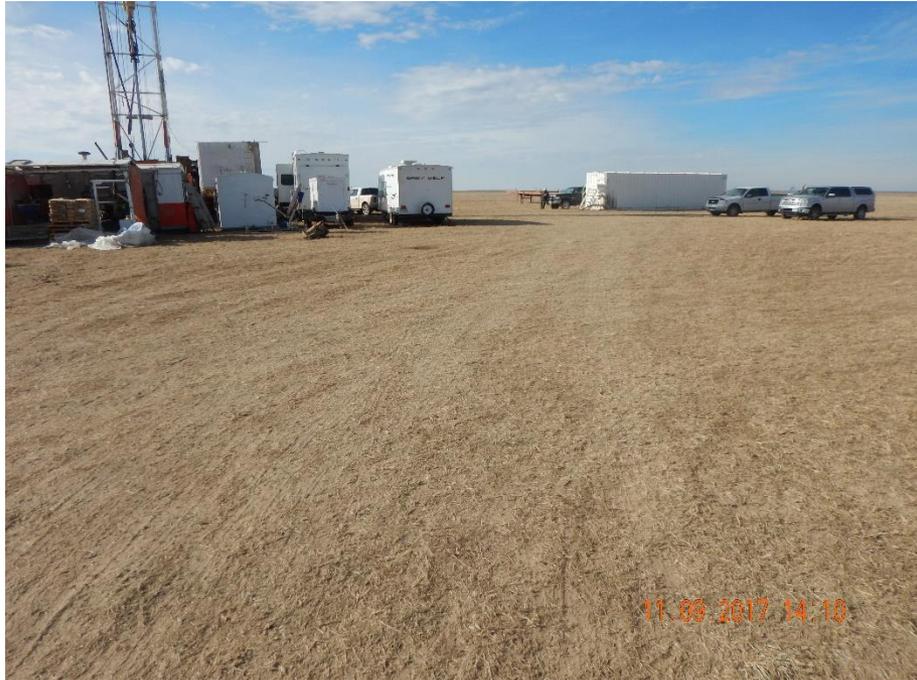
**Photo 3:** Photo taken from the east end of the location, facing west. See comments under photo 1.

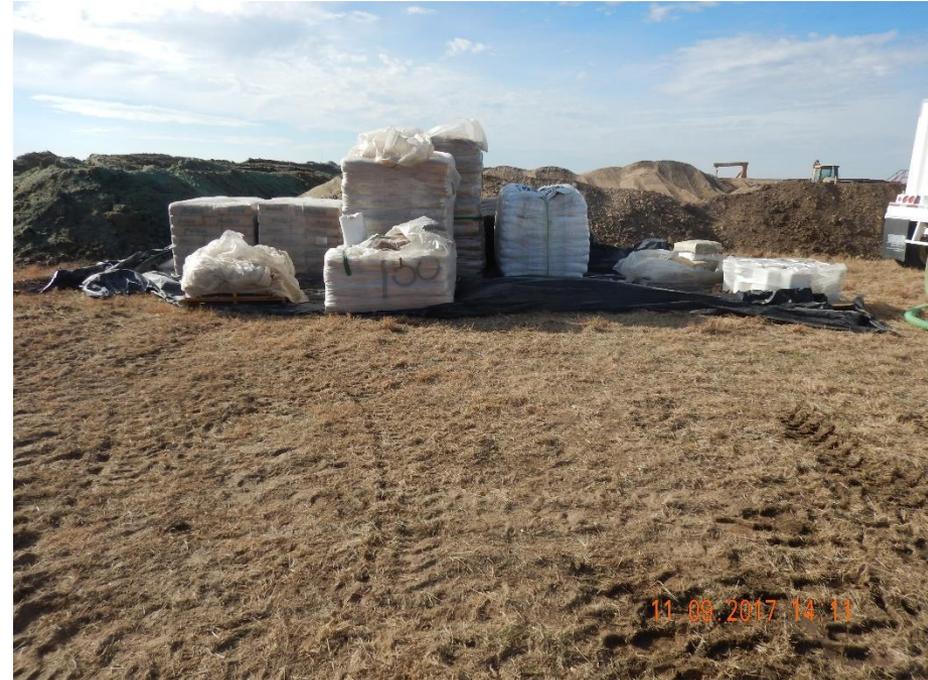
**Photo 4:** Photo taken from the east side of the pit. Photo shows materials have been placed onto a tarp.

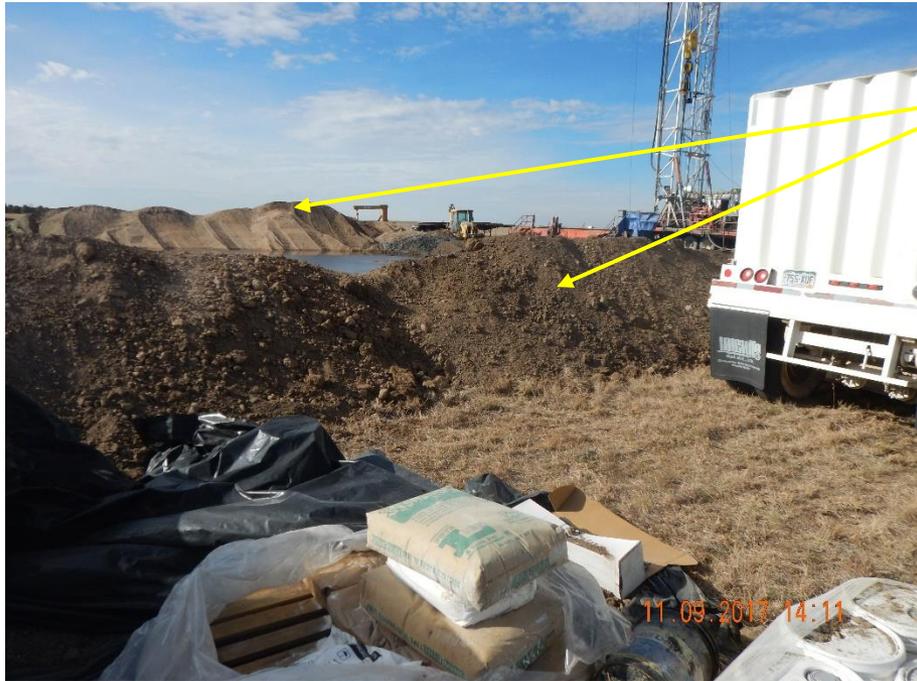
**Photo 5:** Photo taken from the east end of the pit. Previous inspections documented that soil around pit are loose materials and have not been stabilized. Inspection required operator to implement BMPs to stabilize soils. Photo shows soil stockpile berm on the east (and west) end of the pit remains unstabilized.

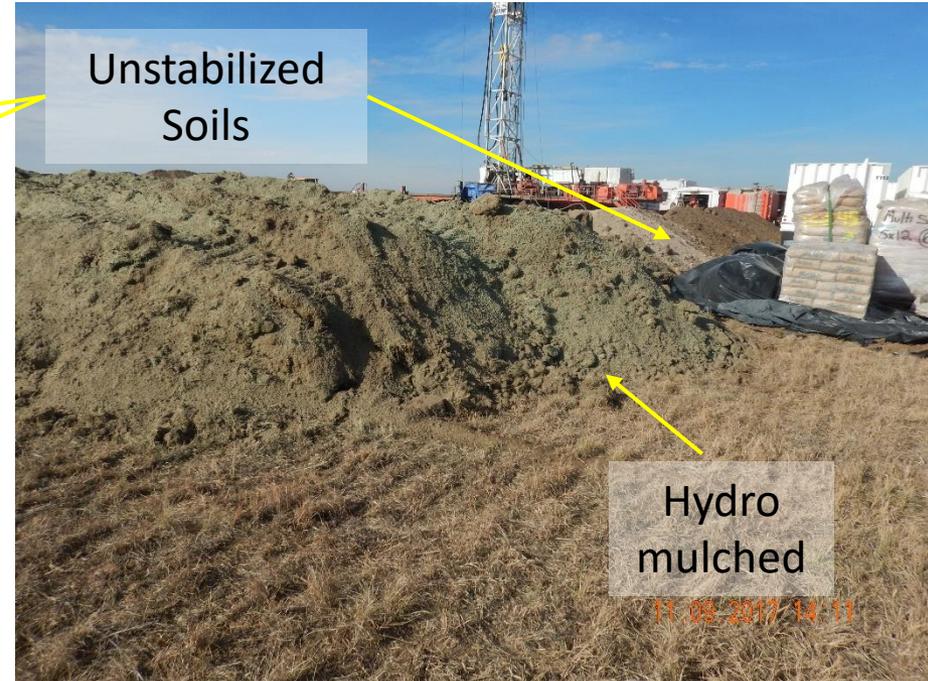
**Photo 6:** Photo taken from the east end of the pit. Previous inspections documented that soil around pit are loose materials and have not been stabilized. Inspection required operator to implement BMPs to stabilize soils. Photo shows operator has implemented hydro mulch on the southern portion of the soil stockpile, however, soil stockpile berm on the east end of the pit remains unstabilized.

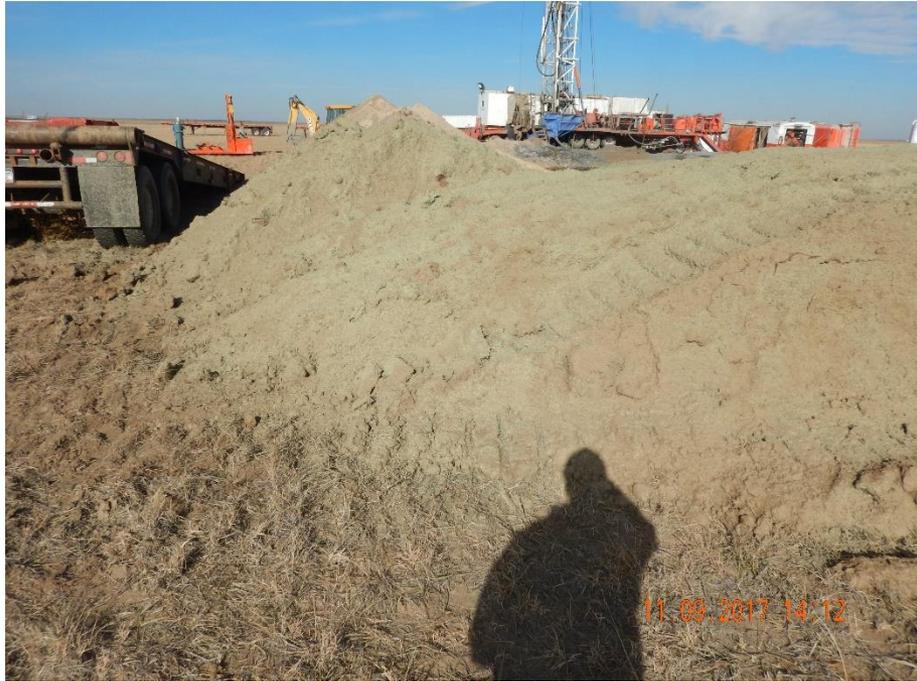
**Photo 7:** Photo taken from the southwest end of the location, facing northeast. Photo shows operator has implemented hydro mulch on the southern portion of the soil stockpile

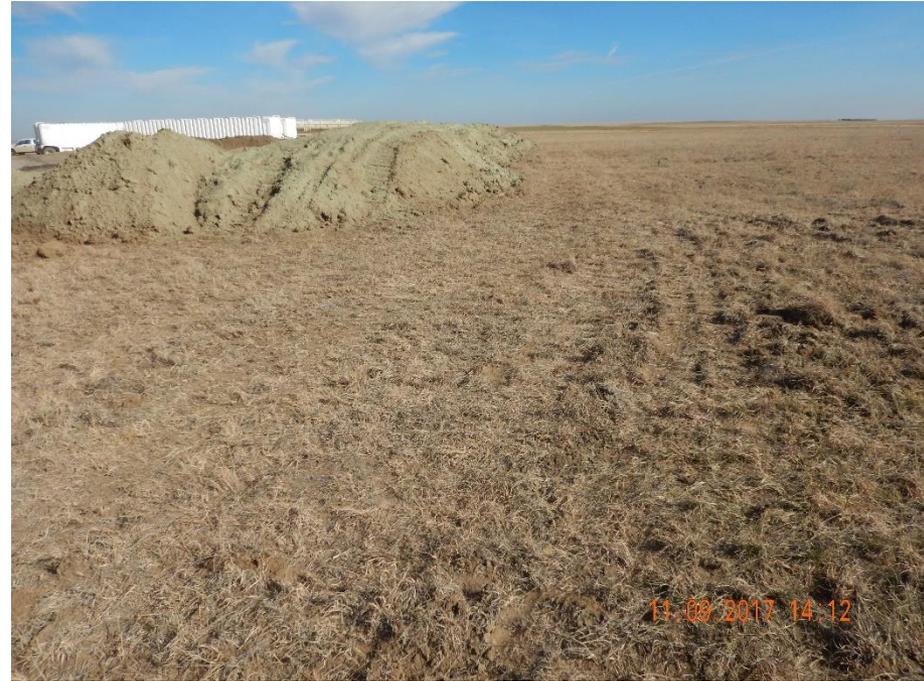
**Photo 8:** Photo taken from the southwest end of the location, facing east. Photo shows operator has implemented hydro mulch on the southern portion of the soil stockpile

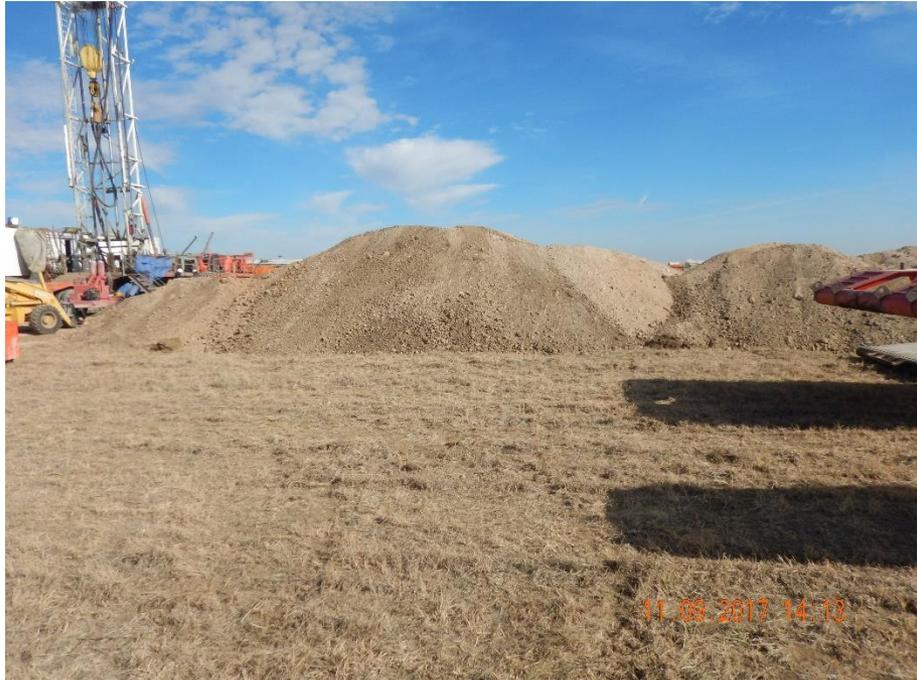
**Photo 9:** Photo taken from the west end of the location, facing east. Previous inspections documented that soil stockpiles around pit were loose materials and have not been stabilized. Inspection required operator to implement BMPs to stabilize soils. Photo shows soil stockpiles on the east end of the pit remains unstabilized.

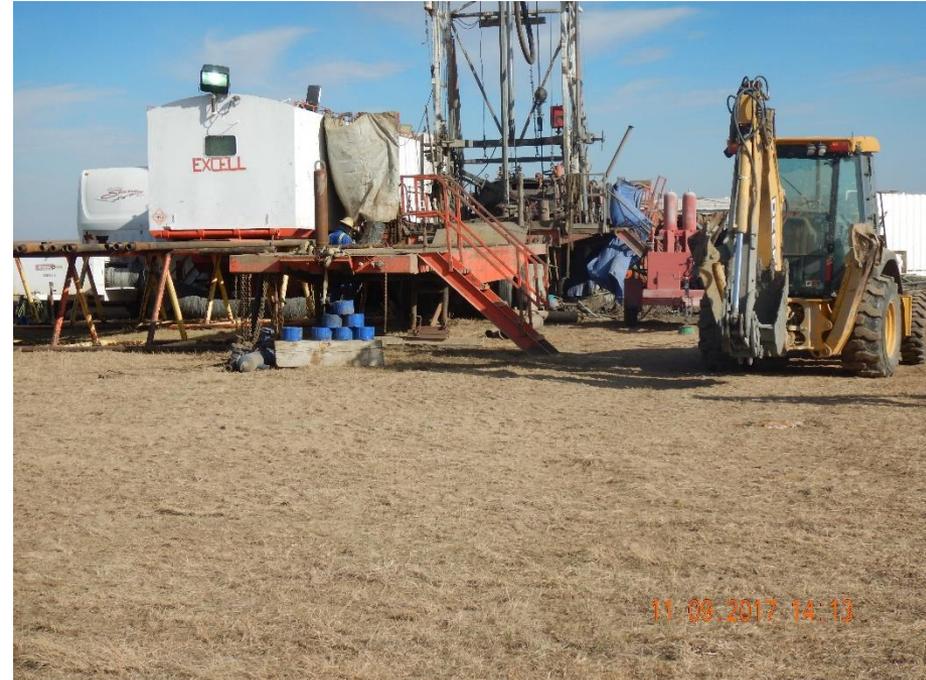
**Photo 10:** Photo taken from the west end of the location, facing east. Photo shows that with exception to the pit, no topsoil salvage has been conducted on the location. Photo shows drill rig has been set up and in operation.

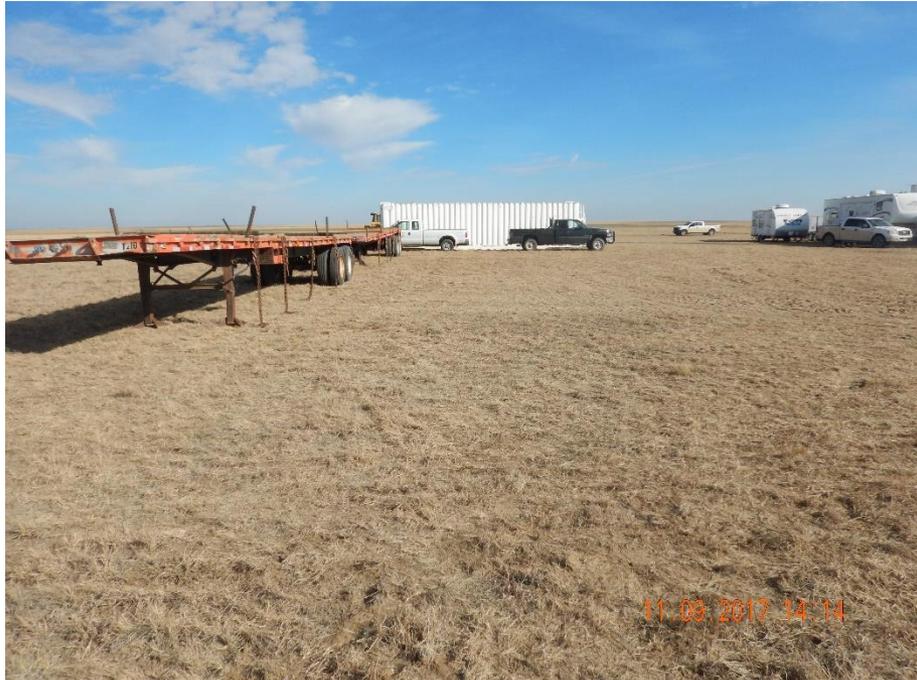
**Photo 11:** Photo taken from the northwest end of the location, facing east. Photos 11-13 provide a “panoramic” overview of the location. Photo shows that, with exception to the pit, no topsoil salvage has been conducted on the location. All equipment has been stored directly upon the soil surface/topsoil.

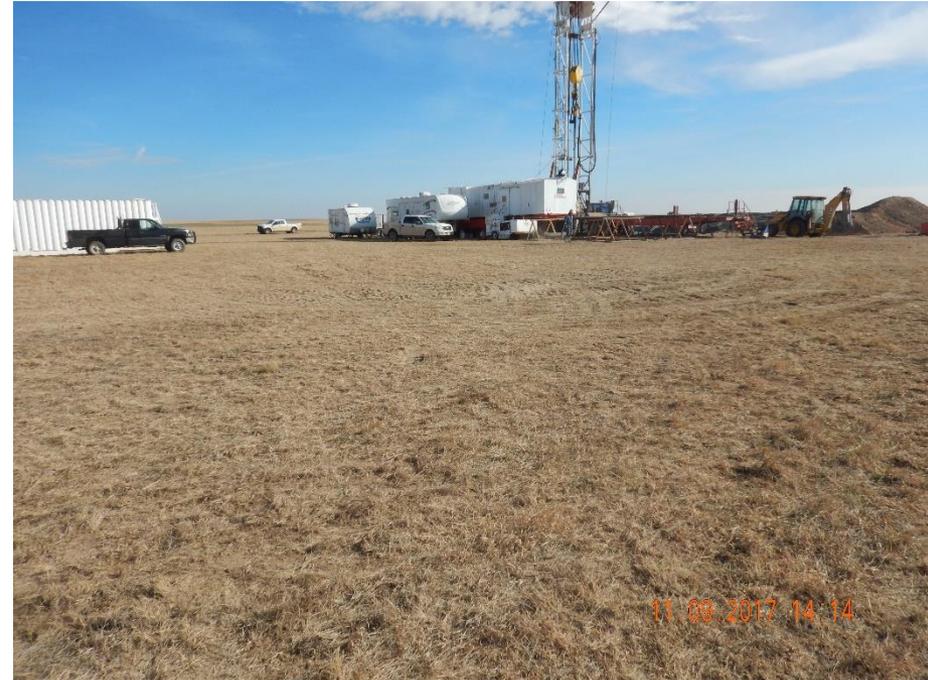
**Photo 12:** Photo taken from the northwest end of the location, facing southeast. See Comments under photo 11

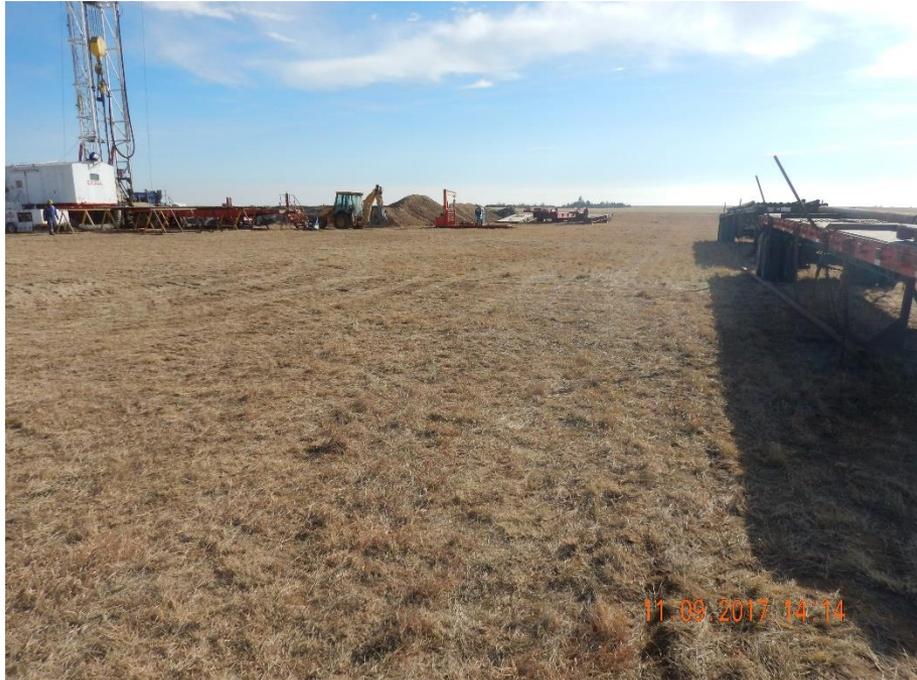
**Photo 13:** Photo taken from the northwest end of the location, facing south. See Comments under photo 11

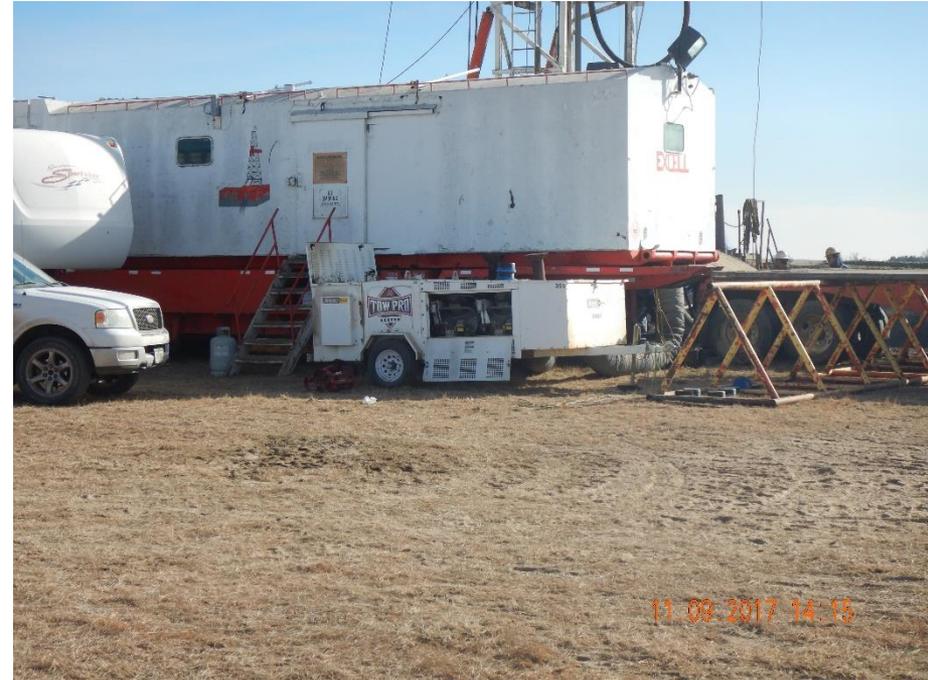
**Photo 14:** Photo taken from the north end of the location, facing south. See Comments under photo 11

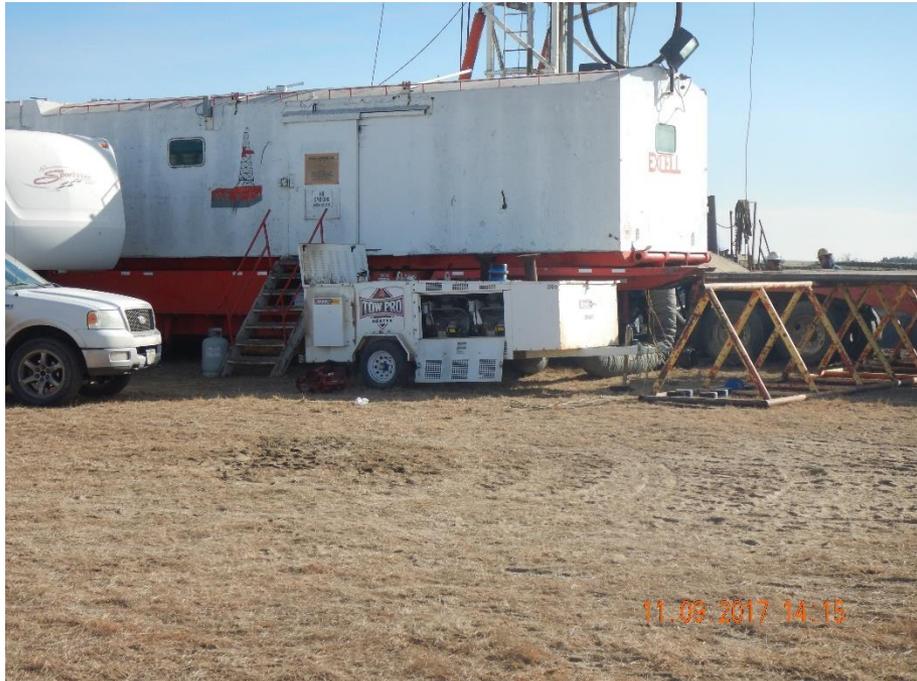
**Photo 15:** Photo taken from the north end of the location, facing south. See Comments under photo 11

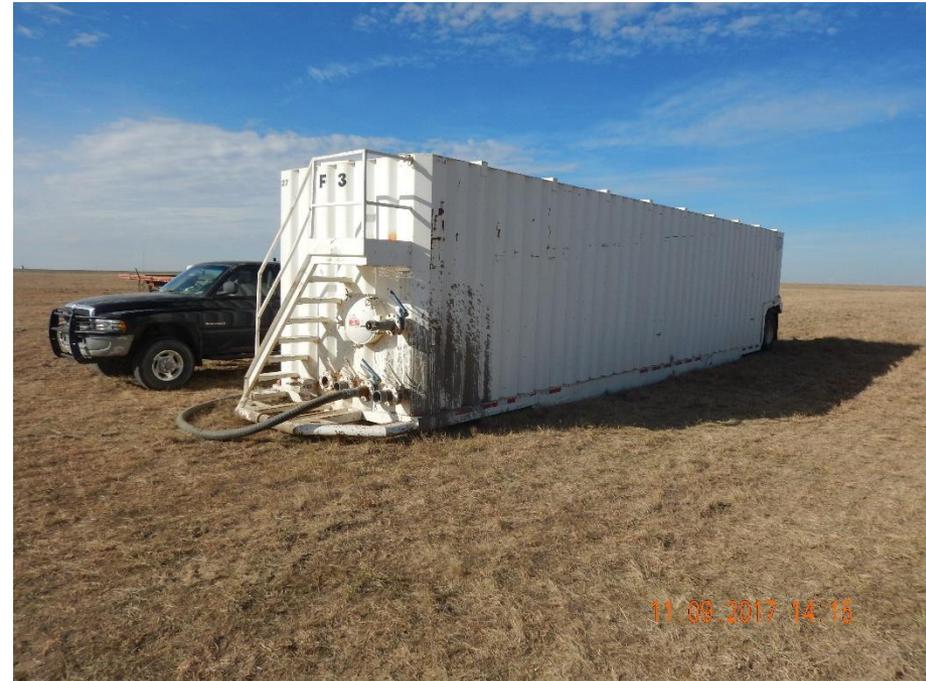
**Photo 16:** Photo taken from the north end of the location, facing north. See Comments under photo 11

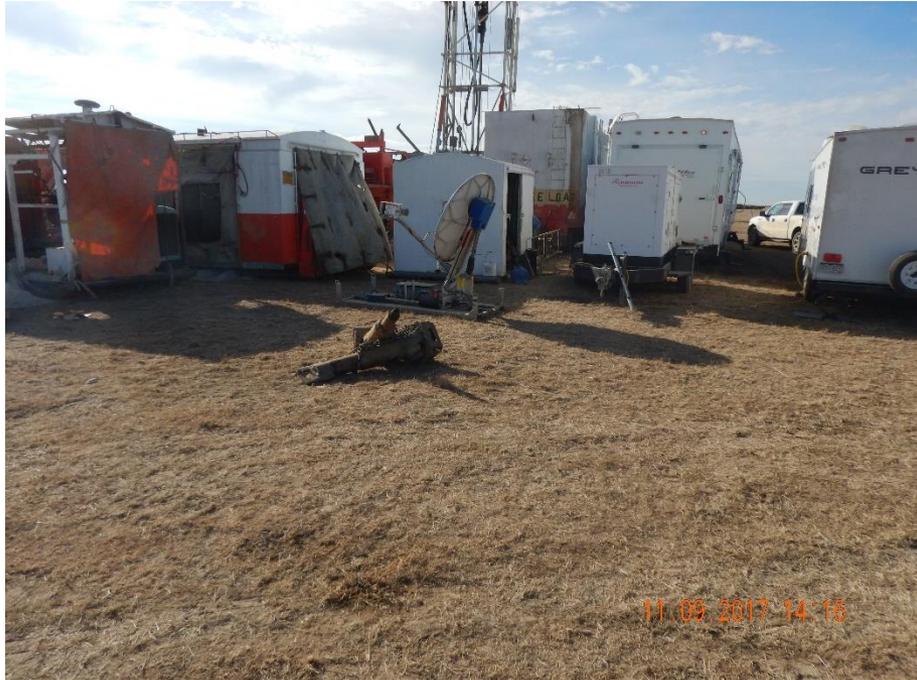
**Photo 17:** Photo taken from the east end of the location, facing west. See Comments under photo 11

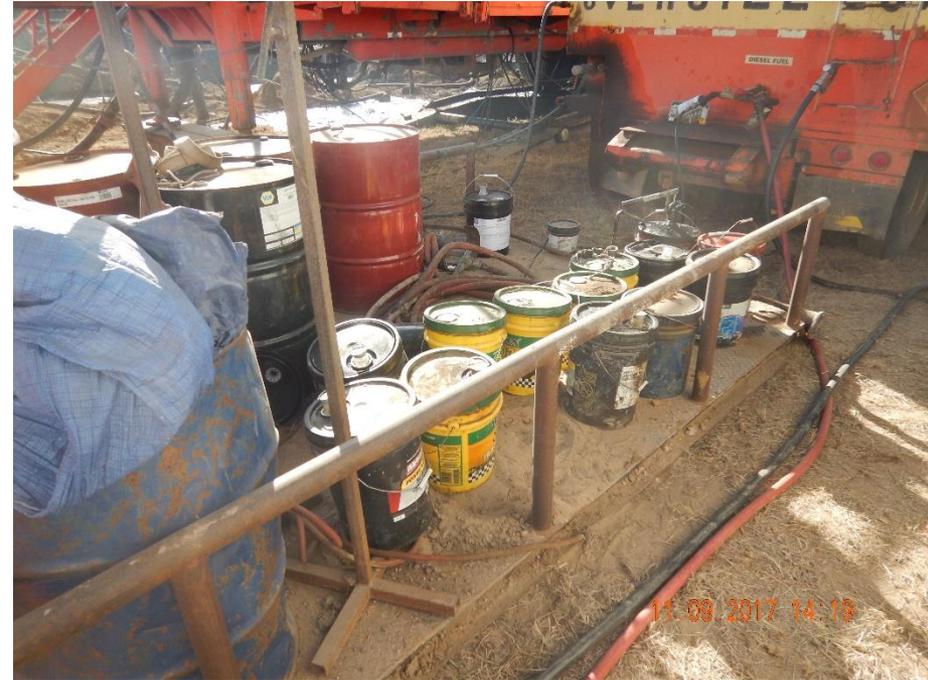
**Photo 18:** Photo shows materials appear to be stored appropriately.

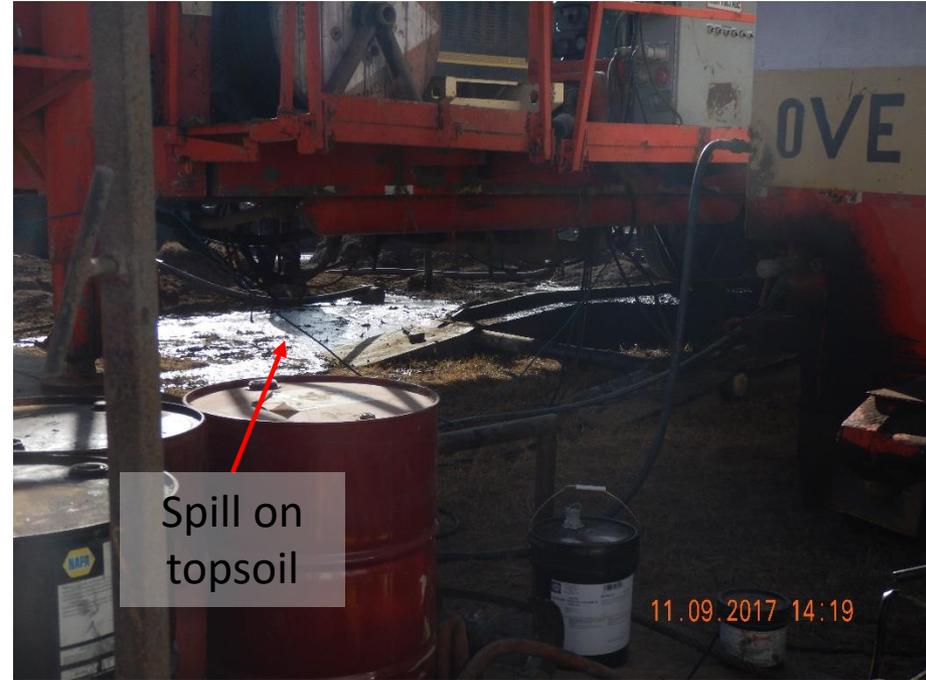
**Photo 20:** Photo taken from the northeast end of the drill rig, facing southwest. Photo drill rig has been set up and operated directly upon the topsoil. Photo also shows what appears to be drilling mud has spilled onto the topsoil from either the pit, or the rig.

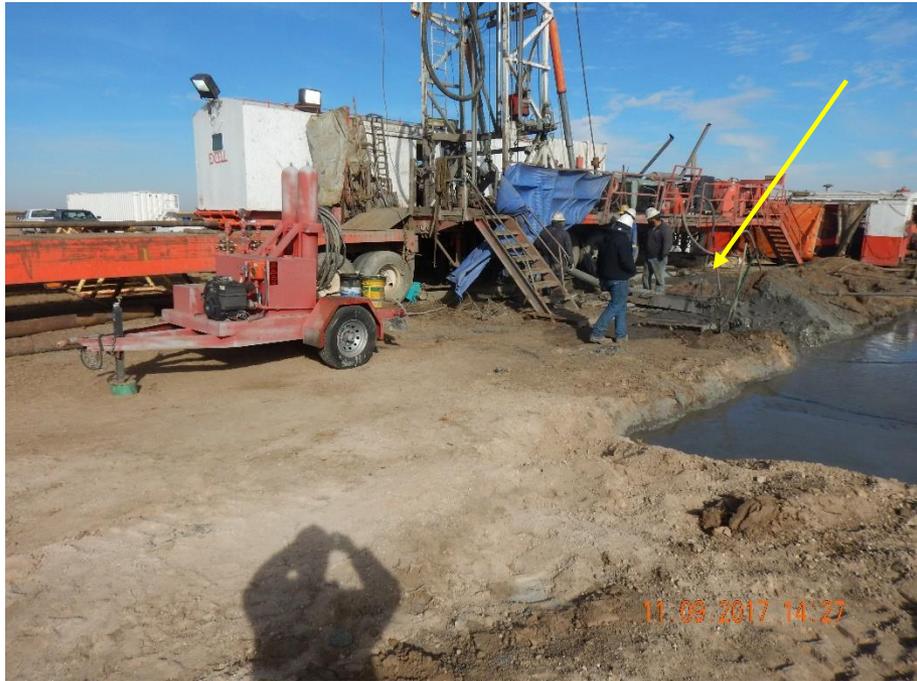
**Photo 21:** Photo taken from the southeast end of the drill rig, facing northeast. Photo shows drill rig has been set up and operated directly upon the topsoil. Photo also shows area where, what appeared to be drilling mud, has spilled onto the topsoil from either the pit, or the rig (see photo 20).
