COGCC conducted an inspection of the Lilli Unit 2-8 location (Location ID 326772) on September 26, 2017 (Document 684904467). During that inspection, COGCC made the following observations:

Name: Lilli Unit 2-8
Location ID: 326772

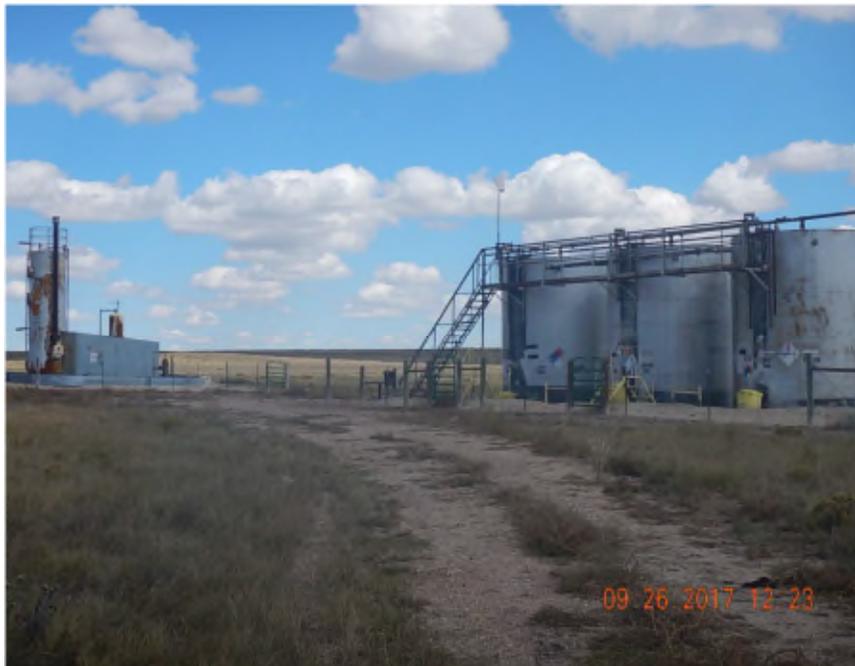
COGCC – 9/26/17

Stormwater: Stormwater erosion in center of site, eroding to the east. Install or repair required BMPs per Rule 1002.f.

Photo 1: Location, looking NE

Response: Noble has repaired the berms and erosion on-site.

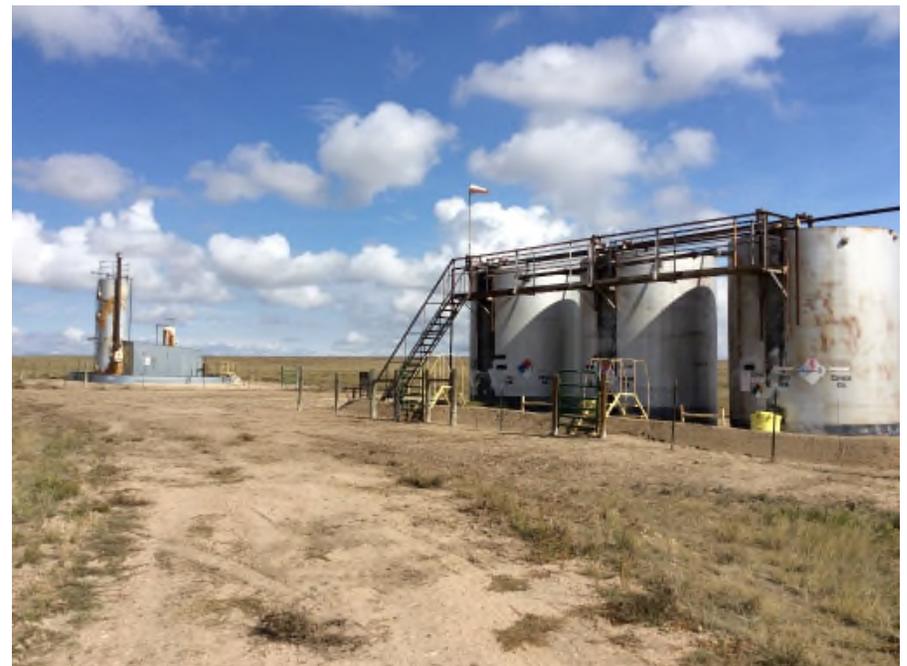
Noble Energy – 10/10/17

Photo NBL1. Erosion and berms have been repaired

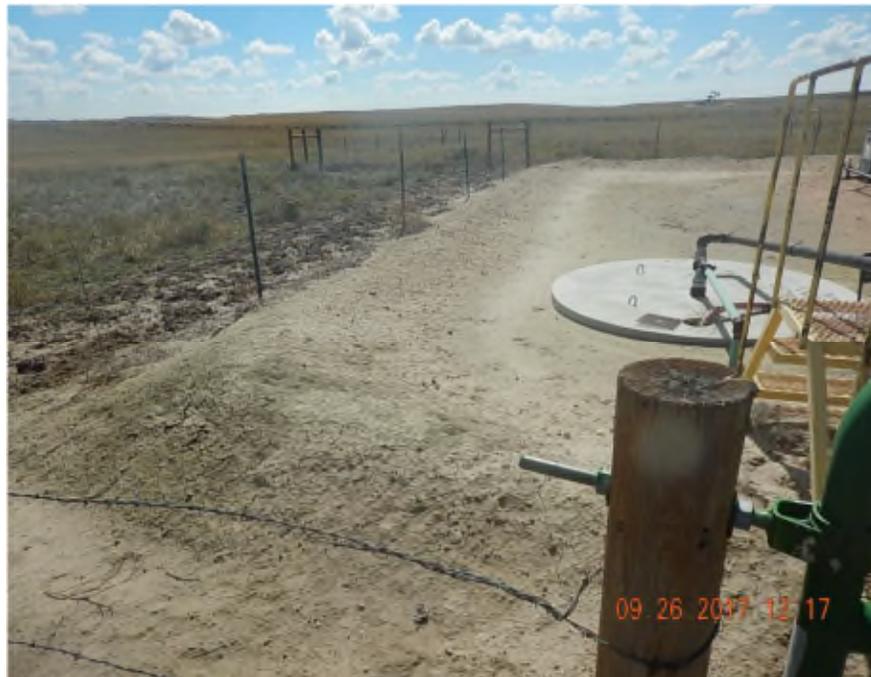
COGCC – 9/26/17

Tanks and Berms: Berms – Berms are low in places. Repair or install berms or other secondary containment devices per Rule 605.a.(4).

Photo 3: Low berms at tank battery

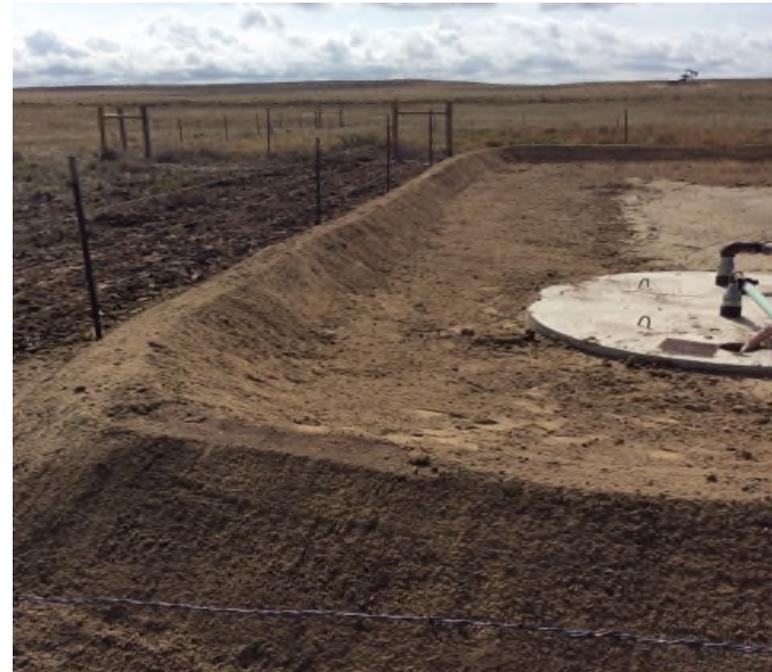
Noble Energy – 10/10/17

Photo NBL2. The berms of the containment have been enlarged and compacted.

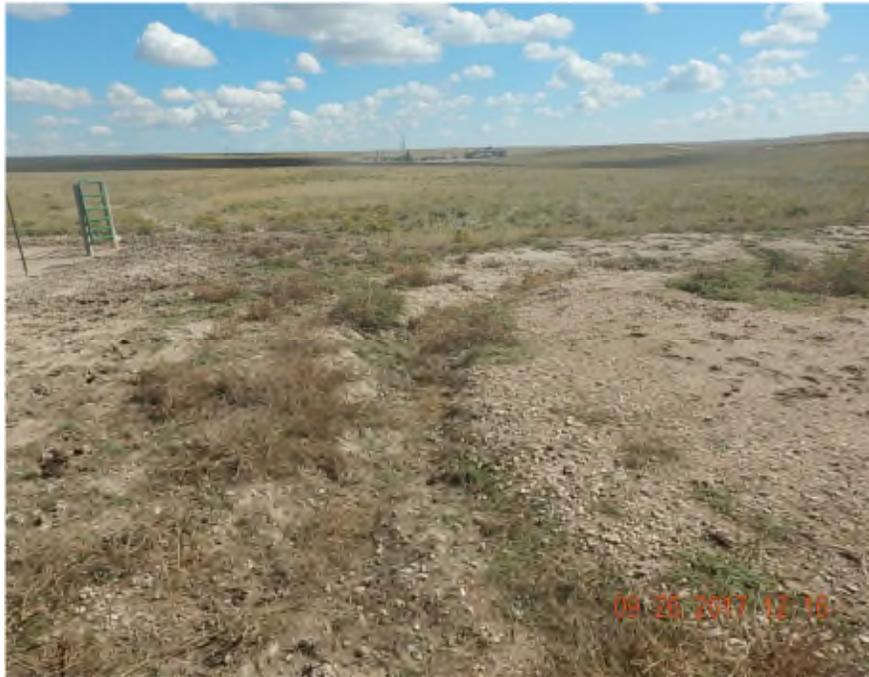
COGCC – 9/26/17

Stormwater: Stormwater erosion in center of site, eroding to the east. Install or repair required BMPs per Rule 1002.f.

Photo 5: Stormwater erosion at location, between treater and battery.

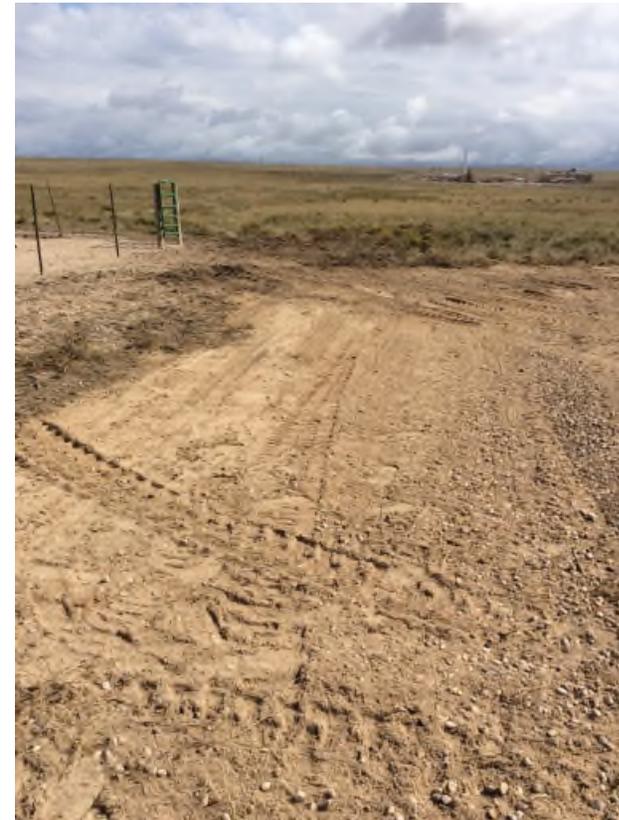
Noble Energy – 10/10/17

Photo NBL3. The erosion has been repaired by filling and grading.
