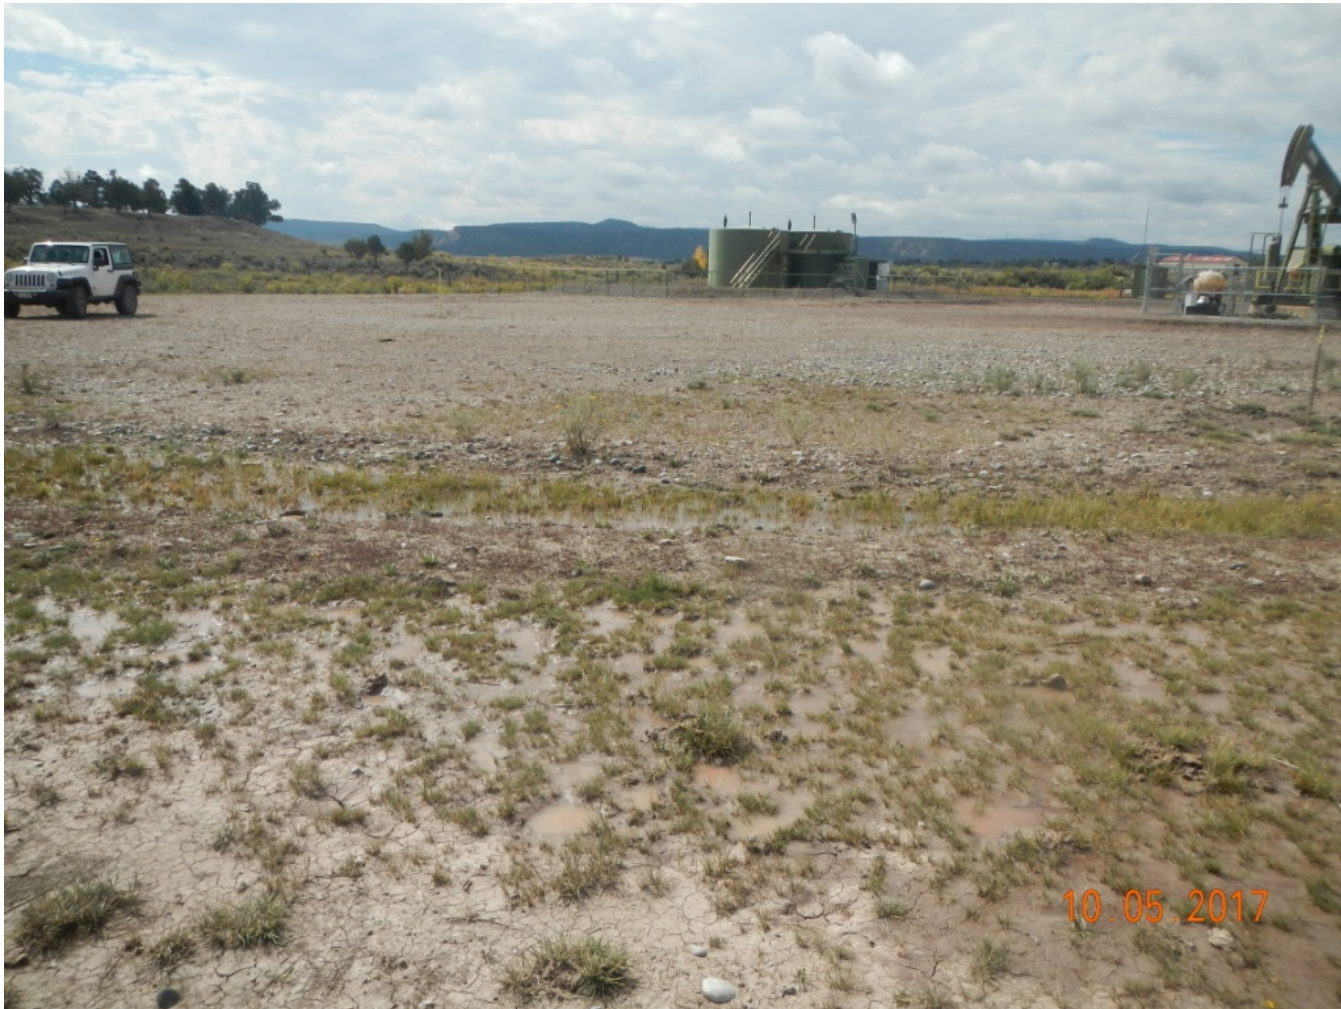
Photo 1. View from the northeastern corner facing center.

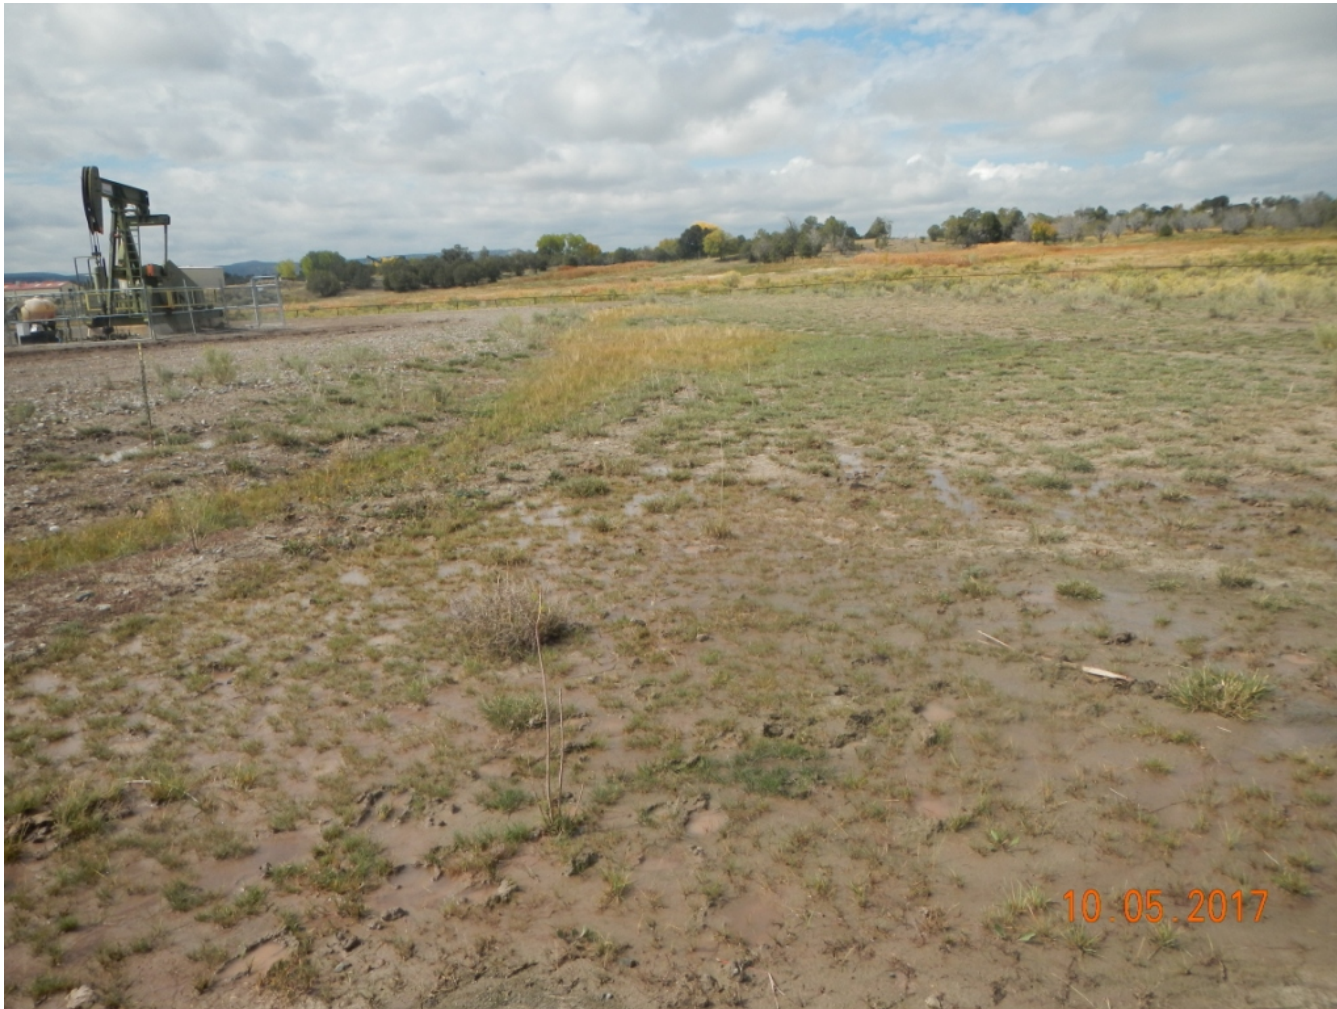
Photo 2. View of the northern portion of the project area facing westward. Revegetation is progressing, largely with grasses. Vegetation is grazed and not in identifiable form. Grazing should be monitored as livestock exclusion may be needed.

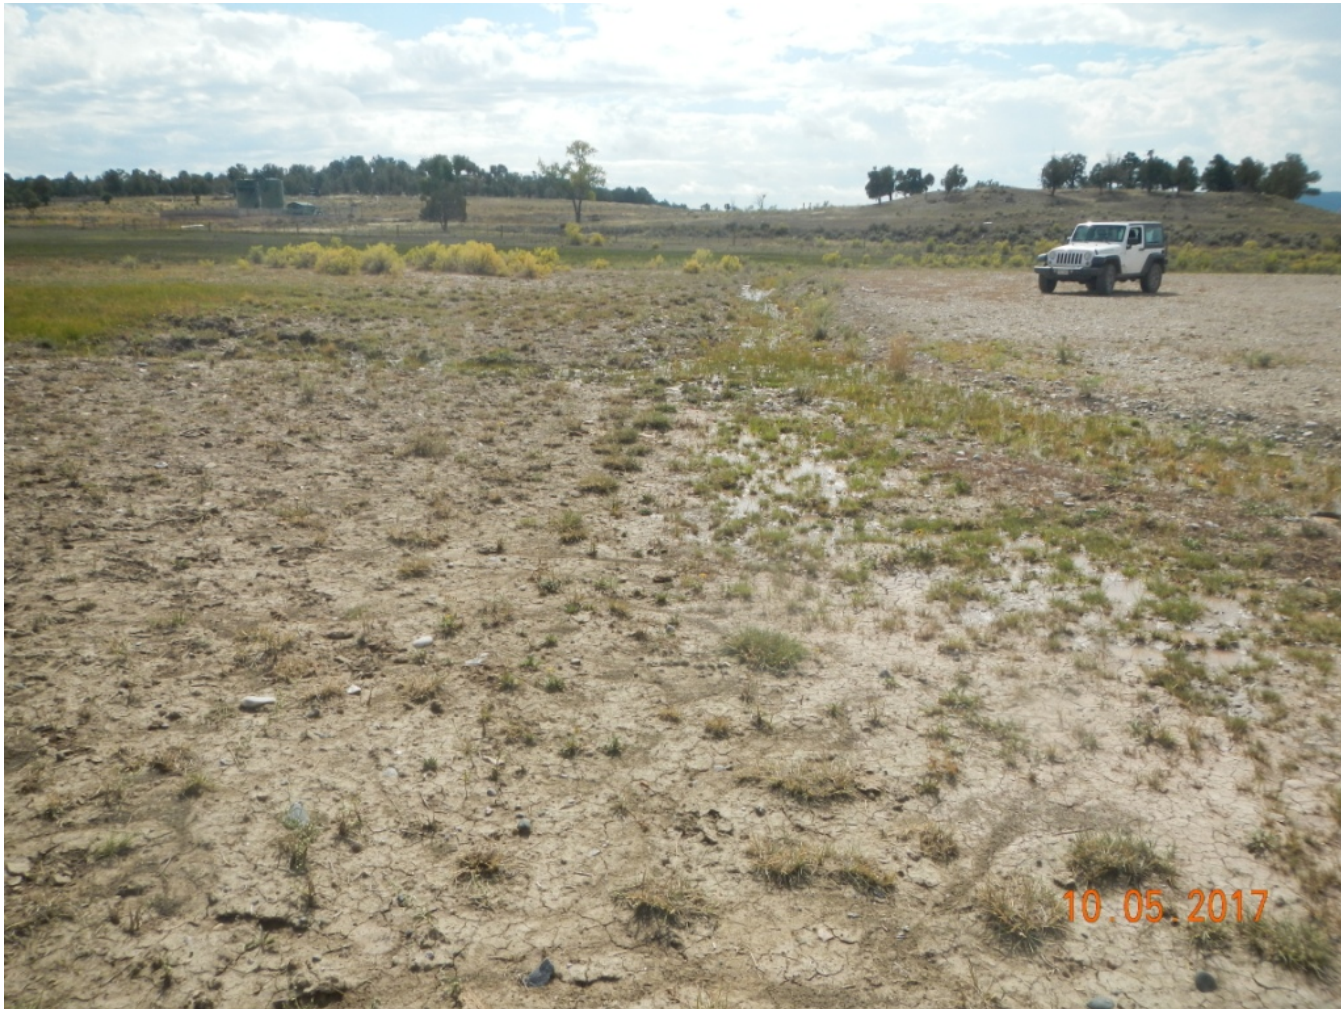
Photo 3. View of the eastern portion of the project area from the northeastern corner facing southward.

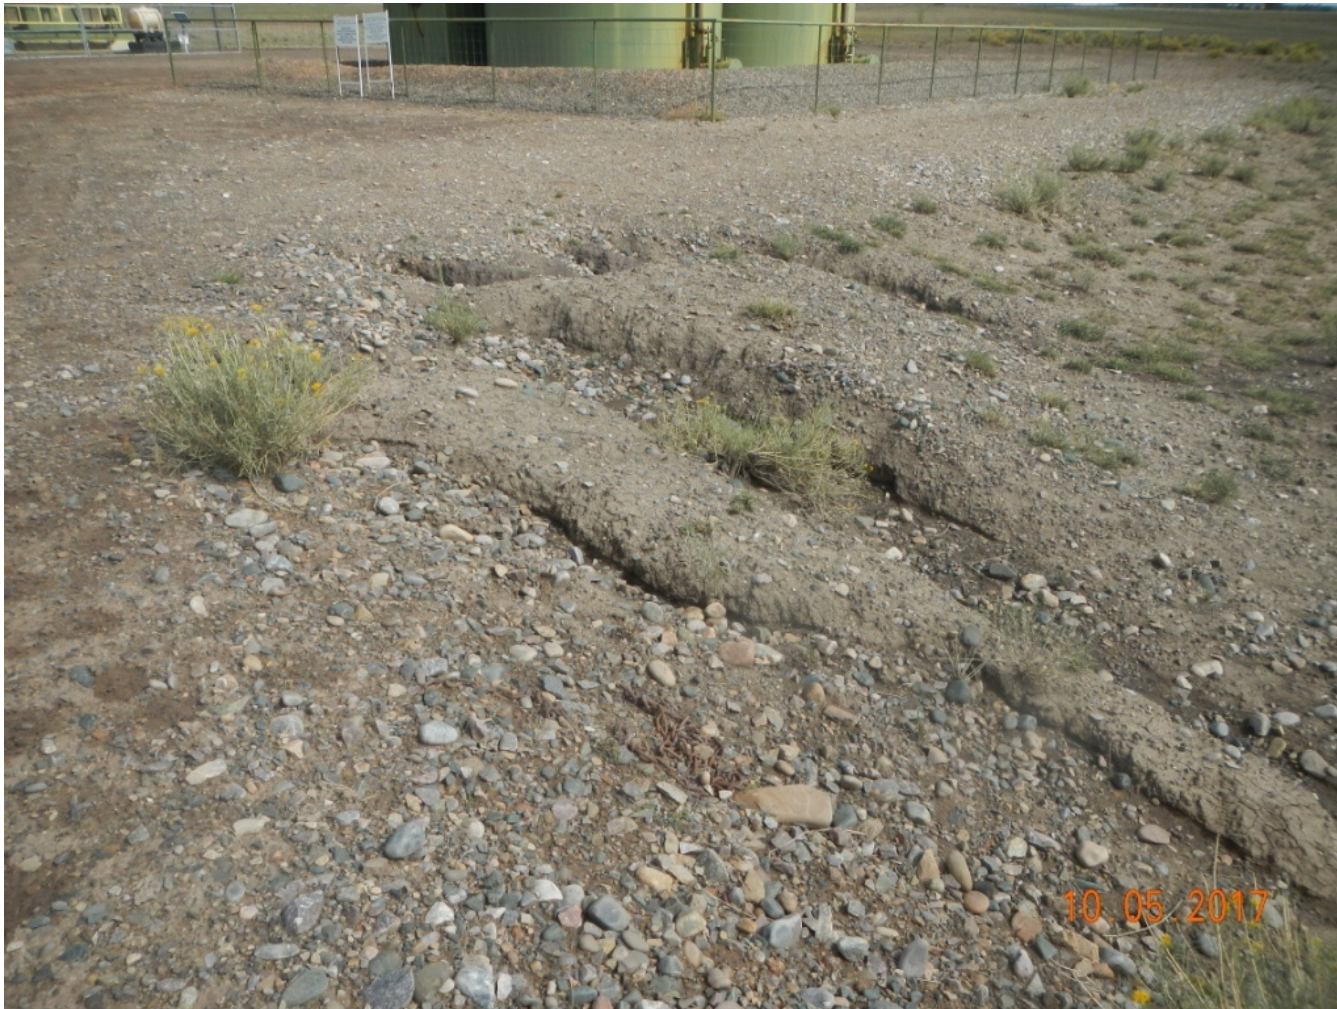
Photo 4. View of erosional channels forming near the well pad entrance. Stormwater controls need to be installed to stabilize erosion in eroding areas.

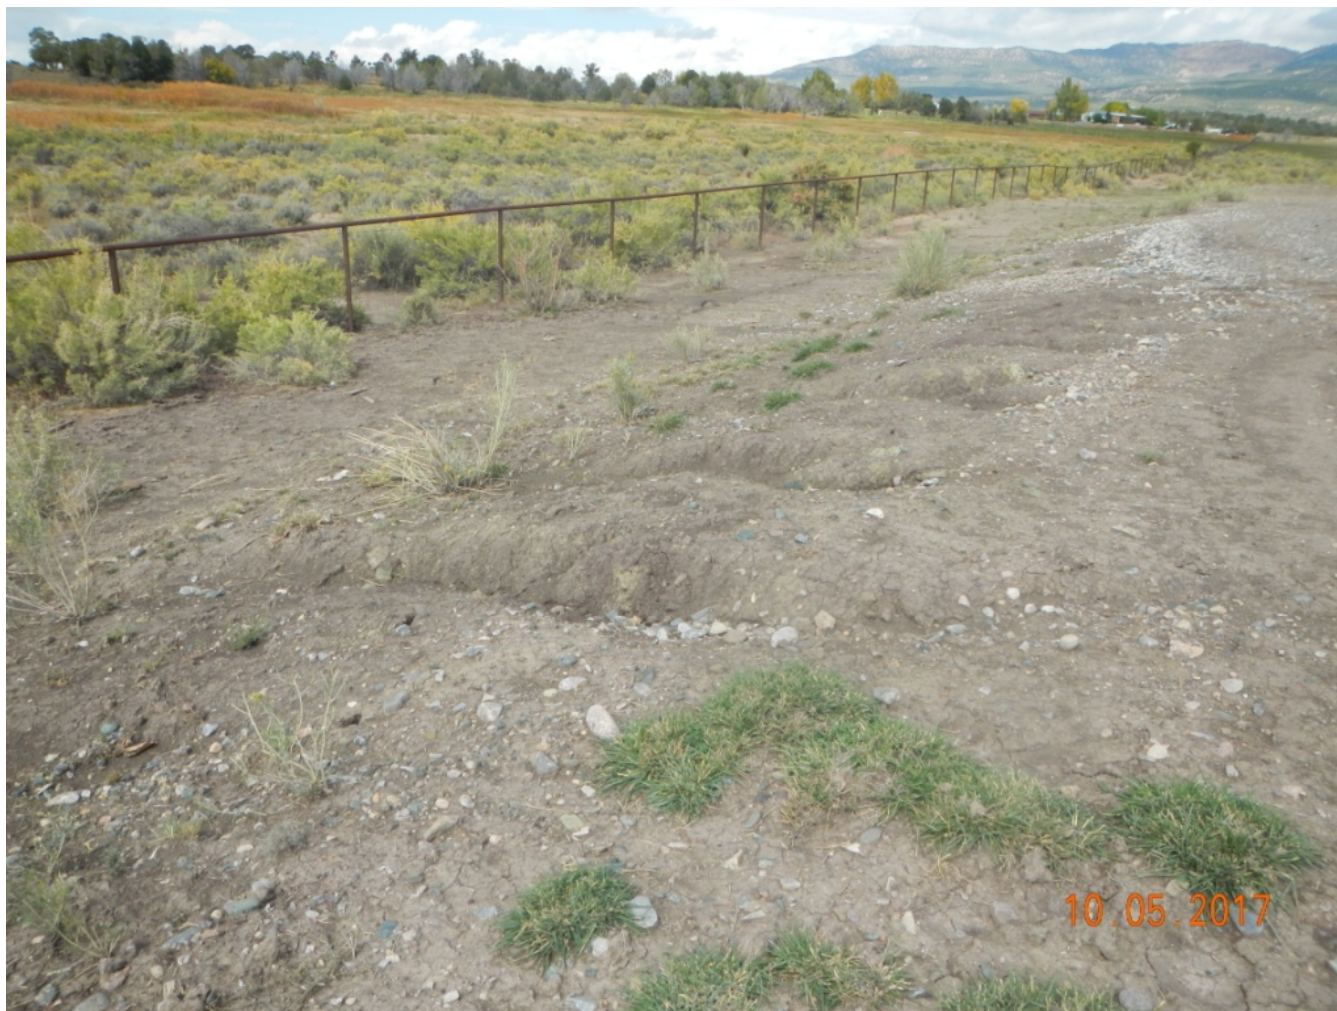
Photo 5. View of erosional channels in the southwestern portion of the project area.
