**Inspection Photos**  
**Location Name: Ditorro, John #1-A**  
**API: 05-123-09622**

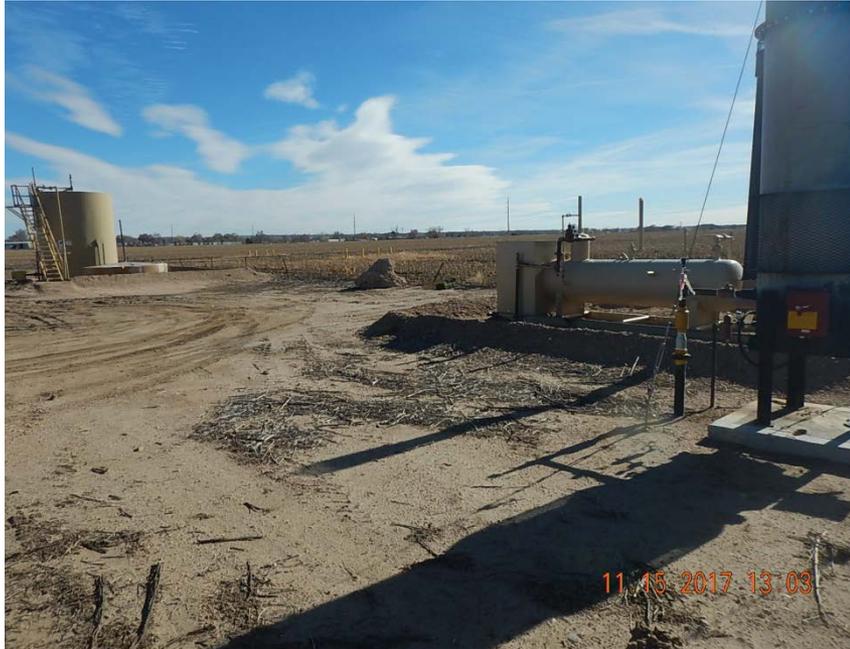
**Photo 1: Location, looking SE**

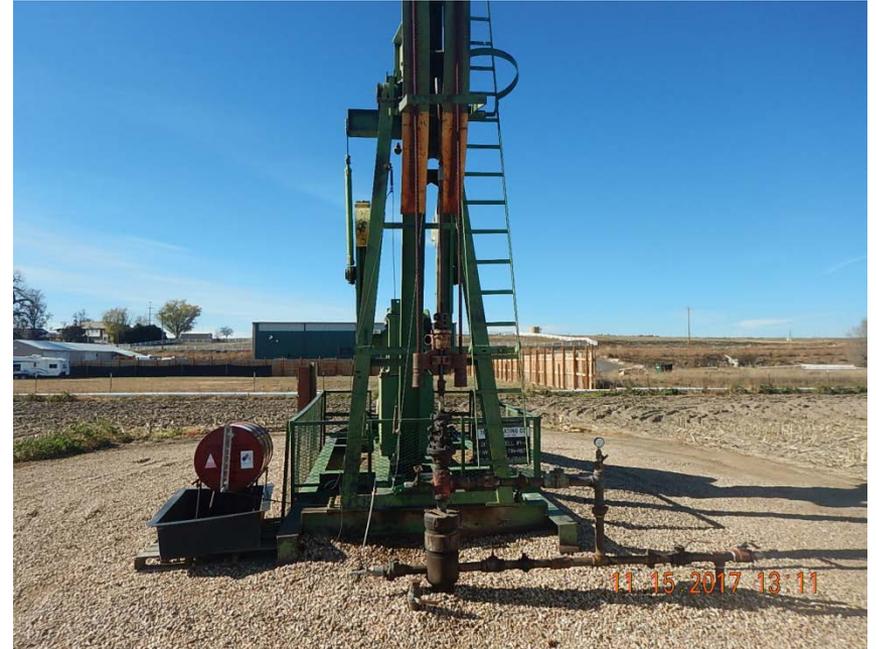
**Photo 2: Wellhead, looking W**

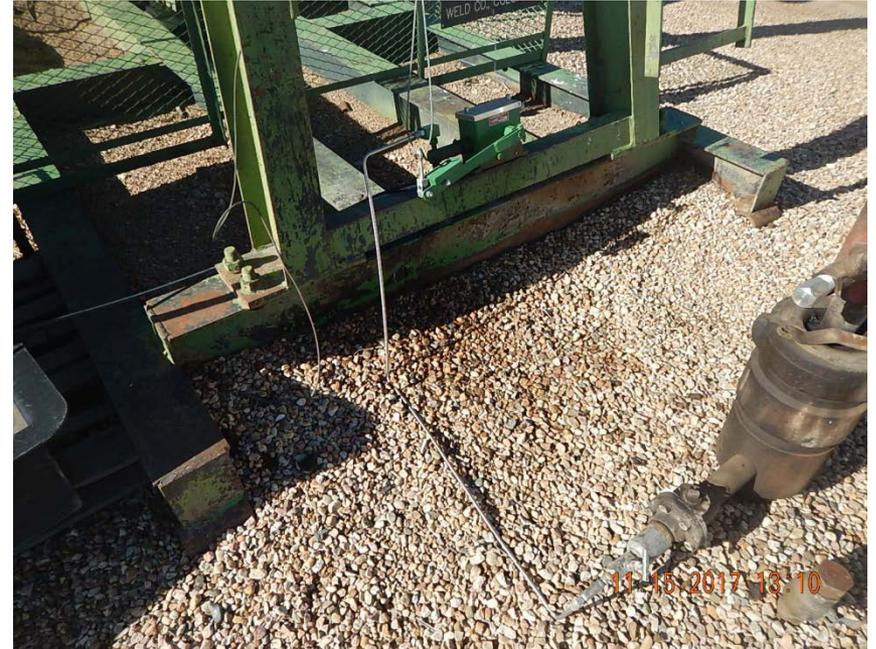
Photo 3: Stained soil wellhead

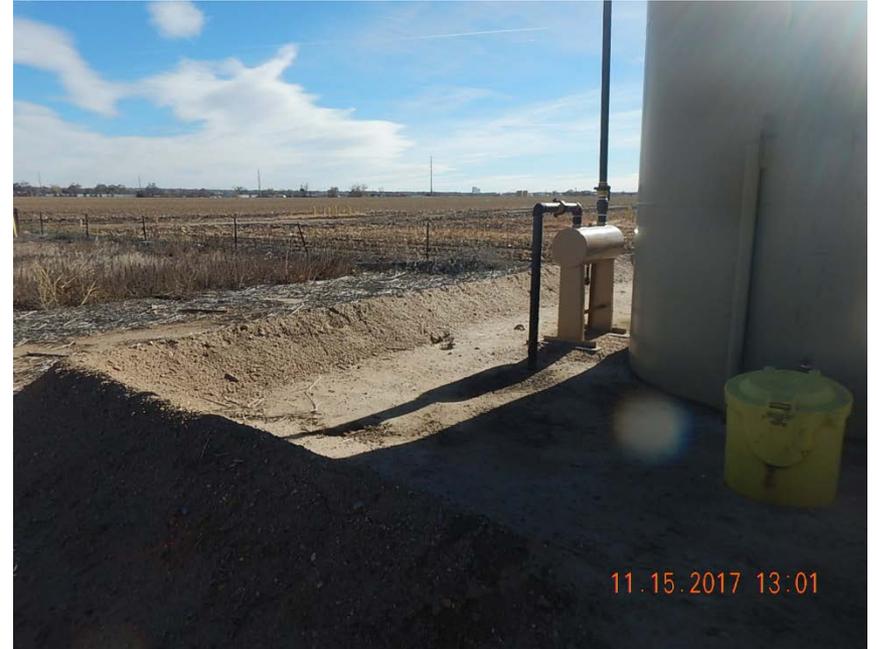
**Photo 4: Weeds controlled**

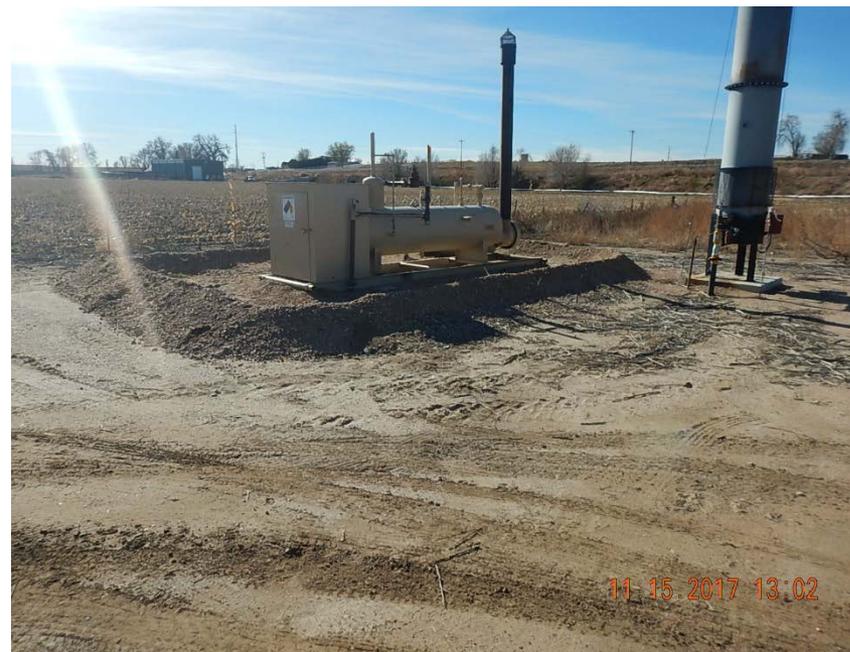
Photo 5: Weeds controlled

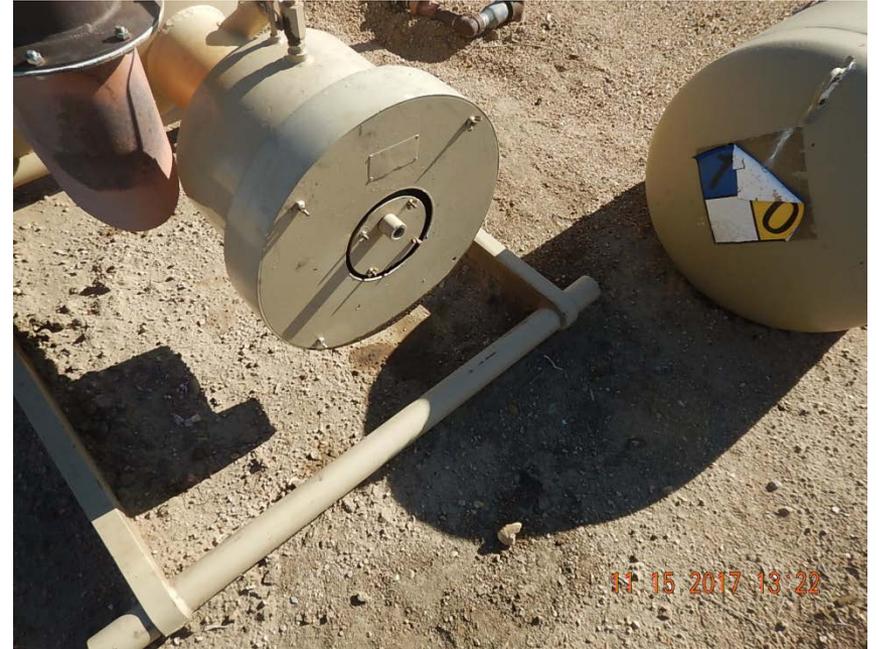
Photo 6: Stained soil removed, some impacted soil remaining

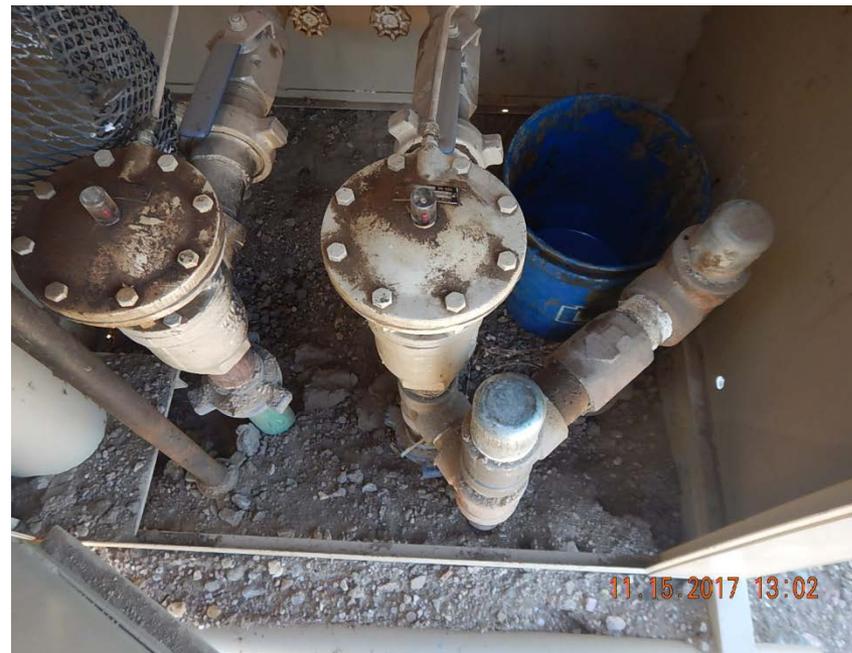
Photo 7: Stained soil in separator house removed

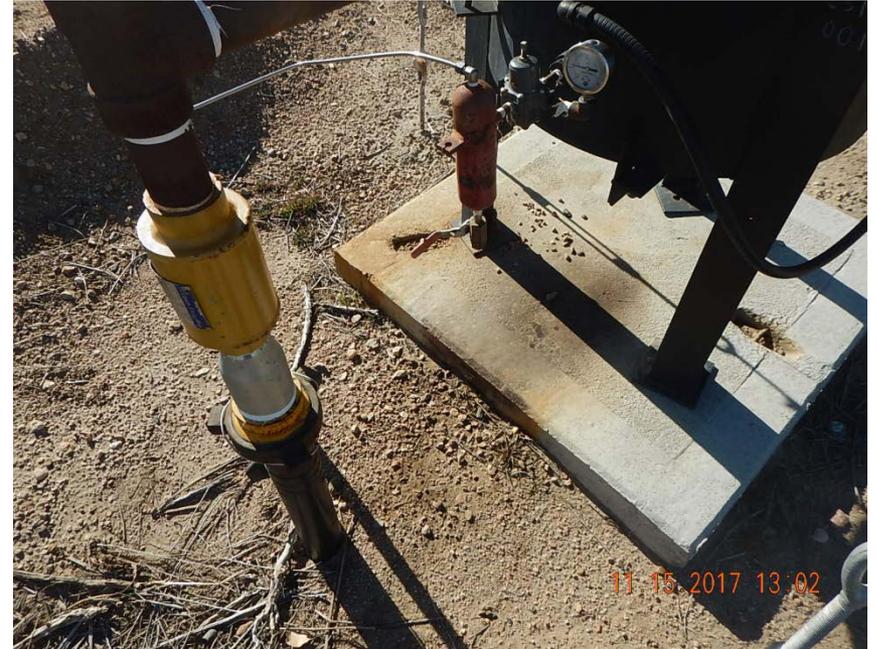
Photo 8: Stained soil at ECD removed
