Inspection Photos
Location Name: Moore 13-35
API #: 05-123-19455
Location ID: 330681

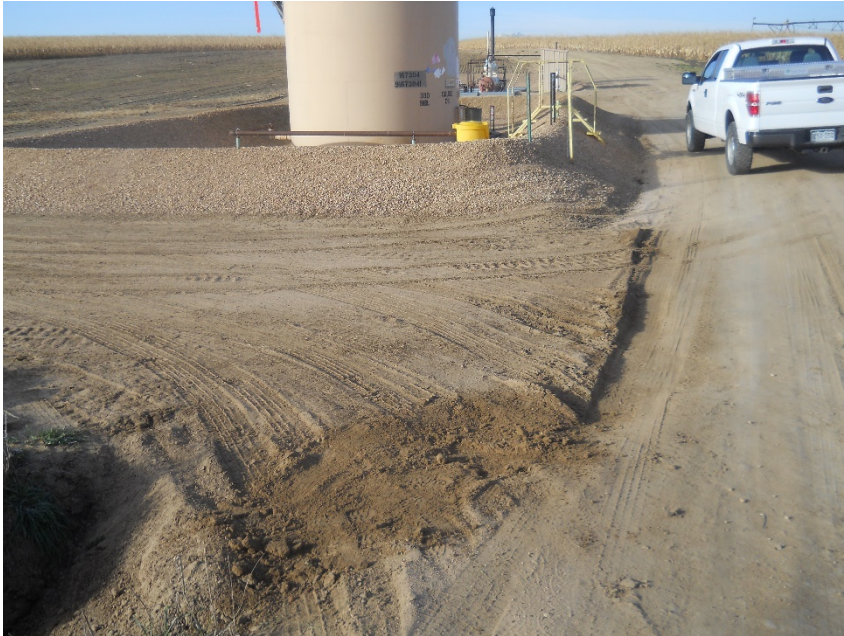
Northeast edge of location erosion has been repaired

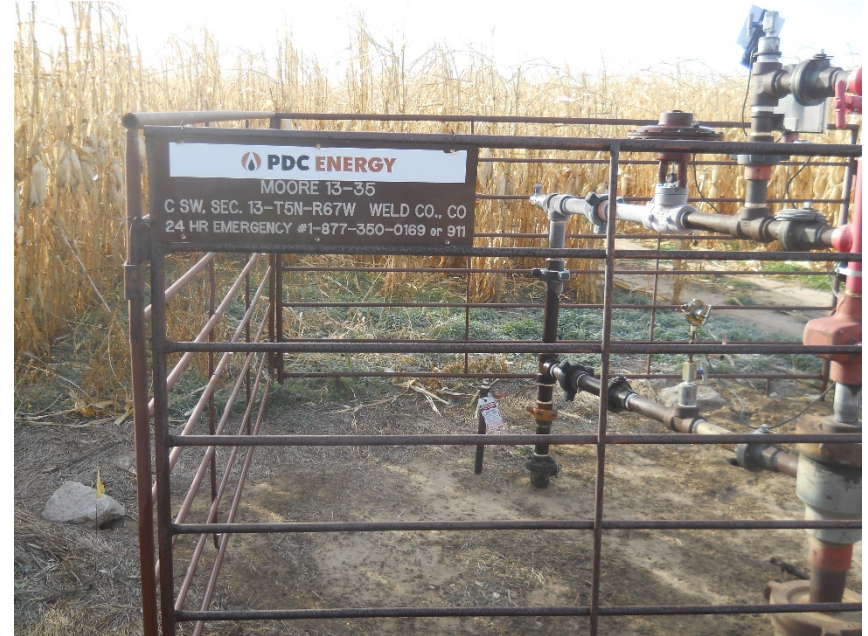
Wellhead looking south. 1" steel riser has been LOTO and labeled
