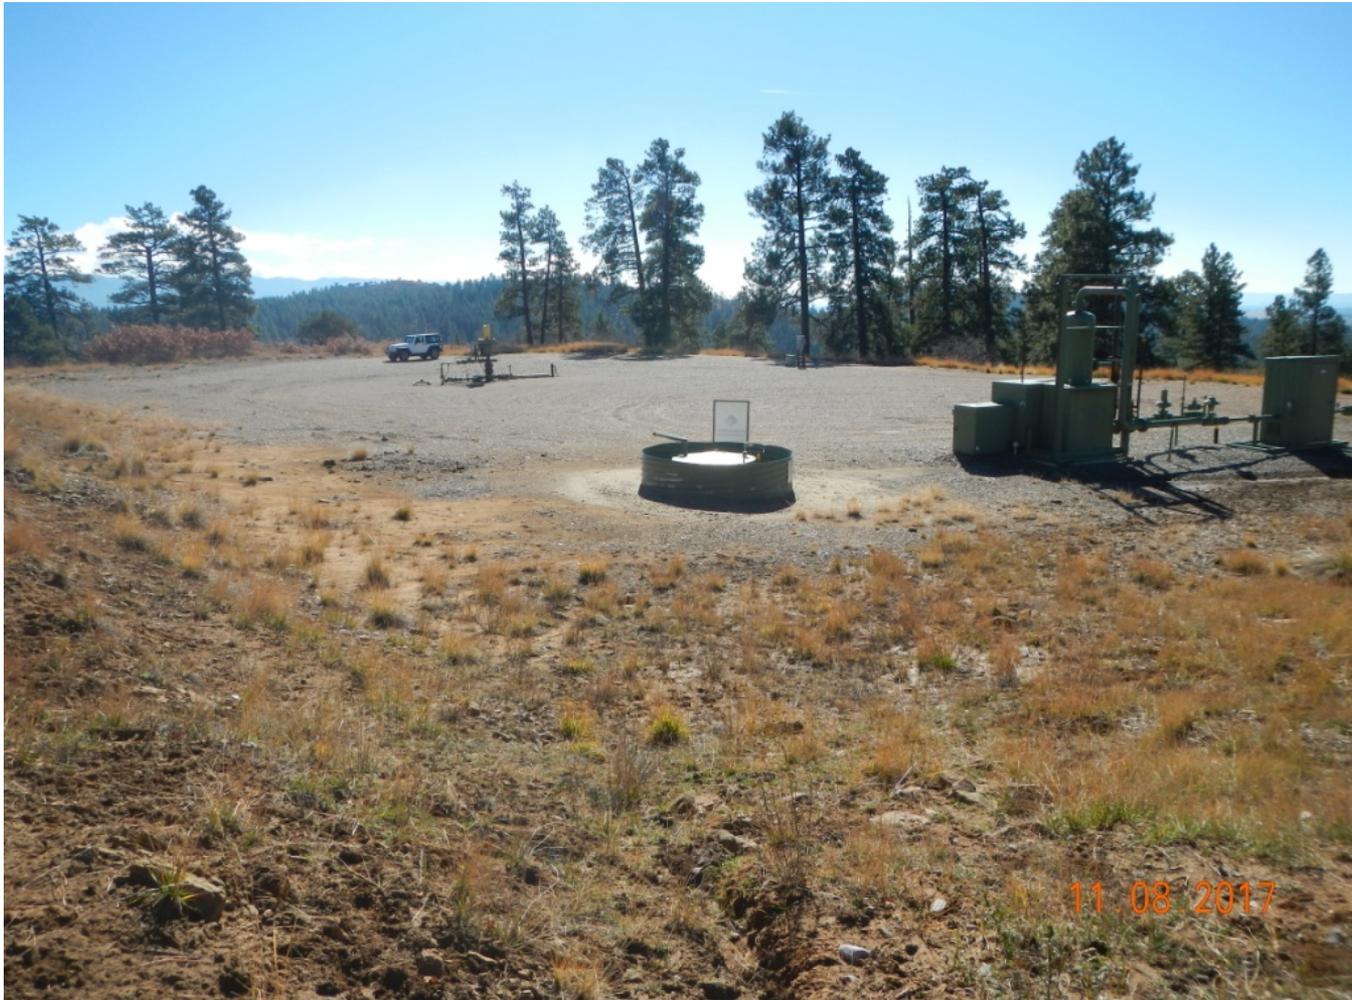
Photo 1. View of the project area from the northwestern corner facing center.

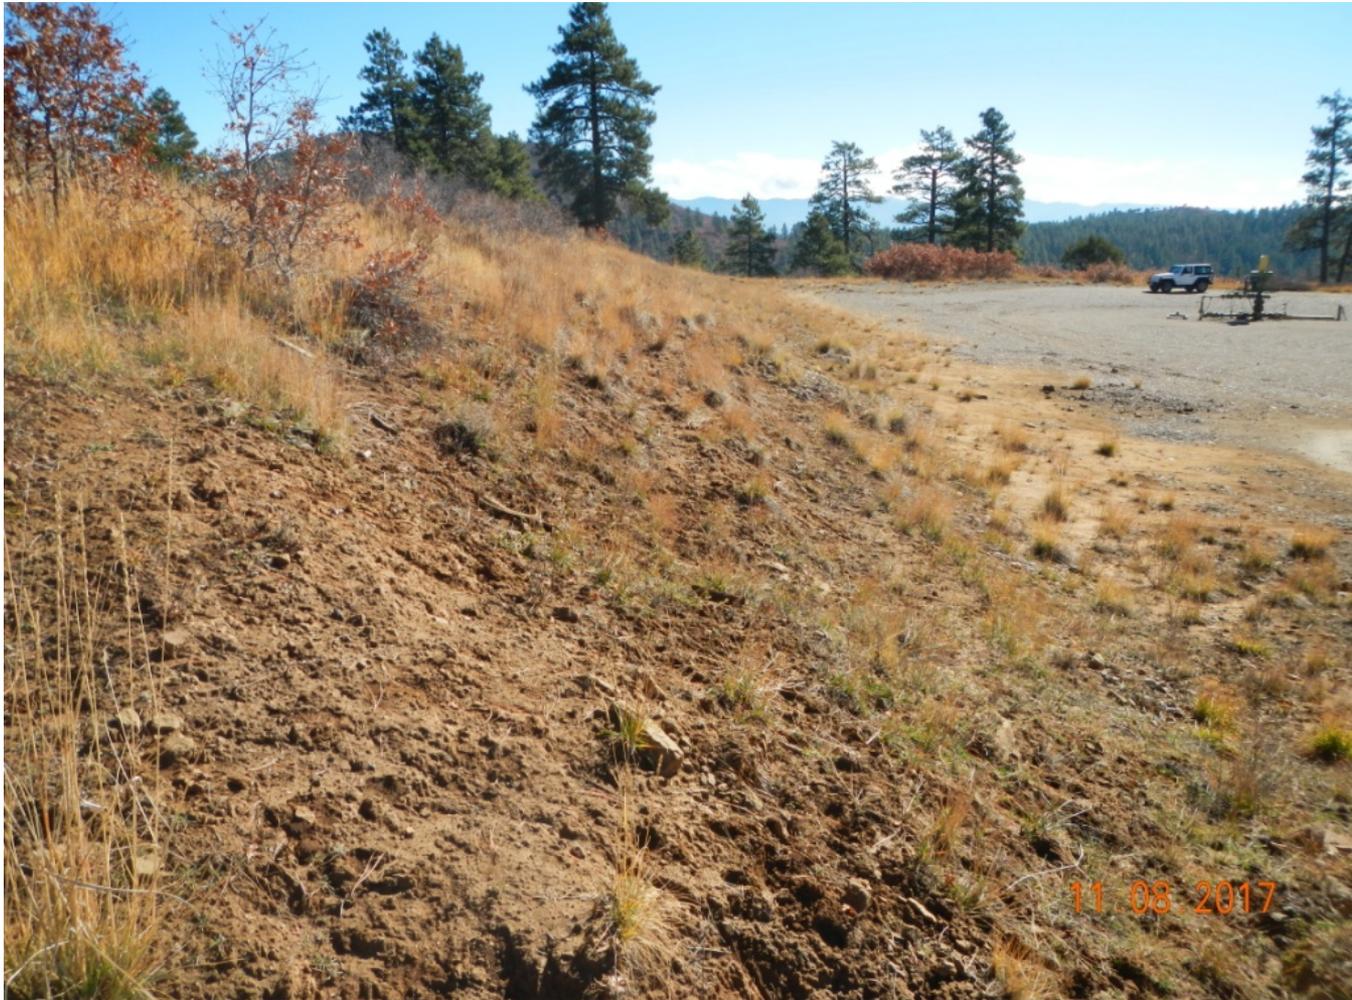
Photo 2. View of the northern portion of the project area from the northwestern corner facing eastward.

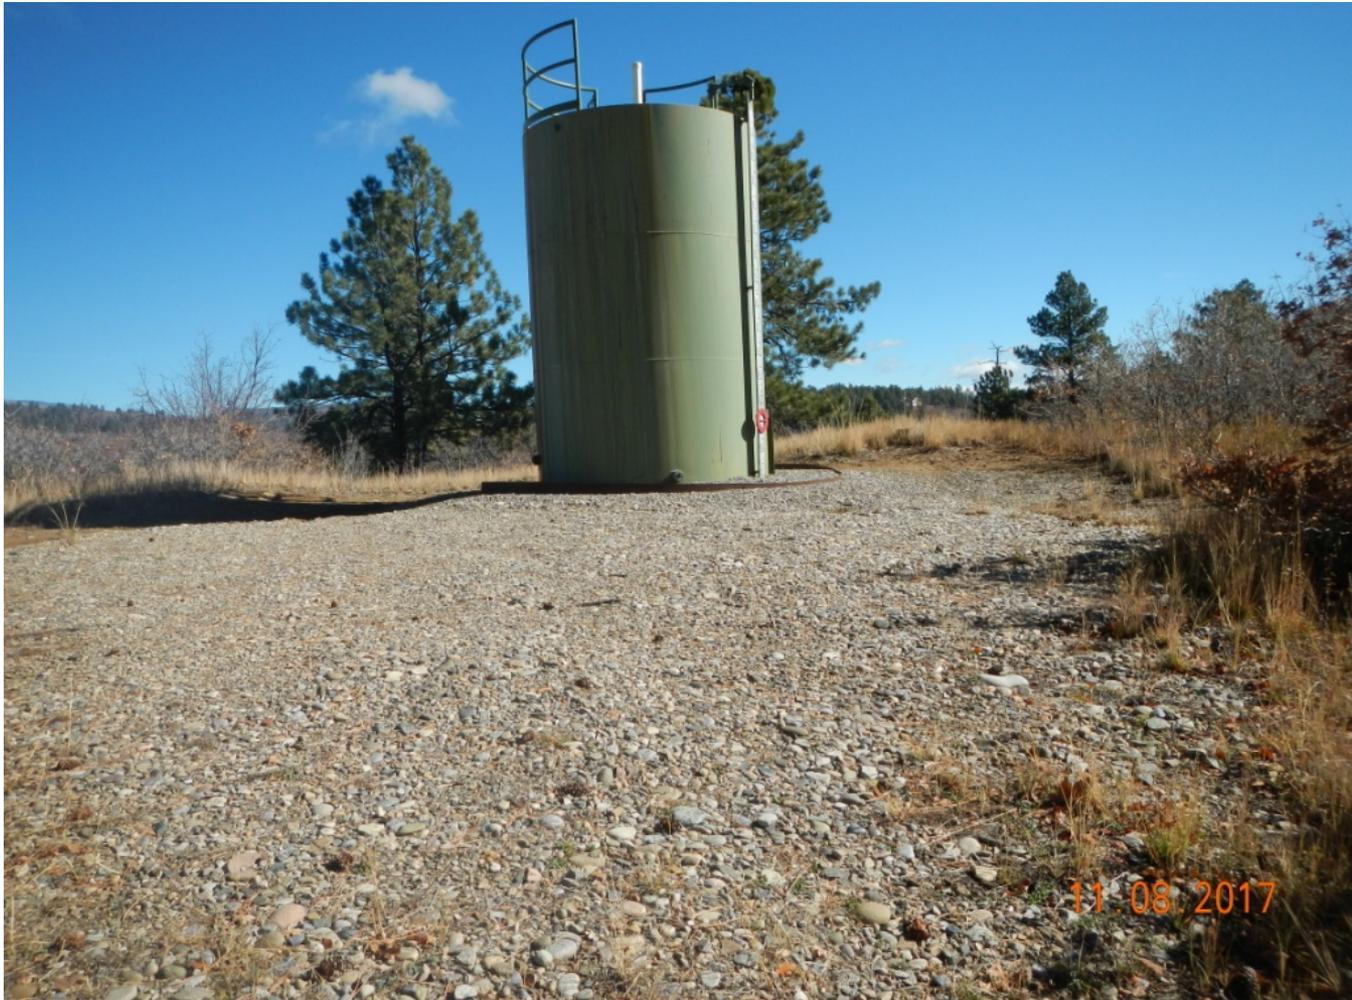
Photo 3. View of tank area in north of the well pad.

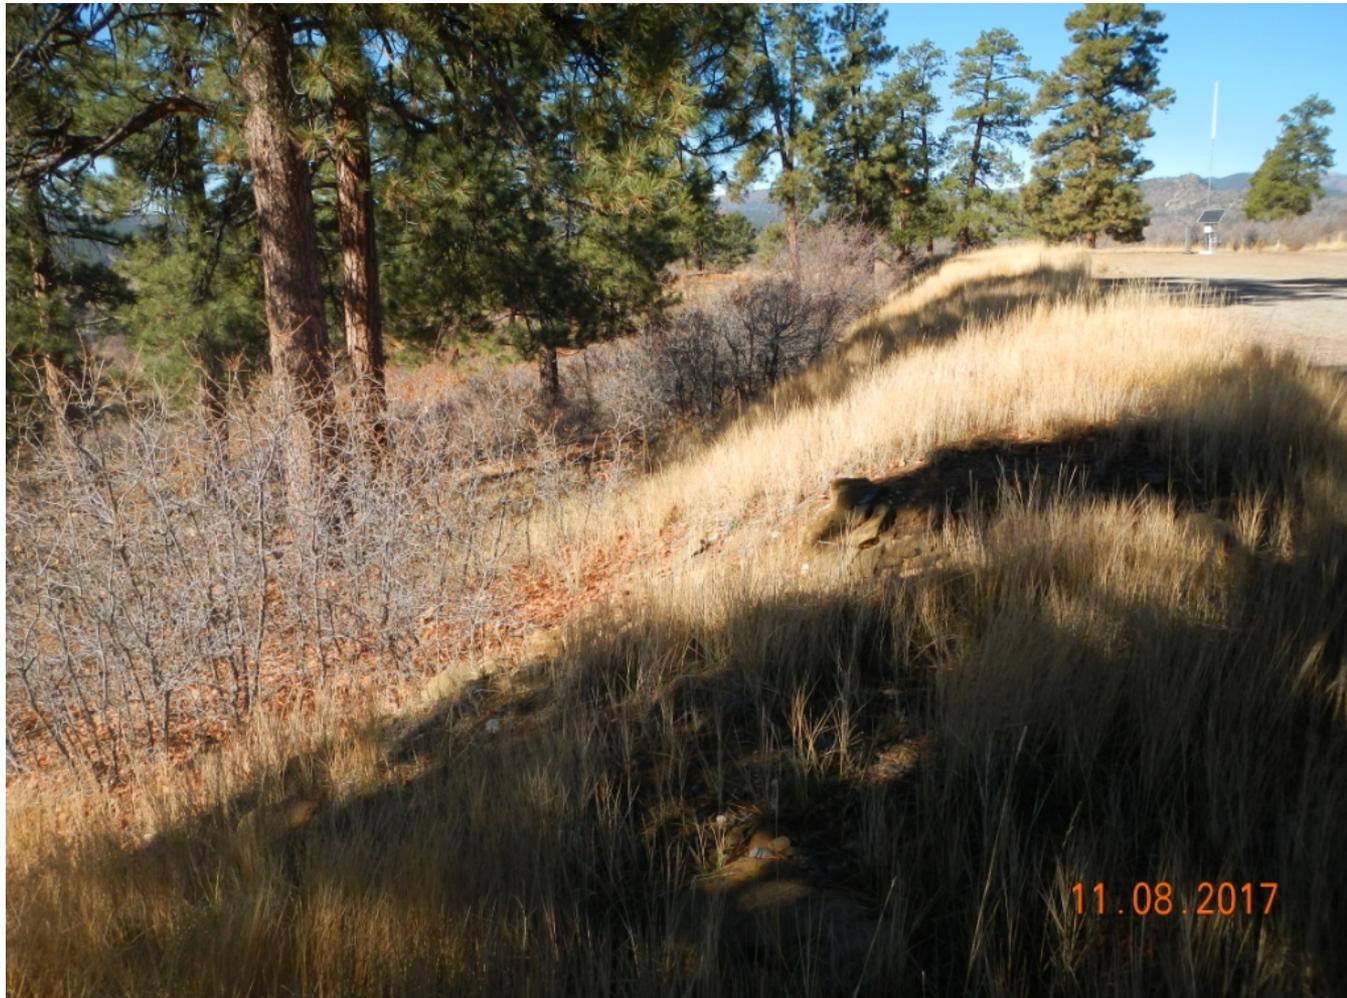
Photo 4. View of the southern portion of the project area from the southeastern corner facing westward. Revegetation is progressing and largely comprised of western wheatgrass (*Pascopyrum smithii*), gambel oak (*Quercus gambelii*), and dropseed (*Sporobolus sp.*).

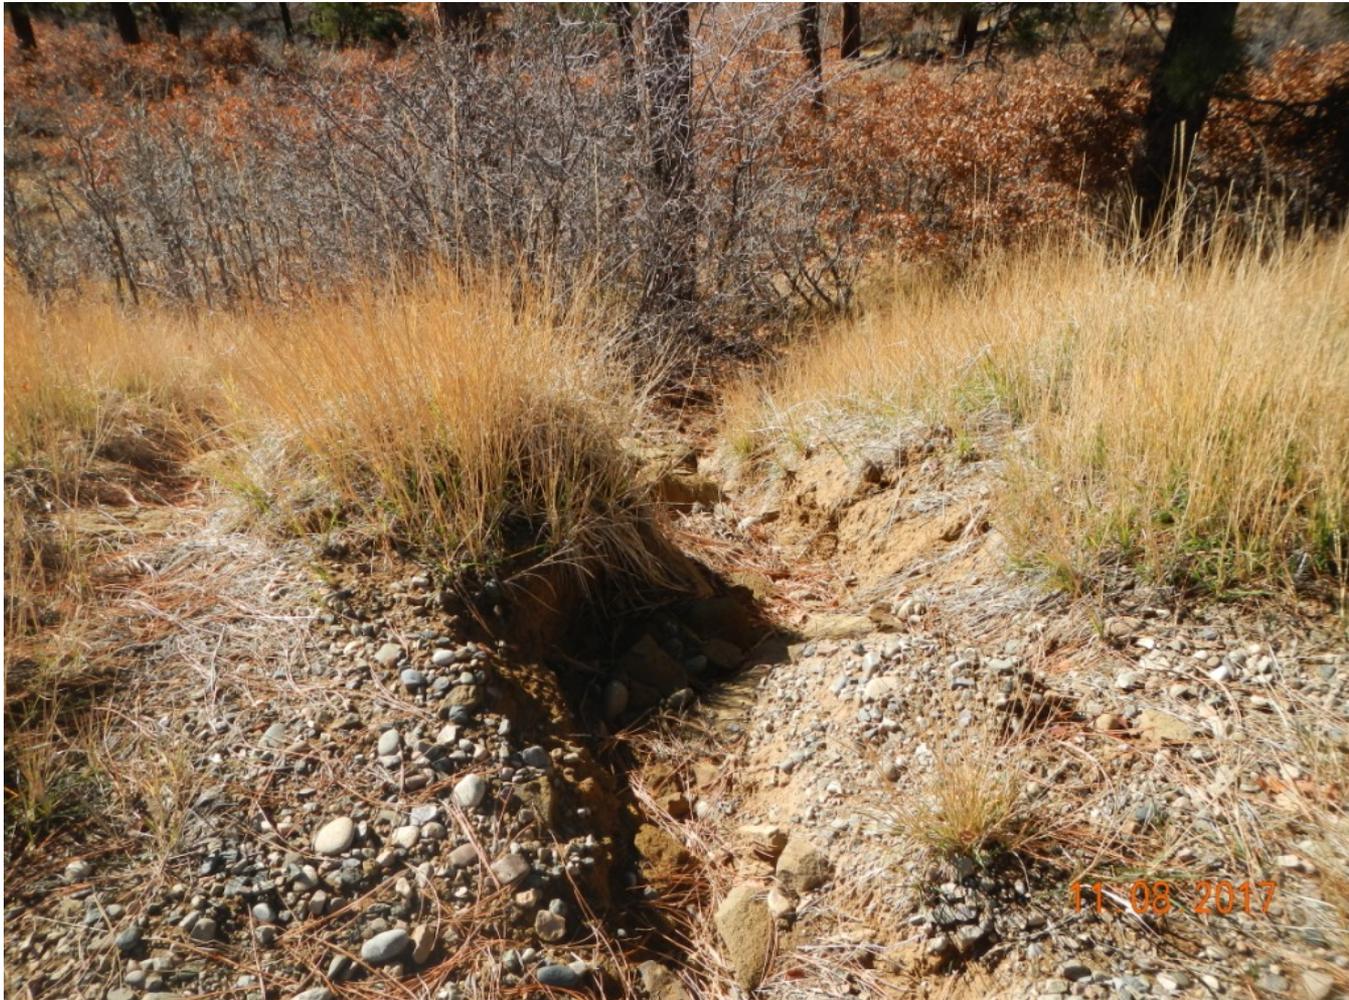
Photo 5. View of erosional channel forming in the southern portion of the project area, approximate 18 inches wide and 10 inches deep.

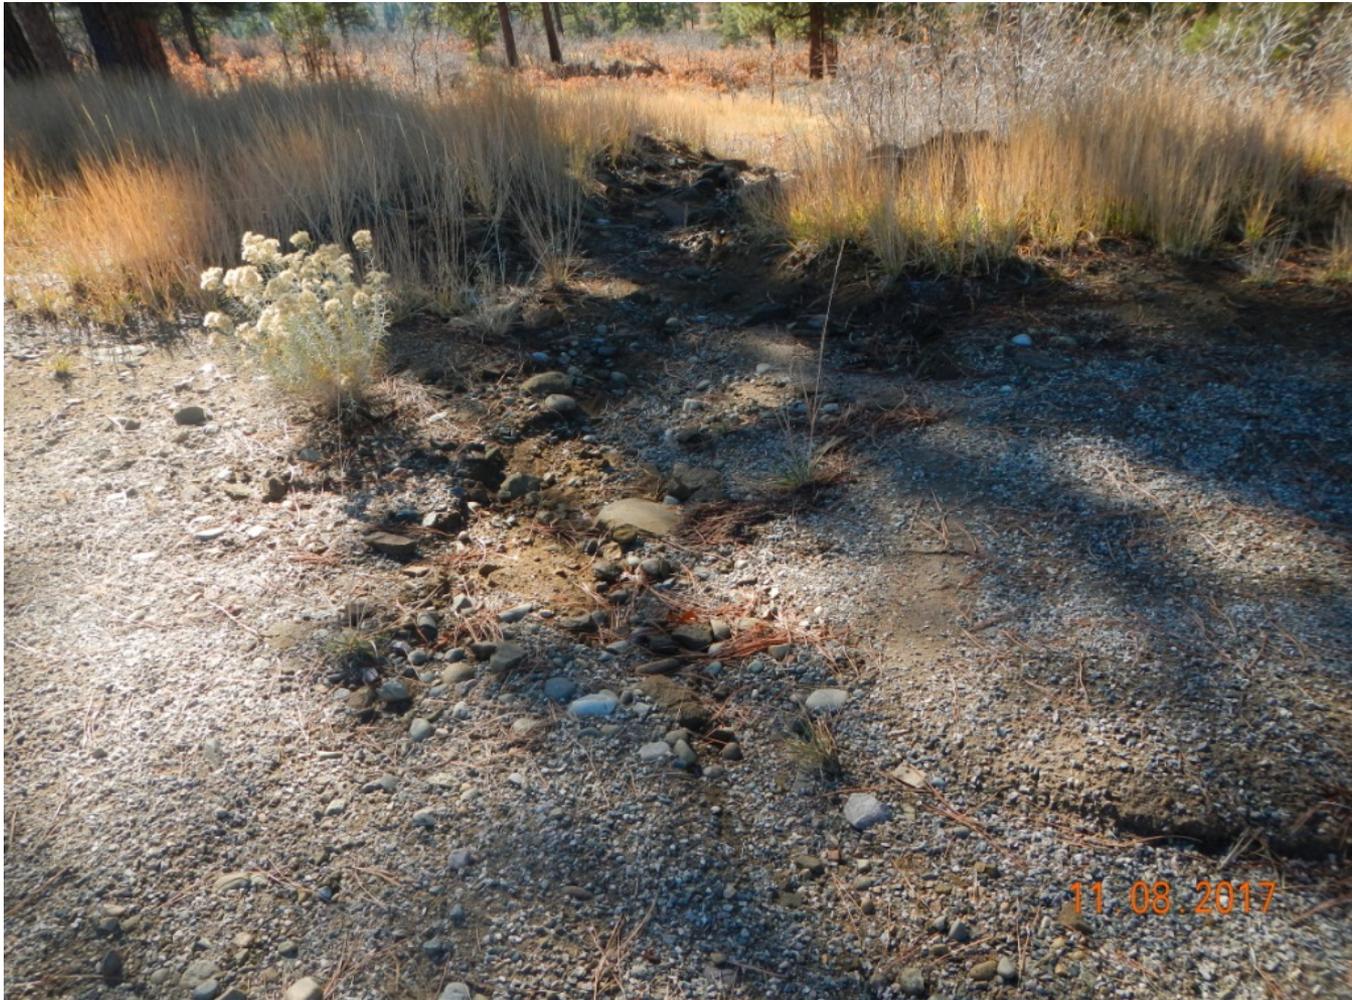
Photo 6. View of another erosional channel forming in the southern portion of the project area.
