Inspection Photos
Location Name: Ruebel et al 1-2
API: 05-001-08664

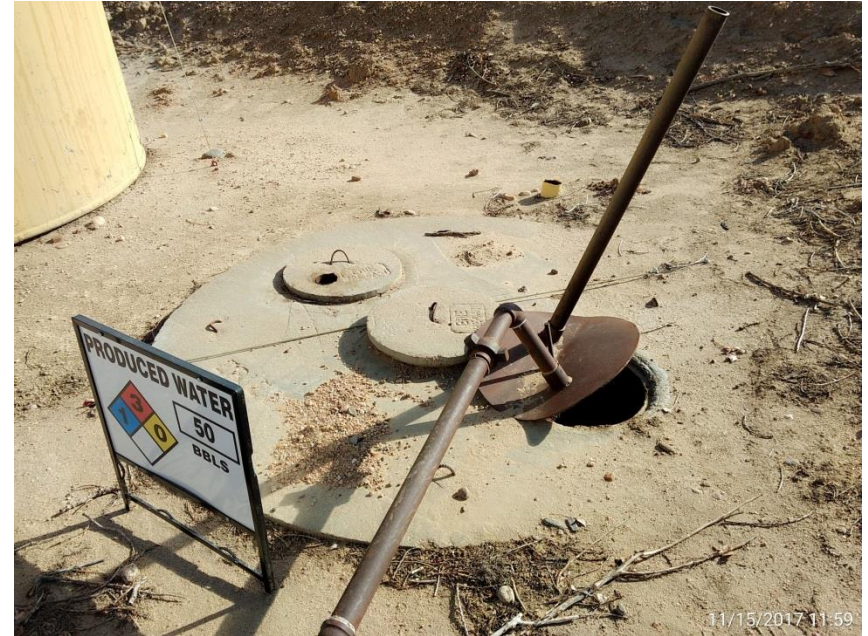
Produced Water Vault, **Corrective Action: Water vault access bent open.**

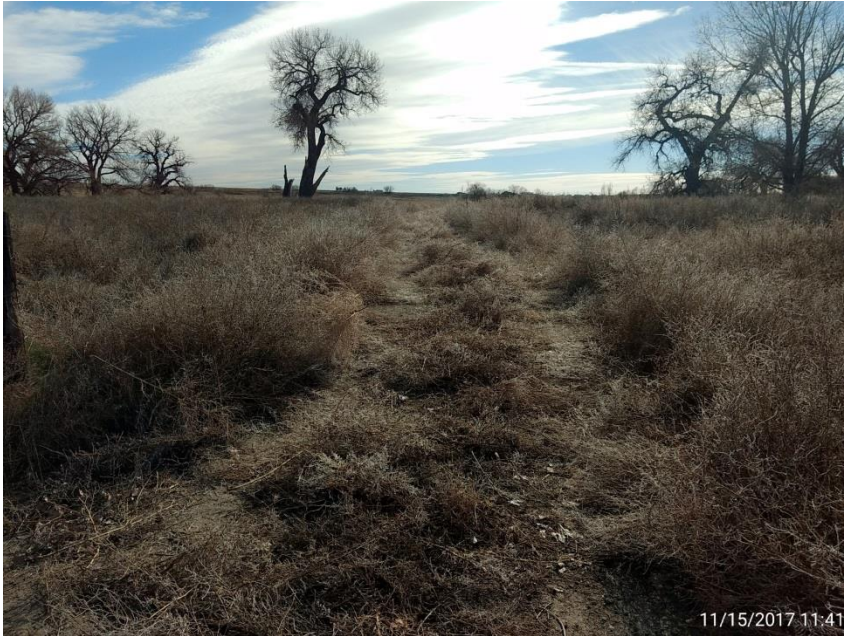
Lease Road, Corrective Action: Overgrown weeds on road from facility to wellhead.

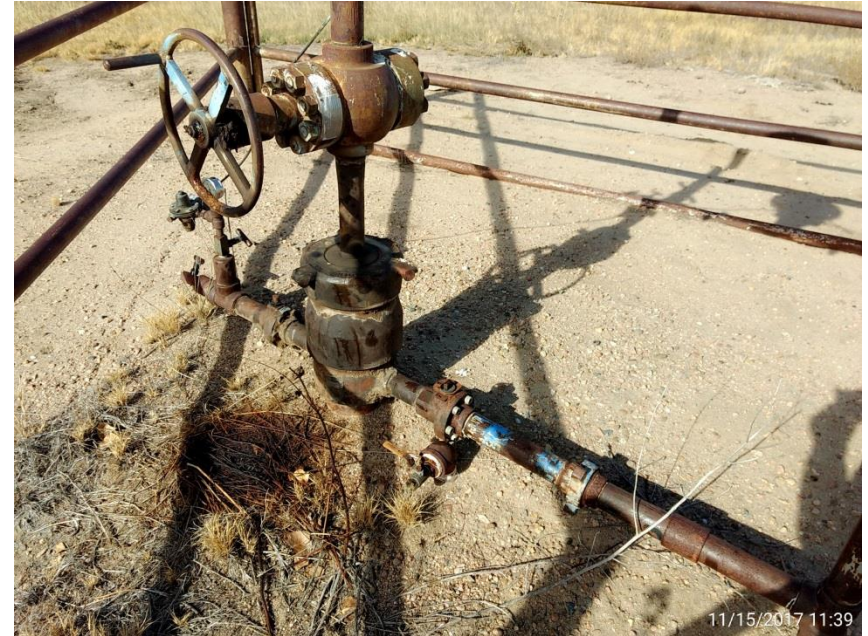
Wellhead detail, Corrective Action: Packing in master valve appears to be leaking causing stained soil.
