# Interim Reclamation and Stormwater Inspection

November 15, 2017

Operator: EXTRACTION OIL & GAS LLC- #10459

Location ID: 450197

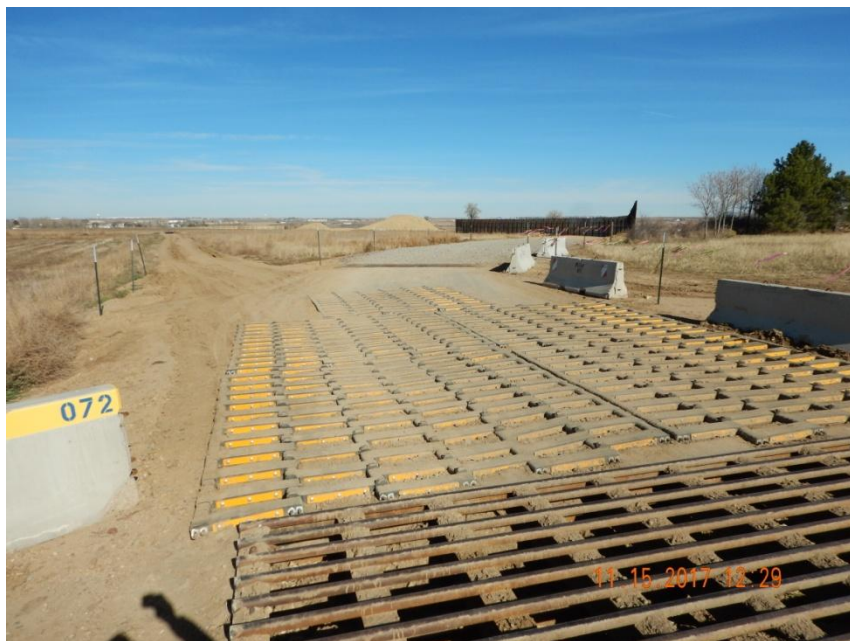
**Photo 1.** Photo taken from the entrance of location, facing North. Tracking pad devices installed at location.

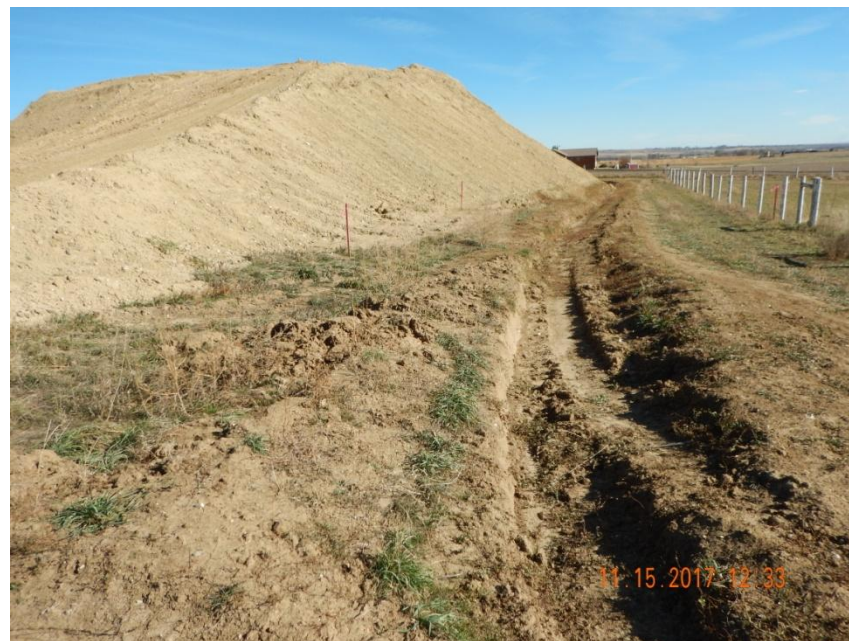
**Photo 2.** Photo taken from the southeastern location, facing East. Ditch BMP installed around the perimeter of the location. Ditch depth appeared shallow along portions. Stockpile has been constructed to a significant height and may need additional stabilization as rill erosion was observed along portions of the stockpile.

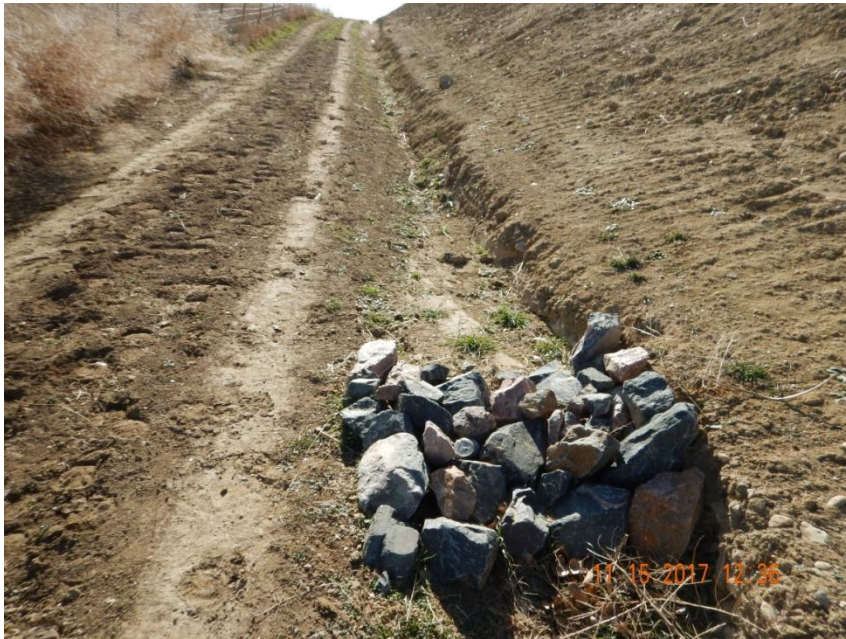
**Photo 3.** Photo taken from the eastern location, facing South. Check dam BMP installed along portions of the eastern ditch BMP. See comments under Photo 2.

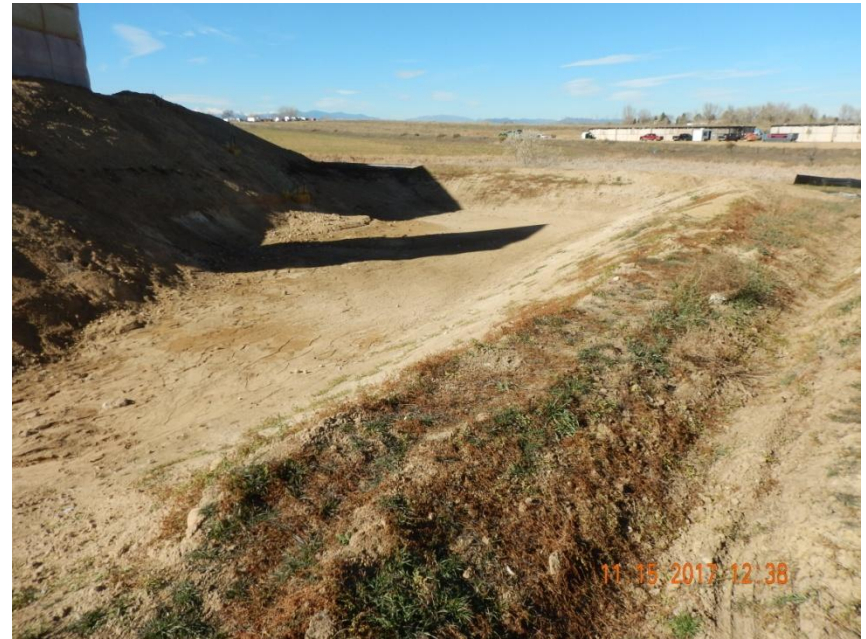
**Photo 4.** Photo taken from the northern location, facing West. Sediment basin has been installed with a stabilized outlet.

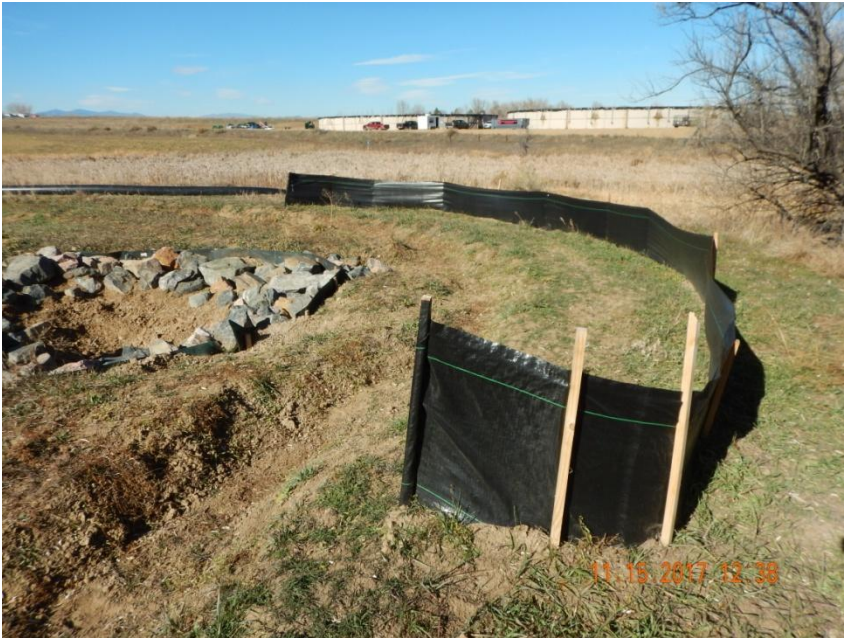
**Photo 5.** Photo taken from the northern location, facing Northwest. Silt fence BMP constructed around the stabilized outlet area of the sediment basin.

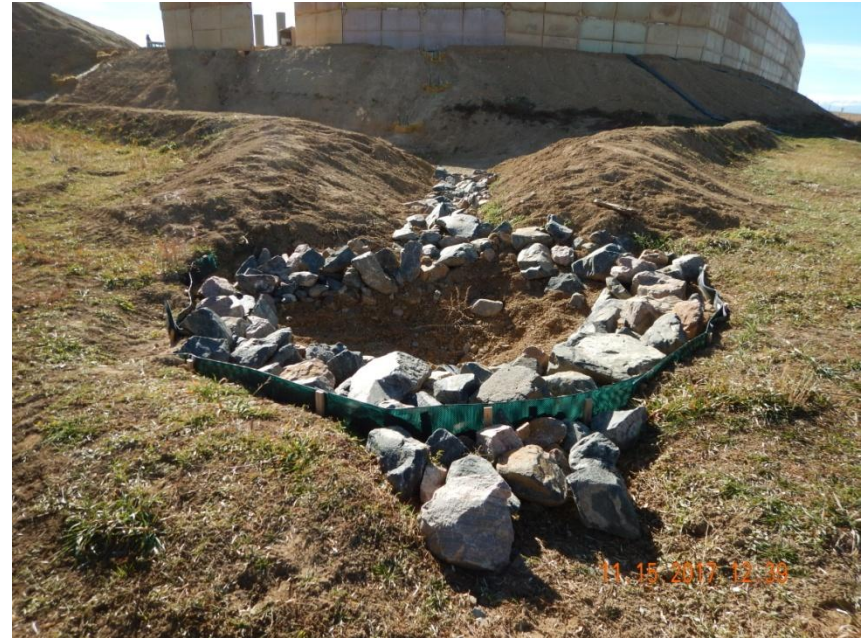
**Photo 6.** Photo taken from the northern location, facing South. Rip-rap and S-Fence have been installed for the stabilized outlet area.

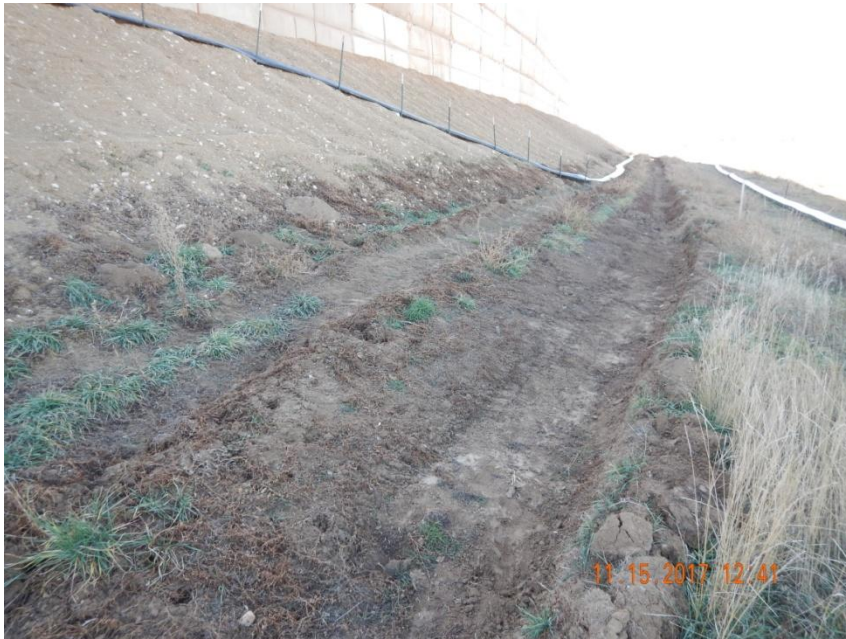
**Photo 7.** Photo taken from the northwestern location, facing Southwest. Ditch BMP has been installed but has not been stabilized. The eastern ditch BMP had check dams to stabilize the ditch BMP.

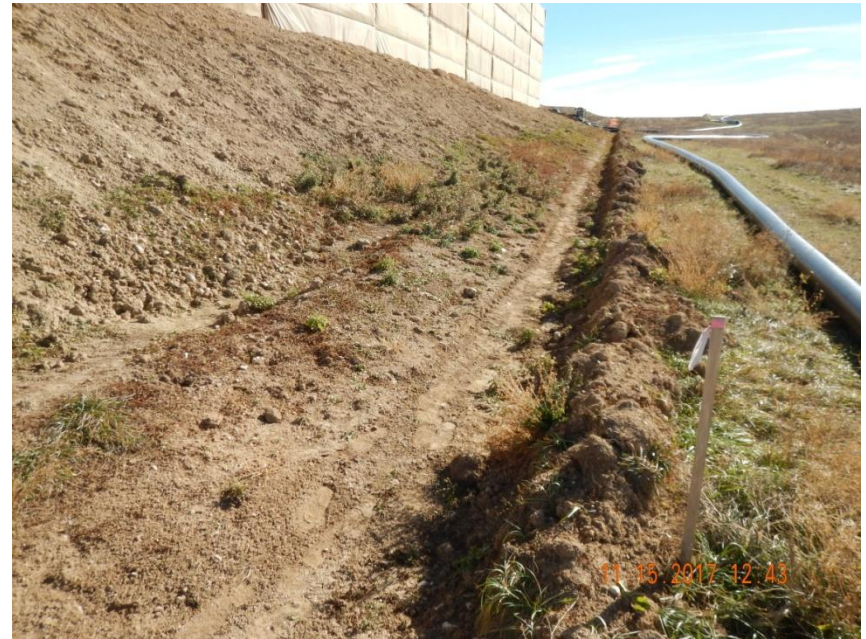
**Photo 8.** Photo taken from the northwestern location, facing South. See comments under Photo 7.

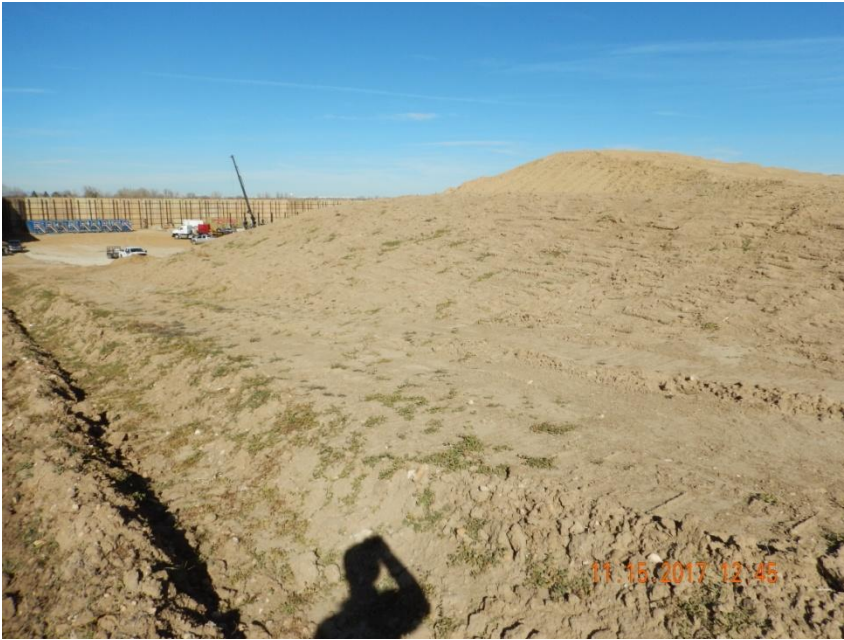
**Photo 9.** Photo taken from the western location, facing North. Appears topsoil has been stockpiled along the western perimeter of the location. All other stockpiles appeared to be left unconsolidated without any stabilization BMP.
