November 24, 2017

**COLORADO**  
Oil & Gas Conservation  
Commission  
Department of Natural Resources

Inspection Photos: Caerus K10 Loc#335676

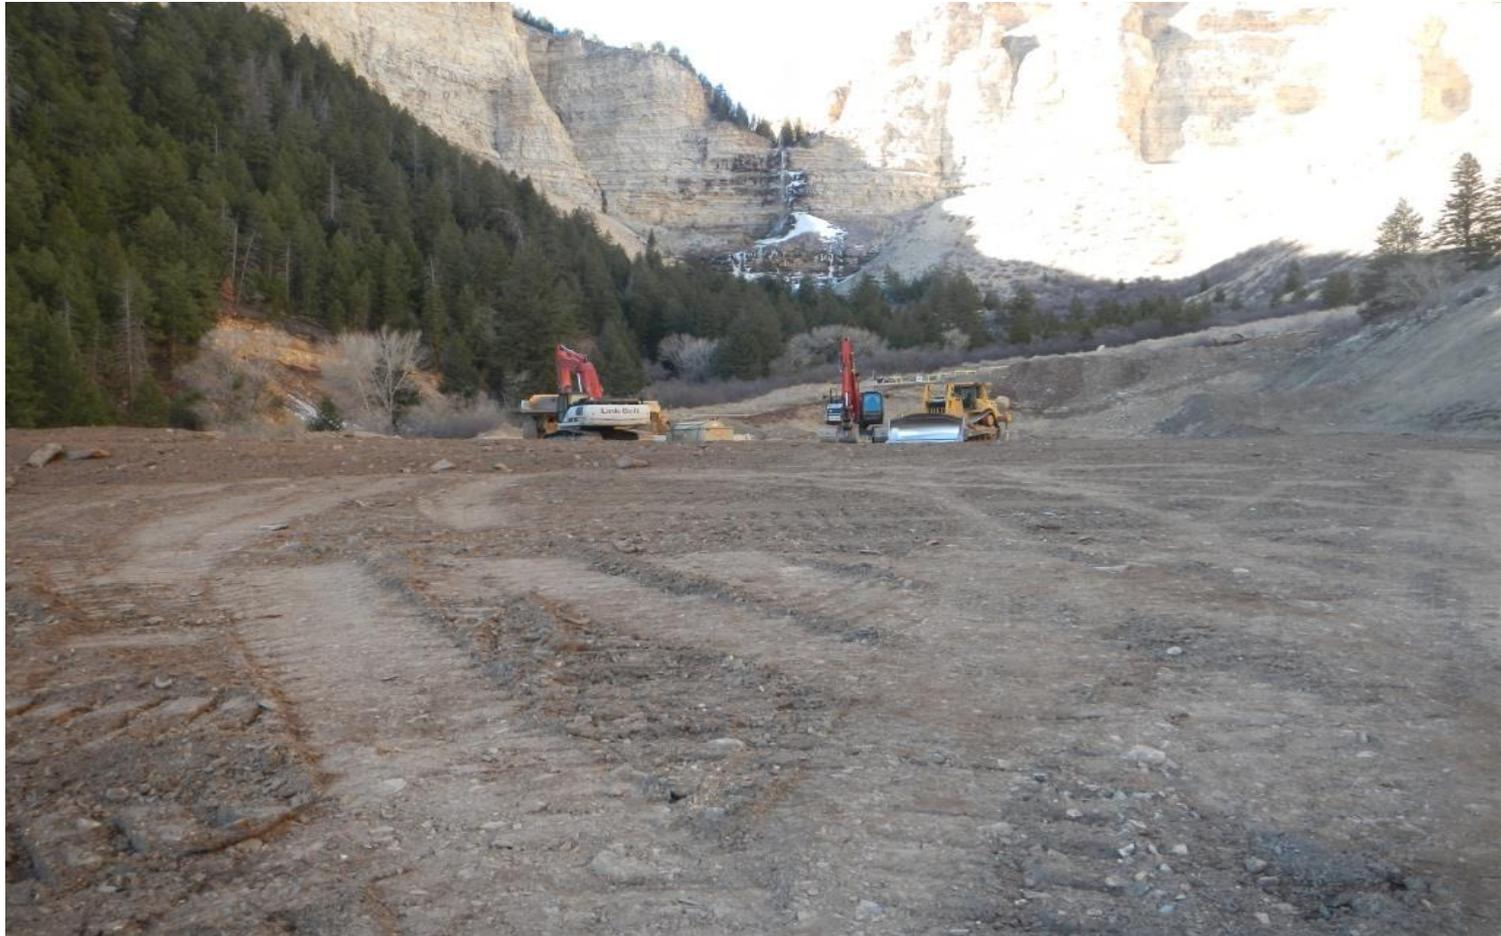
## Photo#1:

Overview of Location from Entry to Northeast.

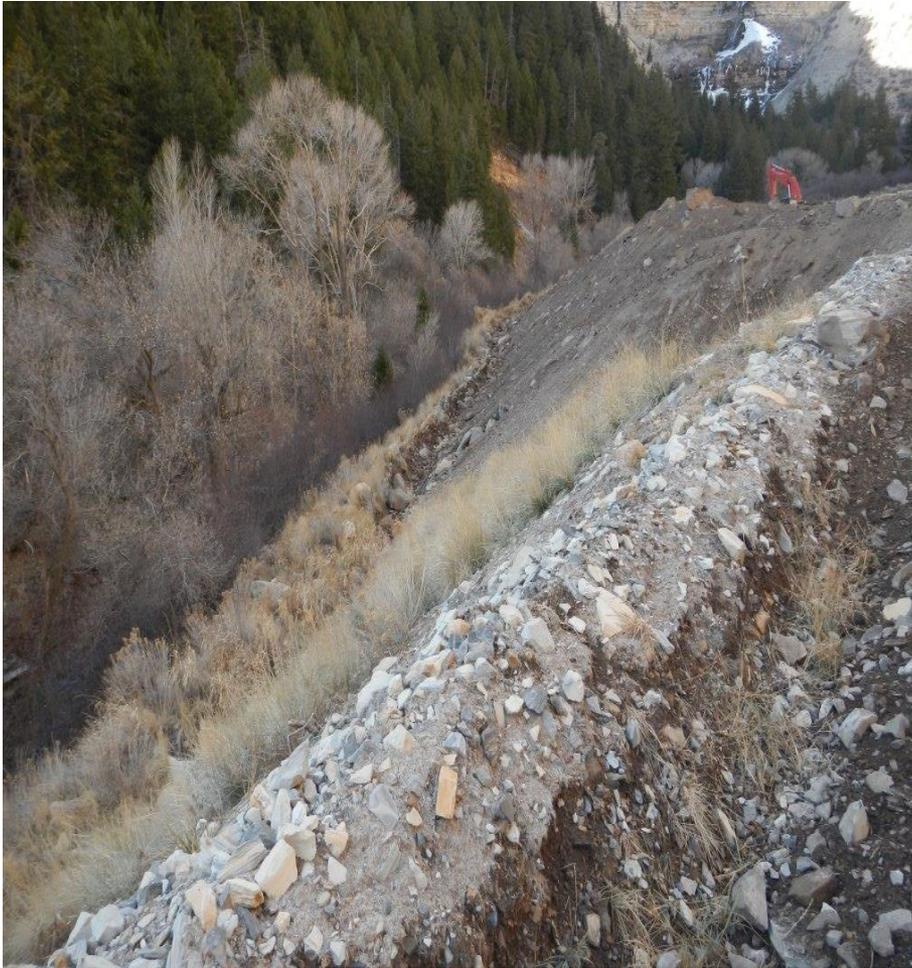
Photo#2:

View from entry along expanded Fill Slope 11/24/17

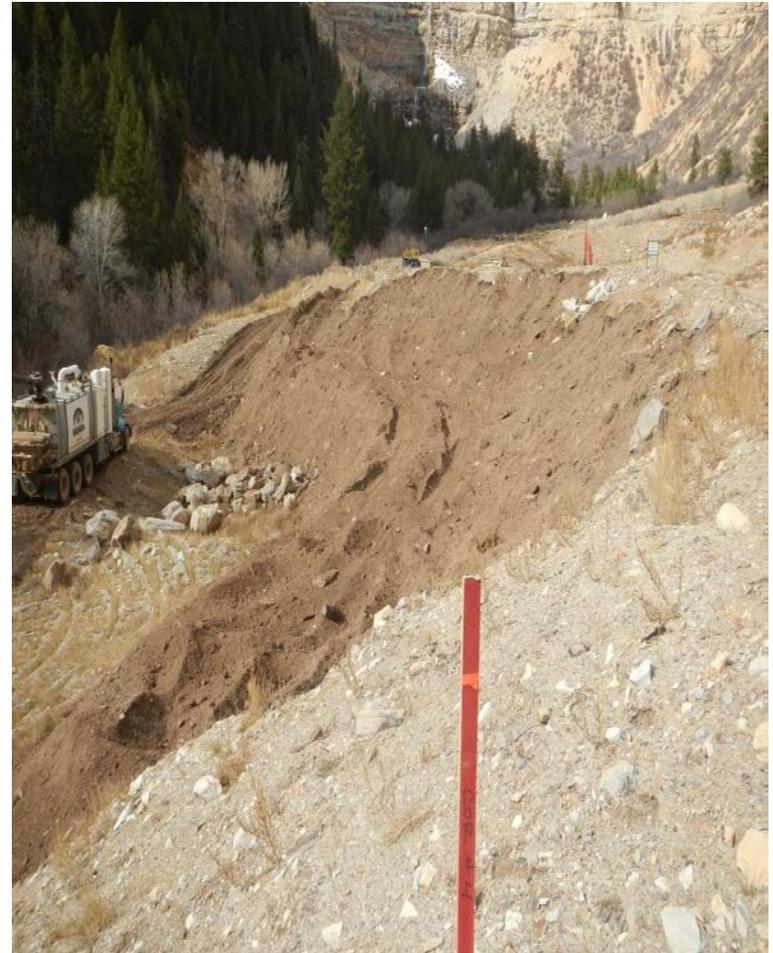
Photo#3:

Vac truck working in same area 11/14/17

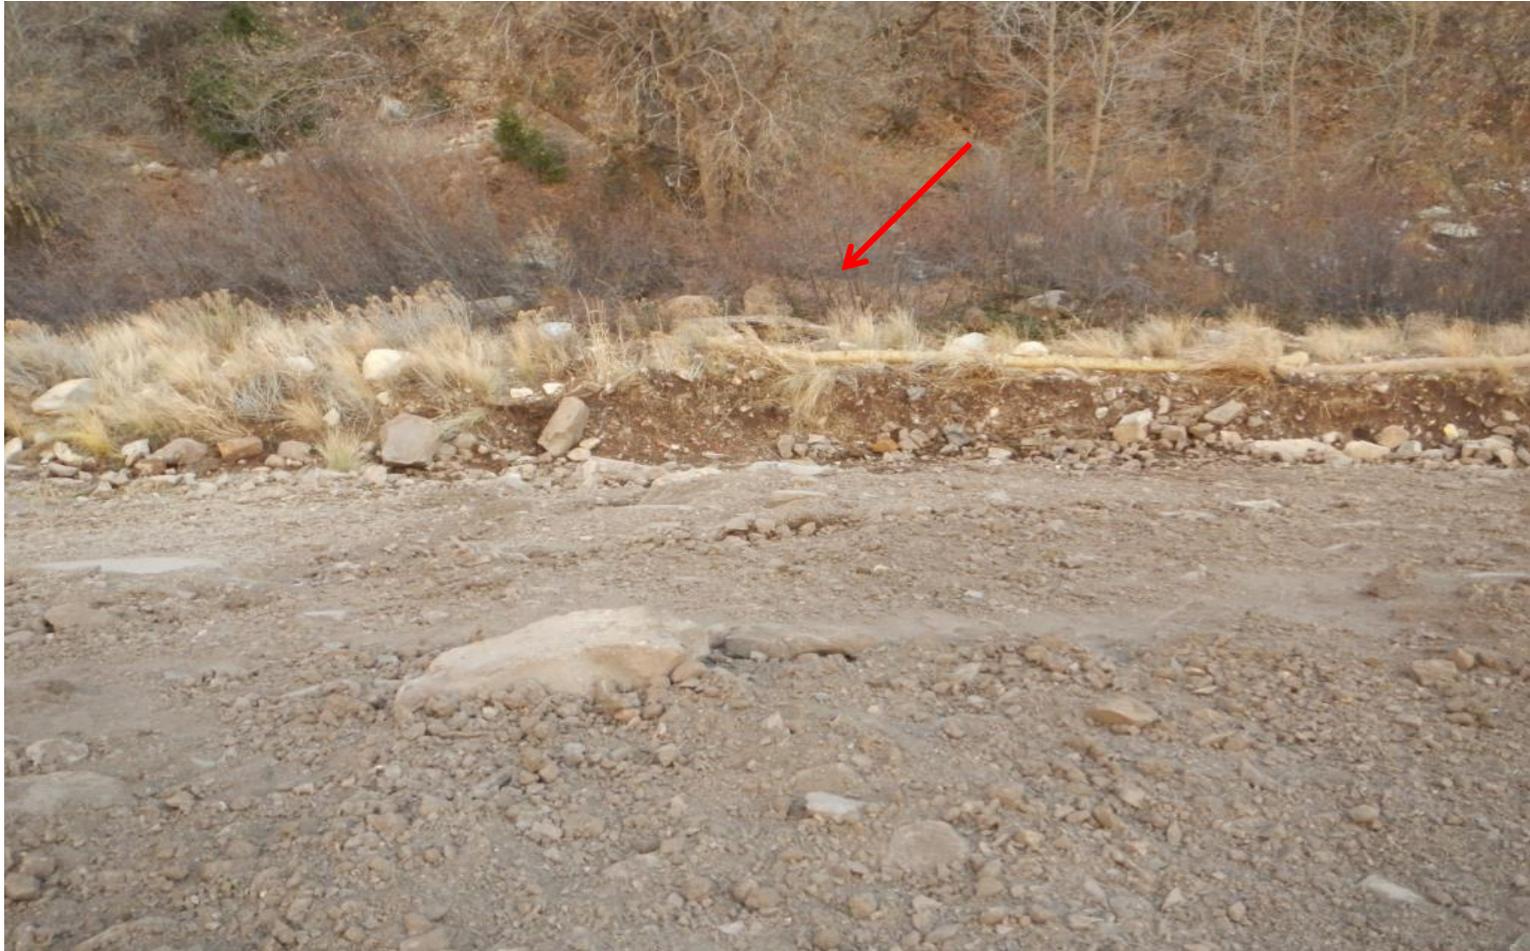
Photo#4:

View down Fill Slope to BMPs installed at base and Creek identified with arrow in background.

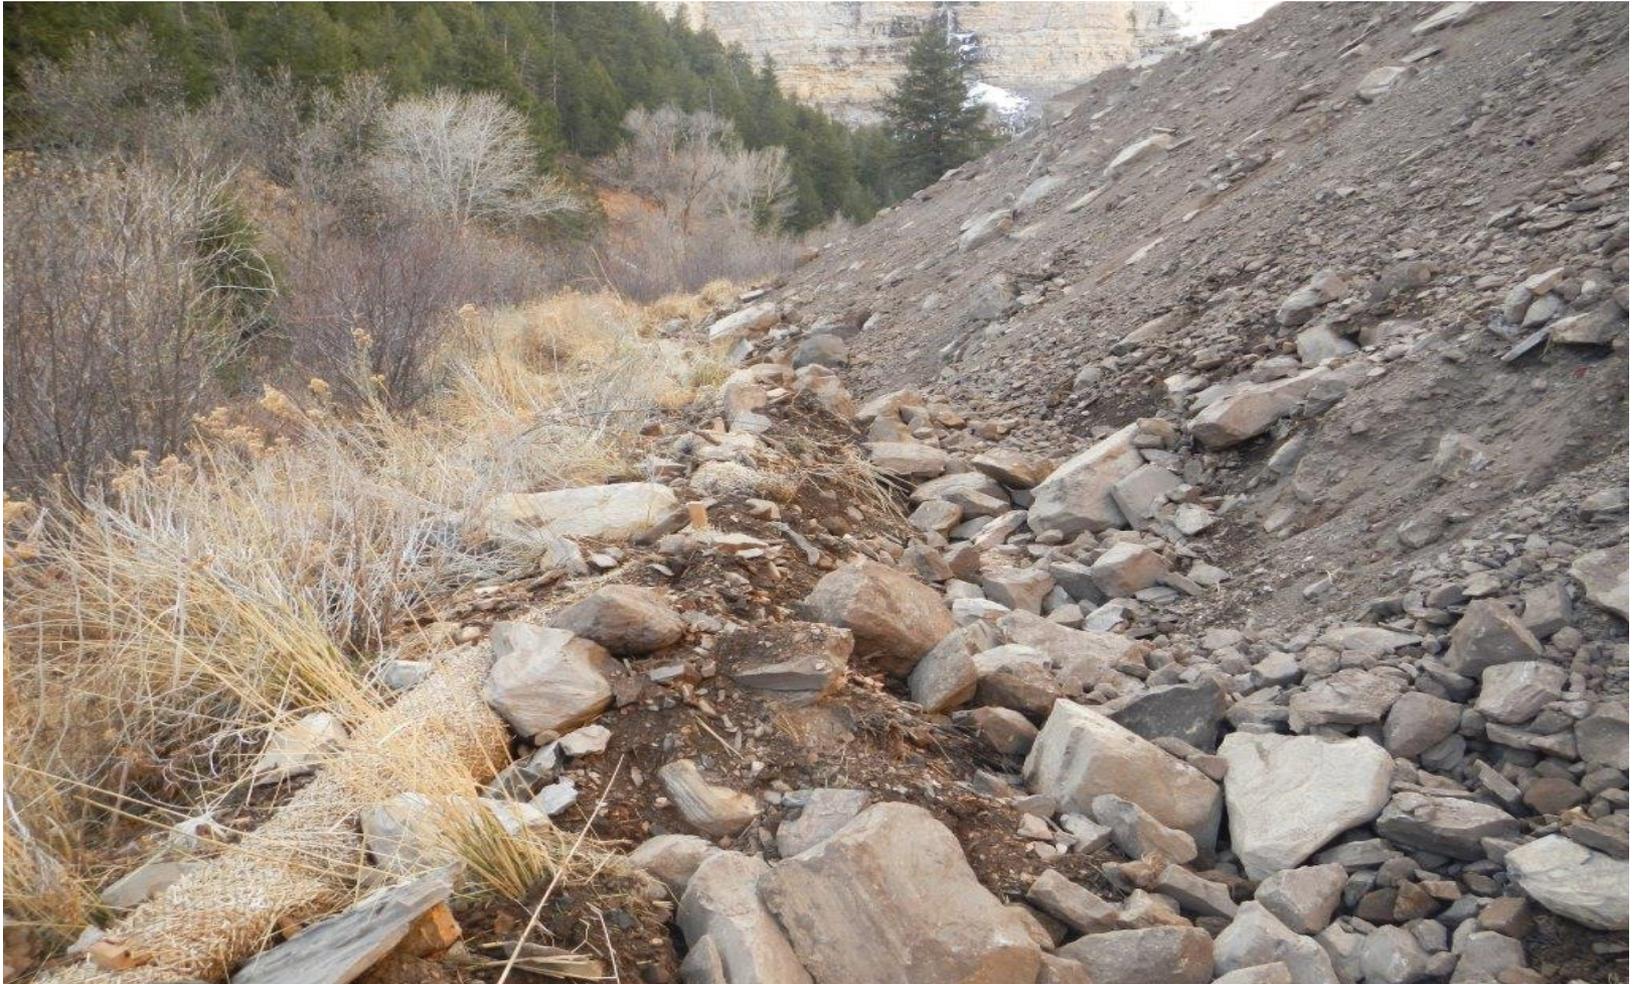
Photo#5:

View along Perimeter Ditch, showing migrating material filling in Ditch & overwhelming Wattles.

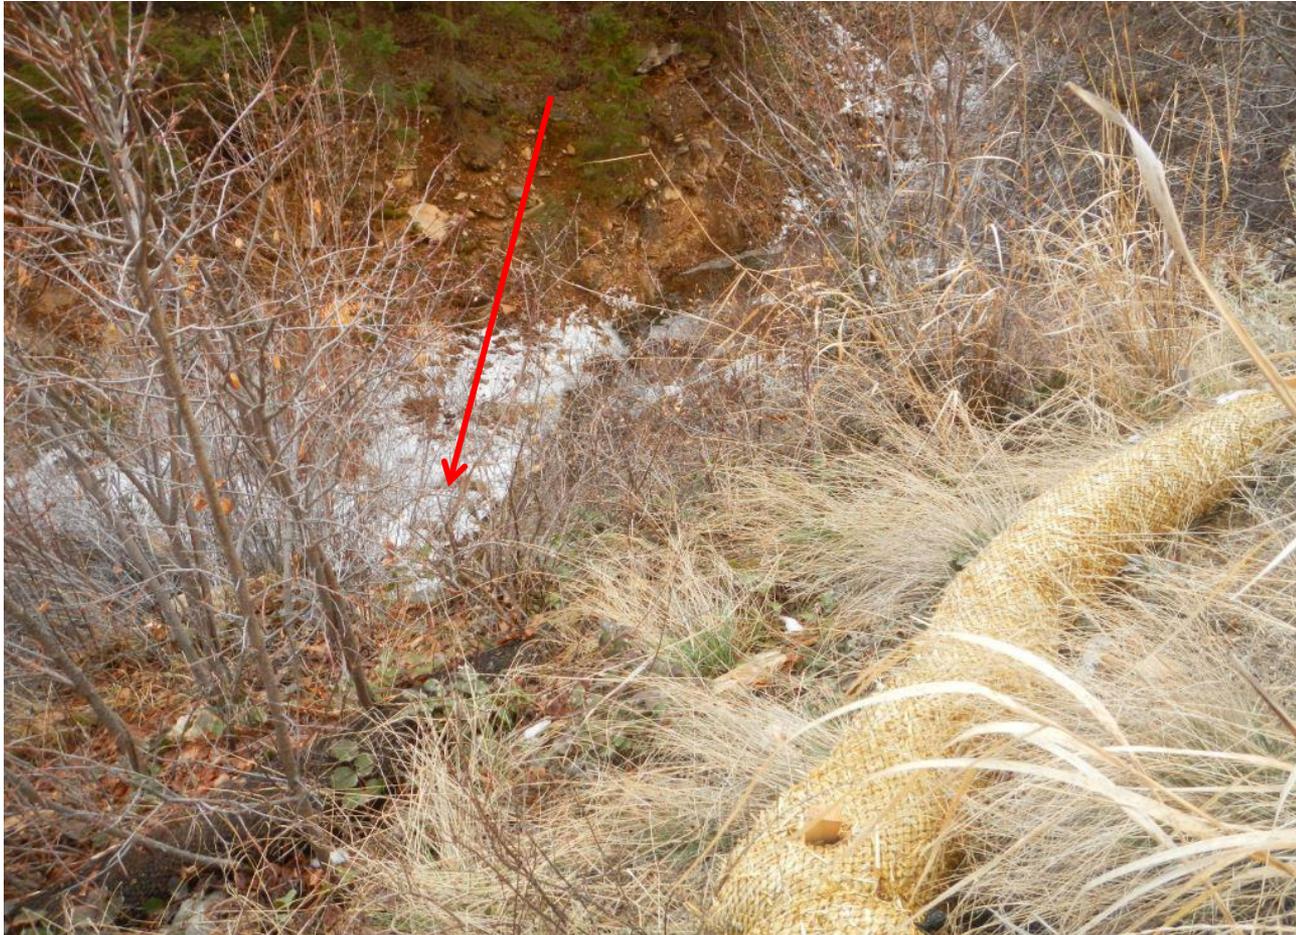
Photo#6:

View of BMPs installed at limits of Disturbance & immediate proximity of Creek, indicated by arrow

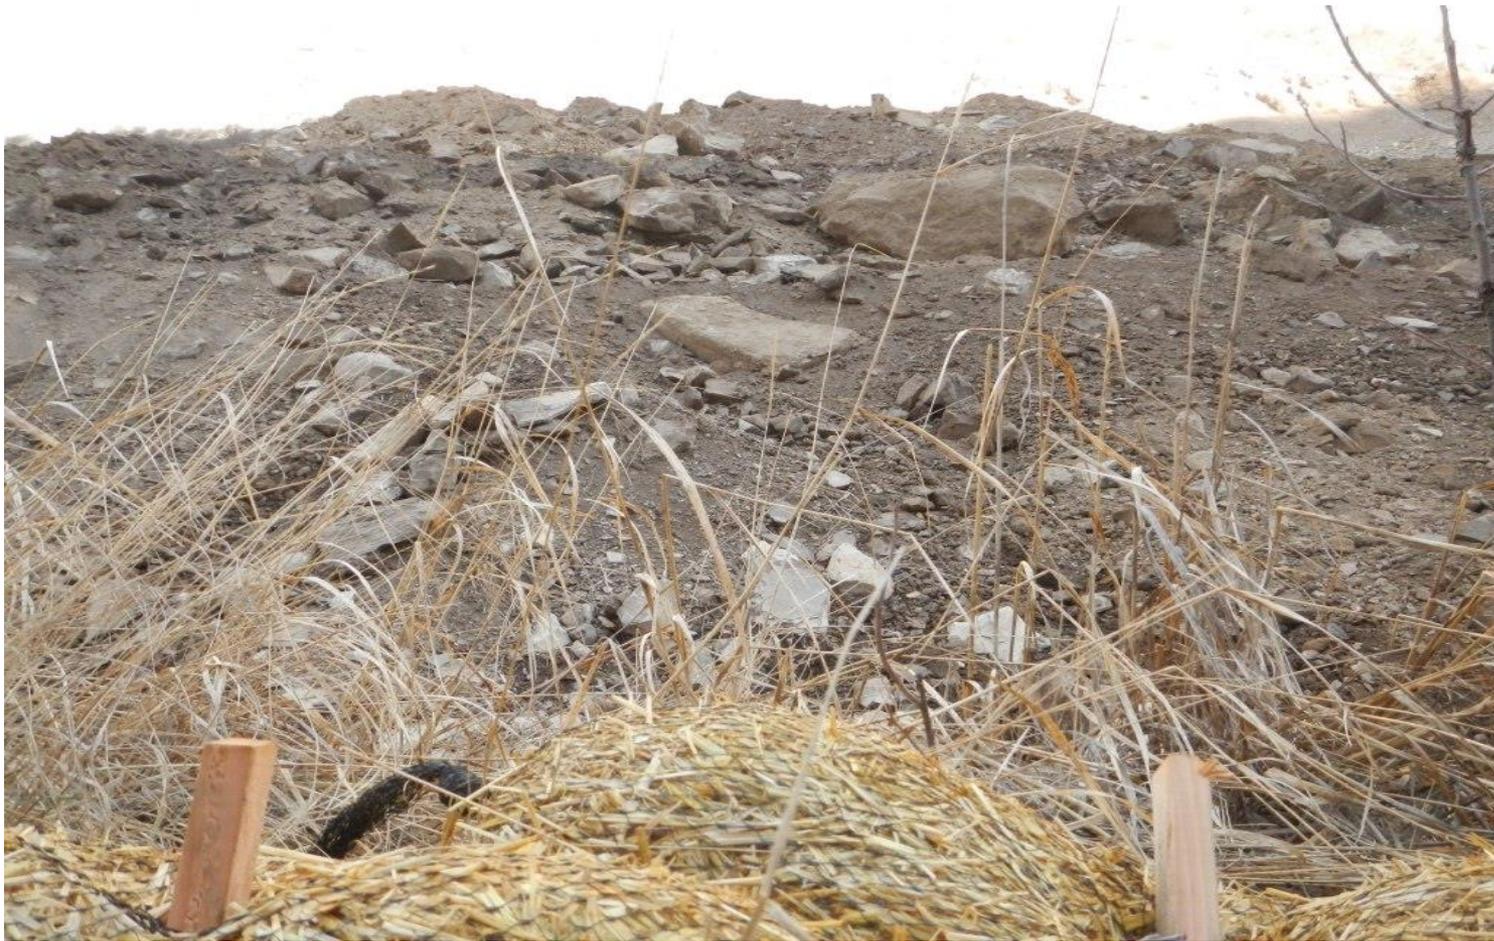
Photo#7:

View from Wattles to top of Fill Slope; Work area is very tight between the toe of the Fill Slope, Limits of Disturbance & the Creek

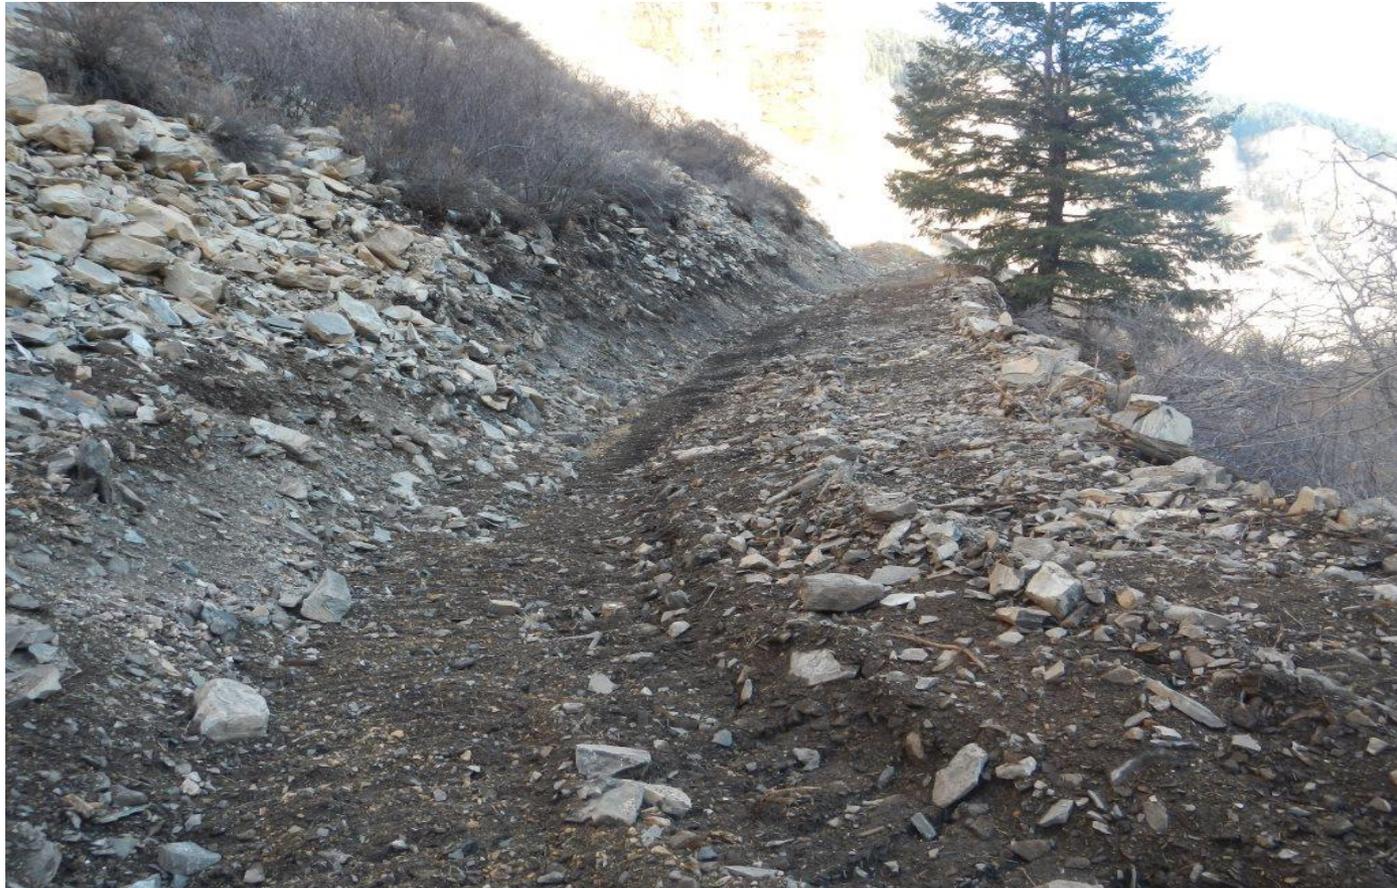
Photo#8:

Bench area installed along mid Cut Slope.
