Interim Reclamation and Stormwater Inspection

November 22, 2017

Operator: CONFLUENCE DJ LLC- #10518

Location ID: 452048

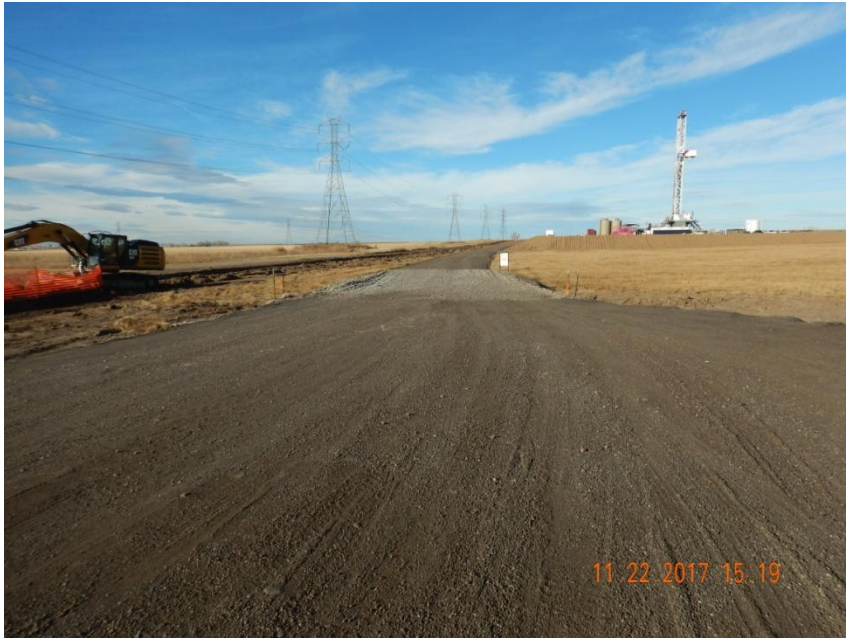
Photo 1. Photo taken from the entrance of the location, facing North. Tracking pad devices installed at the entrance off County Road 2.

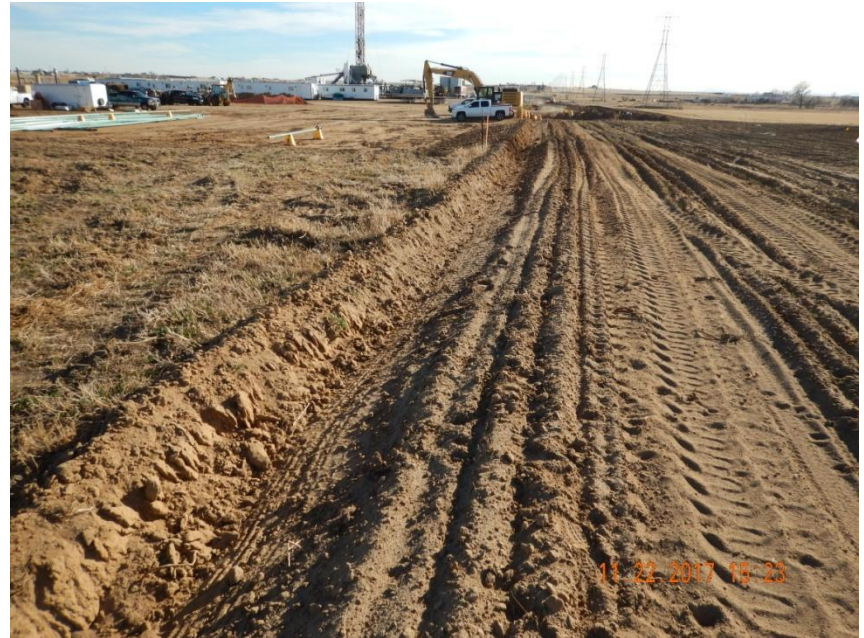
Photo 2. Photo taken from the northwest location, facing South. Ditch and berm BMP installed around the perimeter of the location. Appears portions of the berm have been tracked with equipment for temporary stabilization but portions have been left unconsolidated.

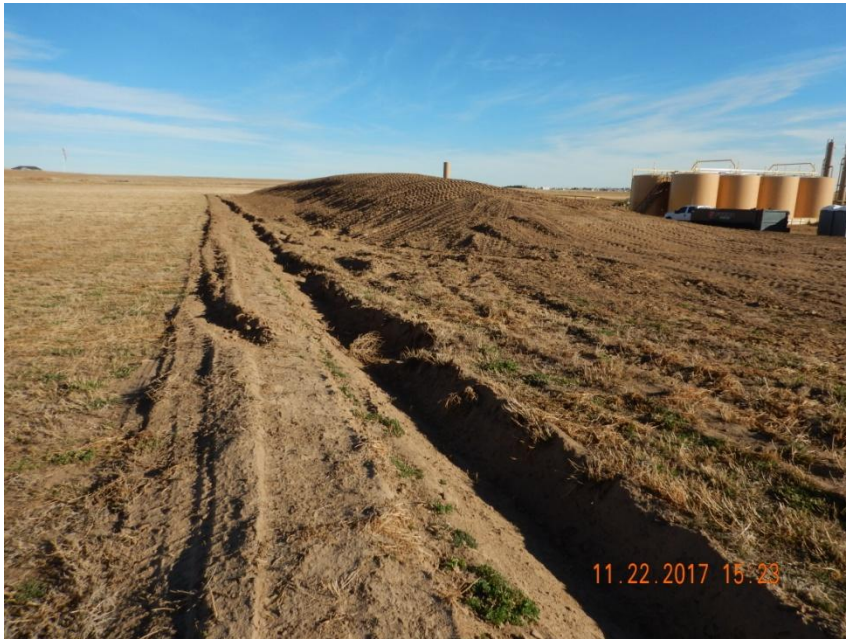
Photo 3. Photo taken from the northwest location, facing East. See comments under Photo 2.

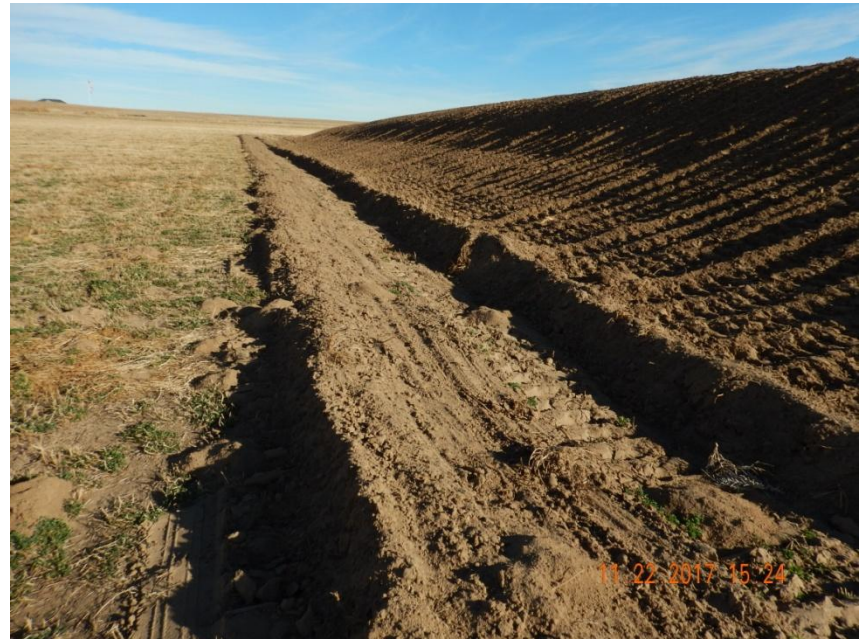
Photo 4. Photo taken from the northern location, facing East. Appears topsoil has been salvaged and stored along the northern perimeter. Topsoil has been temporarily stabilized by equipment tracking. See comments under Photo 2.

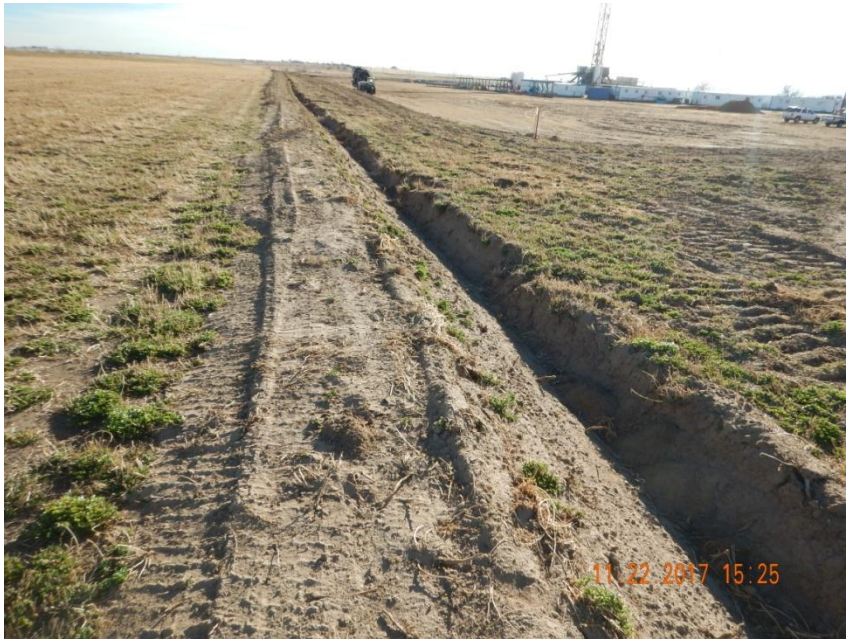
Photo 5. Photo taken from the northeast location, facing South. See comments under Photo 2.

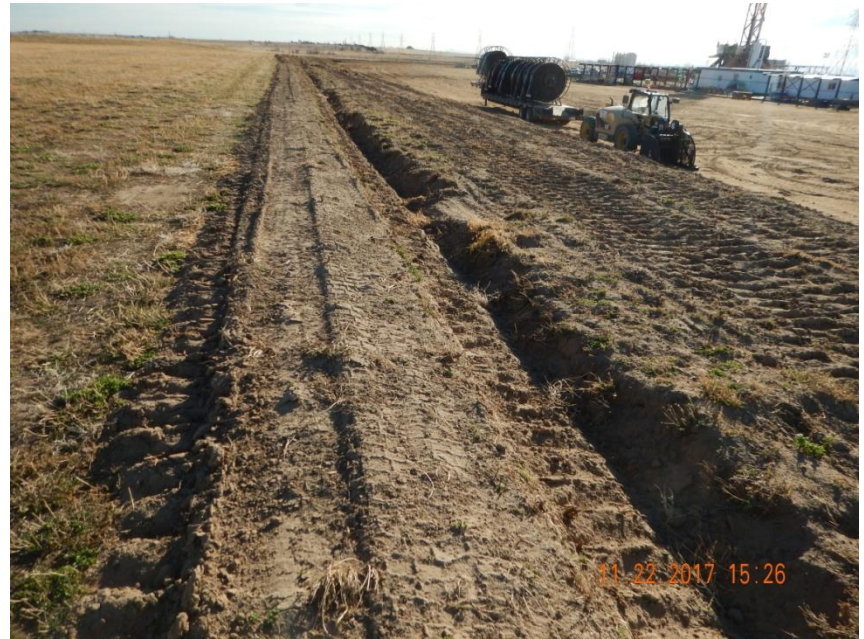
Photo 6. Photo taken from the eastern location, facing South. See comments under Photo 2.

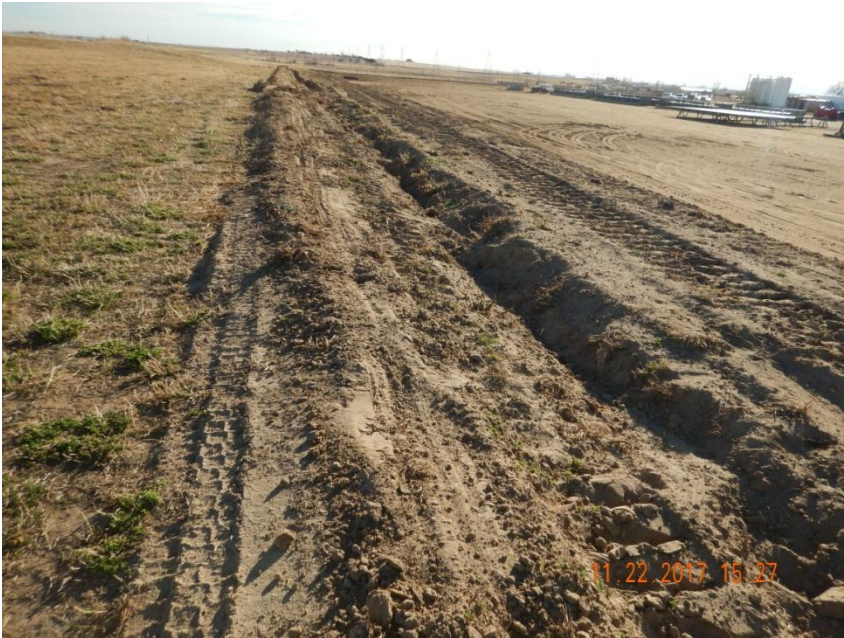
Photo 7. Photo taken from the southeastern location, facing South. Berm BMP has not been properly stabilized and has been left unconsolidated.

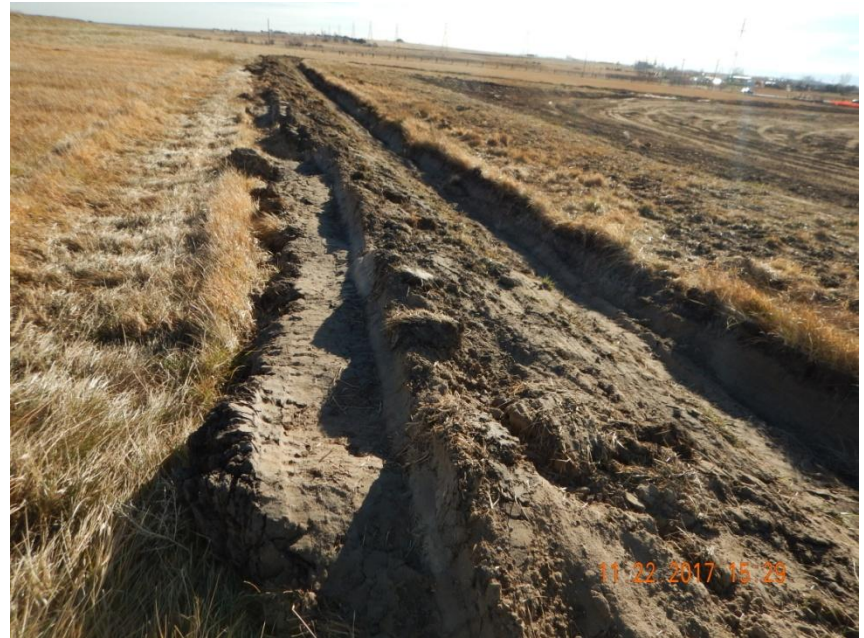
Photo 8. Photo taken from the southeastern location, facing South. See comments under Photo 7.

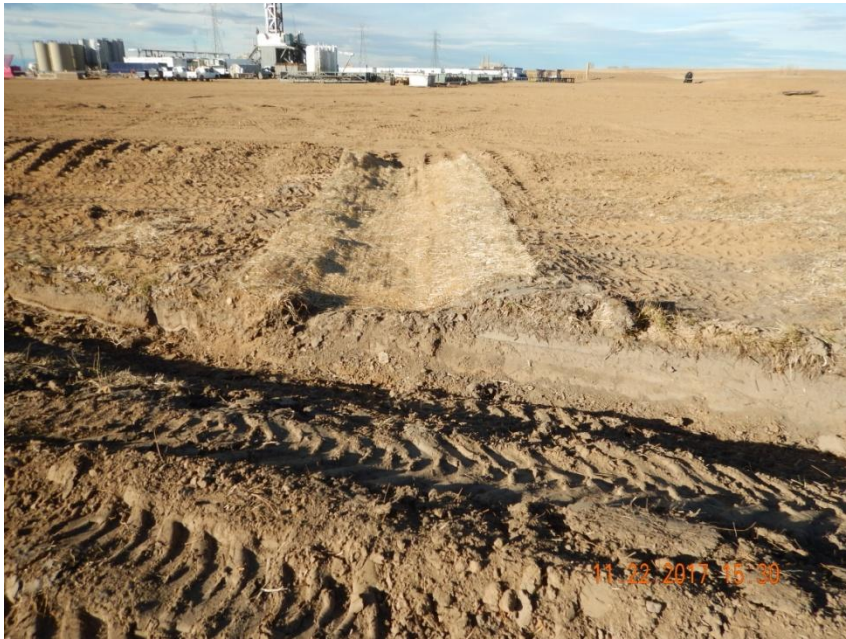
Photo 9. Photo taken from the southern location, facing North. Operator has installed a stabilized outlet which is directed to the perimeter berm and ditch BMP.

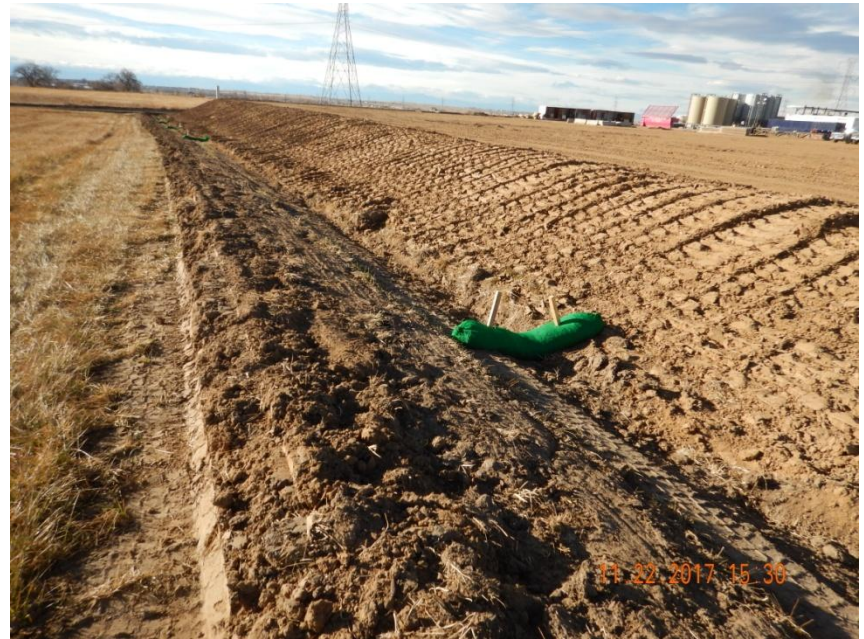
Photo 10. Photo taken from the southern location, facing West. See comments under Photo 2. Check dam BMPs have been installed along portions of the southern ditch and berm BMP.

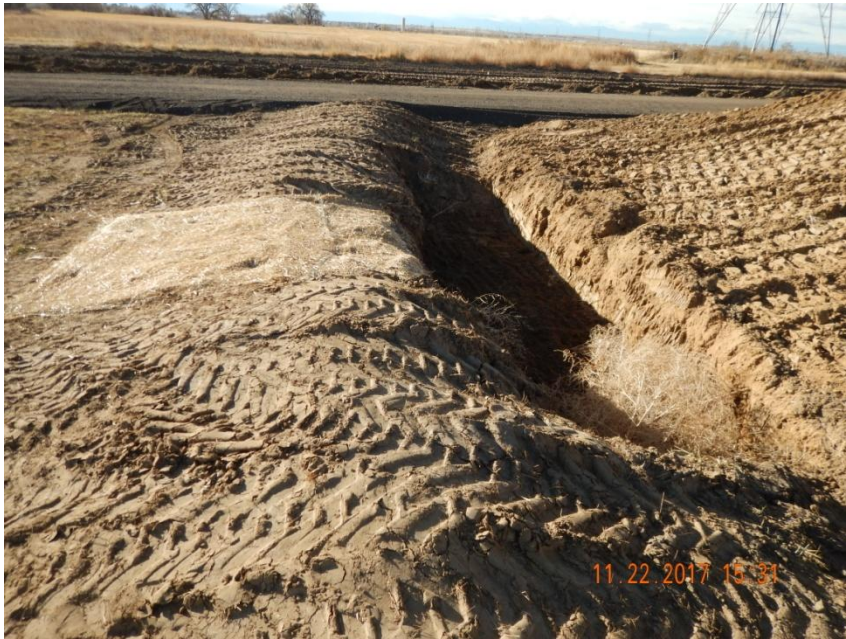
Photo 11. Photo taken from the southwest location, facing West. Sediment trap has been installed with a stabilized outlet; however, the sediment trap does not appear to be properly sized for 17 acres of disturbance.

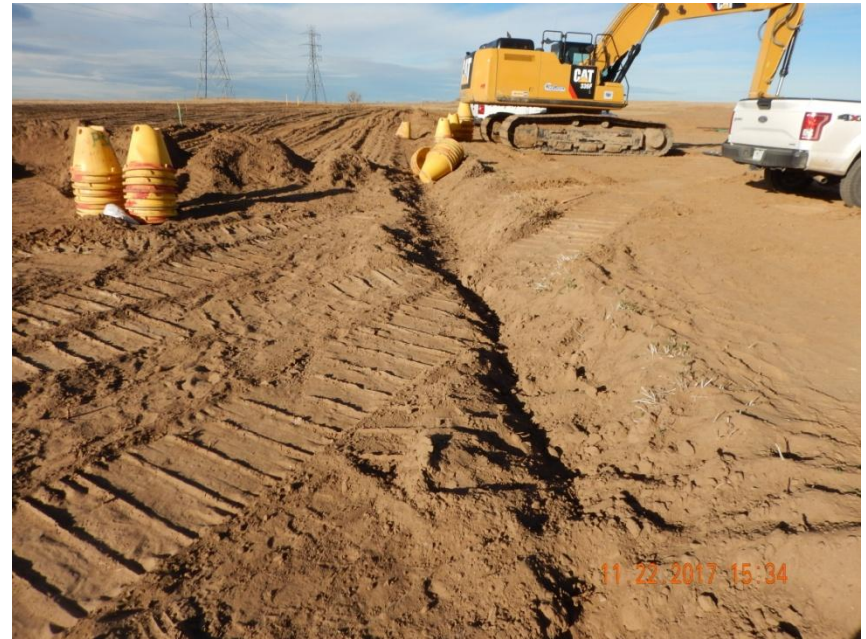
Photo 12. Photo taken from the northwestern location, facing North. Appears disturbances from pipeline construction have damaged the ditch and berm BMP. BMP maintenance is required.
