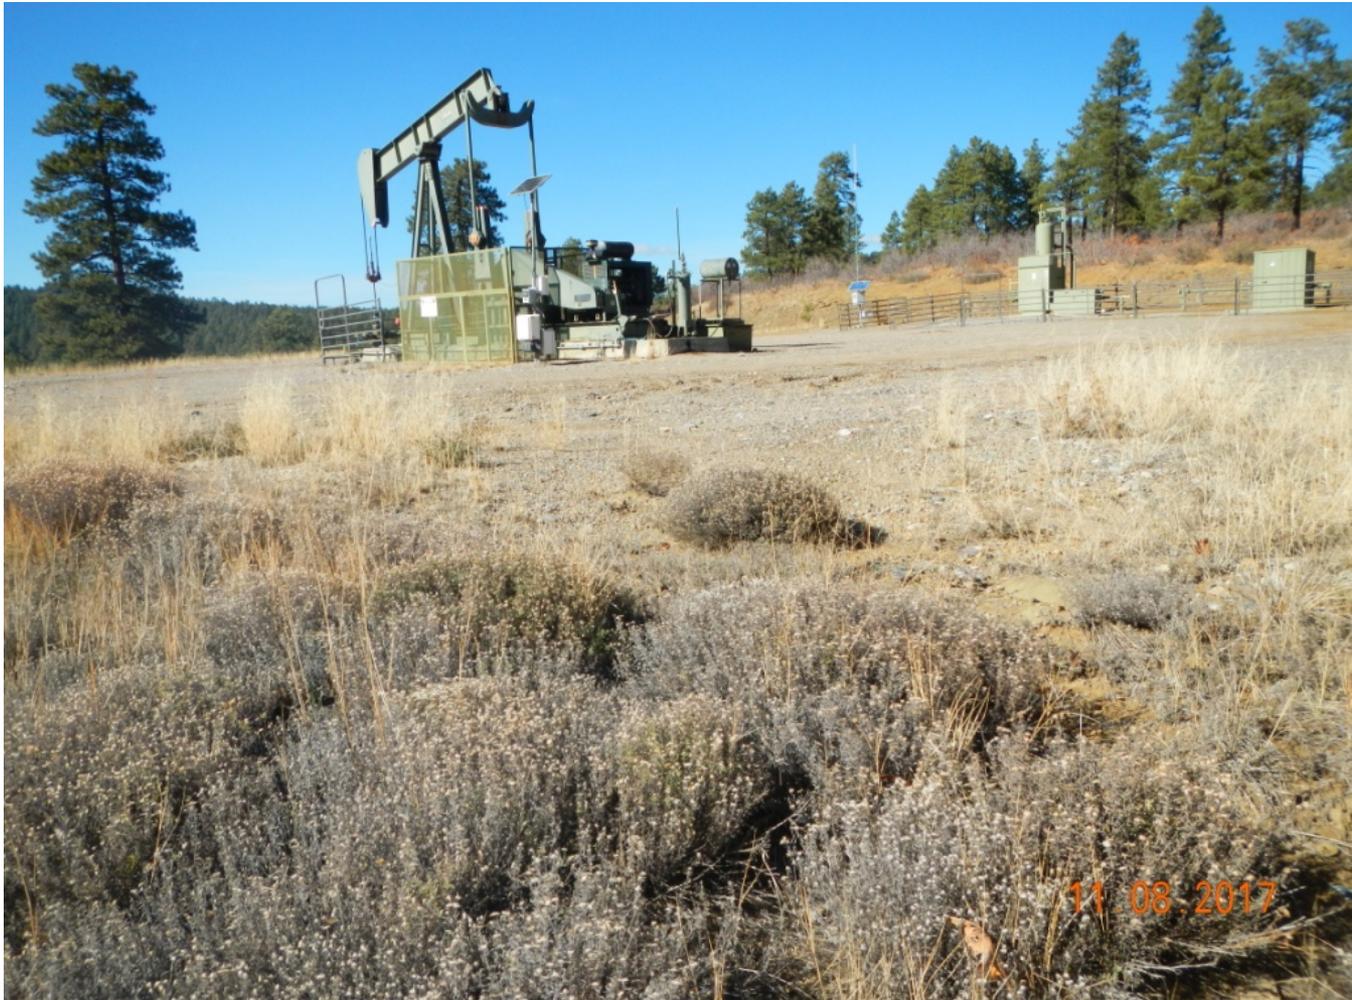
**Photo 1. View from the southeastern edge of the project area facing center.**

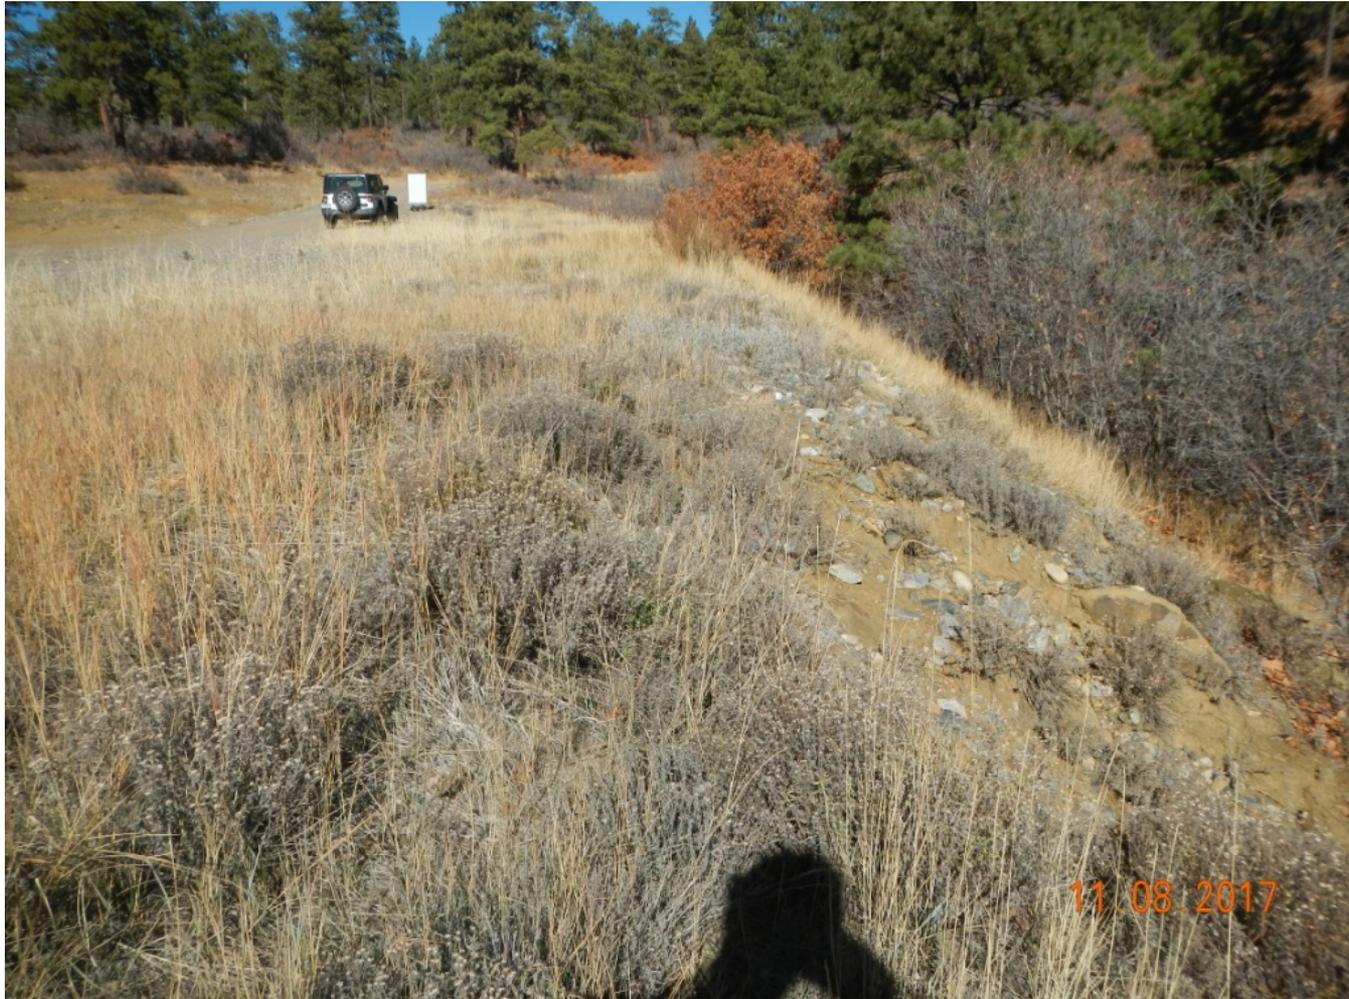
**Photo 2. View of the eastern fill slope from the southeastern edge facing northward.**

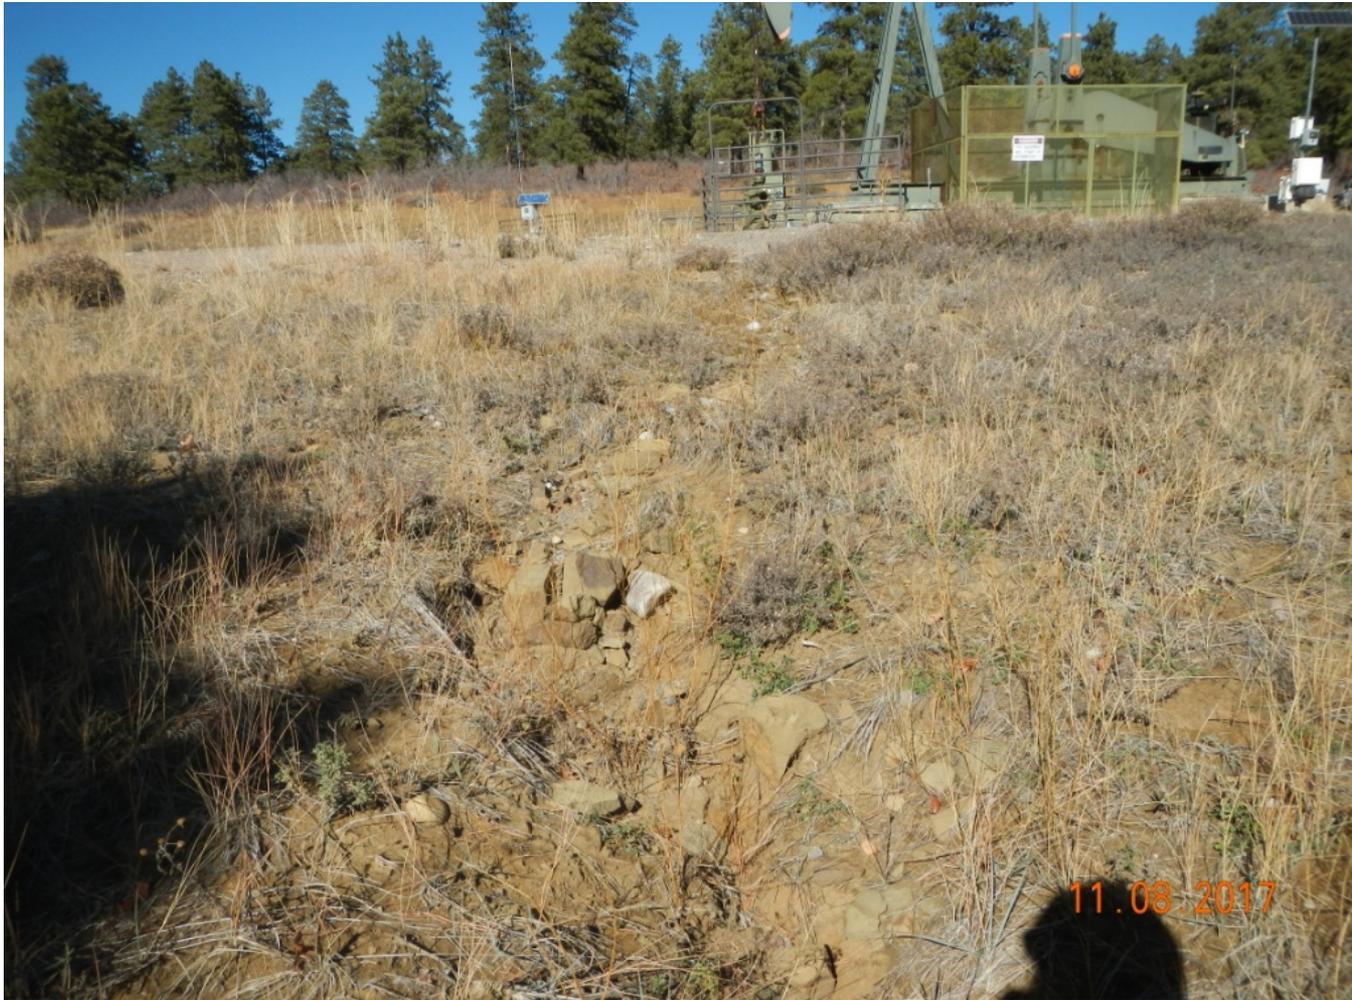
**Photo 3. View of area in the southern project area where concentrated stormwater from the well pad is causing erosion in the southern project area.**

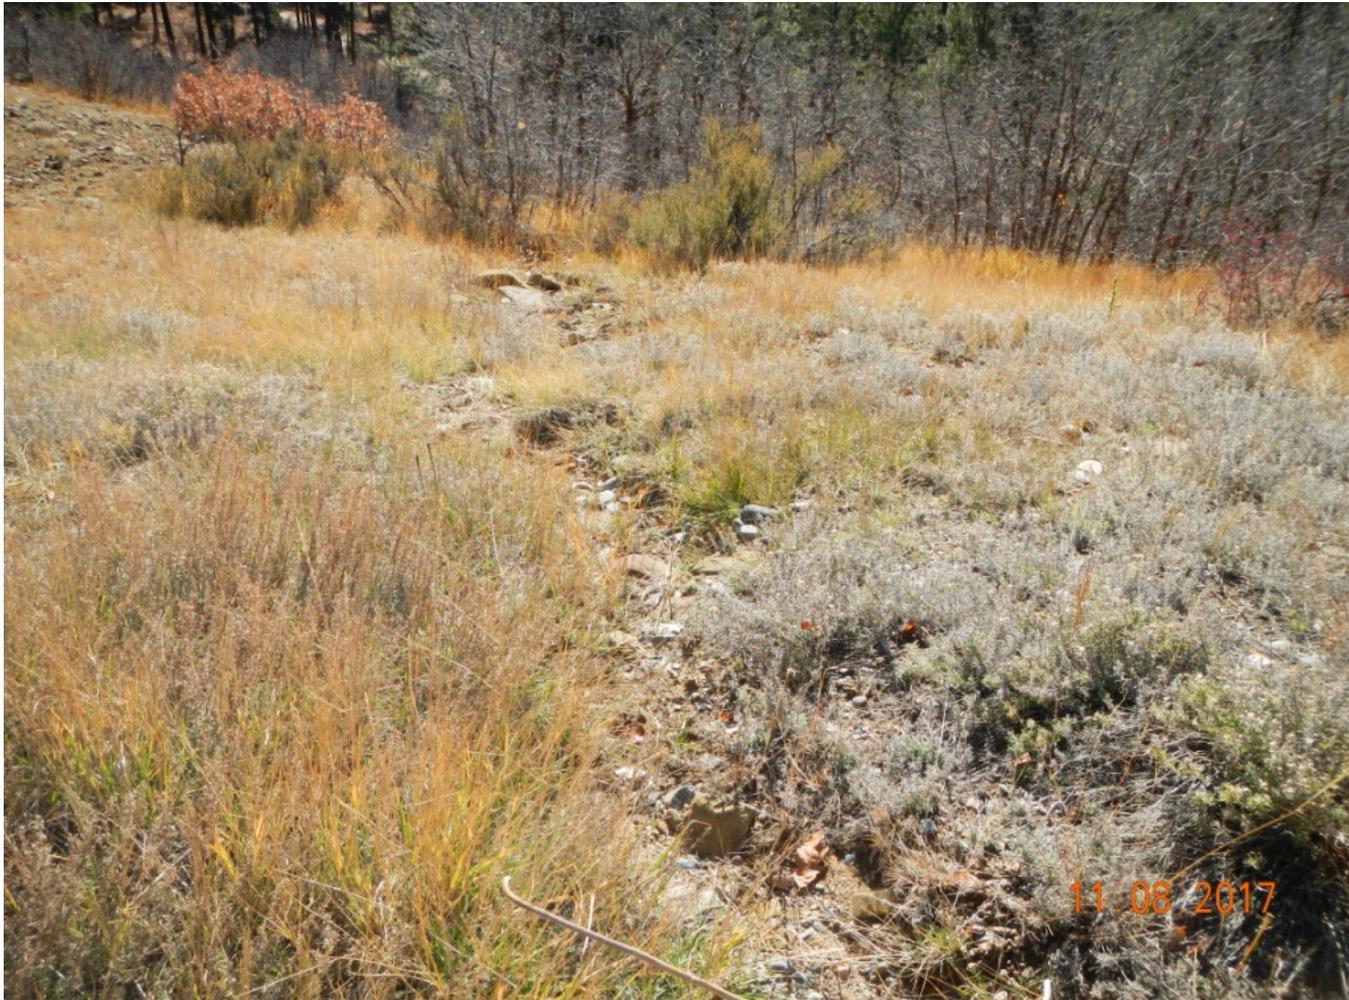
**Photo 4. View of another area in the southern project area where concentrated flows from the well pad are eroding the southern reclamation areas.**

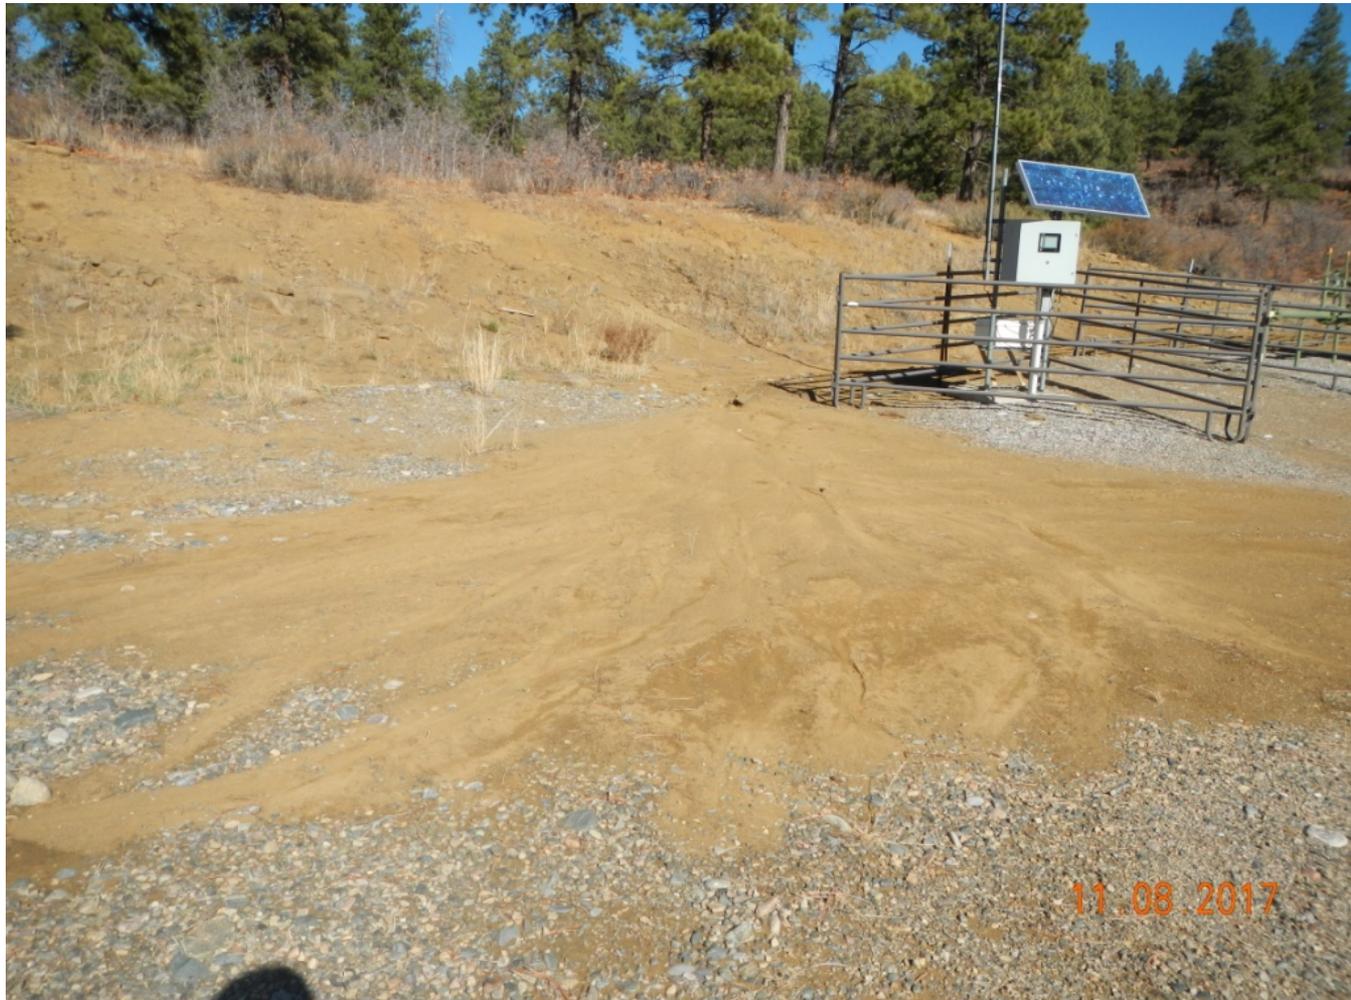
**Photo 5. View of sediment deposition on the well pad from the northern cut-slope.**

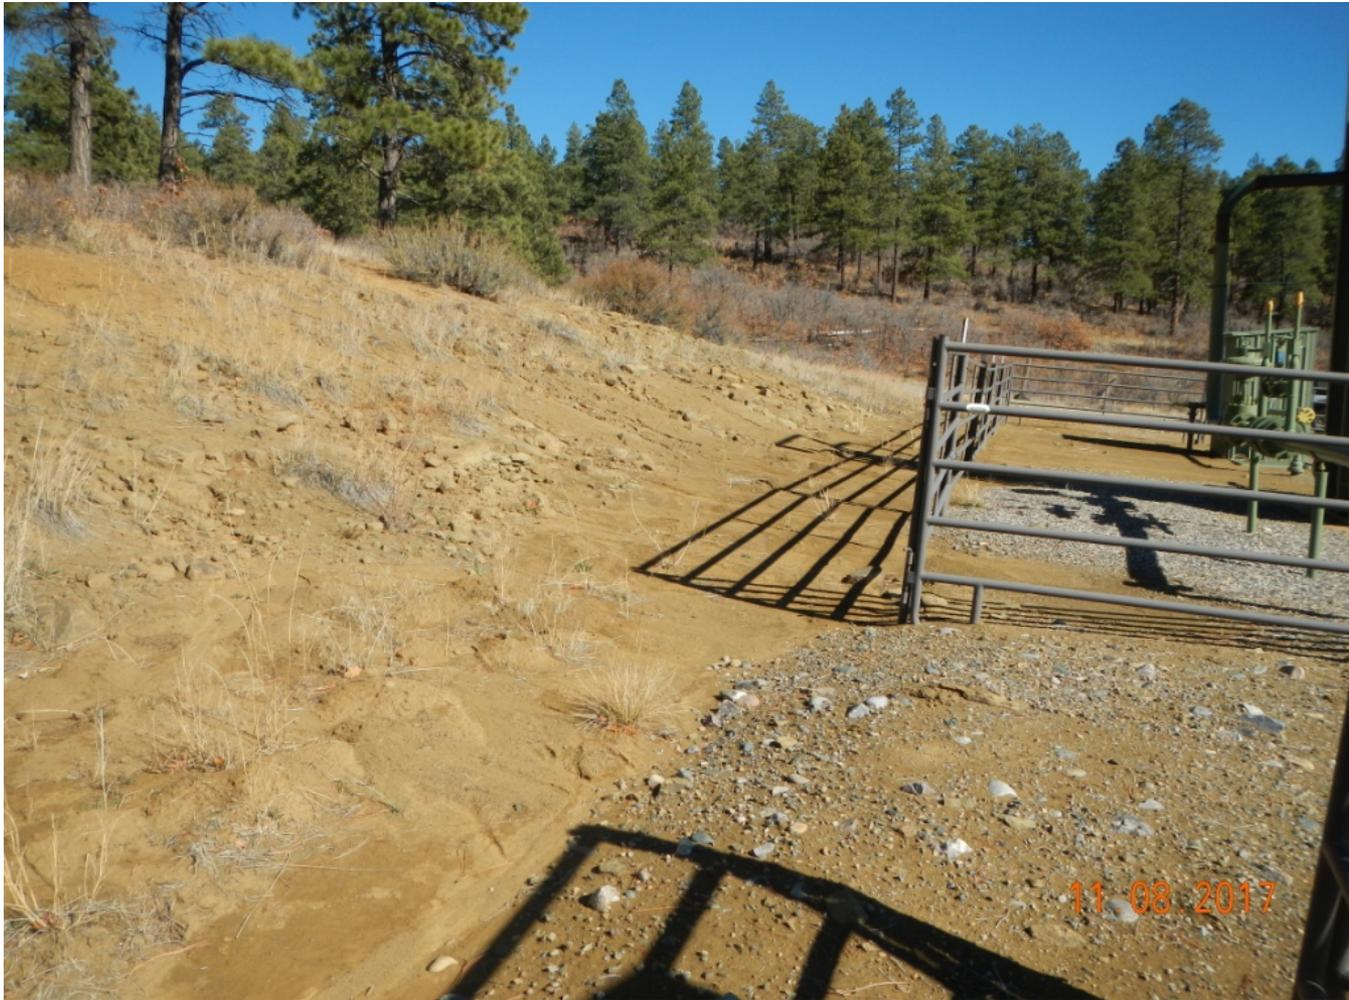
**Photo 6. View of erosion on the northern cut slope and sediment deposition on the well pad. Stormwater controls have not been installed.**
