- Clark WDW (EPA) 4 - 1
- 05-067-07831

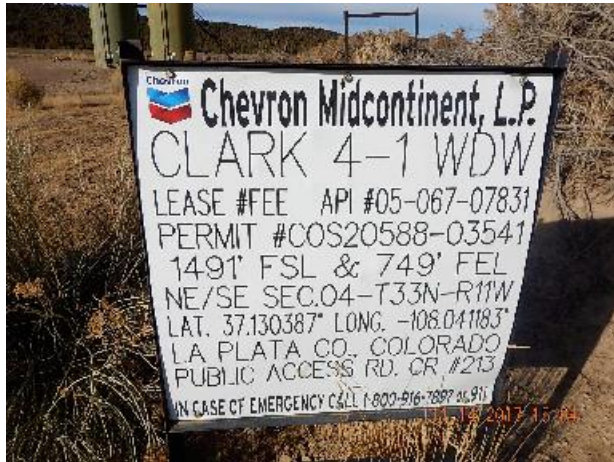
Photo 1: Wellhead sign.

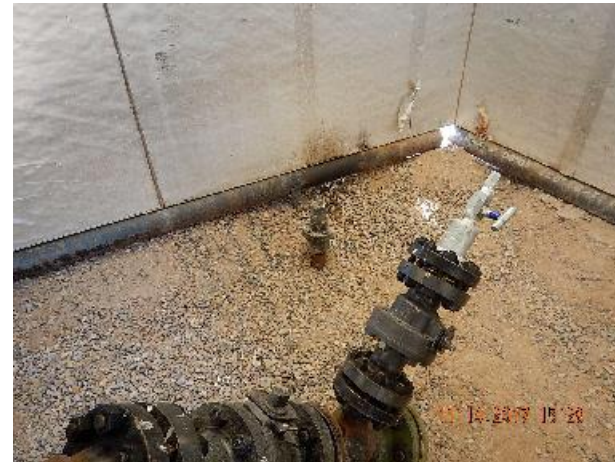
Photo 2: Riser at wellhead.

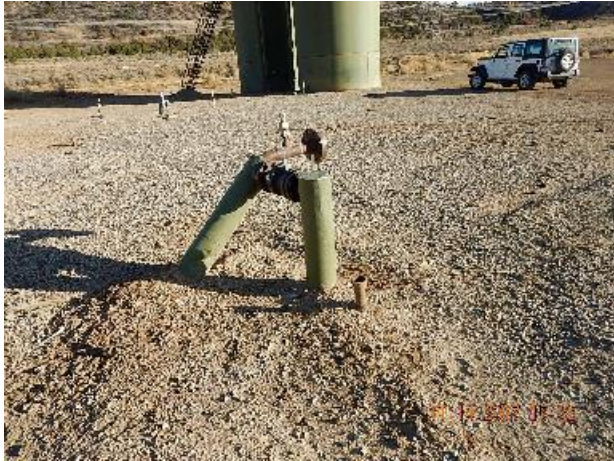
Photo 3: Open ended riser with risers in back ground.

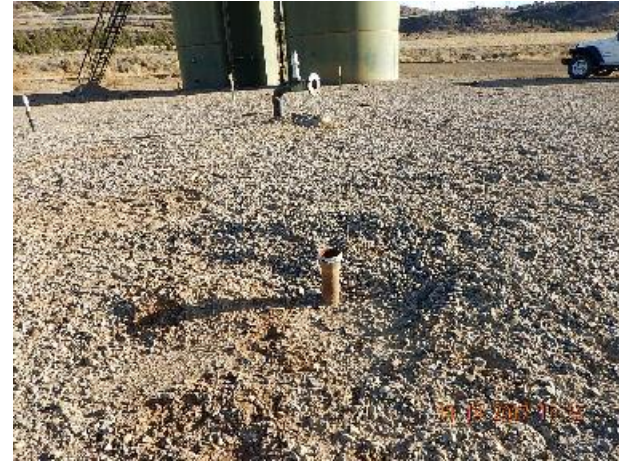
Photo 4: Open ended riser with risers in the back ground.

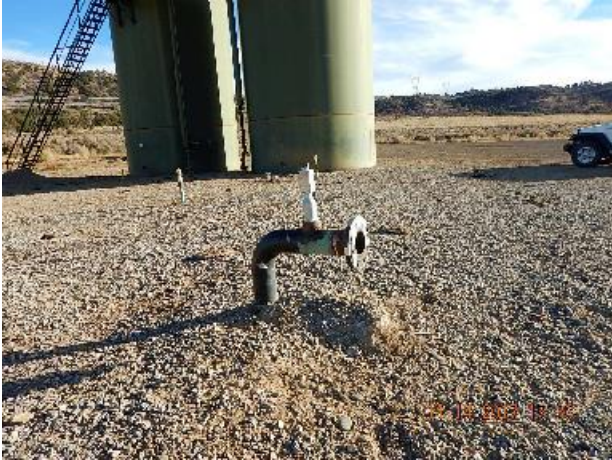
Photo 5: Open ended steel riser with risers in back ground.

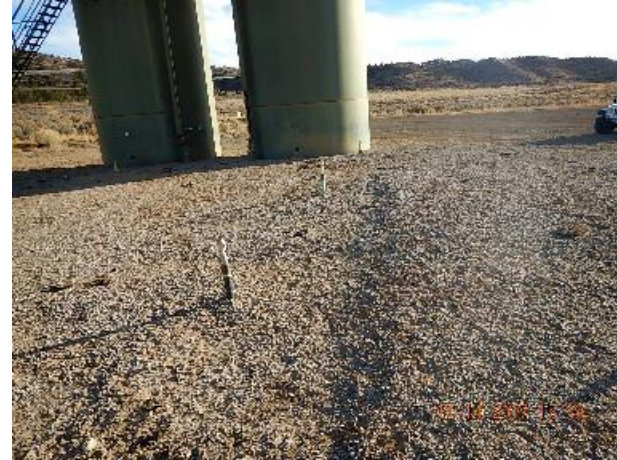
Photo 6: Steel risers behind tanks.

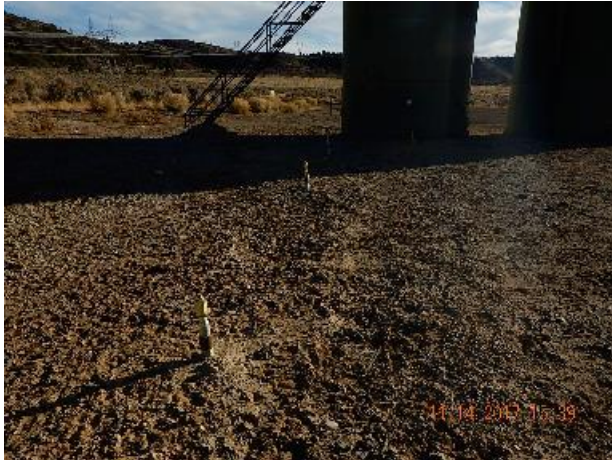
Photo 7: Steel risers backside of tanks.

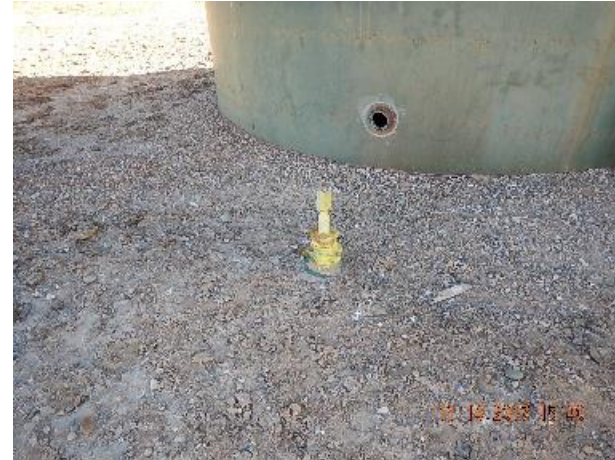
Photo 8: Steel riser at tank.

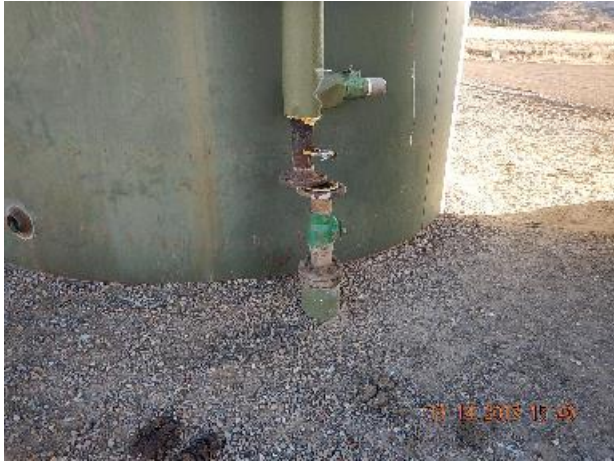
Photo 9: Tank disconnected from flowline.

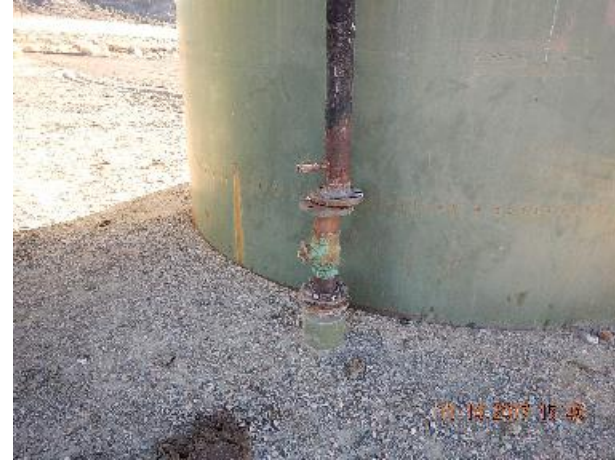
Photo 10: Tank disconnected from flowline.

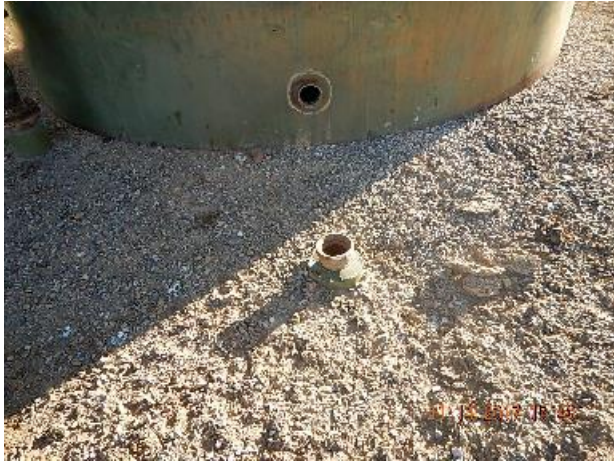
Photo11: Steel riser at tank.

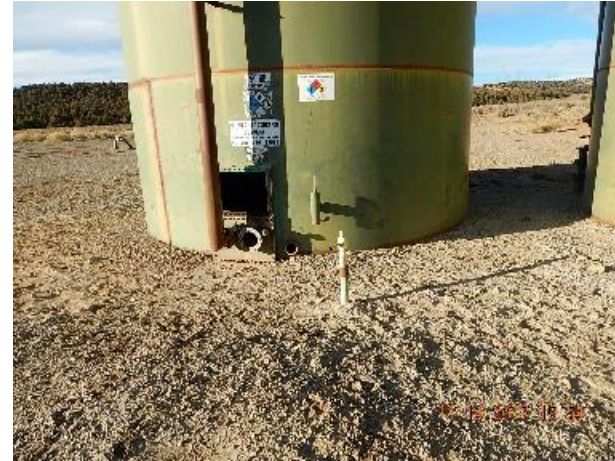
Photo 12: Steel riser at front of tank.

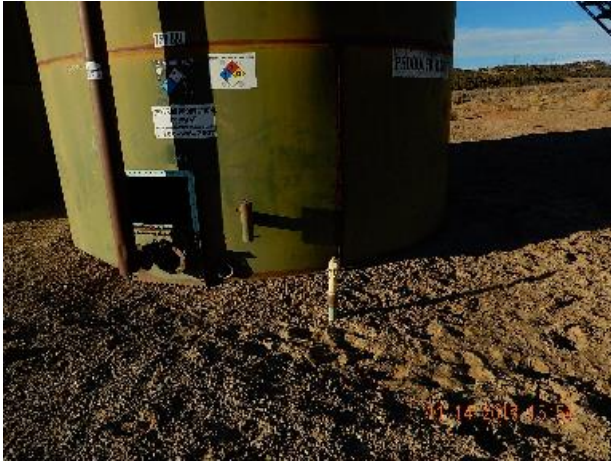
Photo 13: Steel riser at front of tank.

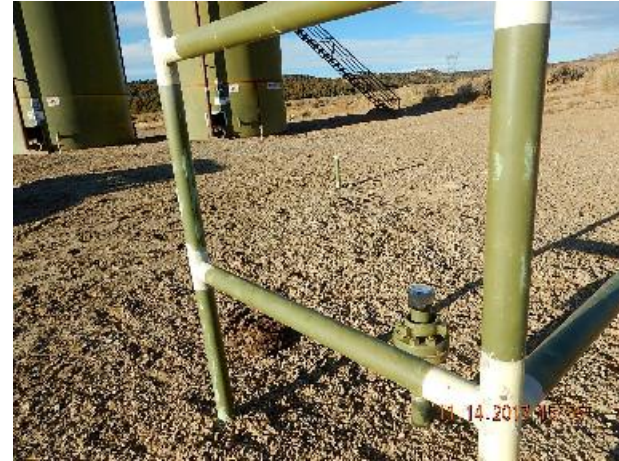
Photo 14: Steel risers of front of tank.

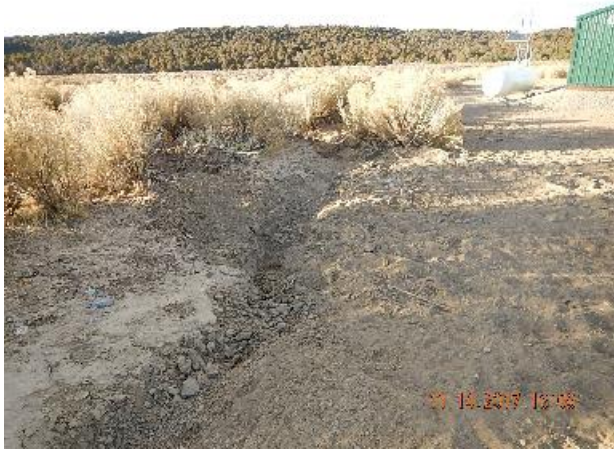
Photo 15: Erosion channel on W perimeter of location.

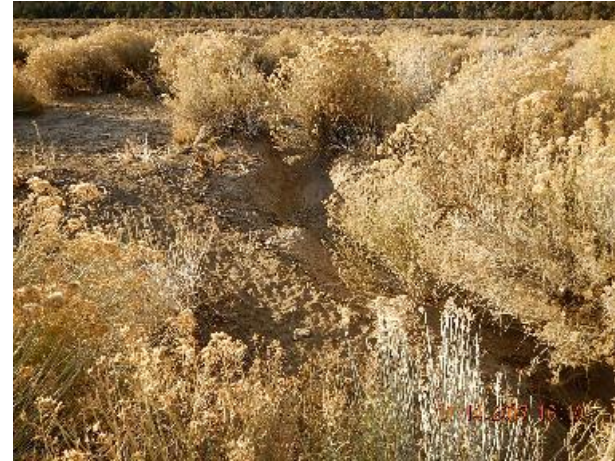
Photo 16: Erosion channel on W perimeter of location into sage brush.

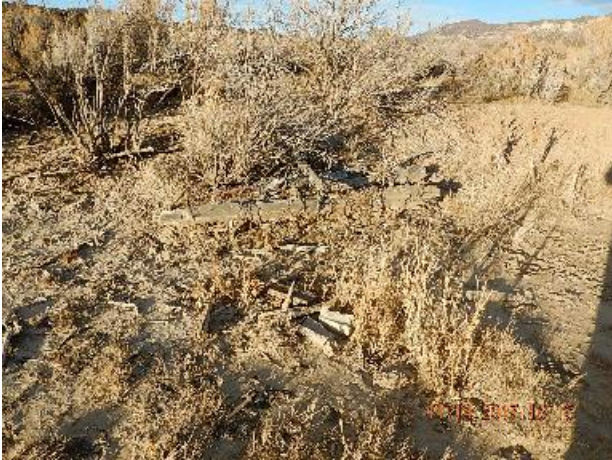
Photo 17: Old wire fencing rolled and on N perimeter of location.

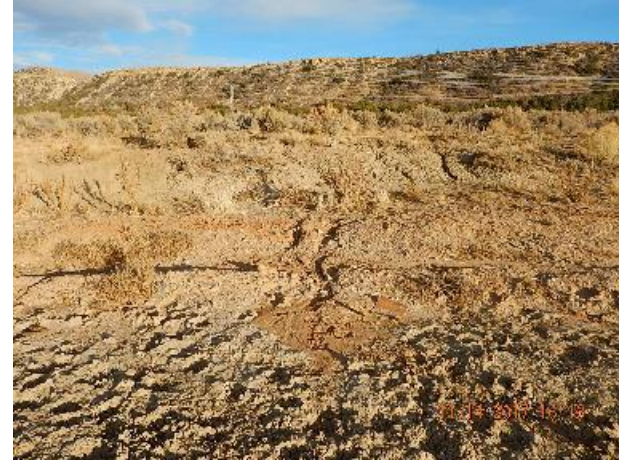
Photo 18: Erosion channels on E perimeter where storm water is flowing onto location and pooling in old tank containment area..
