Inspection Photos

Location Name: Phillips 23-42

API #: 05-123-19268

Location ID: 330547

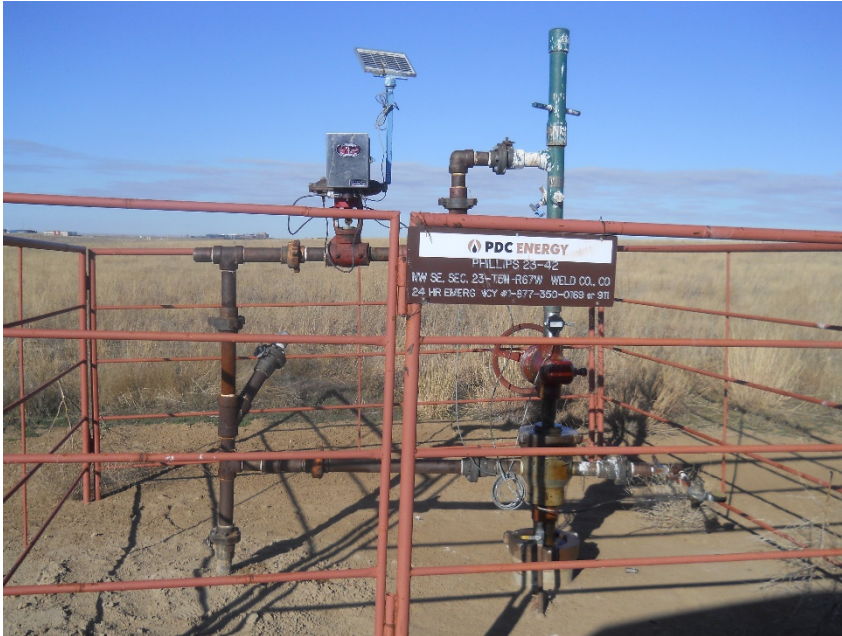
Wellhead looking north

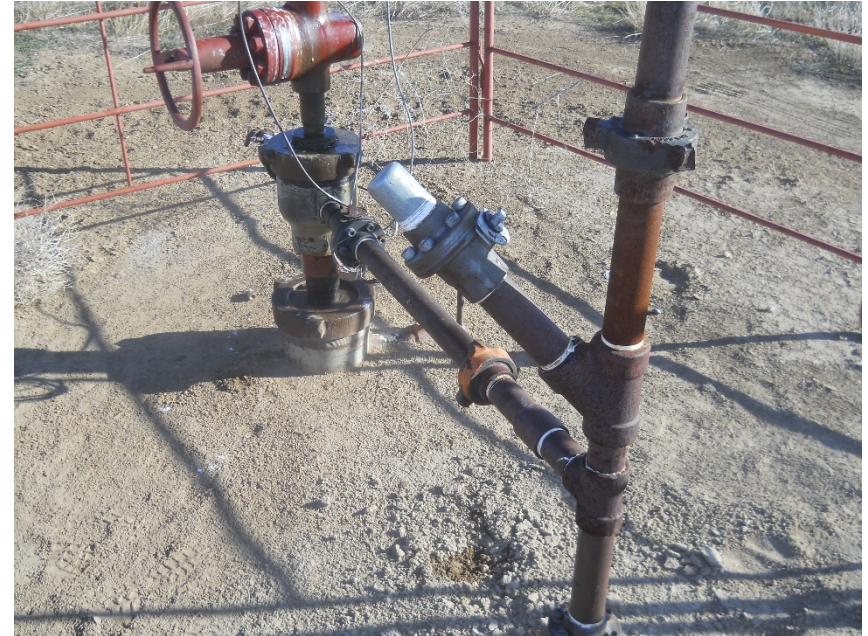
Stained soil under hammer union where casing ties into flowline. Wellhead packing is leaking. Change over above master valve is leaking.
