# Construction and Stormwater Inspection

November 22, 2017

Operator: GREAT WESTERN OPERATING COMPANY LLC- #10110

Location Name: B-Farm LD Pad

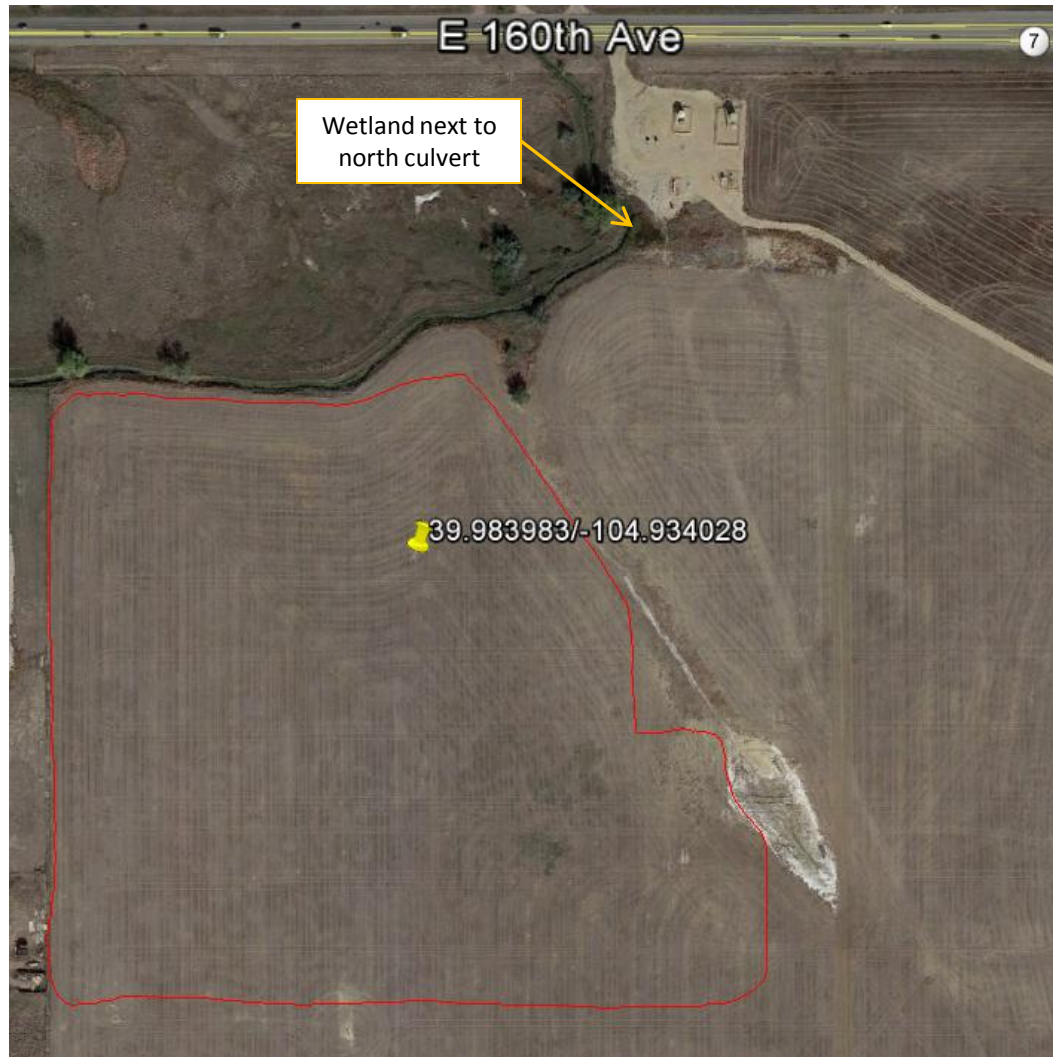
**Photo 1.** Google Earth imagery taken on October 9, 2015 illustrating the location that was mapped on November 22, 2017 using a Trimble Juno 3B handheld device that indicated a total disturbance of 22.33 acres (red line). Appears construction disturbance was exceeded by approximately 8.34 acres.

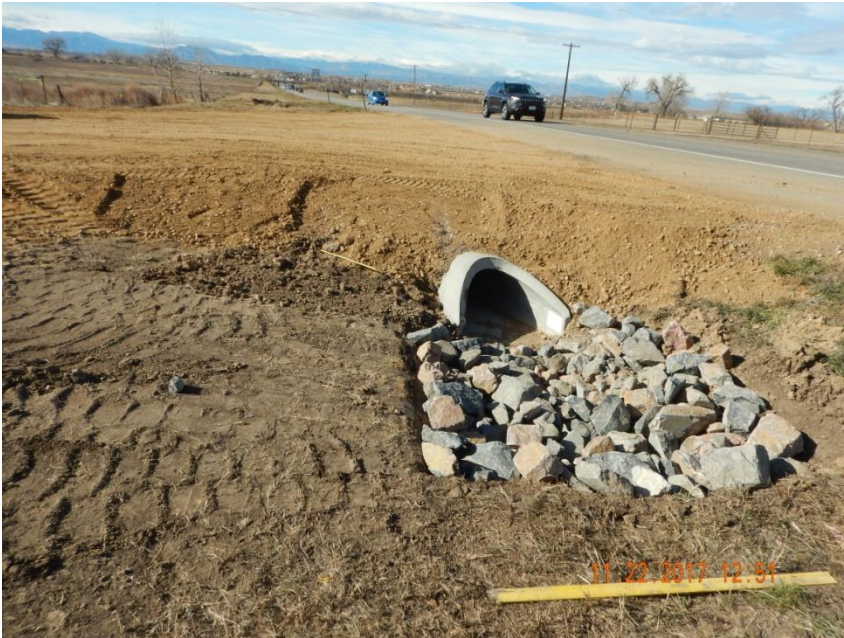
**Photo 3.** Photo taken from the entrance of the location off East 160<sup>th</sup> Ave., facing West. Operator installed culvert along roadside ditch with both inlet and outlet protection.

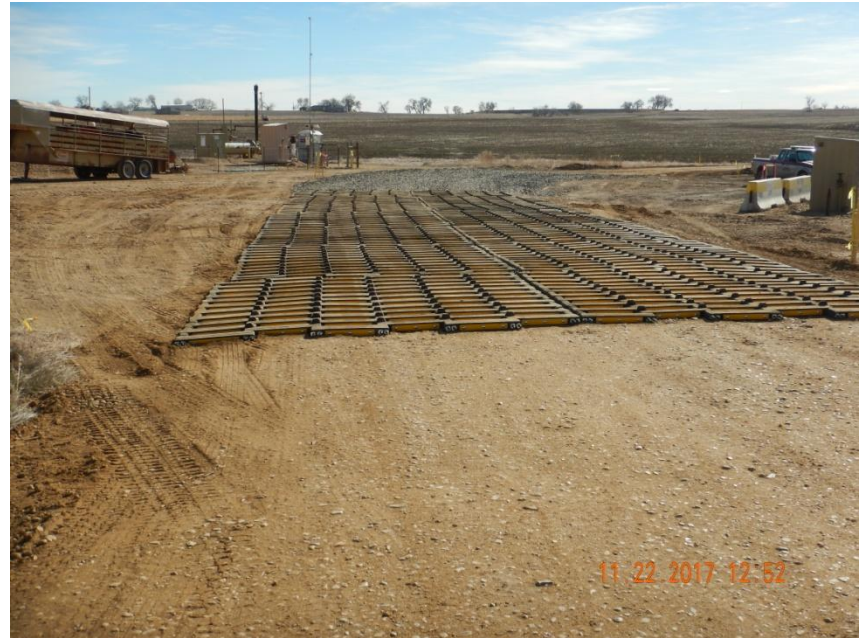
**Photo 4.** Photo taken from the entrance of the location off East 160<sup>th</sup> Ave., facing South. Operator installed vehicle tracking devices.

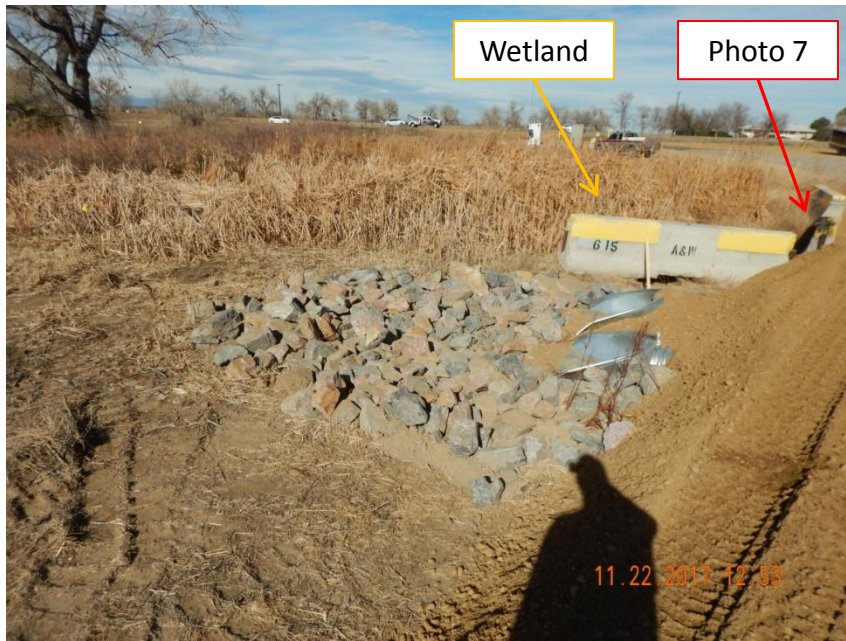
**Photo 5.** Photo taken from the north culvert along the west-side of the access road, facing North. Operator installed an outlet device (rip-rap). Operator needs additional BMPs to protect sediment discharge into the wetland along the western access road.

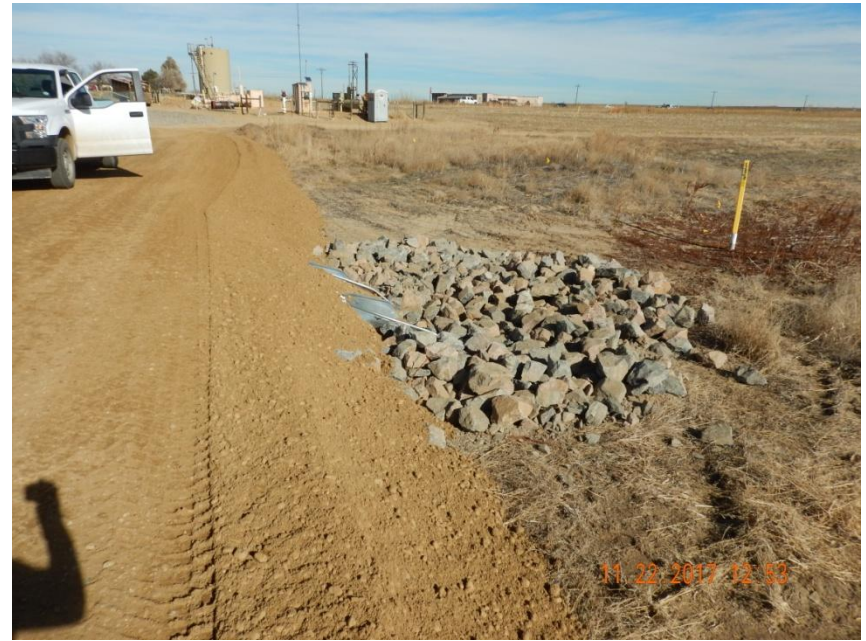
**Photo 6.** Photo taken from the north culvert along the east-side of the access road, facing North. Operator installed an inlet device (rip-rap).

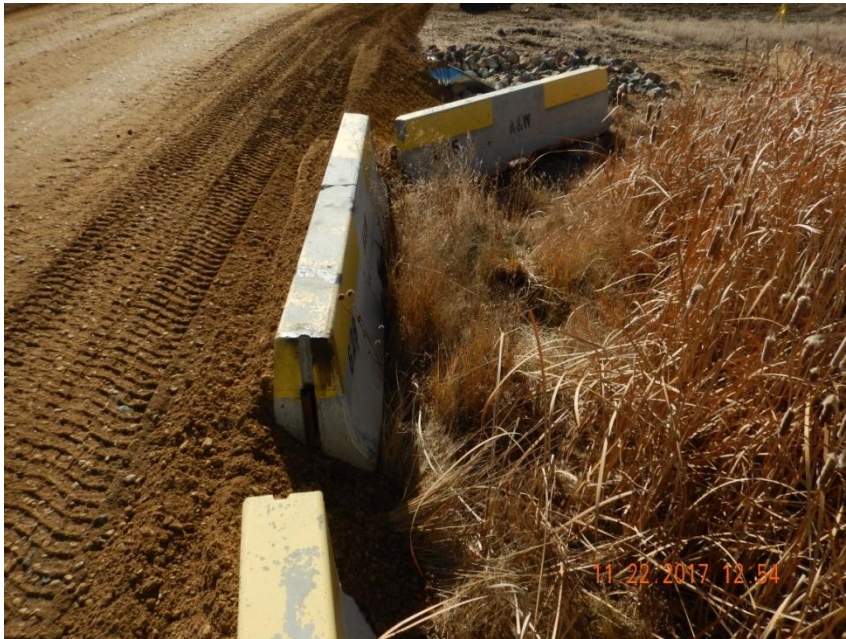
**Photo 7.** Photo taken from the north culvert along the west-side of the access road, facing North. Operator needs additional BMPs to protect sediment discharge into the wetland along the western access road.

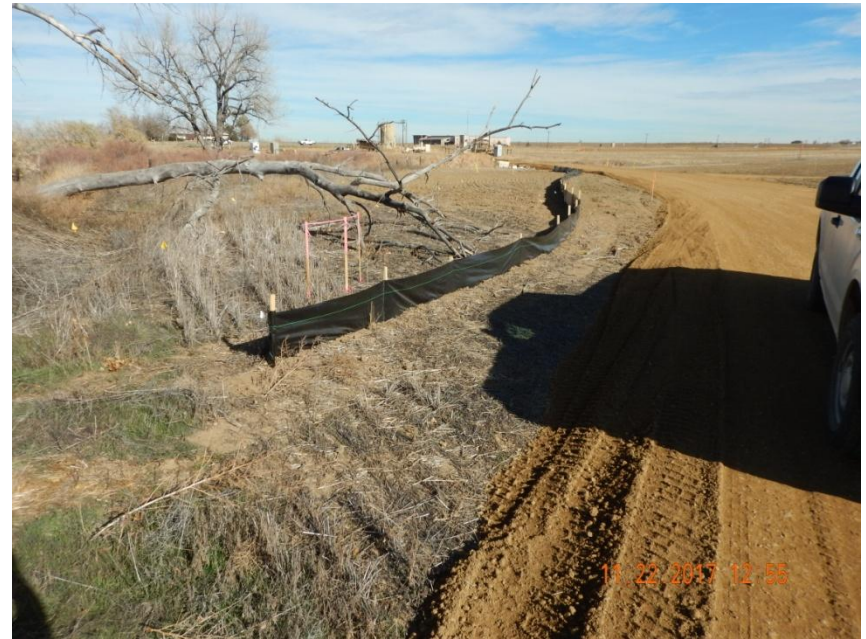
**Photo 8.** Photo taken along the southern portion of the access road, facing Northeast. Operator has installed silt fence along portions of the downgradient slope of the access road. Operator may need to install more silt fence or additional BMPs along portions where there is no BMP along the downgradient slope.

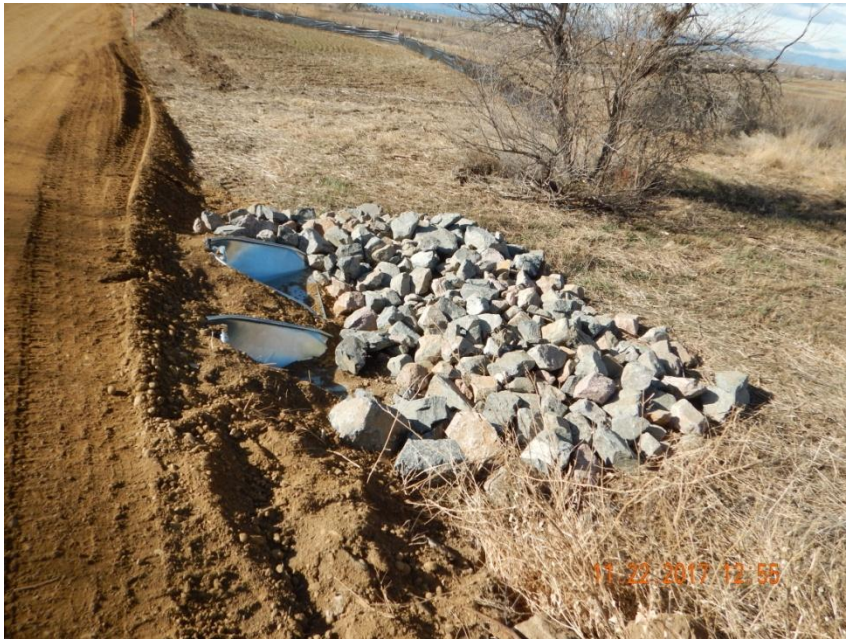
**Photo 9.** Photo taken from the south culvert along the west-side of the access road, facing West. Operator installed an outlet device (rip-rap).

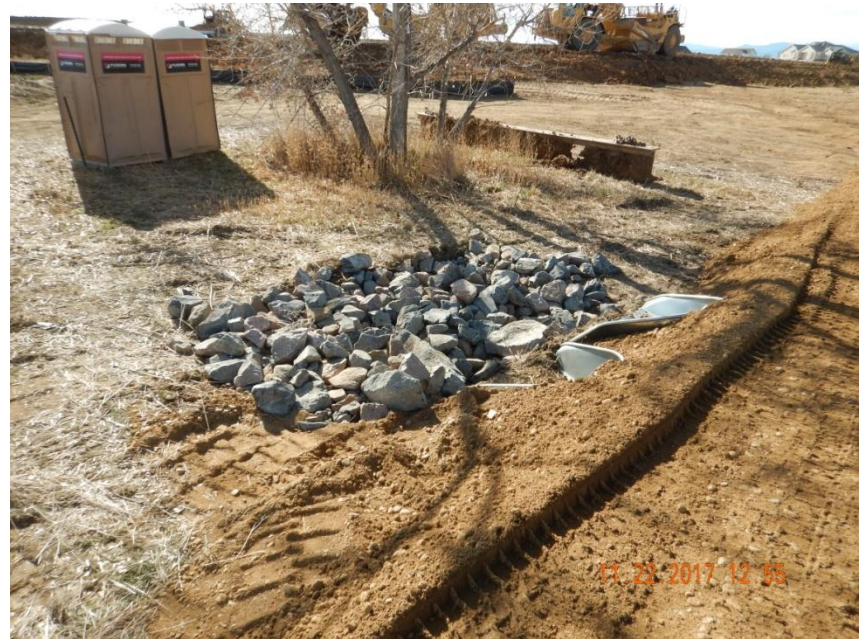
**Photo 10.** Photo taken from the south culvert along the east-side of the access road, facing Southwest. See comments under Photo 9.

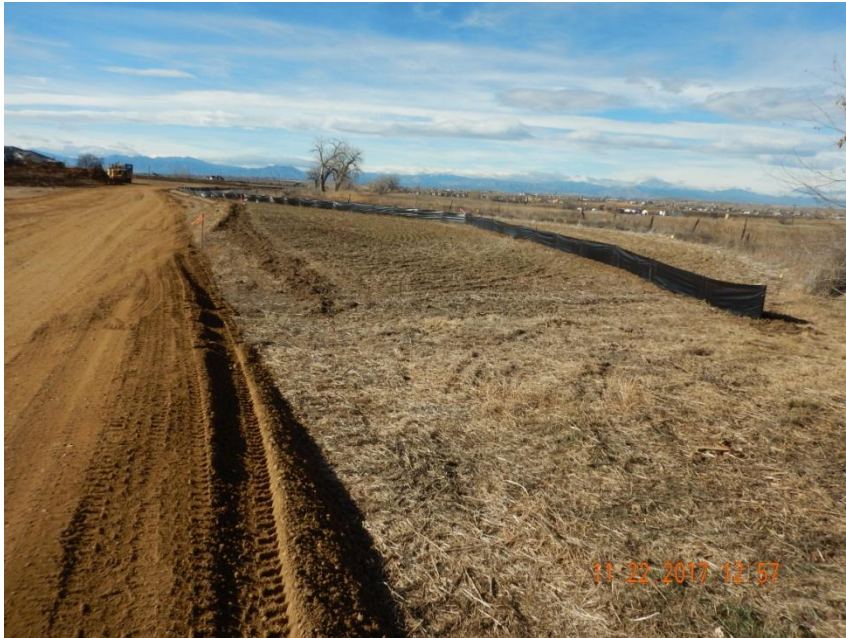
**Photo 11.** Photo taken from the northeast location, facing West. Operator has installed silt fence BMP, except along the southeastern and southwest portion, in conjunction with a ditch around the perimeter of the location.

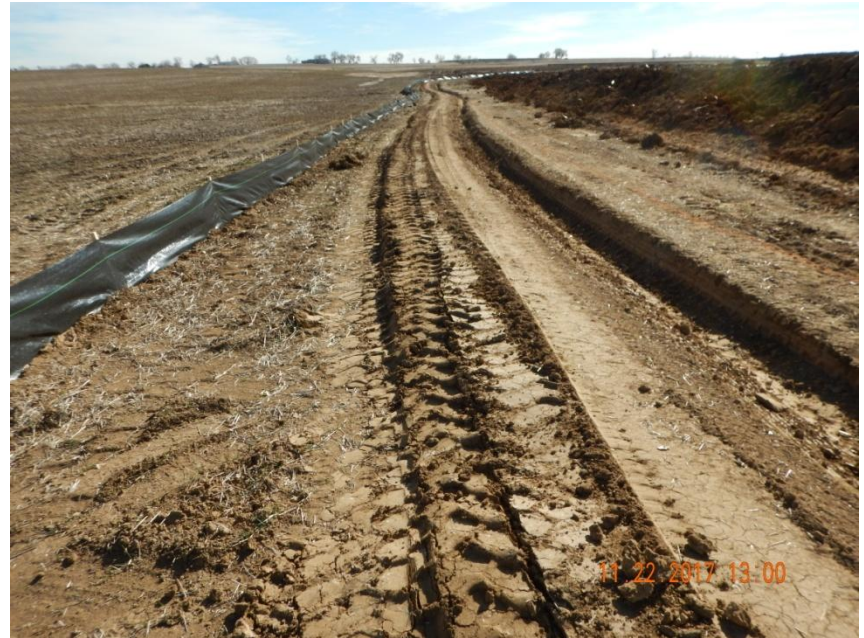
**Photo 12.** Photo taken from the northeast location, facing South. See comments under Photo 11.

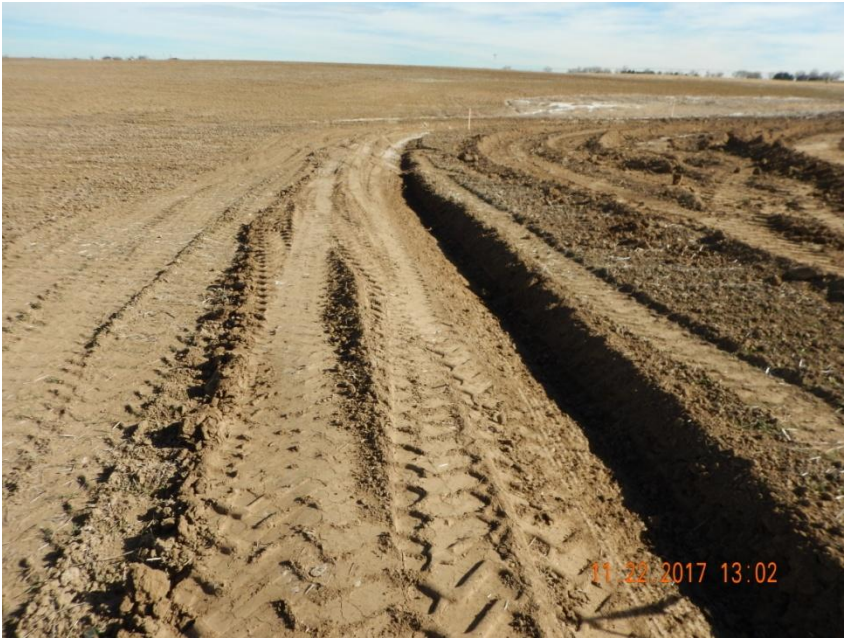
**Photo 13.** Photo taken from the southeastern location, facing East. The southeastern perimeter of the location only has a ditch BMP.

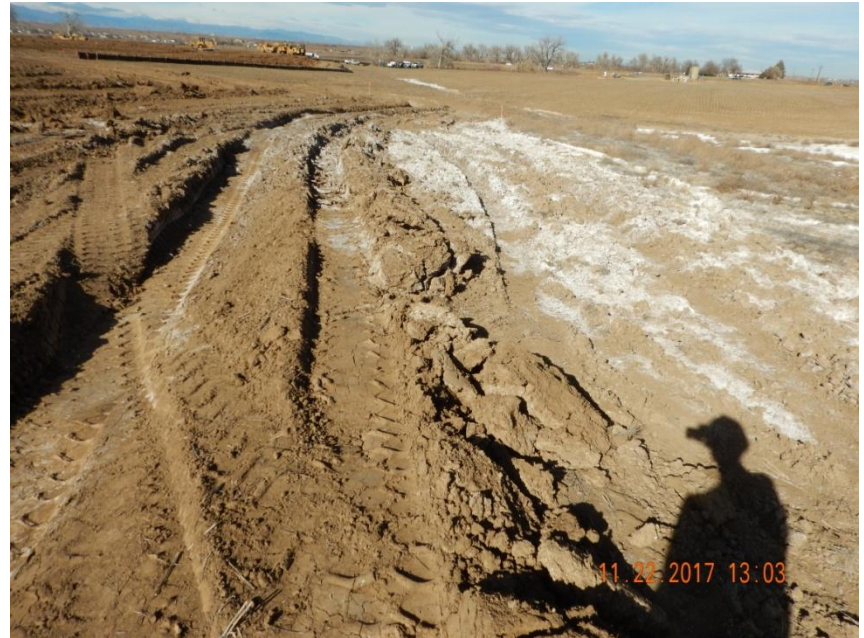
**Photo 14.** Photo taken from the southeast location, facing Northwest. Operator needs to improve and implement BMPs along this portion of the perimeter.

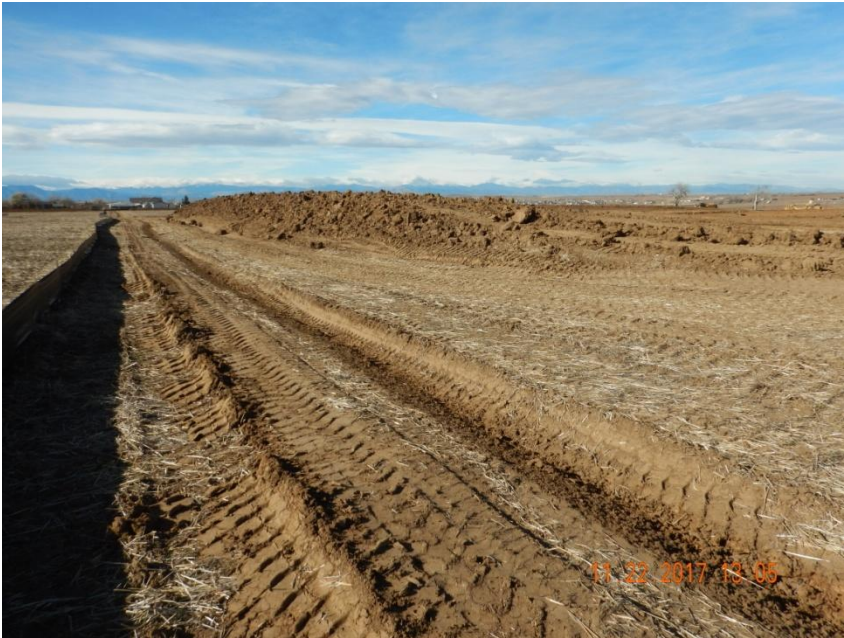
**Photo 15.** to taken from the southern location, facing West. See comments under Photo 11.

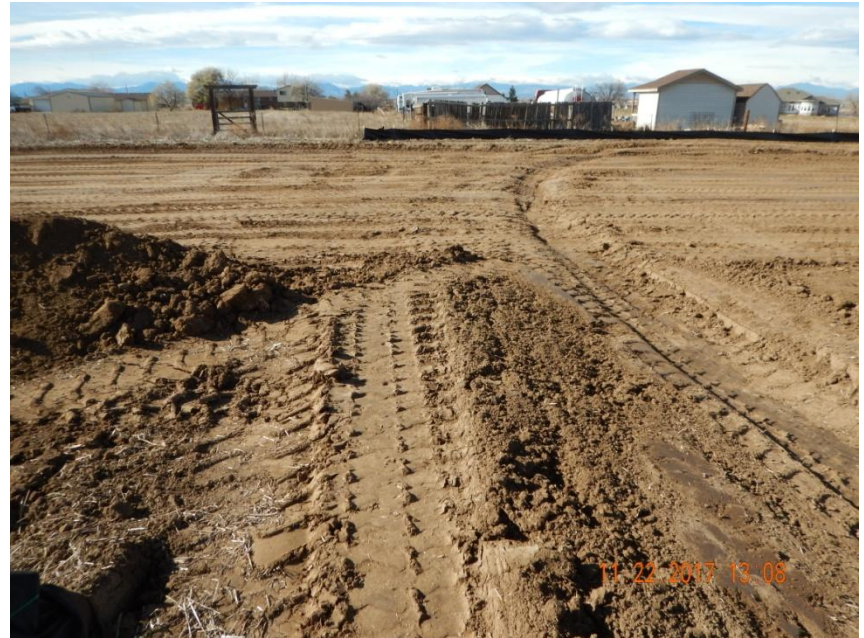
**Photo 16.** Photo taken from the southwest location, facing West. Evidence of the ditch BMP but appears to be additional disturbance, maybe a flowline, where no BMPs are in place.

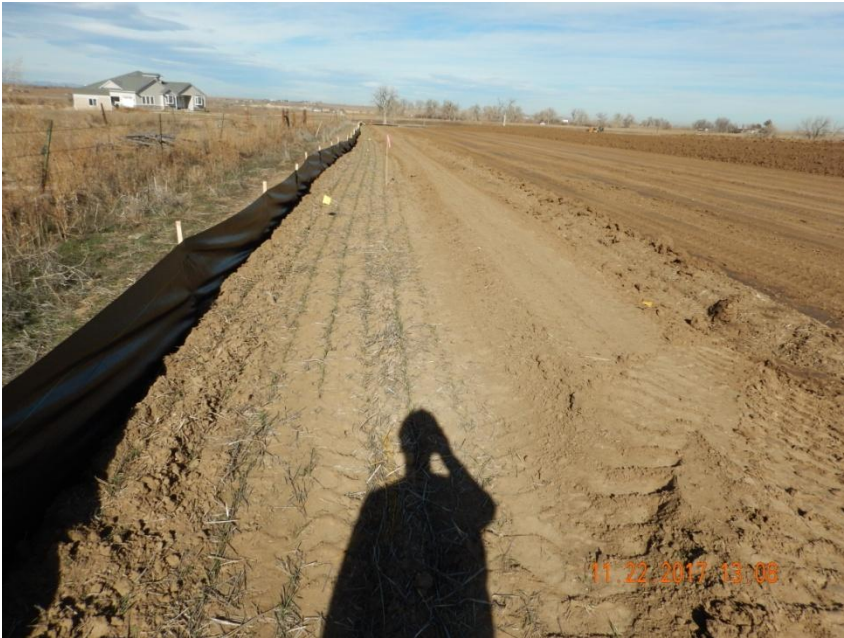
**Photo 17.** Photo taken from the southwest location, facing North. See comments under Photo 11.

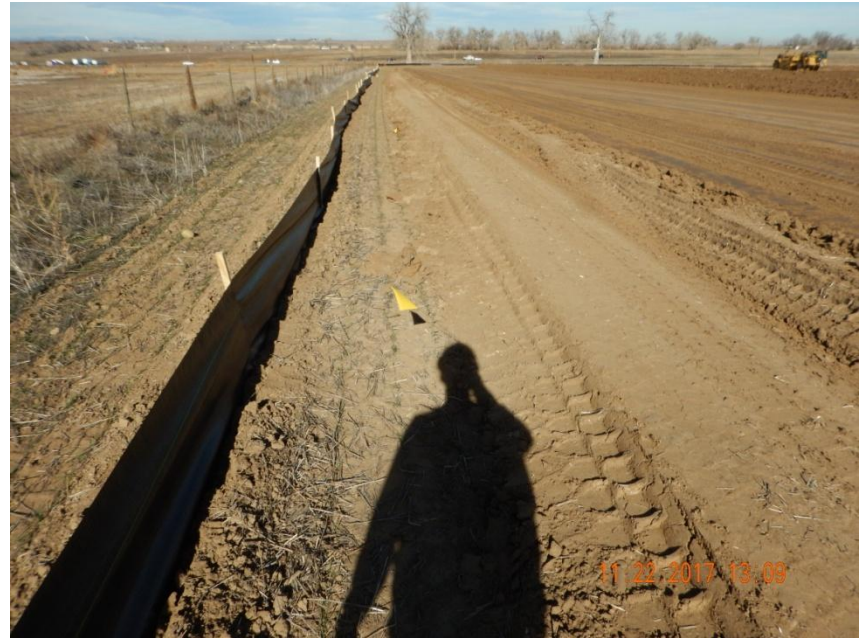
**Photo 18.** Photo taken from the western location, facing North. See comments under Photo 11.

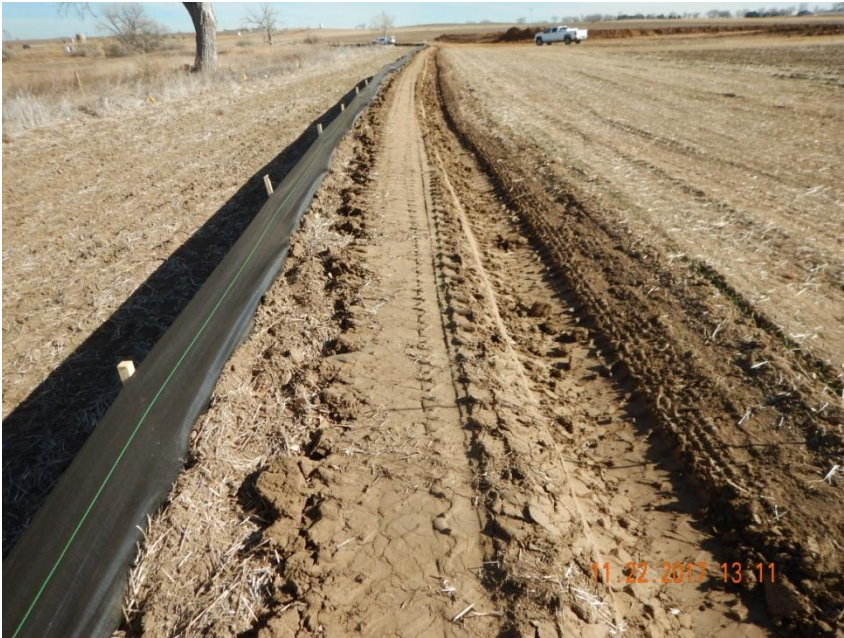
**Photo 19.** Photo taken from the northwestern location, facing East. See comments under Photo 11.

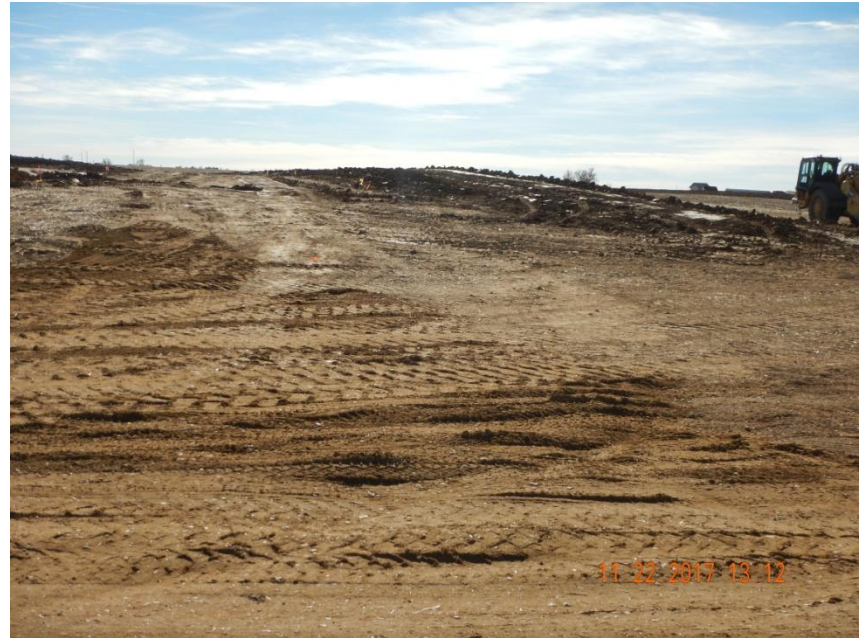
**Photo 20.** Photo taken from the northwestern location, facing South. Appears to be the start off constructing the berm for visual mitigation.
