Inspection Photos
Location Name: Tiffany C #1
API: 05-067-06416

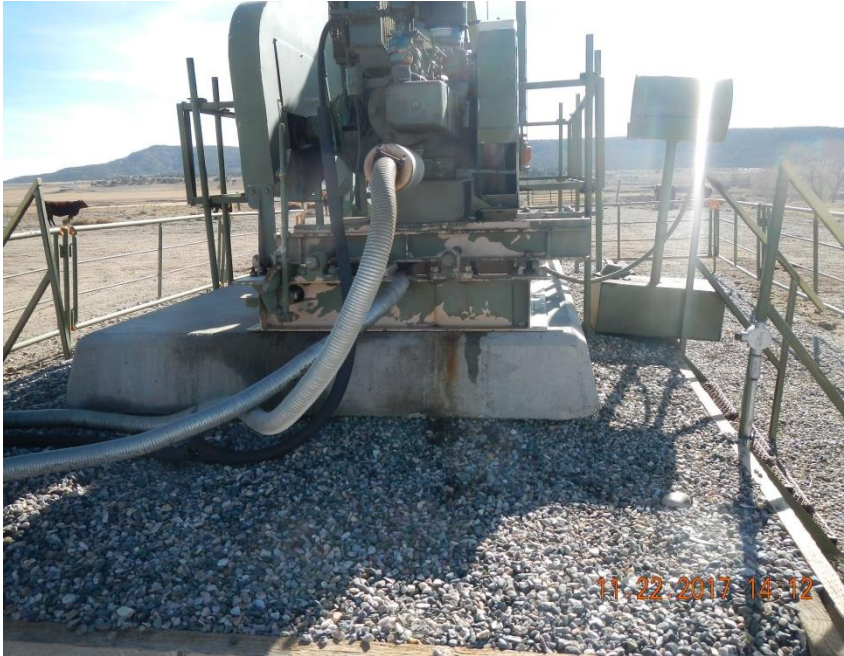
Stained gravel beneath prime mover on C #1.

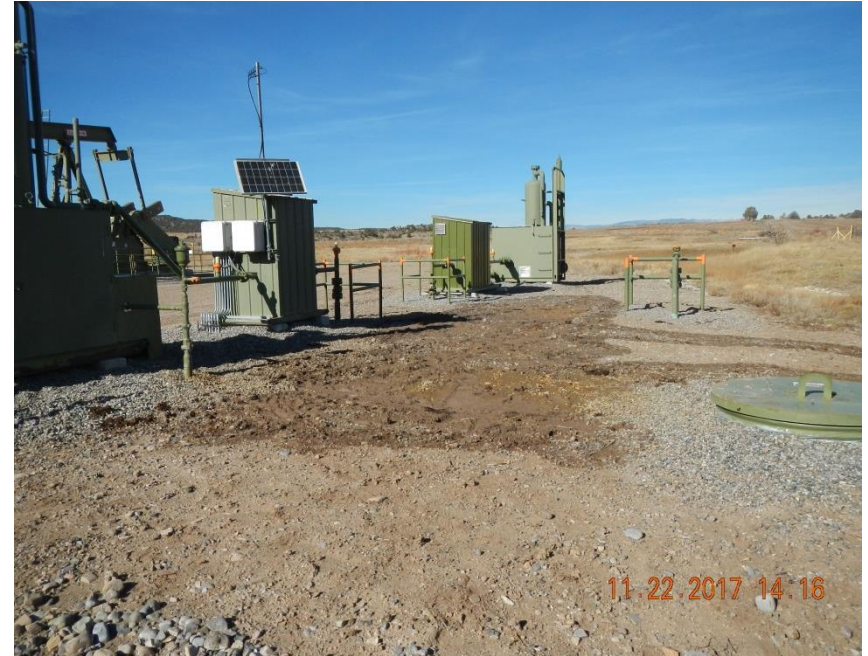
Location of produced water release with flow paths running off of location and mixing with irrigation water.

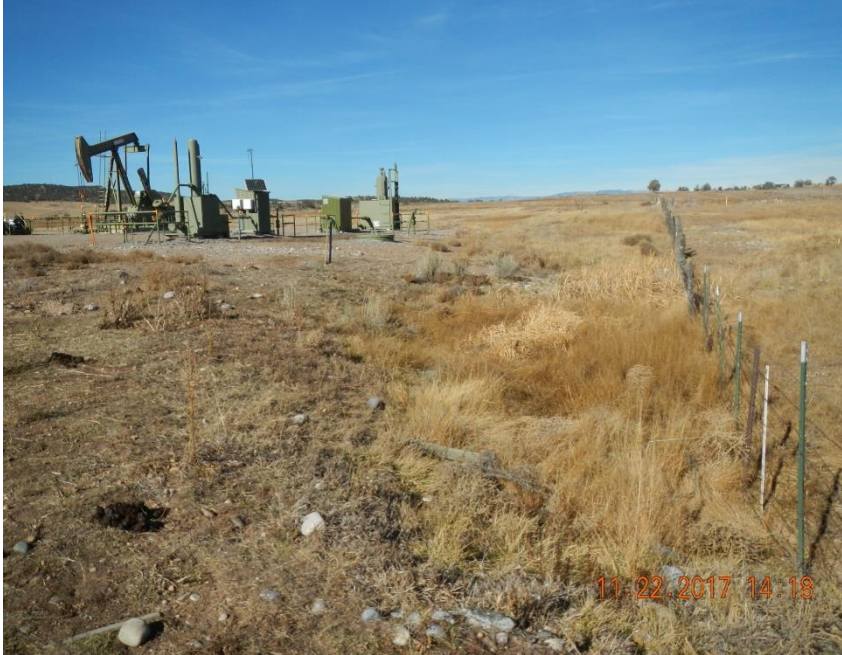
Downstream of release area where water enters culvert.

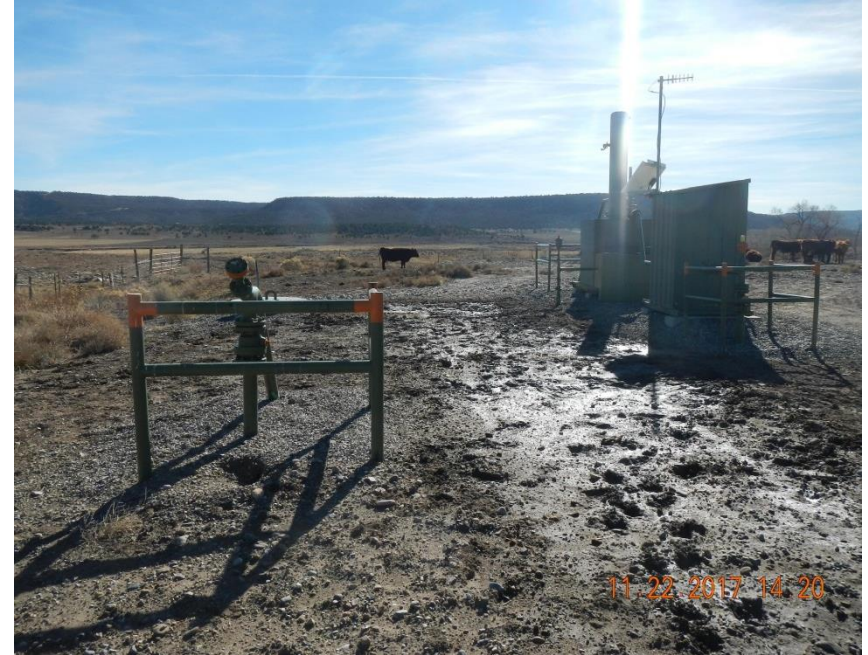
Wet soil east of separator and meter run.

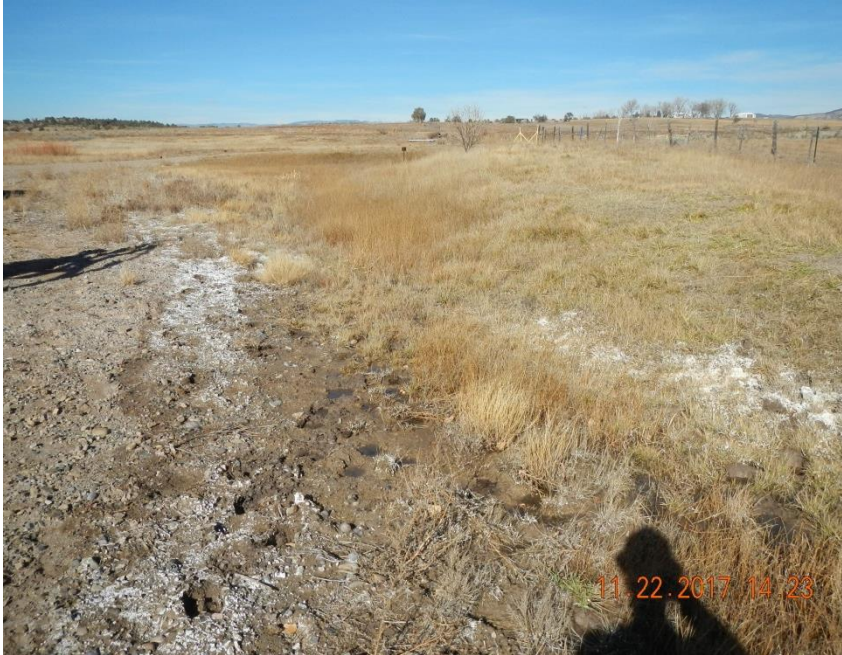
Edge of location up gradient of release area.

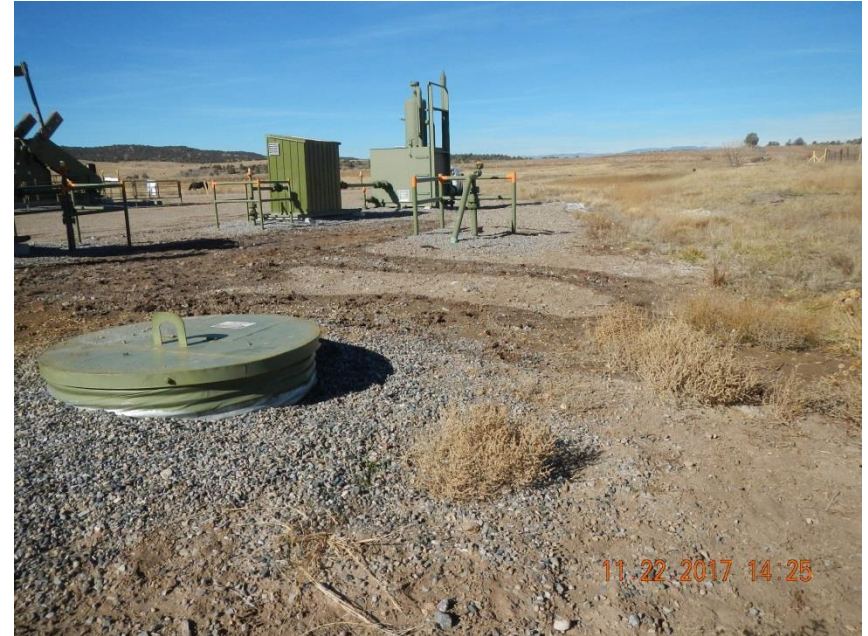
Release area on east edge of location. Flow paths left pad.

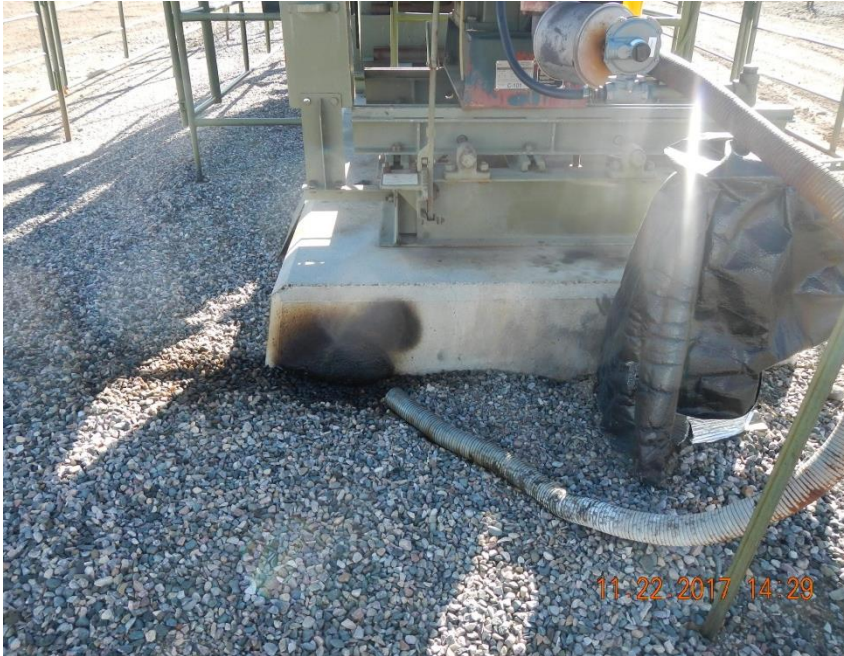
Stained gravel at exhaust on Tiffany #2-3.

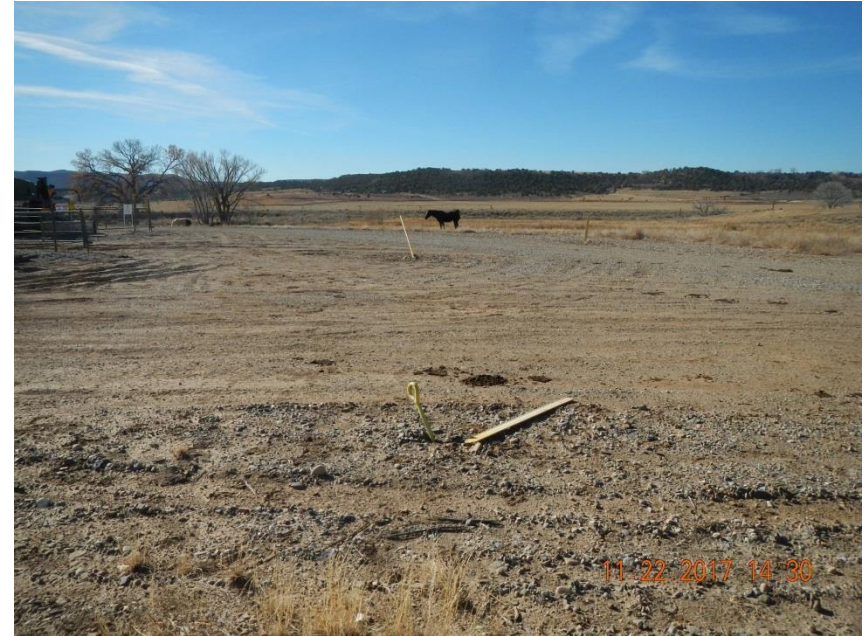
NE anchor marker has been knocked down.
