Interim Reclamation and Stormwater Inspection

November 22, 2017

Operator: KERR MCGEE OIL & GAS ONSHORE LP #47120

Location ID: 448228

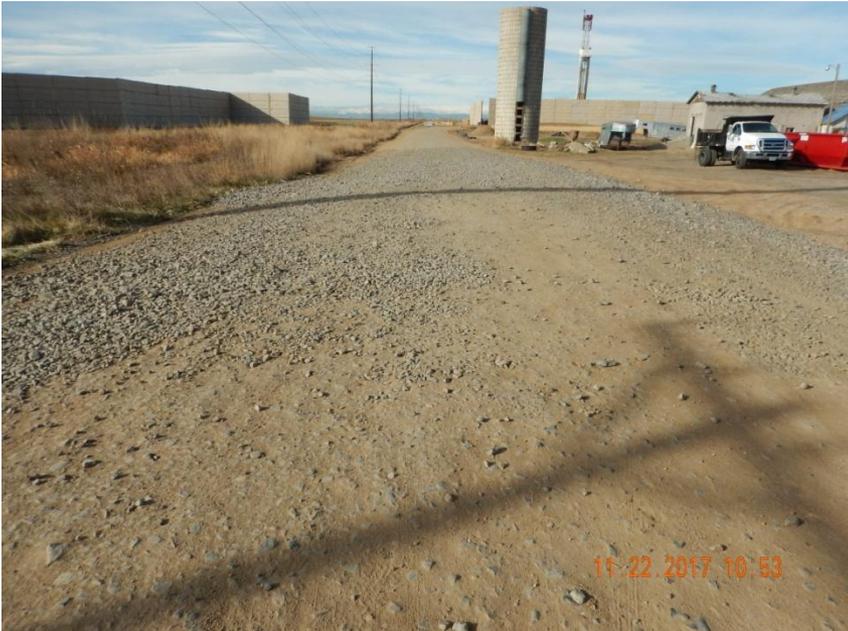
Photo 1. Photo taken from the entrance of the location, facing West. Tracking pad device has been installed. May need maintenance to ensure BMP is in proper functioning condition.

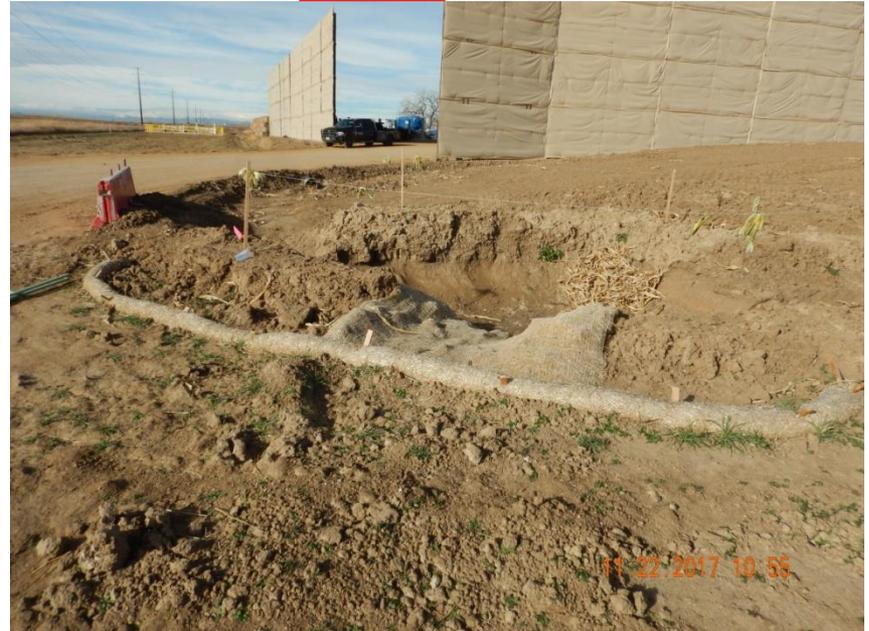
Photo 2. Photo taken from the southeast location, facing West. Sediment trap installed with a stabilized outlet. Embankment berms of sediment trap have not been properly compacted.

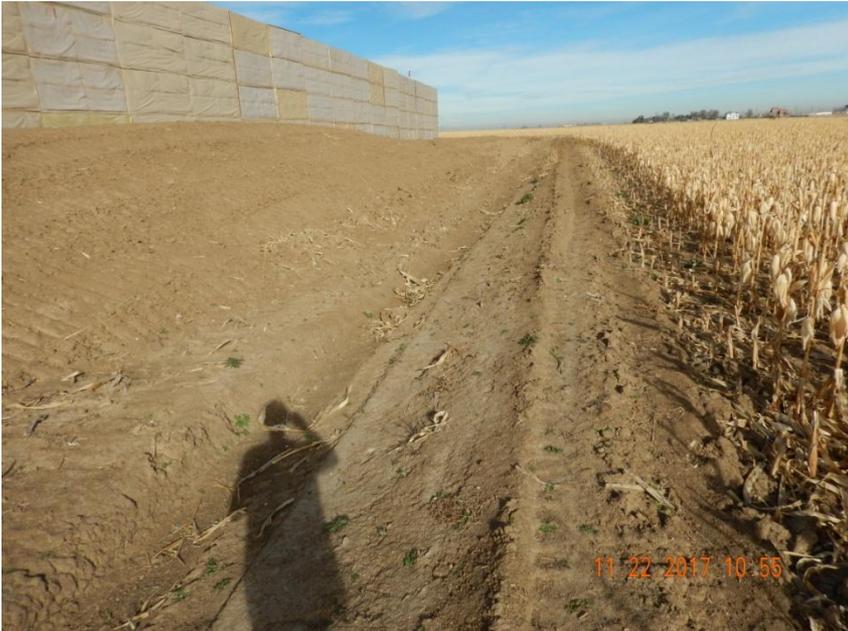
Photo 3. Photo taken from the eastern location, facing North. Appears topsoil has been salvaged and stored along the eastern perimeter. Does not appear topsoil has been properly tracked with equipment. Equipment tracking should be up and down the slope to reduce potential erosion. Ditch and berm BMP installed around the perimeter of the location.

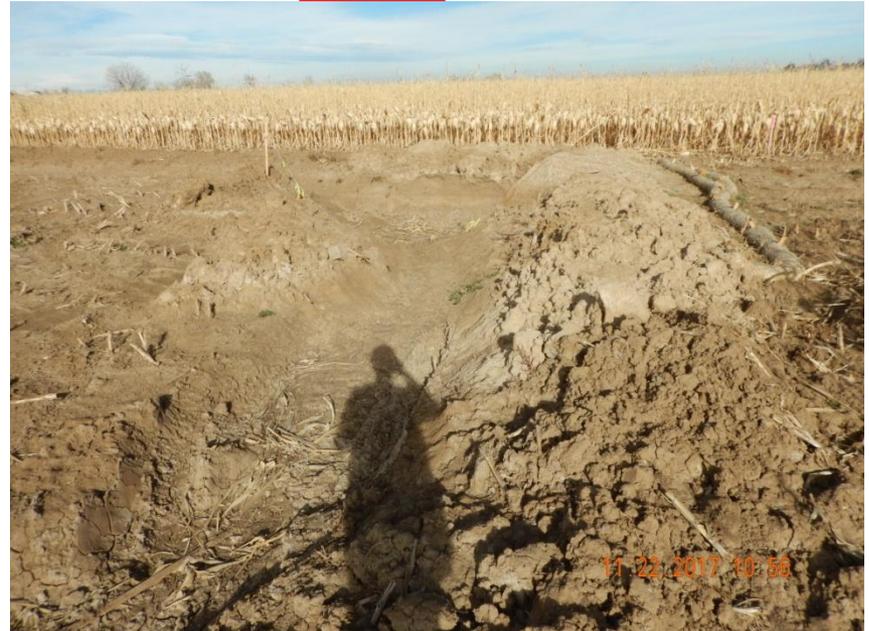
Photo 4. Photo taken from the northeast location, facing North. See comments under Photo 2.

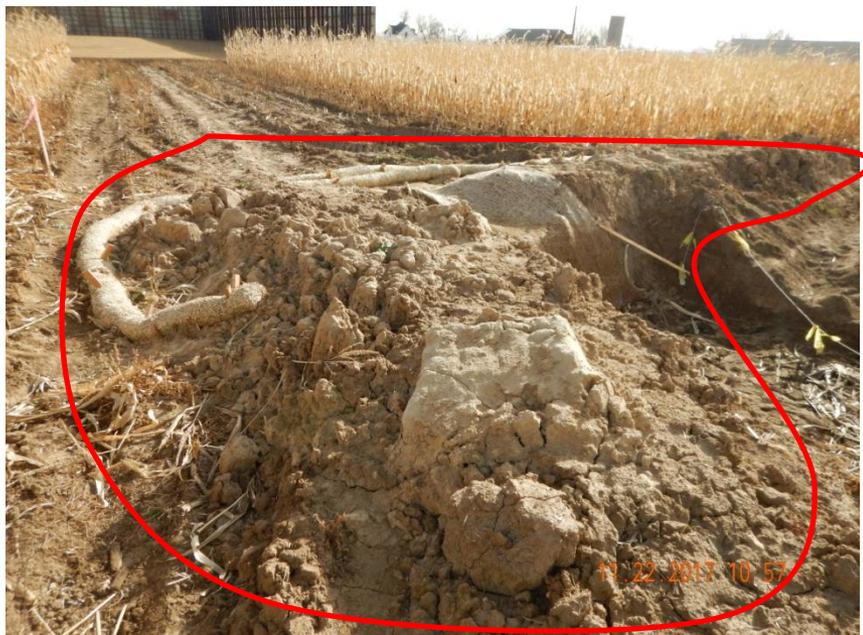
Photo 5. Photo taken from the northeast location, facing East. See comments under Photo 2.

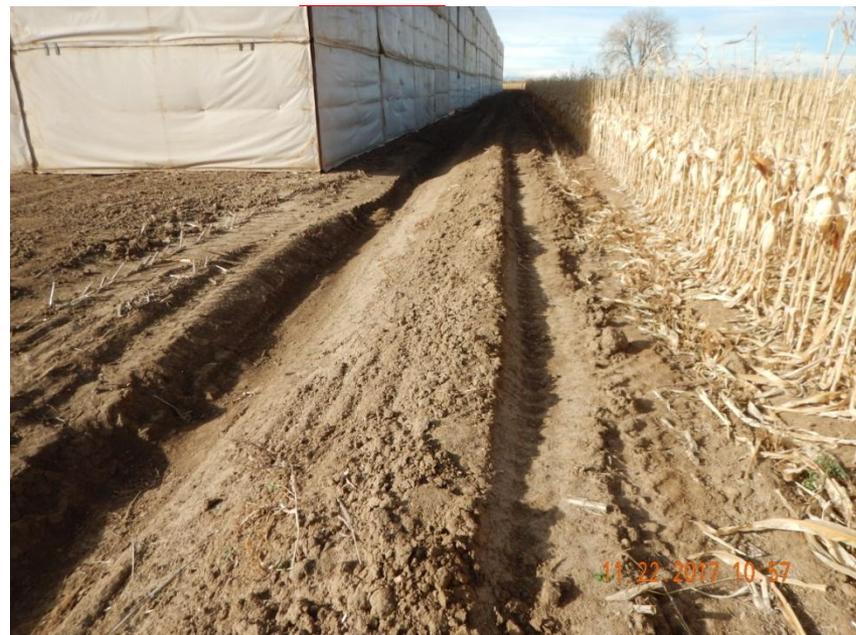
Photo 6. Photo taken from the northeast location, facing West. Ditch and berm BMP installed around the perimeter of the location. Appears portions of the berm have been tracked with equipment for temporary stabilization but portions have been left unconsolidated.

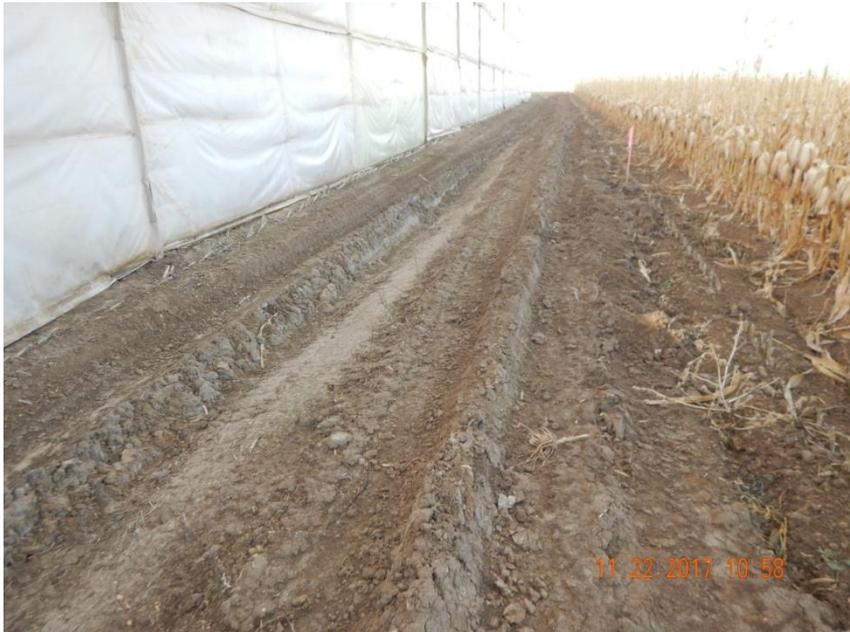
Photo 7. Photo taken from the northern location, facing West. See comments under Photo 6.

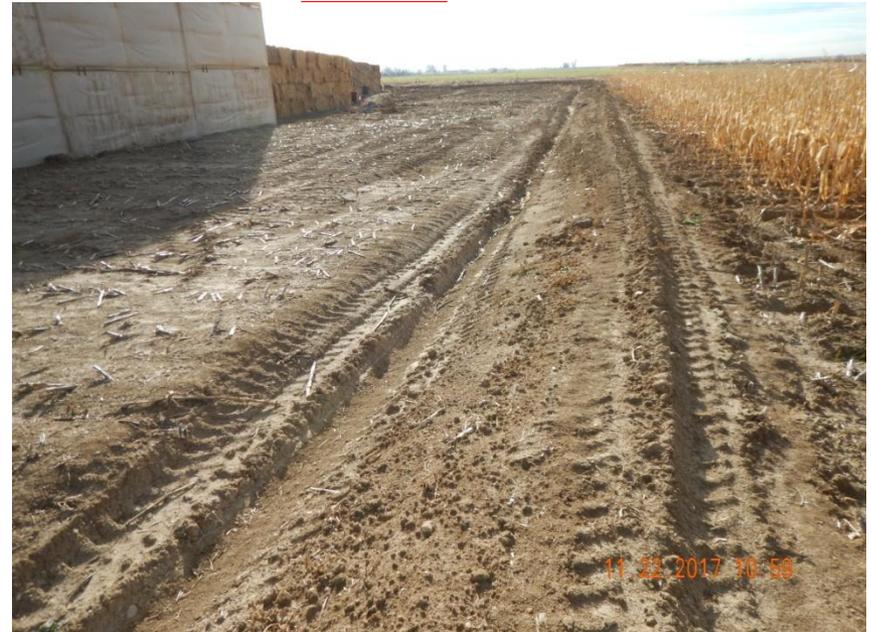
Photo 8. Photo taken from the western location, facing South. See comments under Photo 6.

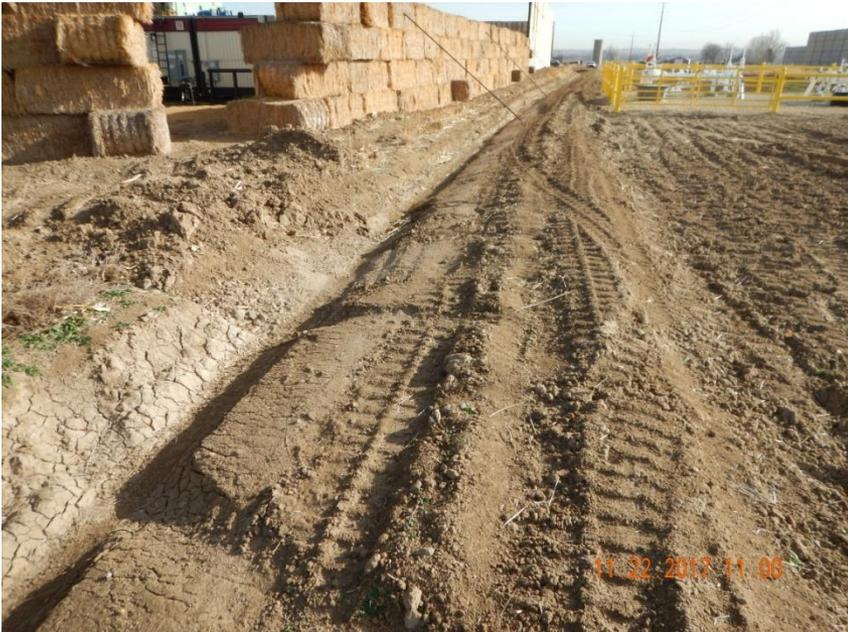
Photo 9. Photo taken from the southwestern location, facing East. See comments under Photo 6. Operator shall minimize equipment traffic on BMPs to ensure BMP is in proper functioning condition.

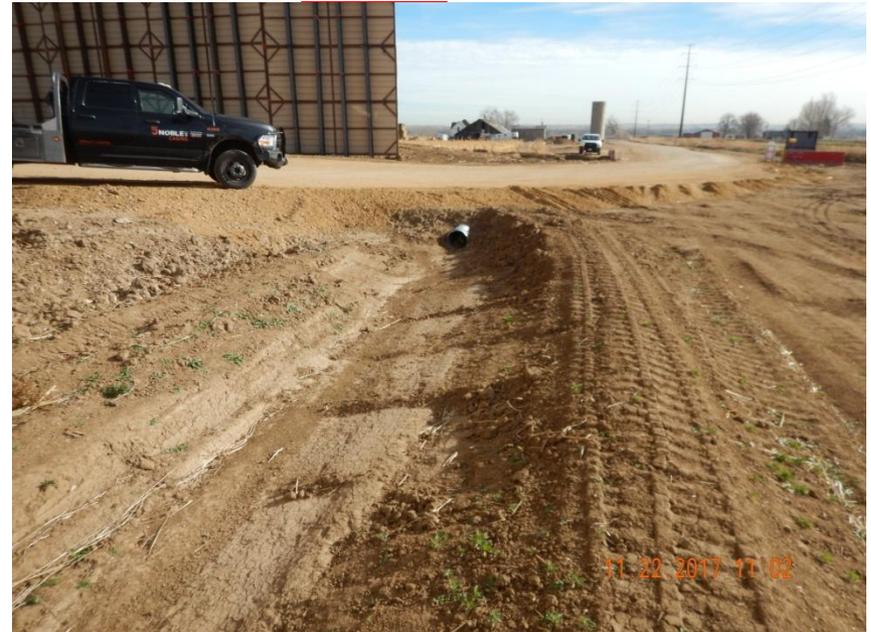
Photo 10. Photo taken from the southeastern location, facing East. See comments under Photo 6. Culvert has been installed in conjunction with the ditch BMP.
