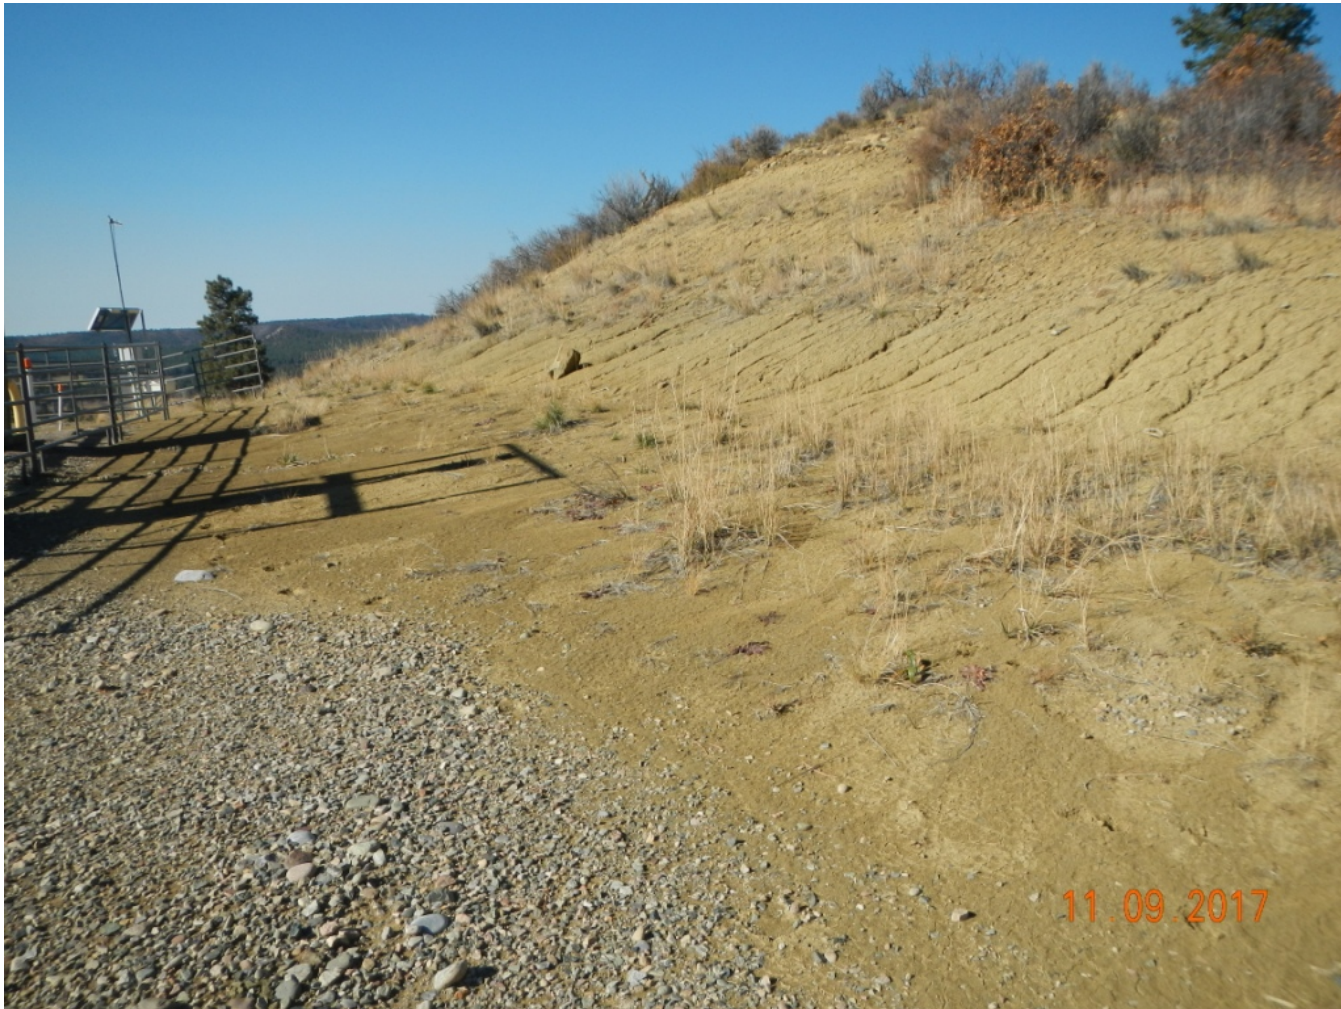
Photo 2. View of the northern cut-slope from the northern edge facing northwestward. Rilling and sediment deposition are occurring within the slope. Slope stabilization and erosion control measures are needed here.

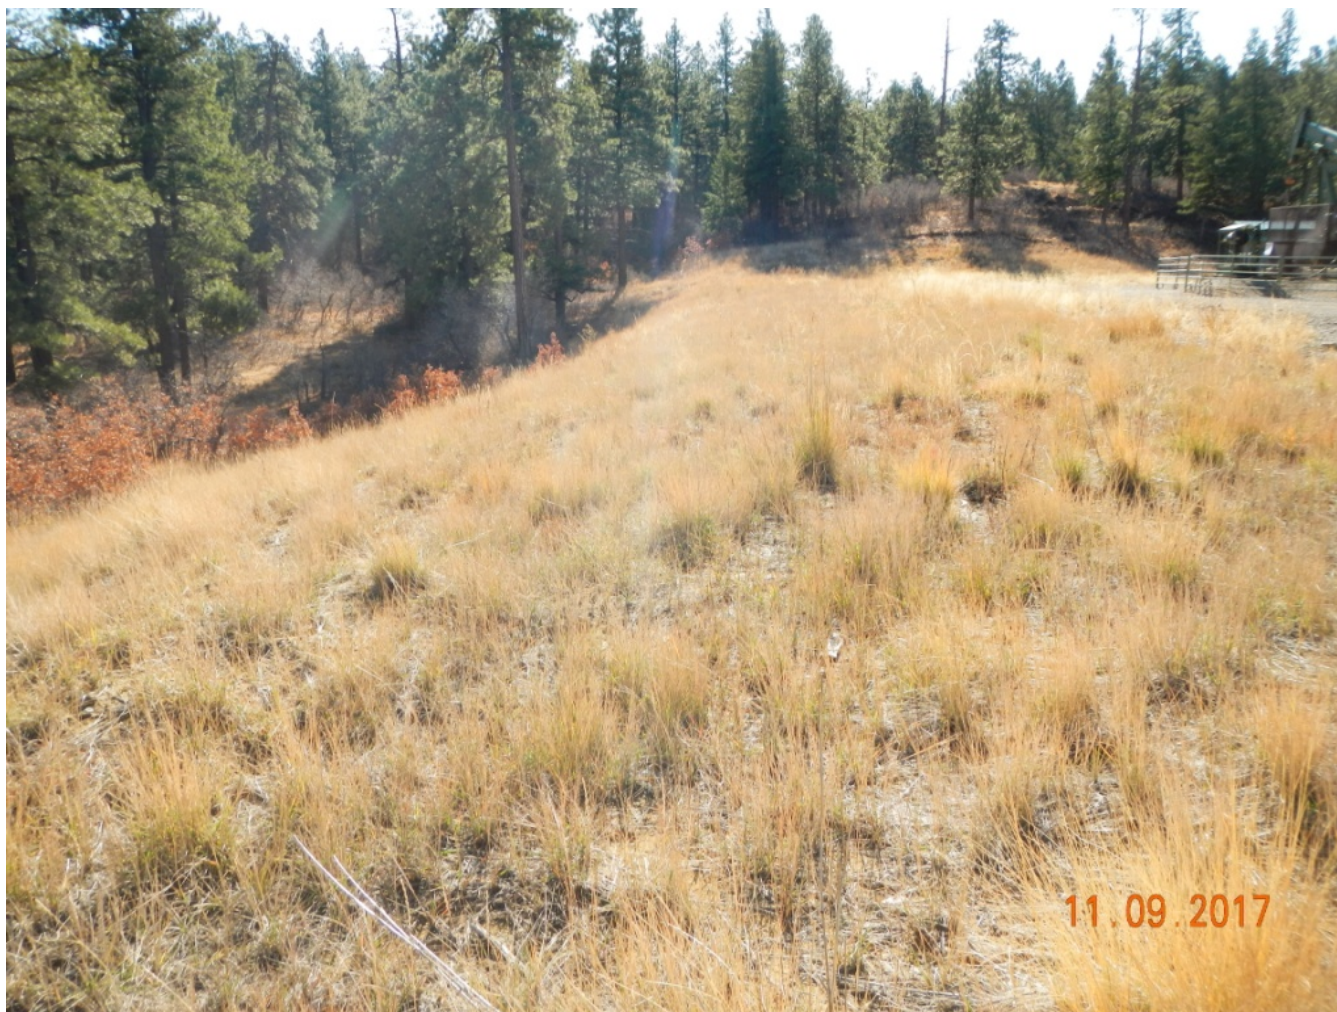
Photo 3. View of the eastern portion of the project area from the northeastern corner facing southward. Revegetation is progressing with grasses such as crested wheatgrass (*Agropyron cristatum*), western wheatgrass (*Pascopyrum smithii*), and dropseed (*Sporobolus* sp.)

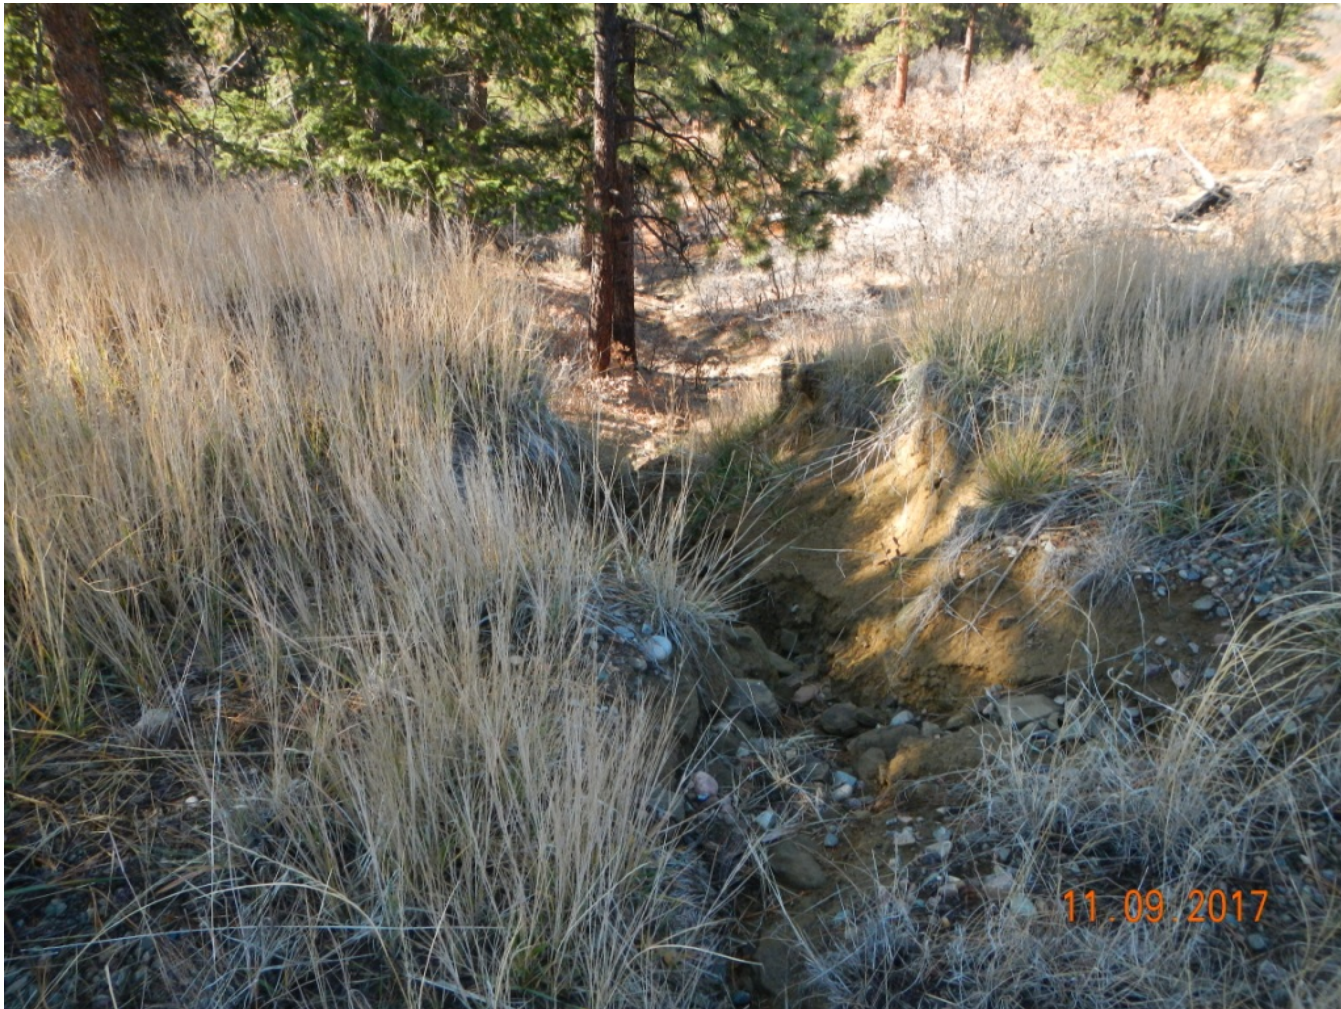
Photo 4. View of an erosional channel approximately 2.5 feet wide and deep in the western portion of the project area.

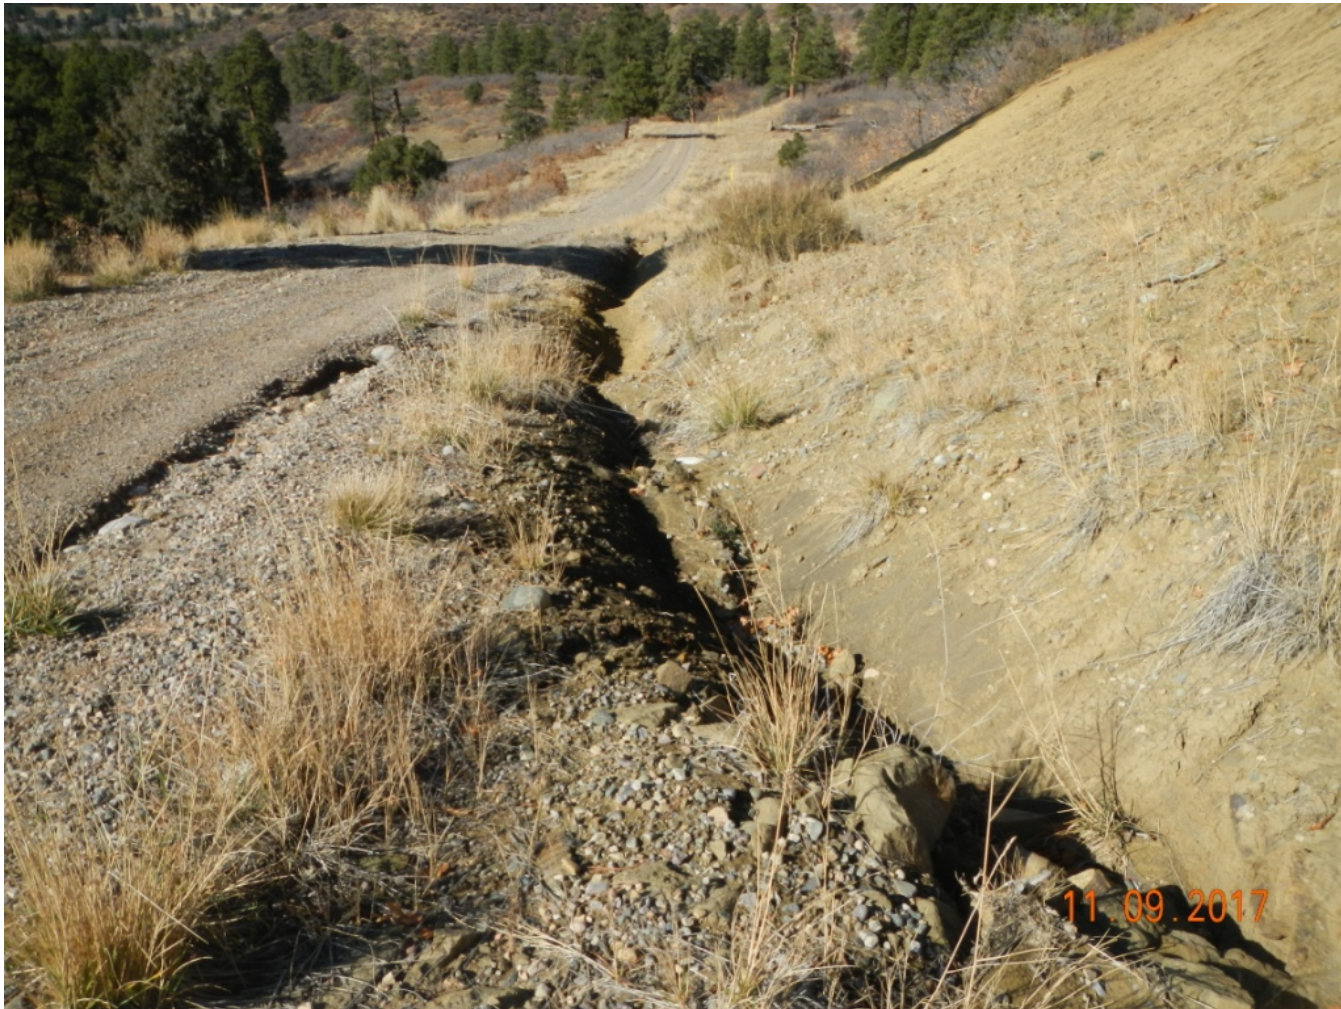
Photo 5. View of area along the northern access road where concentrated stormwater flows are eroding the roadside and result in in sediment loss.
