CAERUS OIL & GAS

DATE: November 27th, 2017
Company: Caerus Oil & Gas
Field: Piceance Basin, Colorado
TO: Jake Janicek
SUBJECT: 17L-794 Flowline Failure Analyses

EXECUTIVE SUMMARY

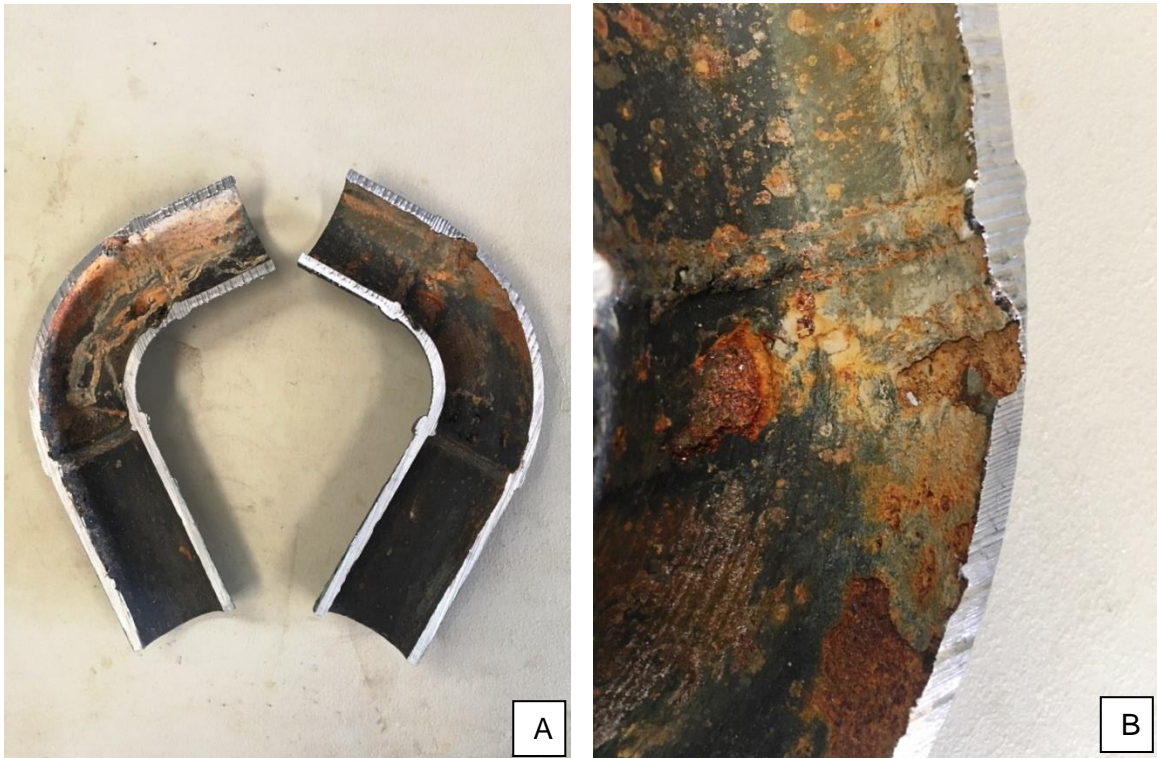
Nalco Champion received a section of 2" pipe from the flowline off the 17L-794 well. Caerus Oil & Gas personnel noticed a leak at a bend in the flowline and the age of the pipe was deemed to be less than a year old. The damaged section was cut out and given to Nalco Champion where it was then split length wise for analysis. The internal portion of the pipe was noted as having a dark coating covering the metal surface along with pitting and two visible breaches through the pipe wall. The majority of the damage was at the bend in the flowline between the welds. This report lines out the analysis and findings of the failure to the pipe.

Picture A & B – 2" Pipe sample from the 17L-794 Well flowline before cleaning

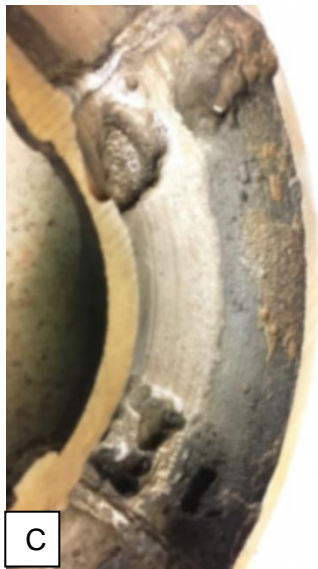
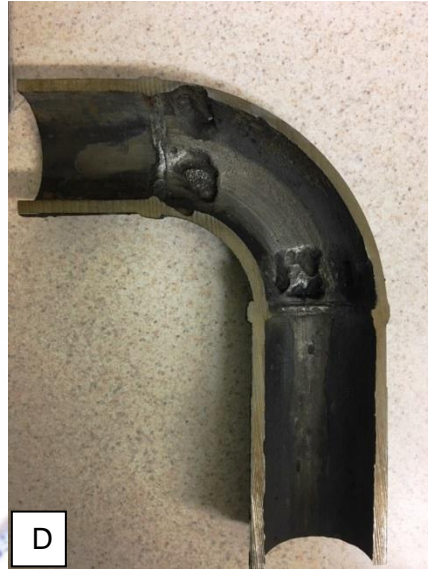
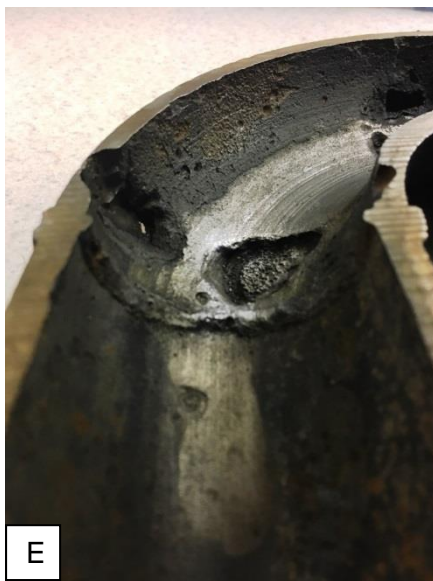
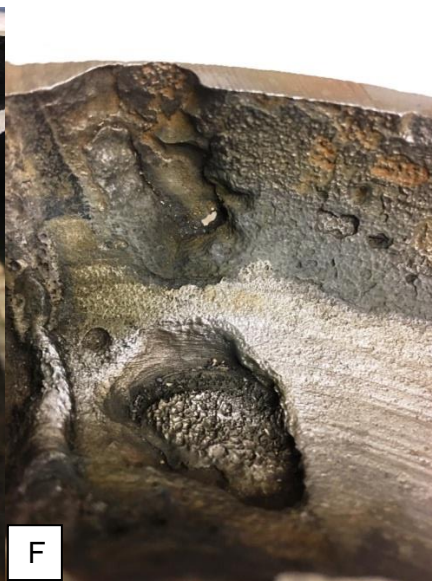
An internal section of the pipe was cleaned using a solution of 15% hydrochloric acid (HCl) and a wire brush to expose the pitting. As soon as the HCl was applied, it immediately started to effervesce and release H₂S that was detected at ~15 ppm with an H₂S monitor. It was then determined that the dark coating on the surface was iron sulfide due to the reaction with the HCl and also iron carbonate (FeCO₃). After the surface was cleaned, a visual inspection of the corrosion damage was conducted. The corrosion was comprised of numerous pits with a “hill and valley” texture in certain spots and a “honeycomb” pattern in others. There were also deep gouges between the flat surfaces indicating “Mesa Attack” corrosion which typically occurs where some areas of the metal surface have a good protective coating and some do not.

Pictures C, D, E & F show the exposed damage after HCl cleaning

The damage and pitting observed on the pipe is indicative of carbon dioxide (CO₂) corrosion. CO₂ is an acid gas that is absorbed in brines and can cause severe corrosive attack to steel. The combination of the damage and pitting being on a bend and close to welds, appear to be the contributing factors of the failure. In this case, it is referred to as “Flow-enhanced” corrosion. Flow-enhanced corrosion usually occurs when a change of direction in the flow of fluids occurs, such as near an elbow. Typically, the mechanism follows a deposition of a protective FeCO₃ film with rubbing off the film by the flow of fluids, and sometimes solids. After the protective coating is abraded off, a new surface is exposed which then immediately starts to corrode. The corrosion product is a softer surface, which is then eroded away, and the process continues until a failure occurs.

Please review and let me know if you have any questions or would like a recommendation to mitigate these types of failures. To do so, Nalco Champion would perform further testing and analysis on the production system to supply the best chemical treatment solution.
