Inspection Photos
Location Name: Wickstrom 6-5
API: 05-123-21315
Inspection Date: 11/28/2017

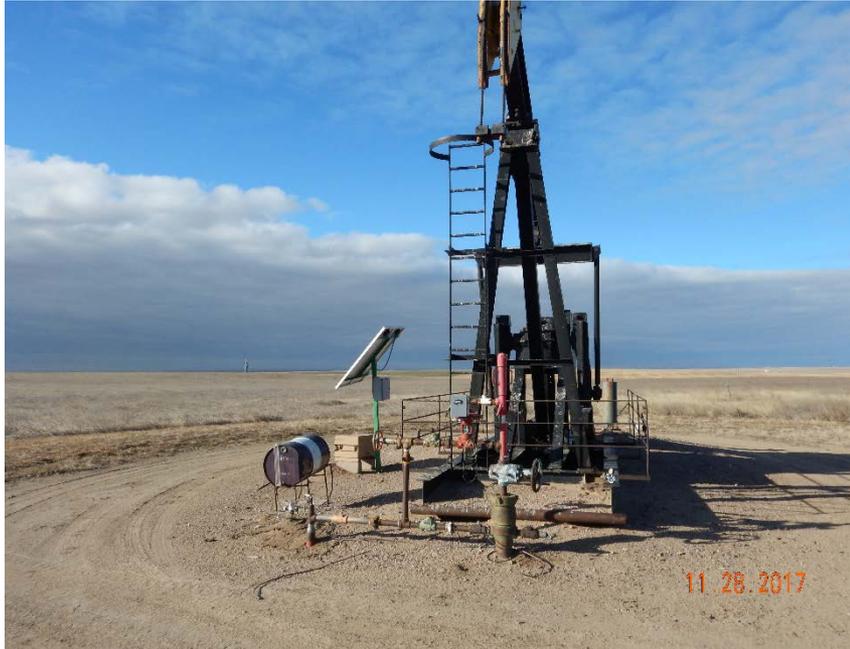
Photo #1 – View of wellhead and pump jack, looking west. Note that the well is equipped with a plunger lift and that the day tank south of the well is lacking secondary containment. There is no well sign at the pump jack.

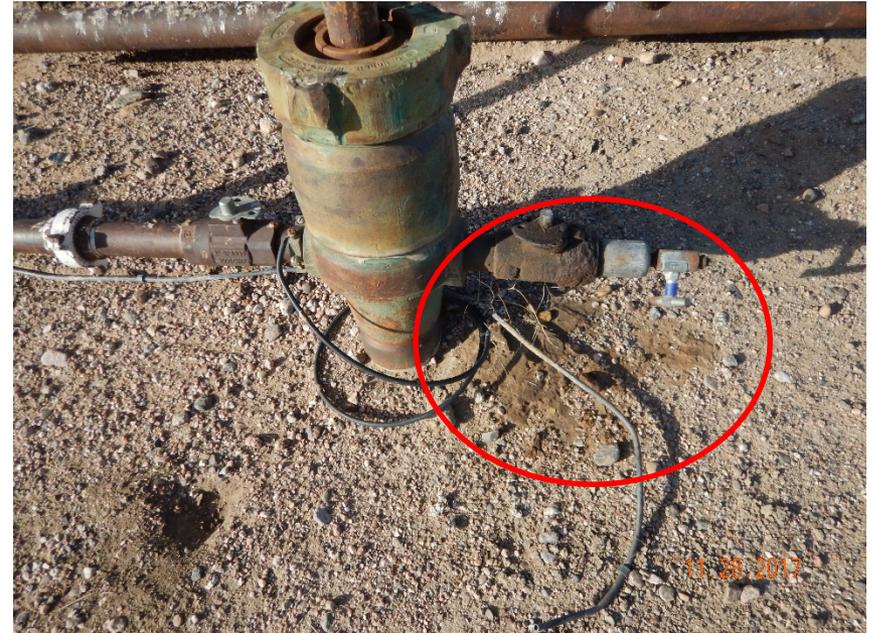
Photo #2 – Historical accumulation of oily waste at wellhead.

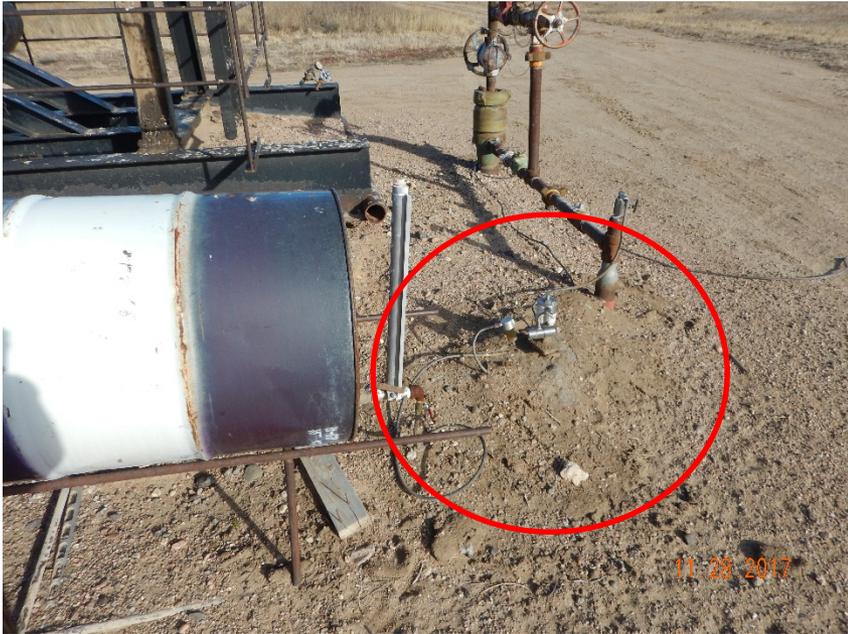
Photo #3 – Historical accumulation of oily waste beneath flowline riser and day tank south of pump jack.

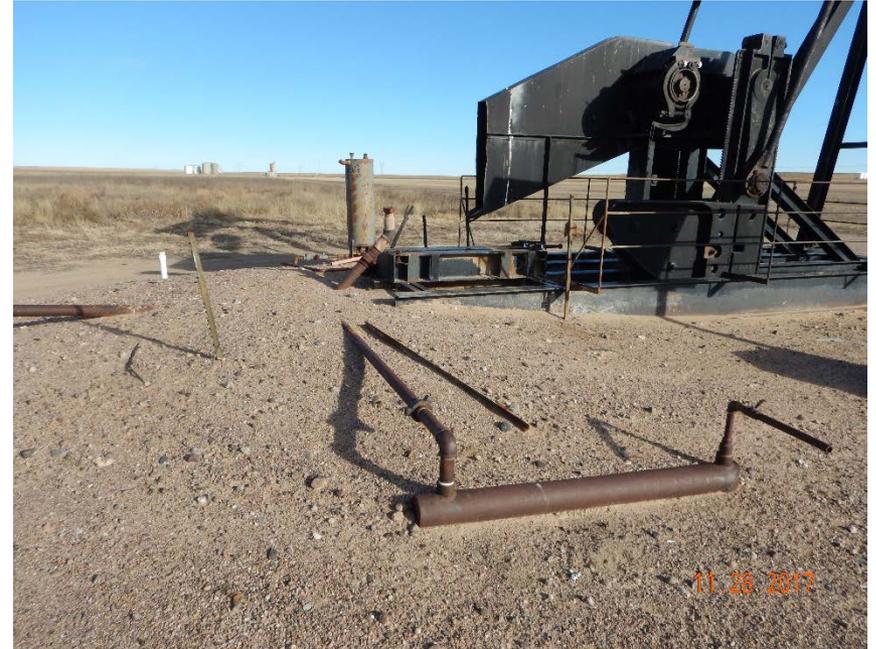
Photo #4 – Pump jack is not in use and lacks a motor.

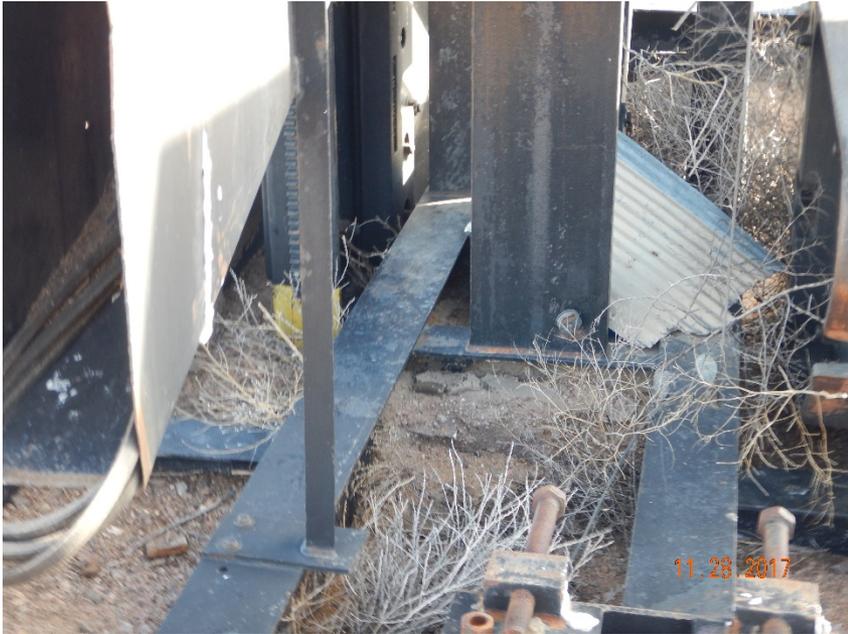
Photo #5 – Accumulation of wind-blown weeds and debris remaining beneath pump jack.

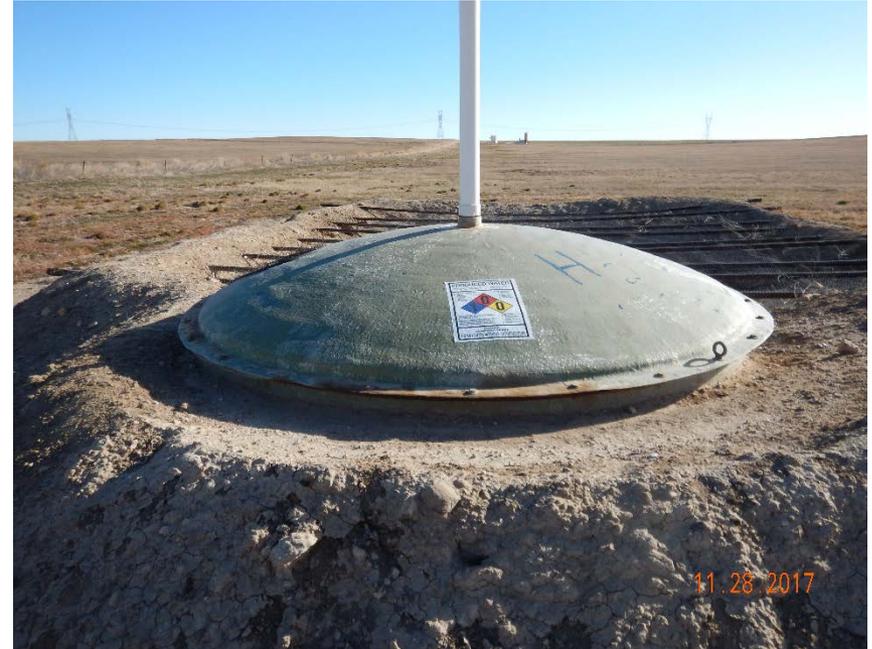
Photo #6 – View of skim tank and production pit (Facility ID #273445) at shared production facility, looking east. Shared production facility is located approximately ¼-mile north of well. Note that skim tank lacks volume label.

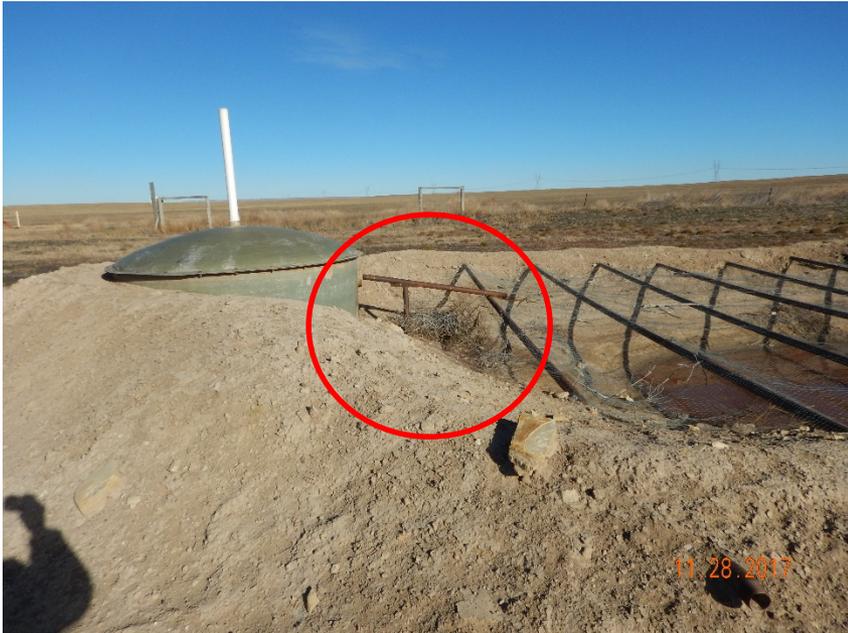
Photo #7 – Accumulation of oil-stained soil and weeds at outlet from skim tank. Note that the outlet of the skim tank is disassembled and that the mesh pit cover is in need of maintenance.

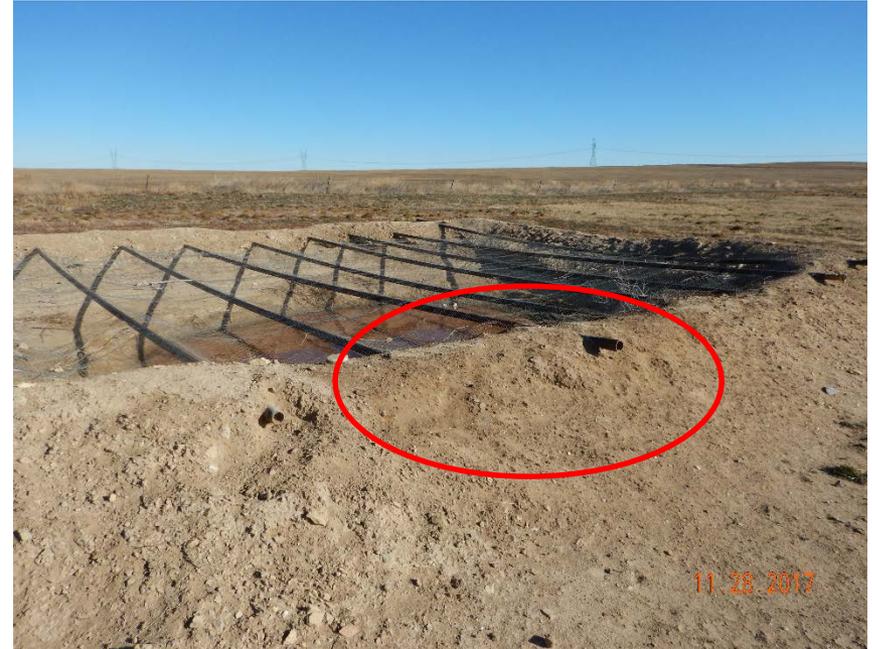
Photo #8 – Oil-stained soil on southern pit berm.

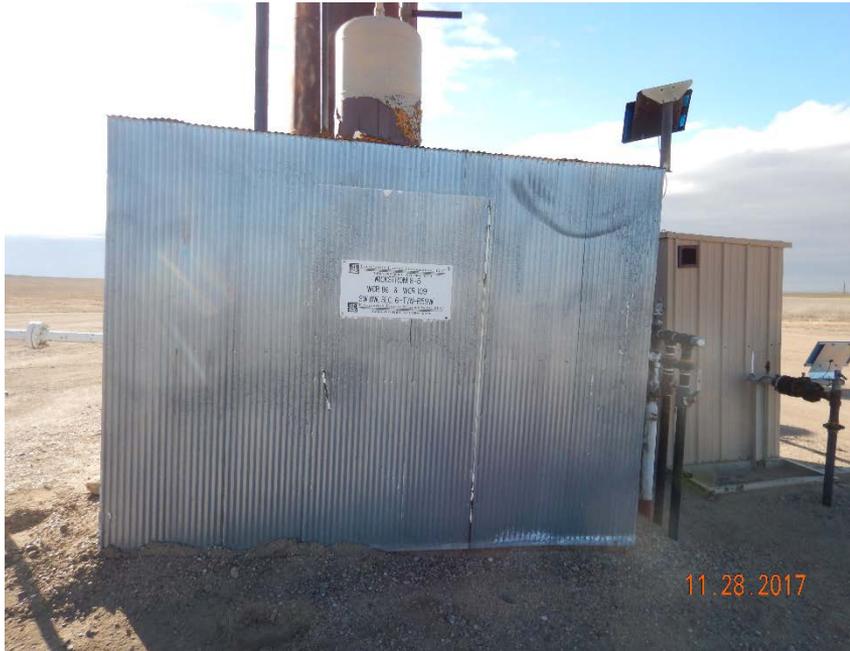
Photo #9 – Wickstrom 6-5 sign is affixed to separator/treater shed, which is located ~1/4-mile NNE of well. Note that the gas meter is located in the tan shed on the right side of the photo.

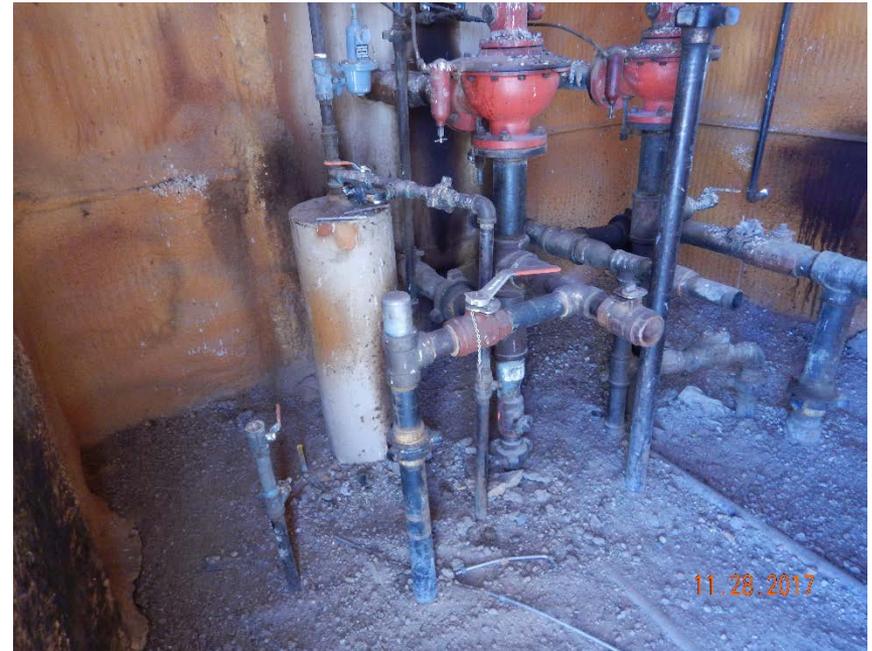
Photo #10 – Localized, oil-stained soil inside of the Wickstrom #6-5 separator/treater shed. A strong hydrocarbon odor was observed inside of this shed on the date of inspection.

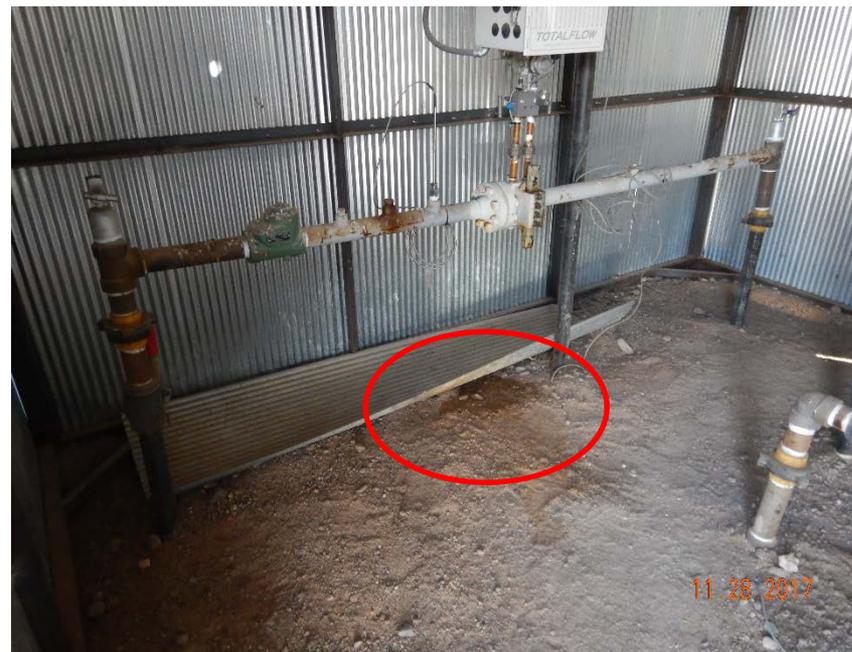
Photo #12 – Localized, condensate-stained soil beneath gas meter inside of Wickstrom #6-4 separator/treater shed. Soil conditions underlying vertical separator and treater were adequate.

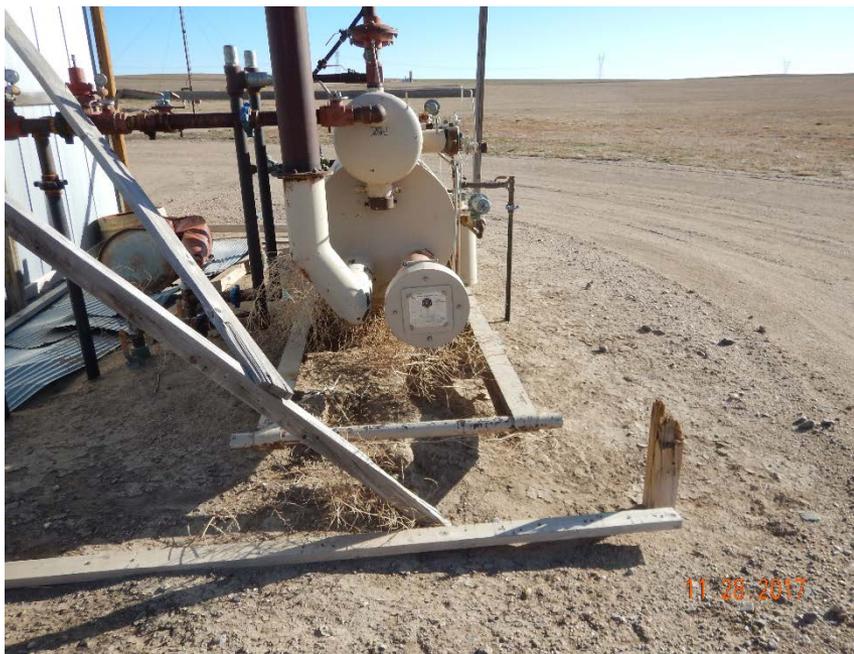
Photo #13 – Unused horizontal separator with associated junk, debris, and wind-blown weeds located south of Wickstrom #6-4 separator/treater shed.

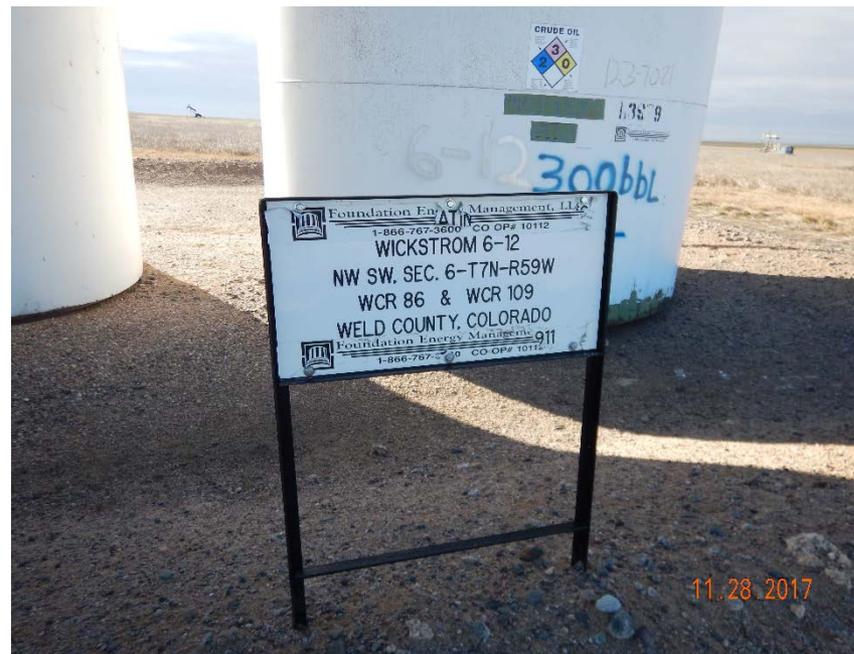
Photo #14 – Wickstrom #6-12 sign at NE corner of tank battery. Signs for Wickstrom #6-4 and #6-5 were not present at the battery.

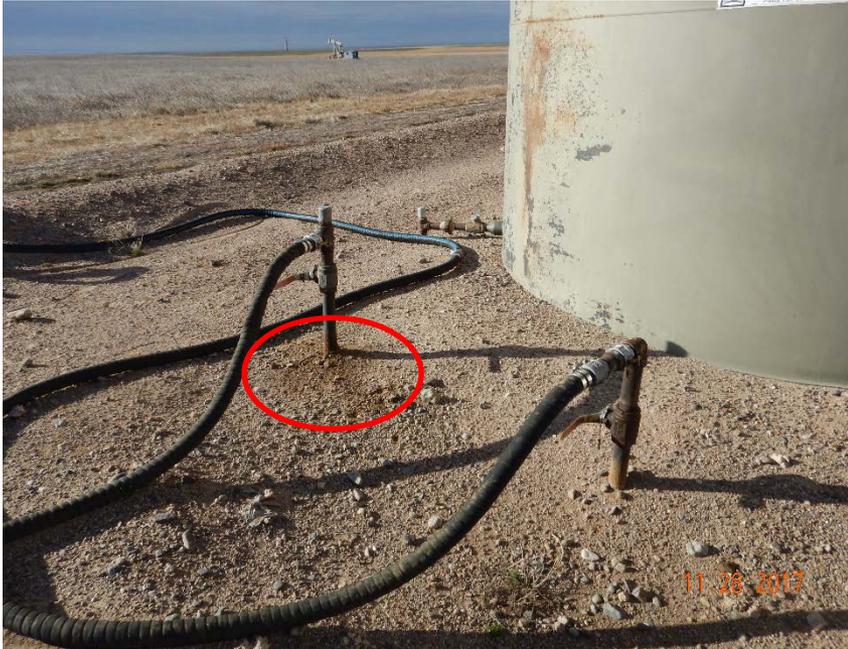
Photo #15 – Steel flowline risers located east of 400-bbl crude oil ASTs. Note localized, oil-stained soil beneath south riser.

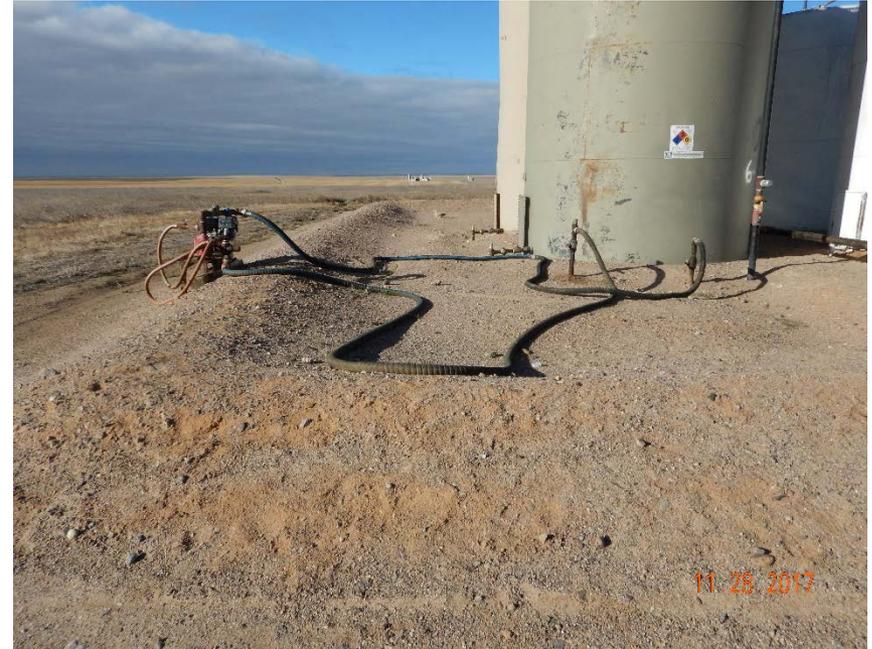
Photo #16 – Steel risers east of 400-bbl crude oil ASTs were plumbed to a pump on south side of tank battery. Note that earthen berm is shallow due to erosion.

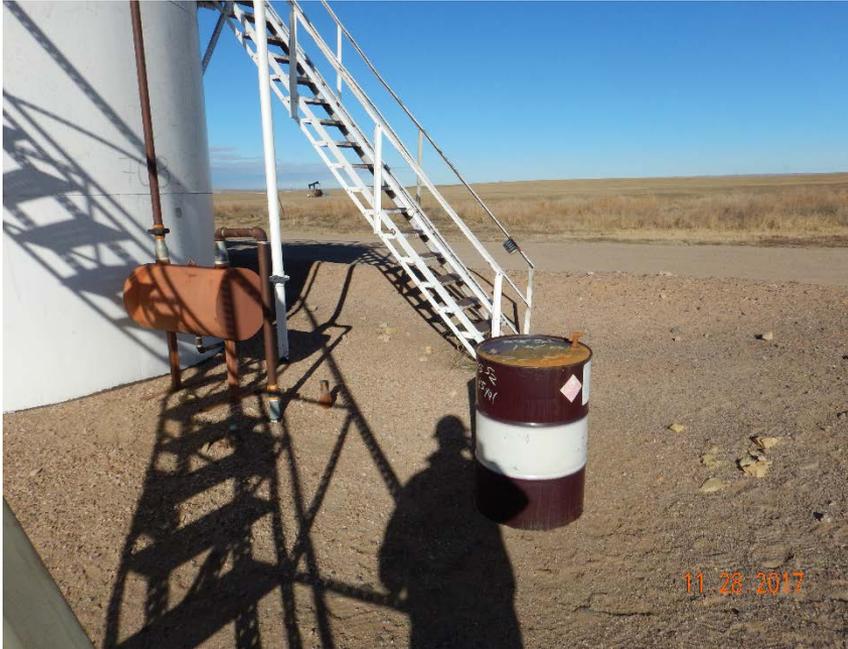
Photo #17 – Rusty 55-gallon drum located east of 300-bbl crude oil ASTs.

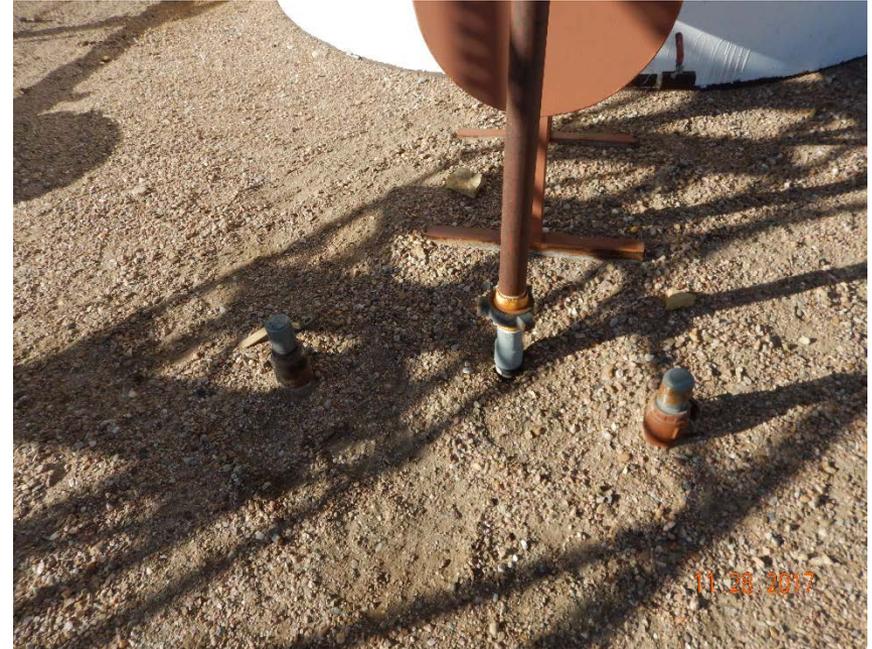
Photo #18 – Unused 2" pipeline risers with bullplugs, located east of 300-bbl crude oil ASTs.

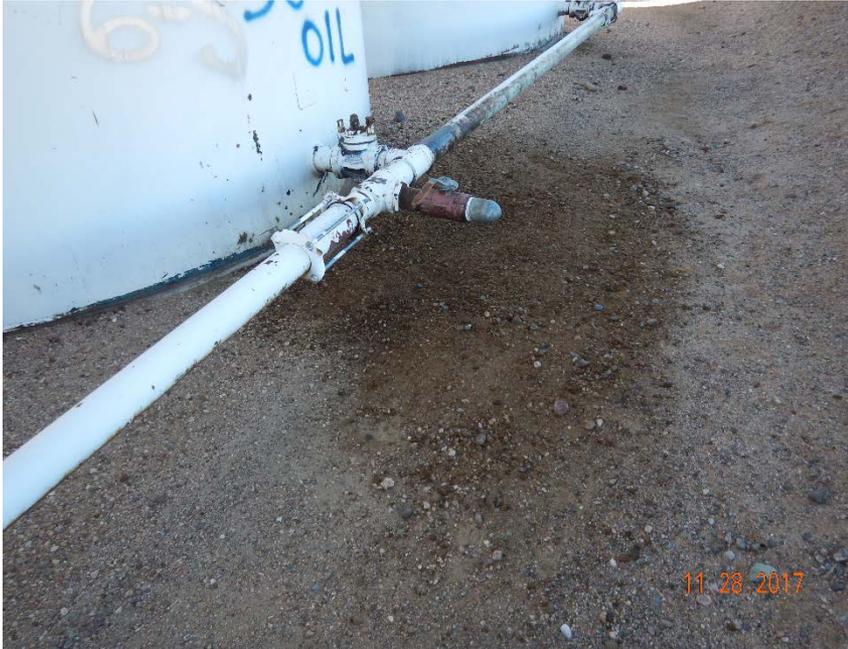
Photo #19 – Localized, oil-stained soil beneath crude oil loadout line.

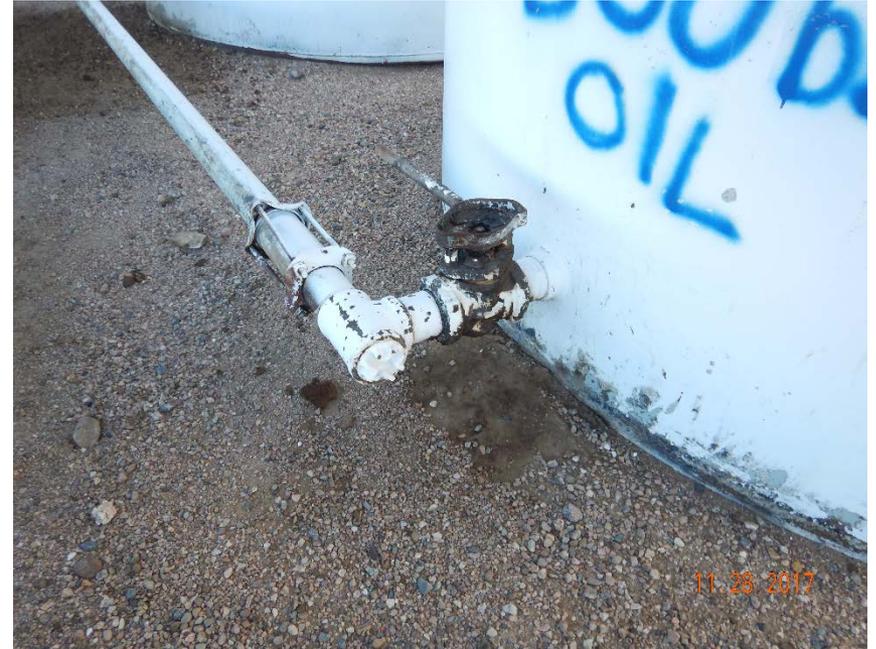
Photo #20 – Localized, oil-stained soil beneath valve on north side of 300-bbl crude oil AST.

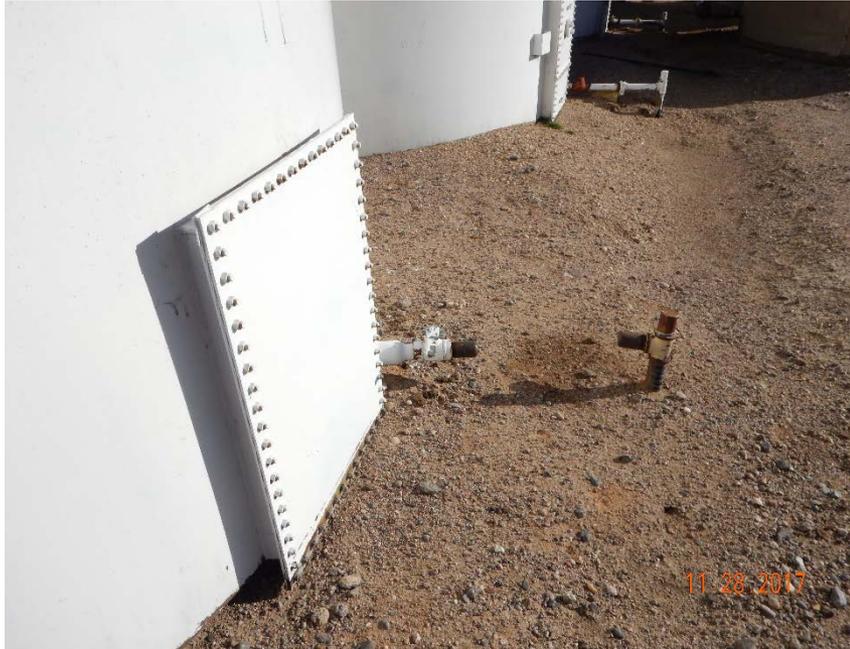
Photo #21 – Bullplugged 2” steel flowline riser on south side of western 300-bbl crude oil AST indicates that the AST is unused. Note localized, oil-stained soil beneath flowline riser.

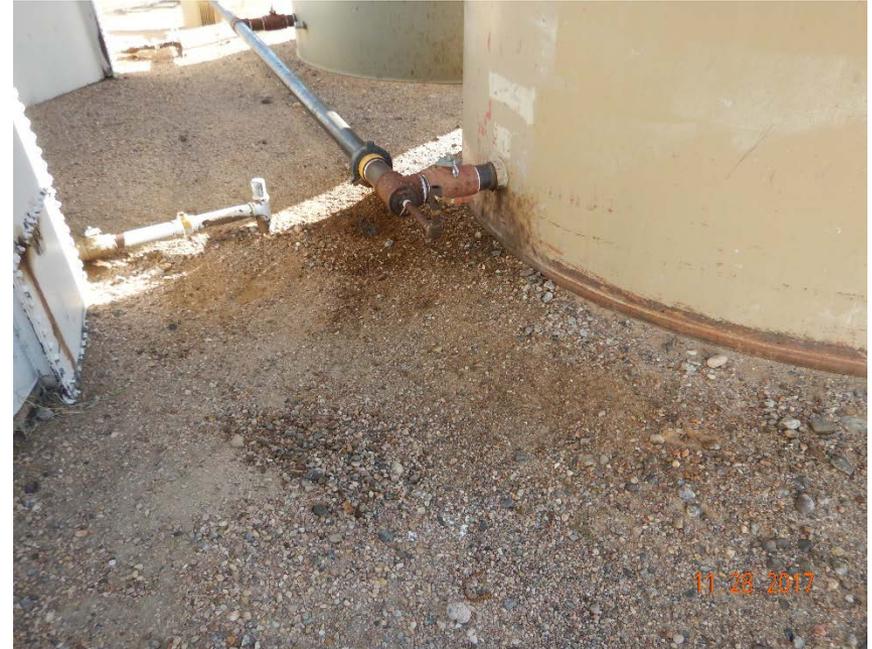
Photo #22 – Localized, oil-stained soil on north side of 400-bbl crude oil ASTs.
