Inspection Photos
Location Name: State #36-16
API: 05-123-20908
Inspection Date: November 28, 2017

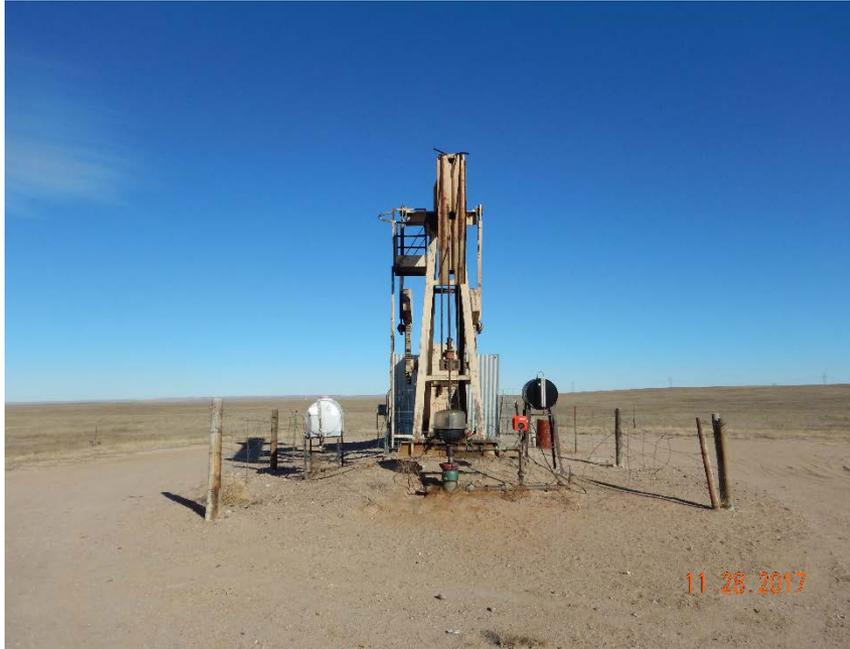
**Photo #1 – View of wellhead and pump jack from south.
Note localized accumulation of oily waste beneath wellhead
and lack of secondary containment devices beneath day
tanks.**

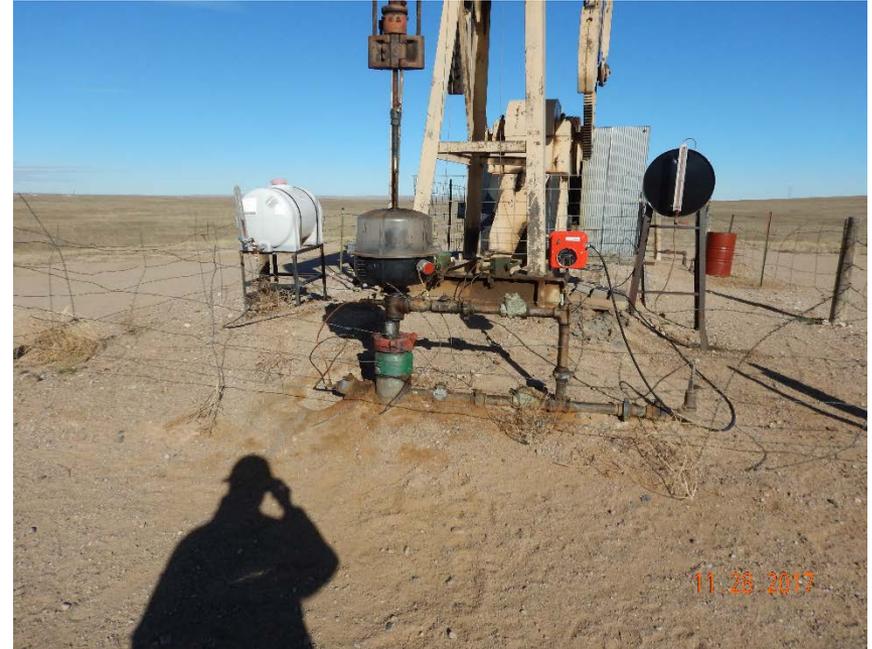
**Photo #2 – Localized accumulation of oily waste beneath
wellhead.**

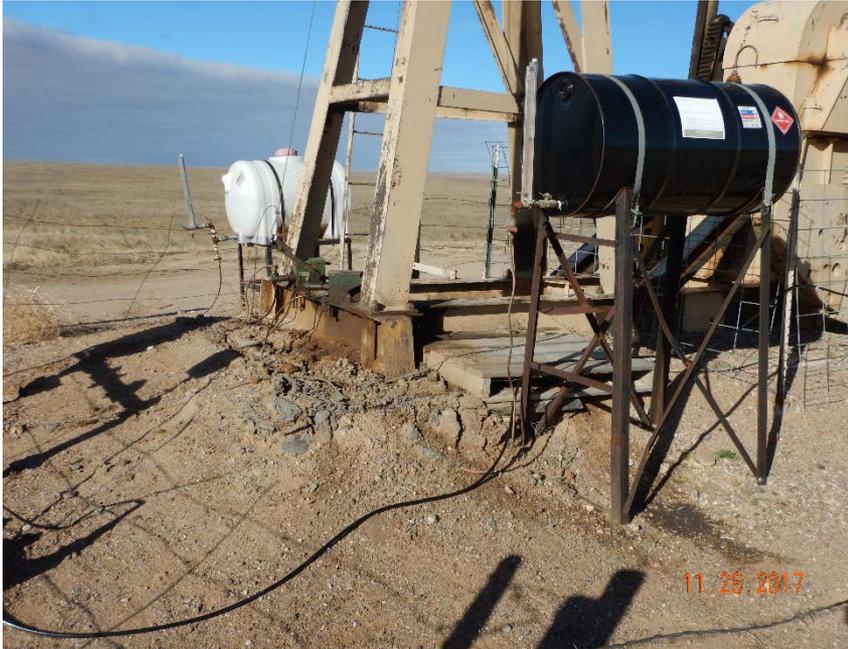
Photo #3 – Historical accumulations of oil-stained soil beneath day tanks at south end of pump jack. Day tanks lack secondary containment devices.

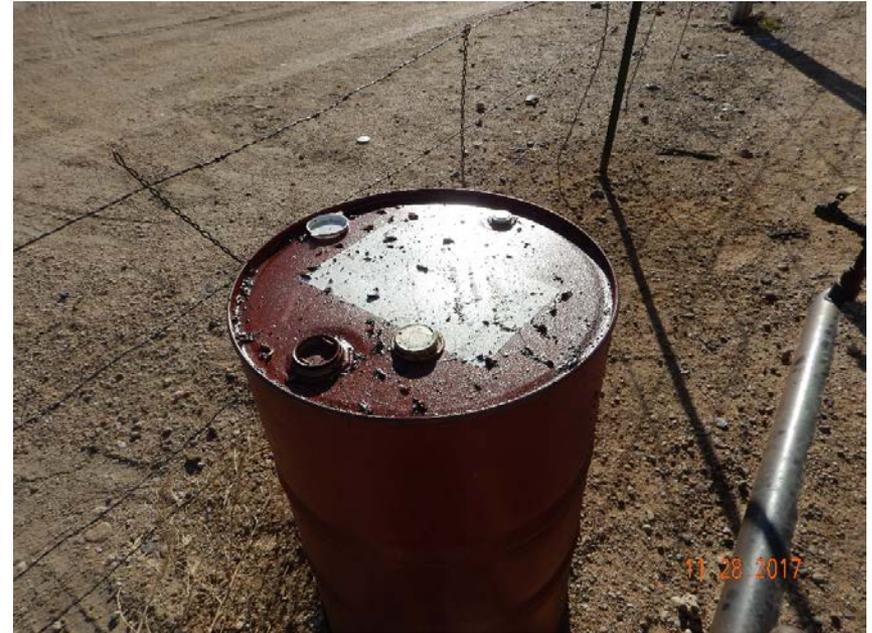
Photo #4 – Uncapped 55-gallon drum on east side of pump jack shed.

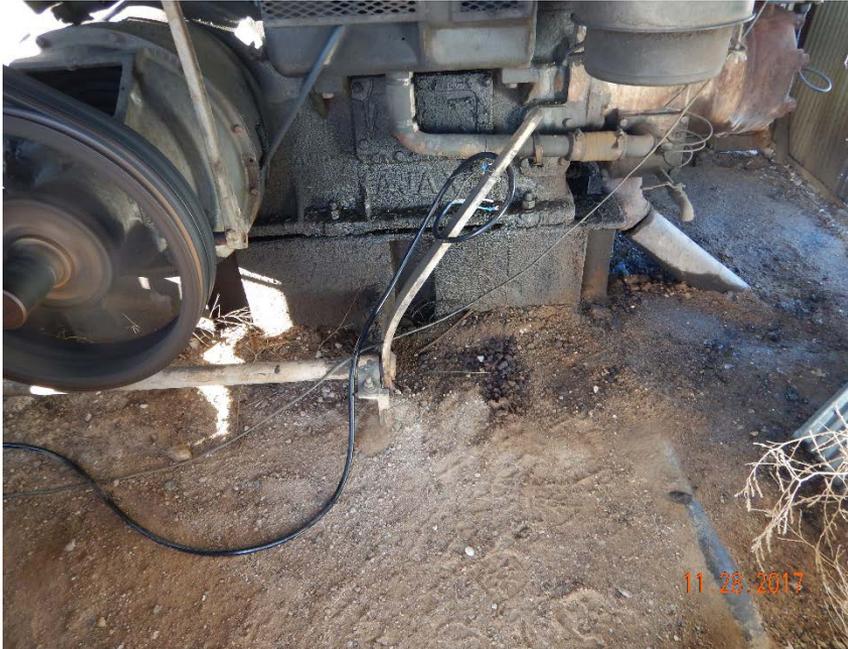
Photo #5 – Historical accumulation of oil-stained soil beneath prime mover.

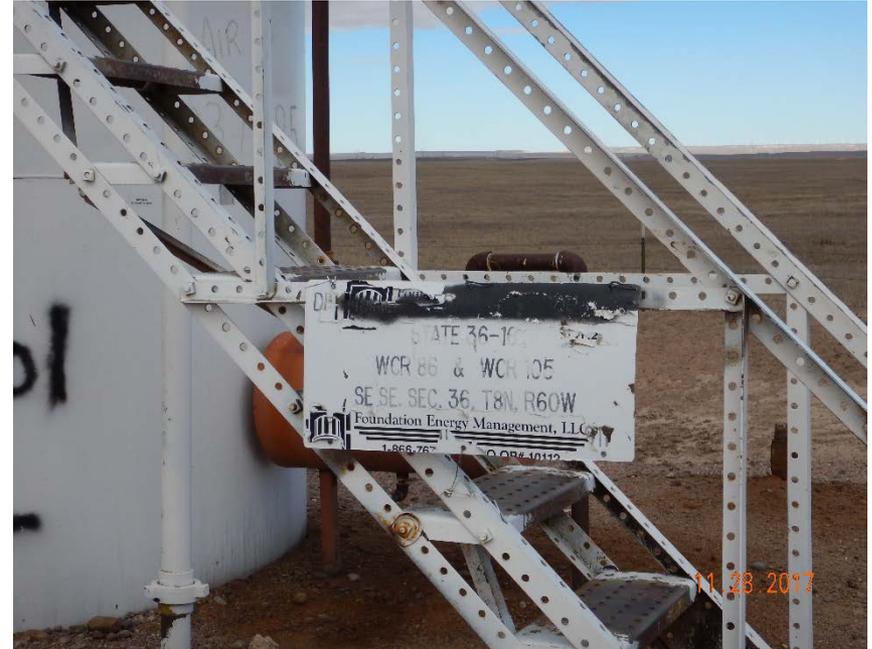
Photo #6 – Battery sign in need of repair. Note that emergency contact information is illegible.

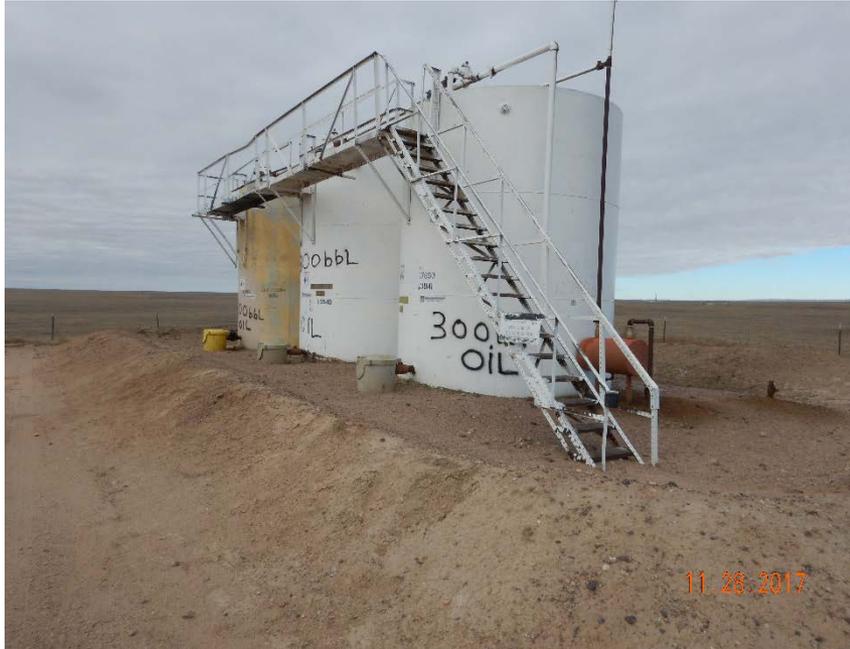
**Photo #7 – View of crude oil tank battery from southeast.
Note shallow earthen berm and oil-stained soil east of tanks.**

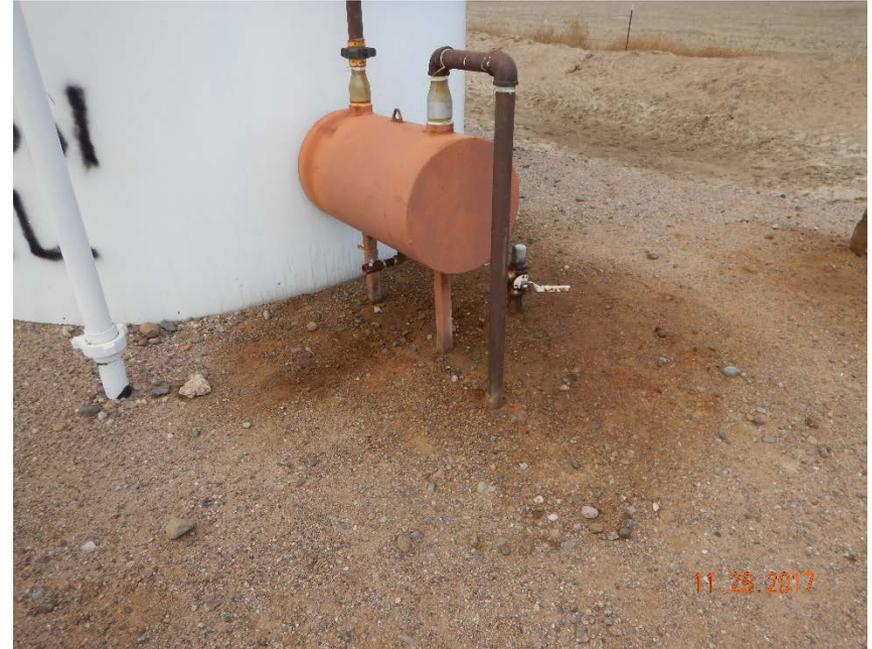
**Photo #8 – Localized, oil-stained soil beneath flowline risers
on east side of crude oil tank battery.**

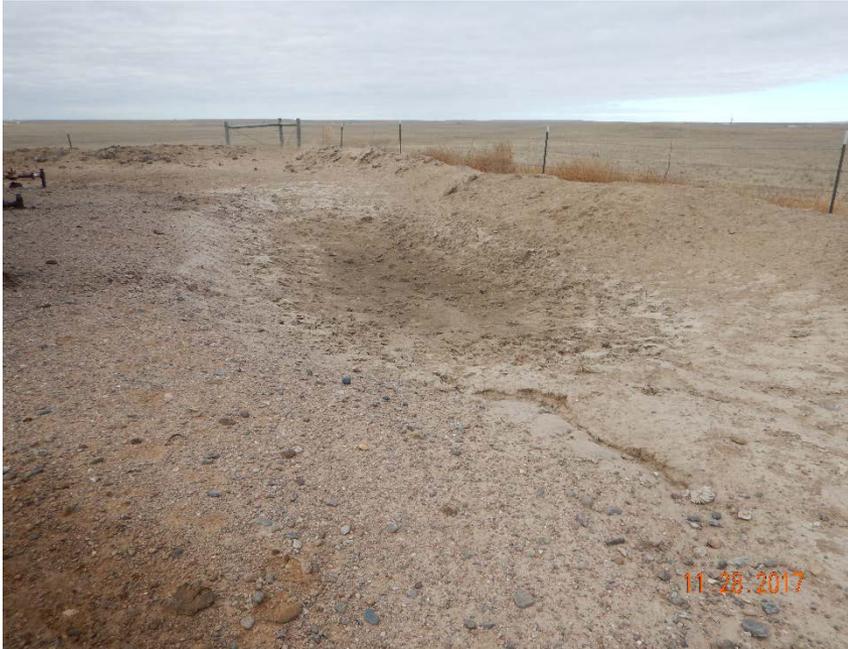
Photo #9 – Depression inside of earthen berm, north of crude oil ASTs.

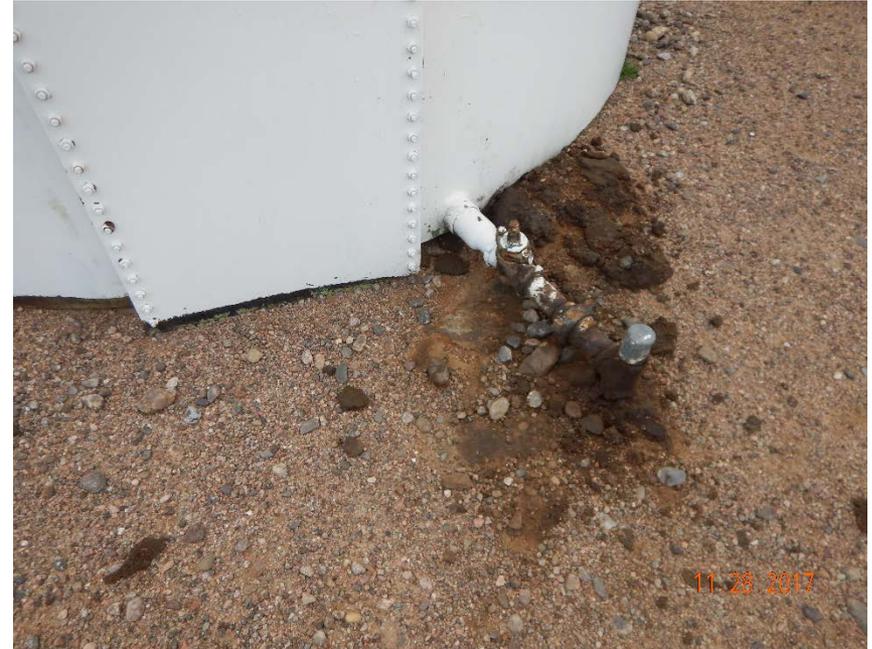
Photo #10 – Historical accumulation of oily waste beneath valves on crude oil ASTs (1).

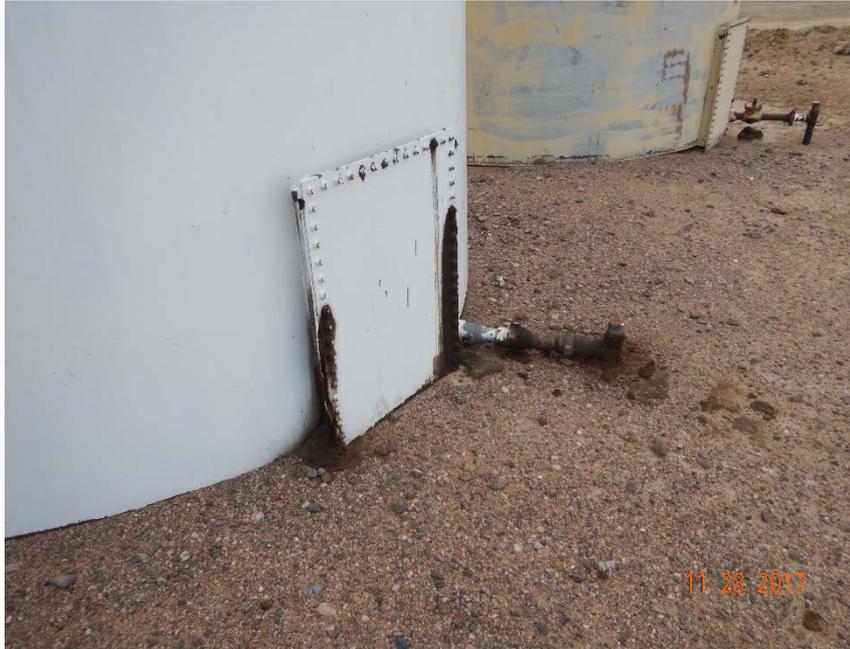
Photo #11 - Historical accumulation of oily waste beneath valves on crude oil ASTs (2).

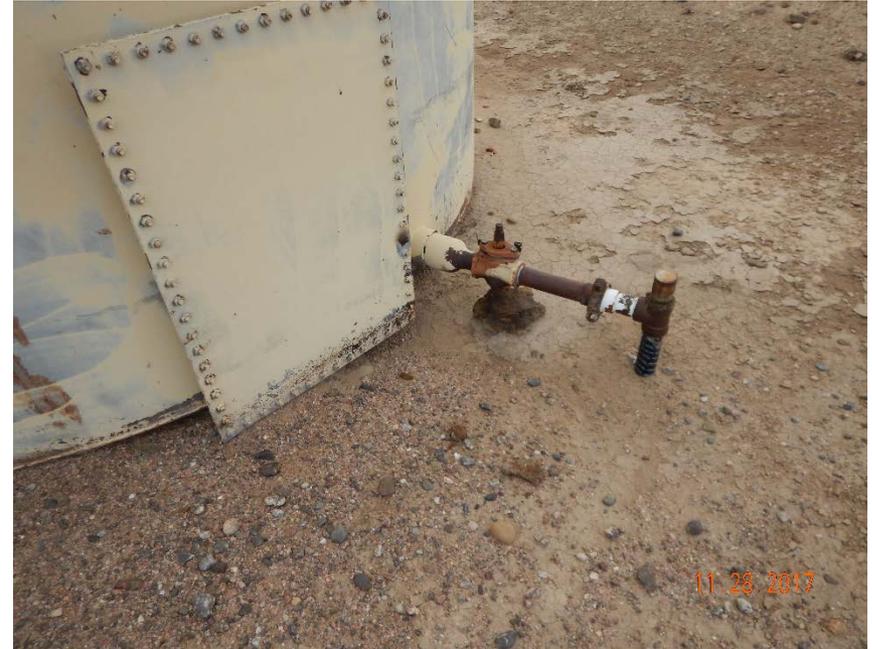
Photo #12 - Historical accumulation of oily waste beneath valves on crude oil ASTs (3).

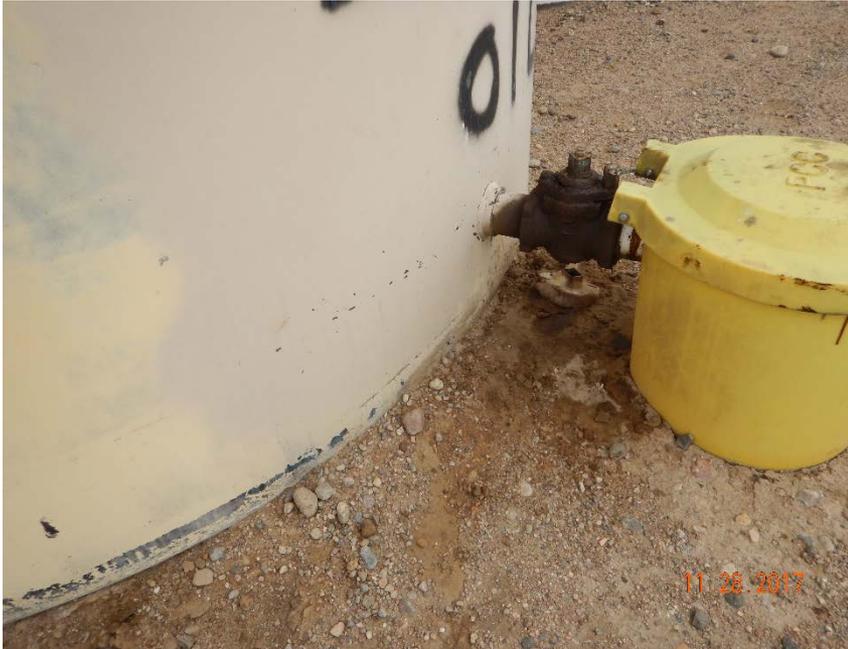
Photo #13 - Historical accumulation of oily waste beneath valves on crude oil ASTs (4).

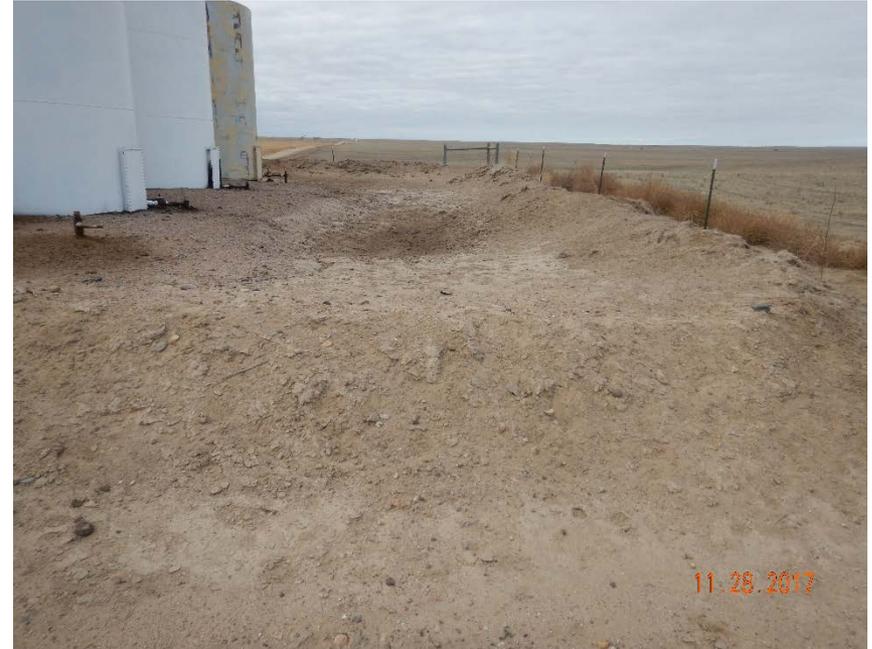
Photo #14 – Earthen berm surrounding crude oil ASTs is shallow and eroded.

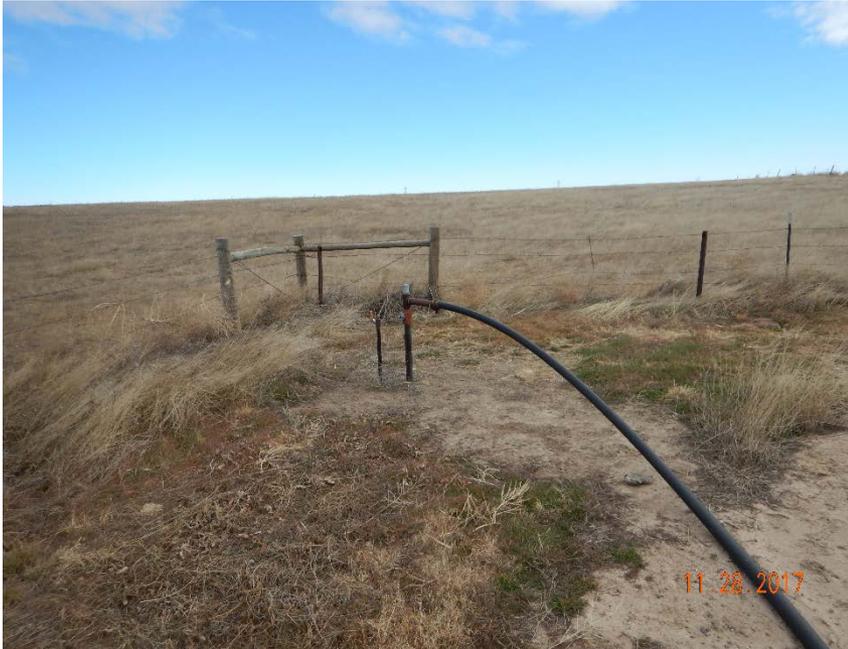
Photo #15 – Flowline risers plumbed to discharge into production pit.

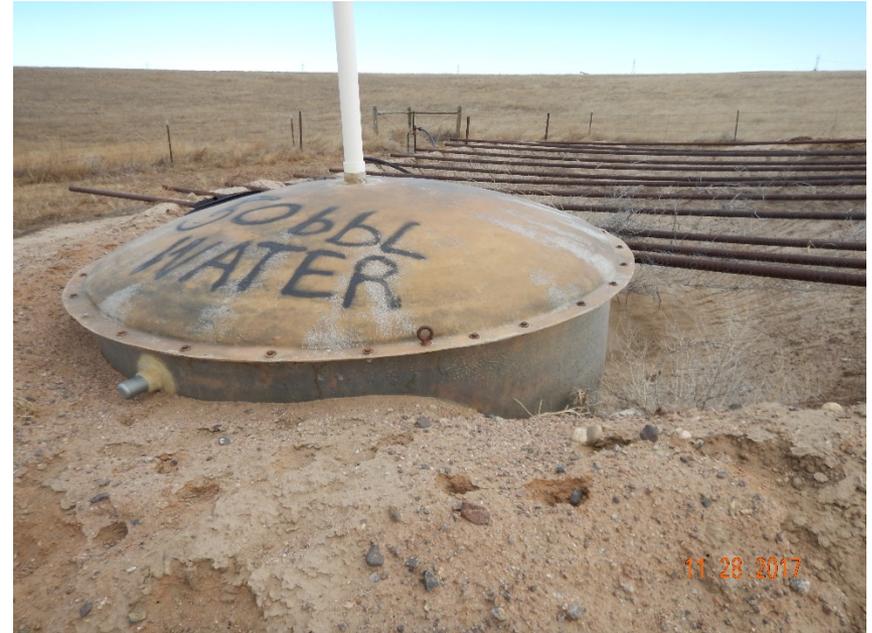
Photo #16 – Skim tank is partially buried in west berm of production pit (Facility ID #273446).

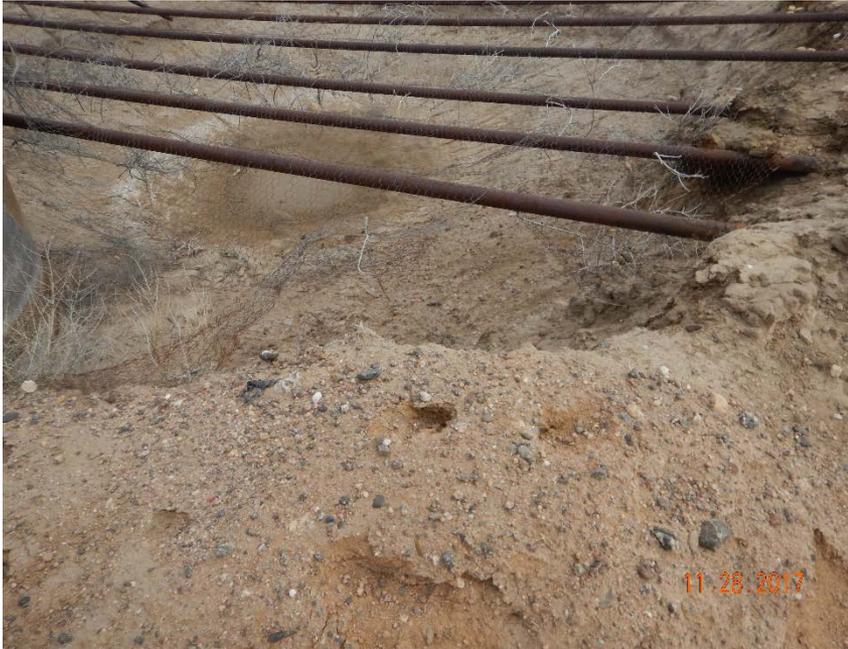
Photo #17 – Damaged berms, gaps in mesh, accumulation of weeds, and stained soil at SW corner of production pit (1).

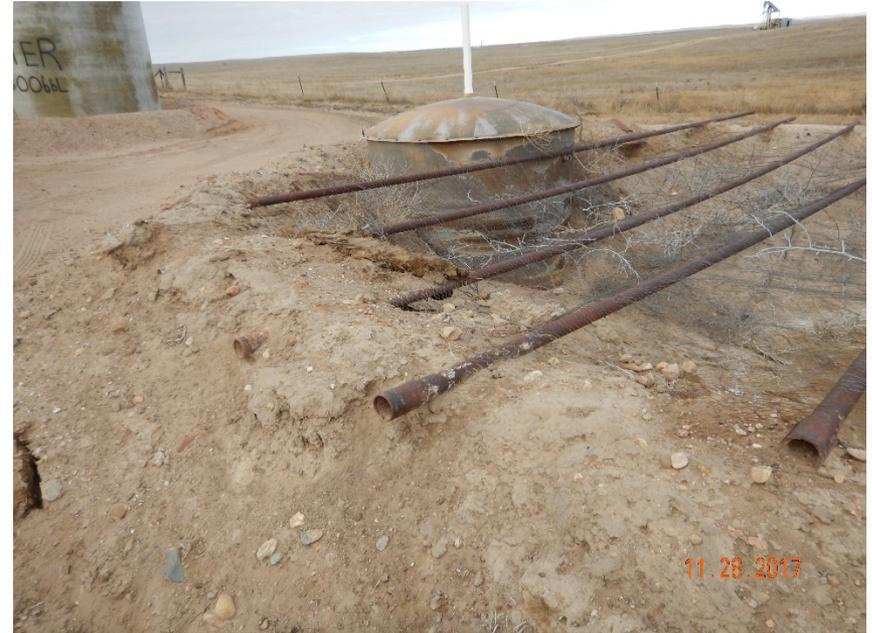
Photo #18 - Damaged berms, gaps in mesh, accumulation of weeds, and stained soil at SW corner of production pit (2).

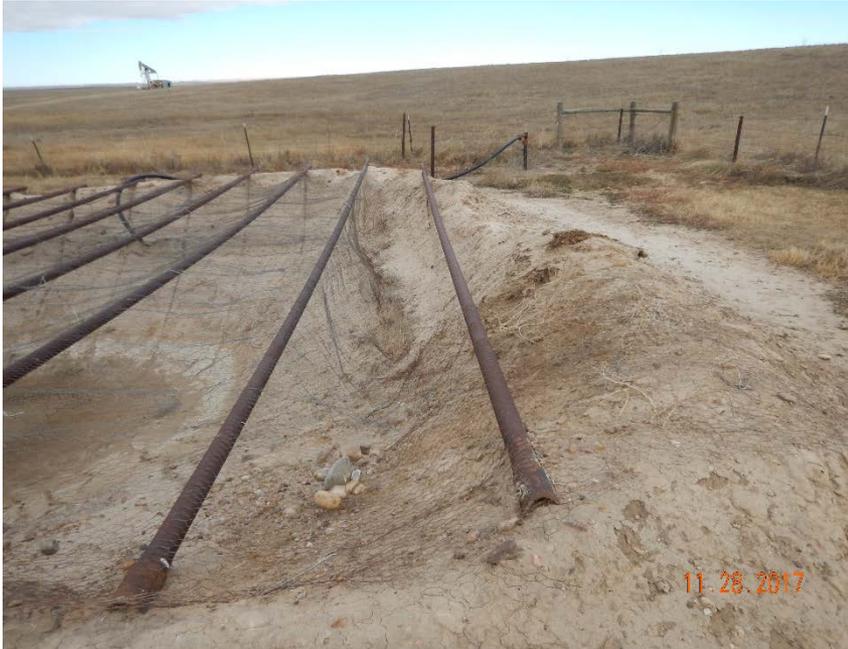
Photo #19 - Damaged berms, gaps in mesh, and stained soil along east side of production pit (1).

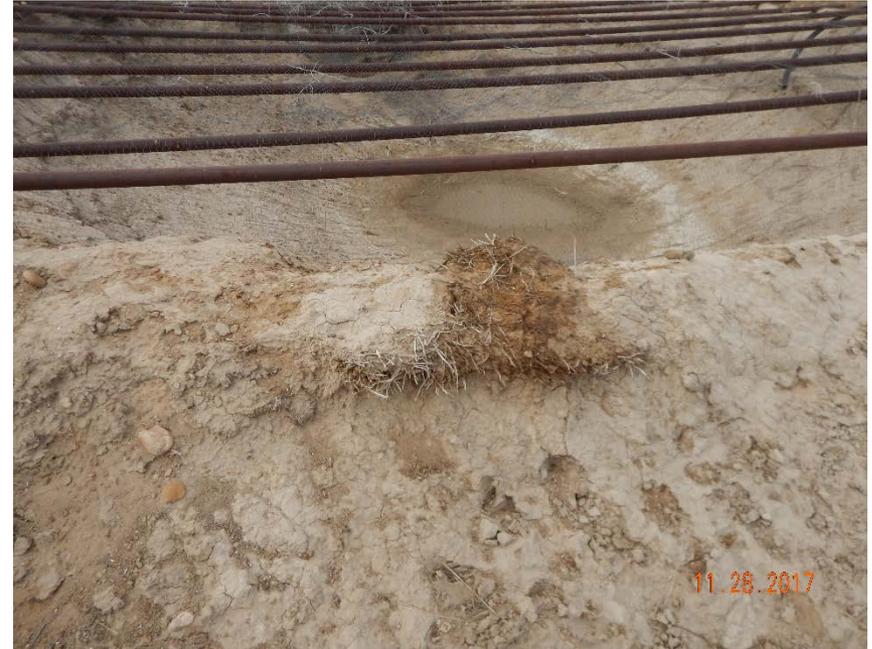
Photo #20 - Damaged berms, gaps in mesh, and stained soil along east side of production pit (2).

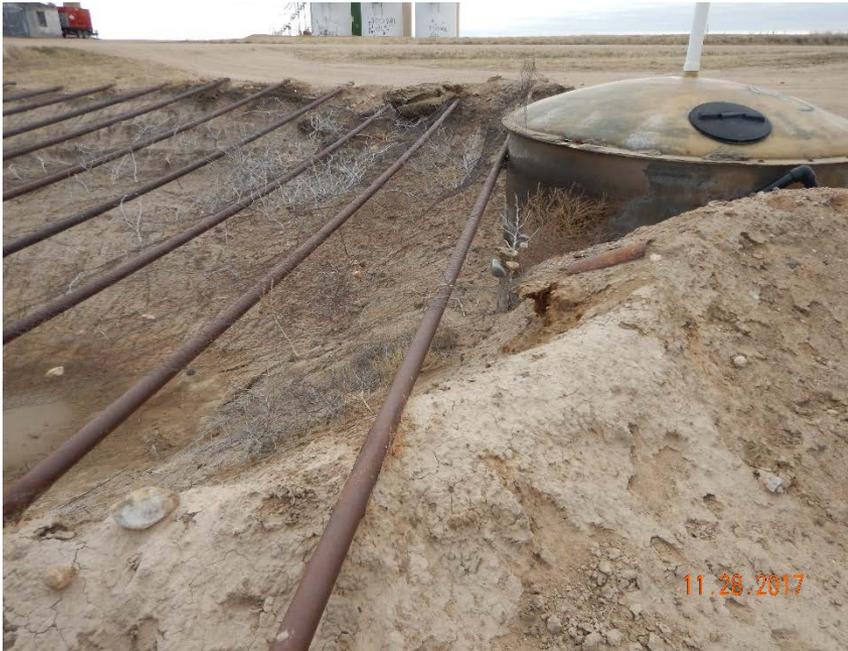
Photo #21 - Damaged berms, gaps in mesh, accumulation of weeds, and stained soil at NW corner of production pit.

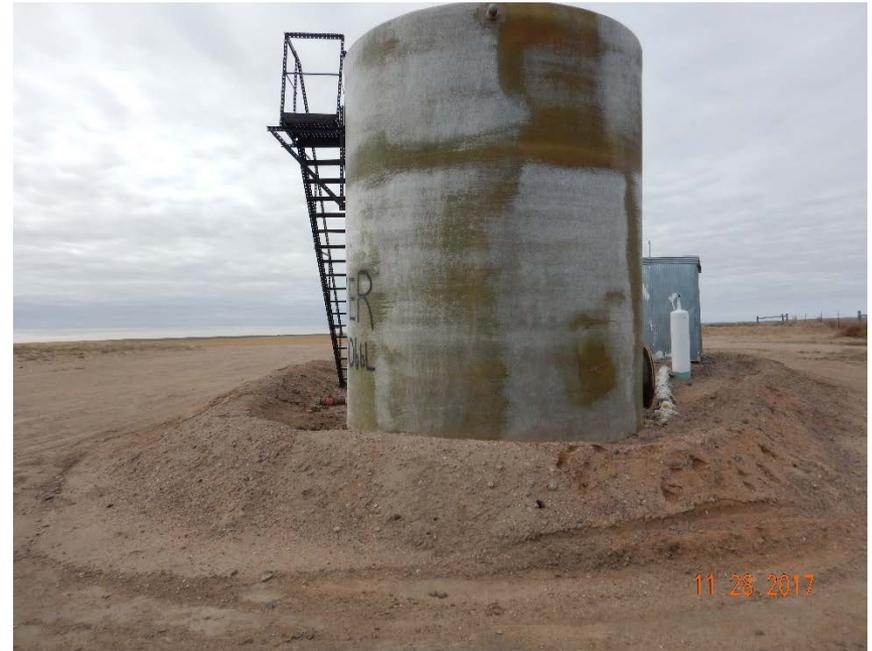
Photo #22 – Eroded and damaged earthen berm around produced water tank has inadequate capacity.

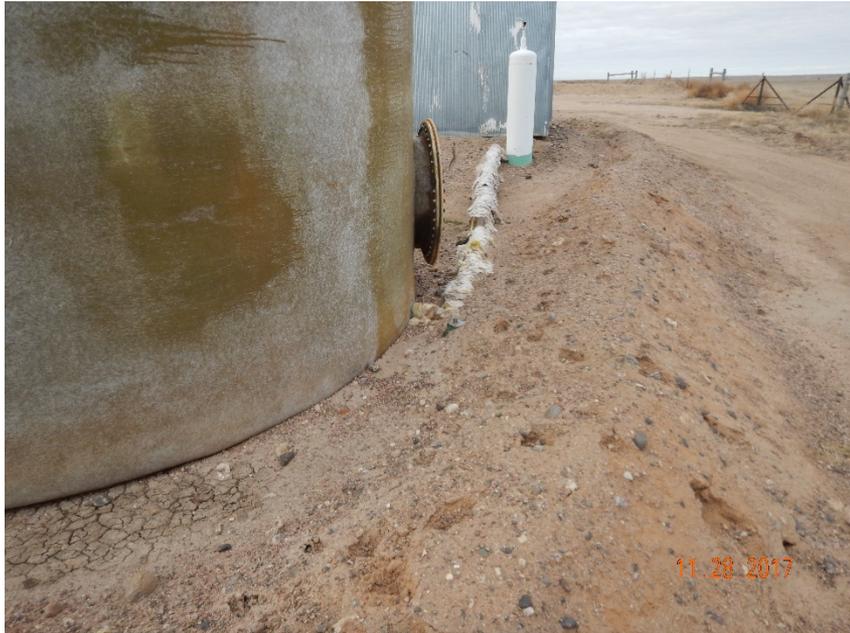
Photo #23 - Eroded and damaged earthen berm around produced water tank has inadequate capacity.

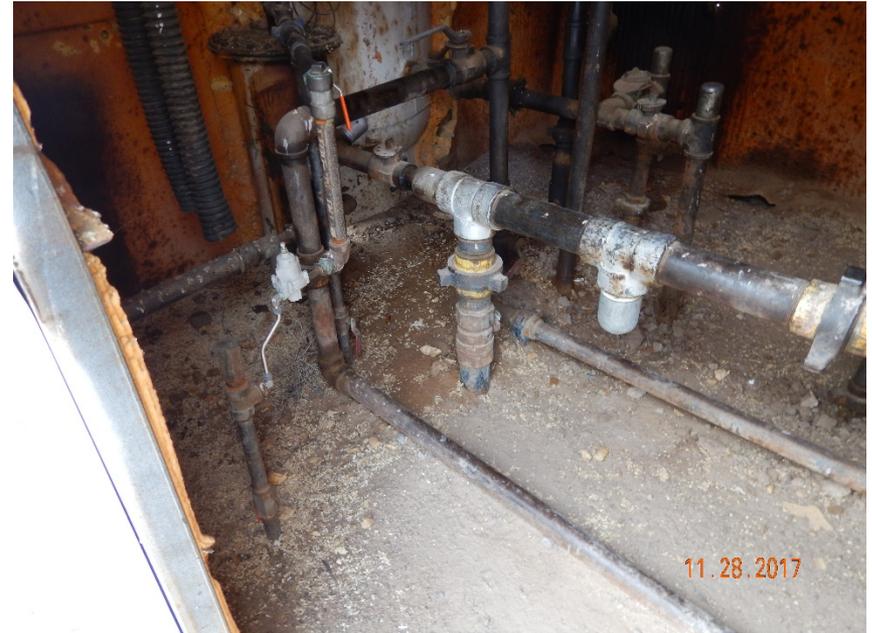
Photo #24 – Historical accumulations of oily waste inside of separator/treater shed.
