COGCC conducted an inspection of the Owl Creek State 10-16 location (Location ID 332045) on November 16, 2017 (Document 684904715). During that inspection, COGCC made the following observations:

Name: Owl Creek State 10-16

Location ID: 332045

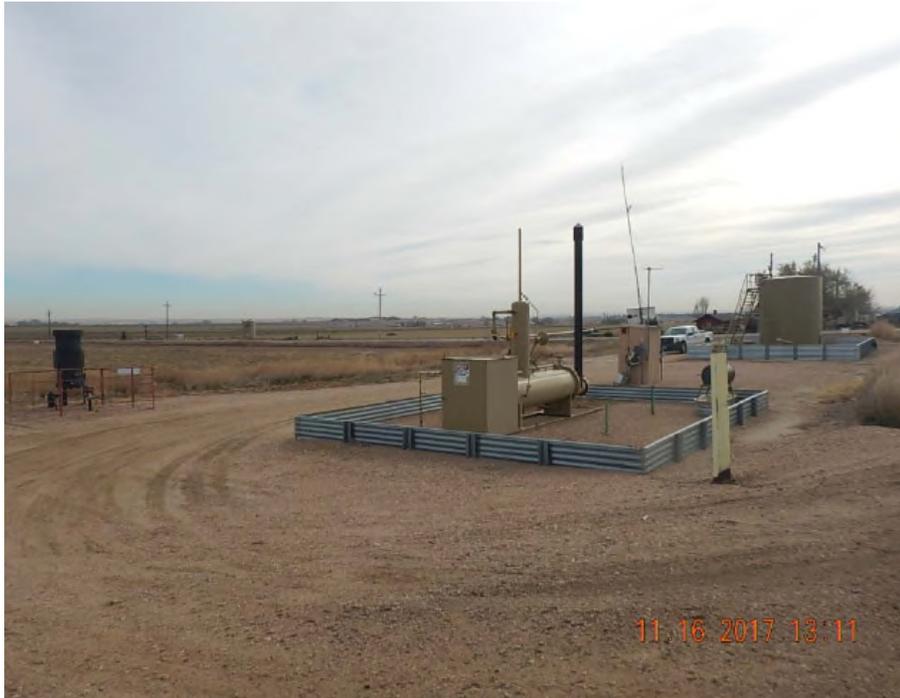
Photo 1: Location, looking SE

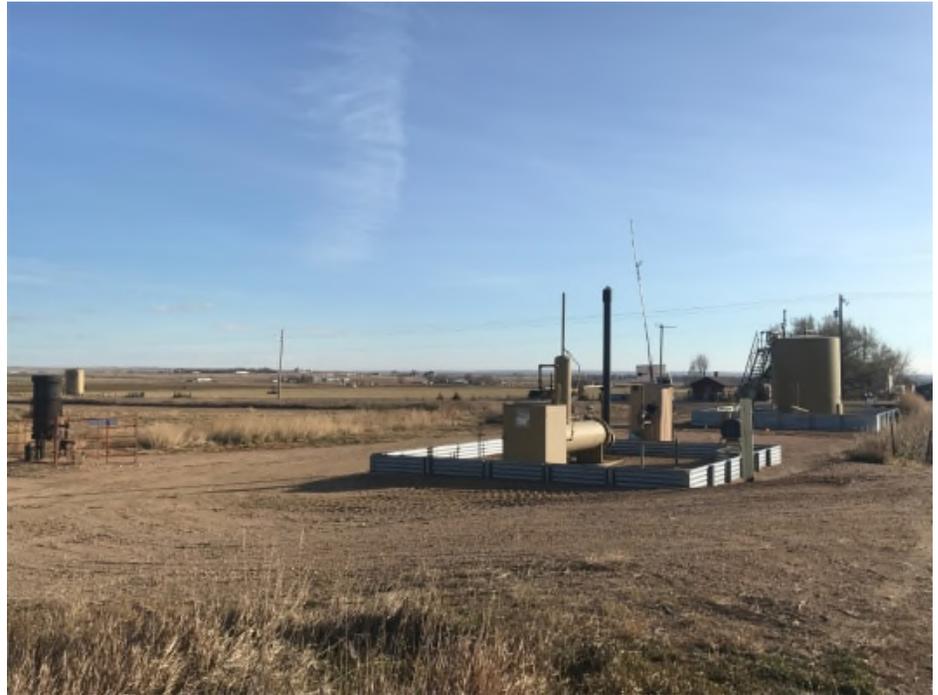
Photo NBL1. Location, looking SE.

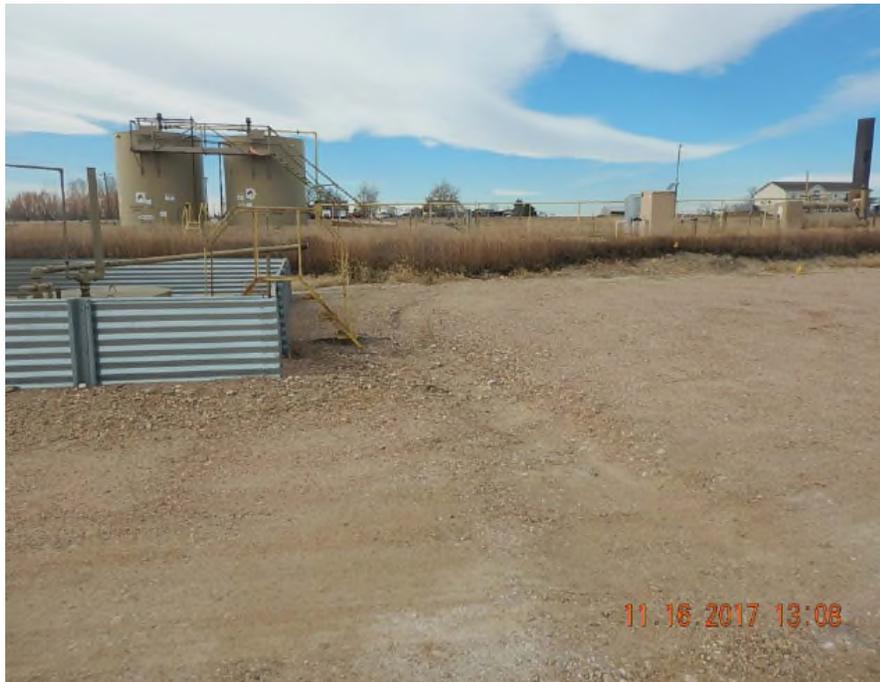
1. Storm Water: Stormwater channeling from W to E through center of location. Install or repair required BMPs per Rule 1002.f.

Photo 3: Stormwater channeling, looking W

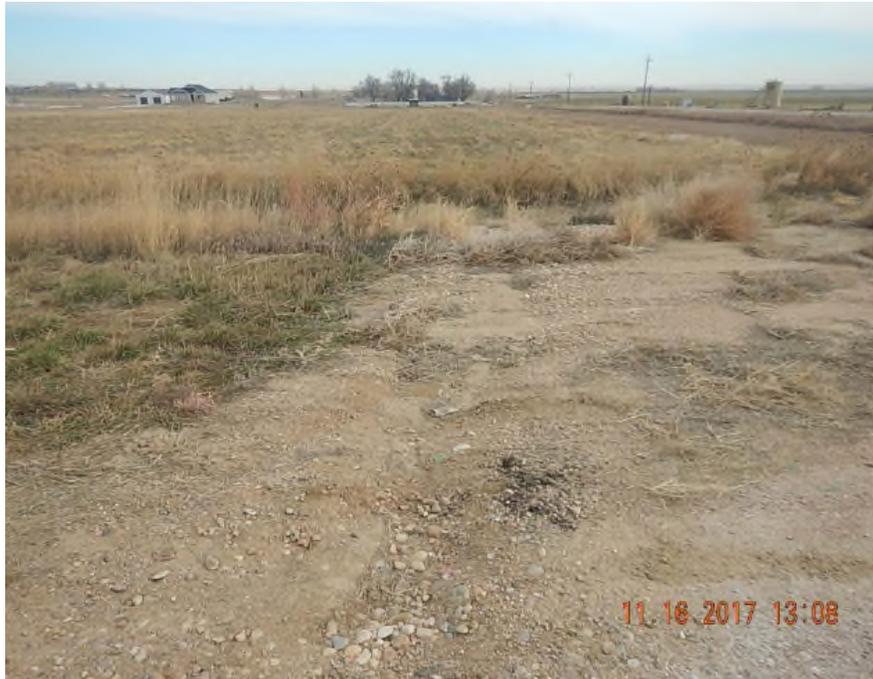
1. Storm Water: Stormwater channeling from W to E through center of location. Install or repair required BMPs per Rule 1002.f.

Photo 4: Stormwater channeling, looking E
