Litton Federal Gas Unit 2 Closure Photos Inspection 685303917

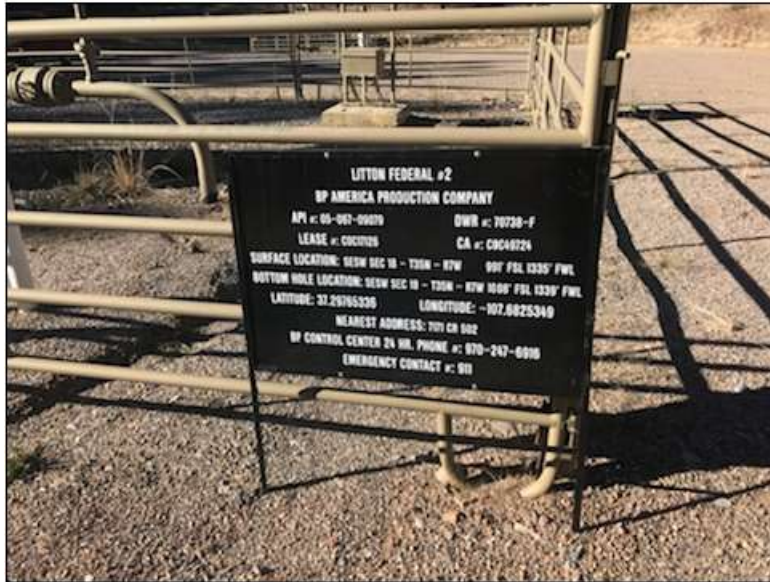
New Well Head Sign in place

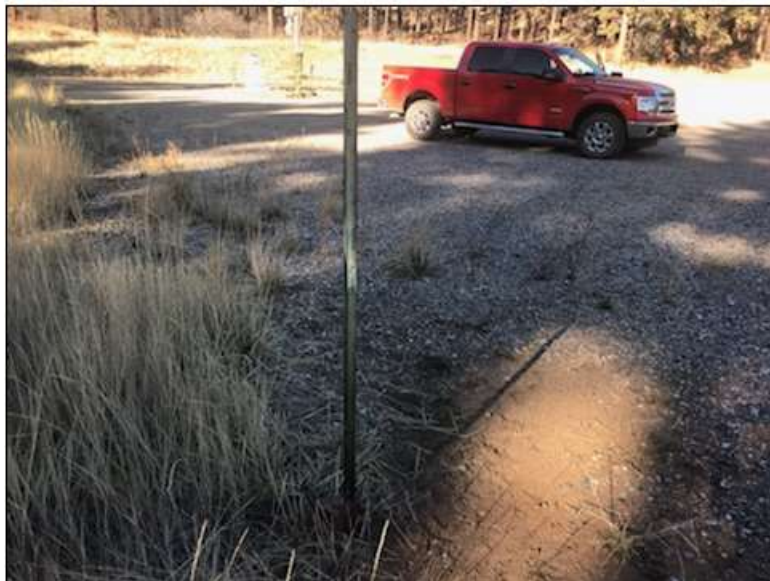
Rig Anchors Marked

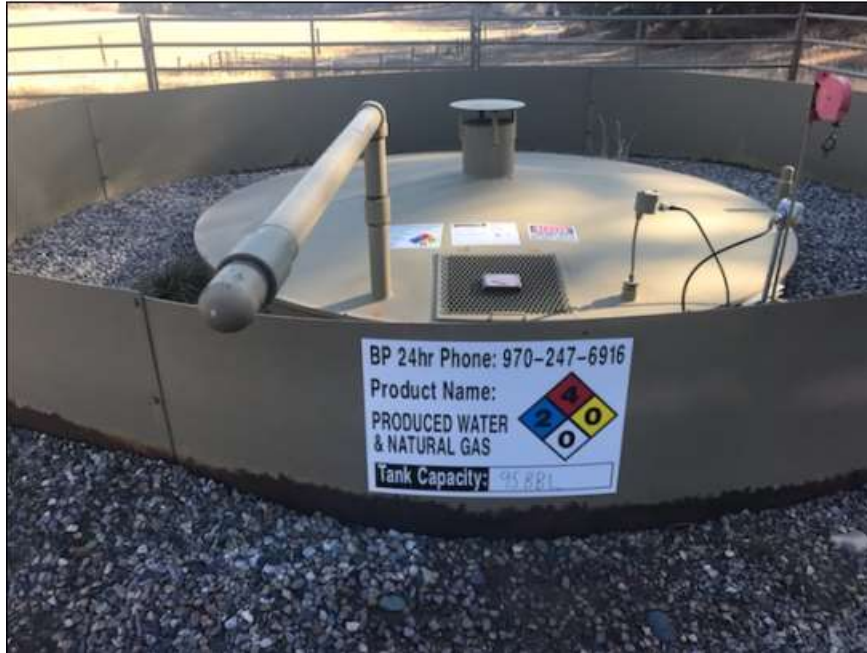
Tank sign in conspicuous location

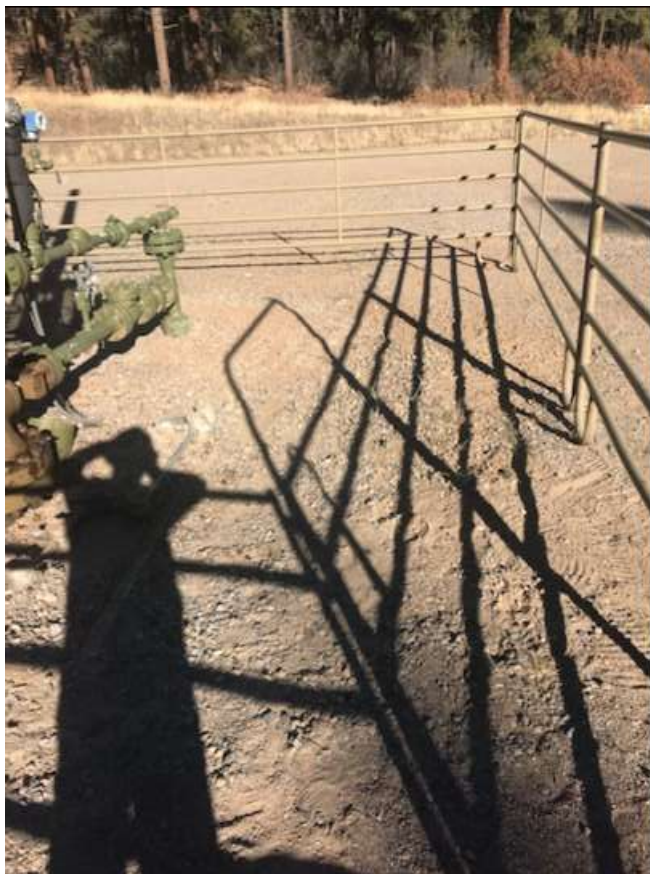
Stained soil around well head cleaned up and disposed of at the Operation Center Soil Box for remediation in bulk at IEI in Farmington NM
