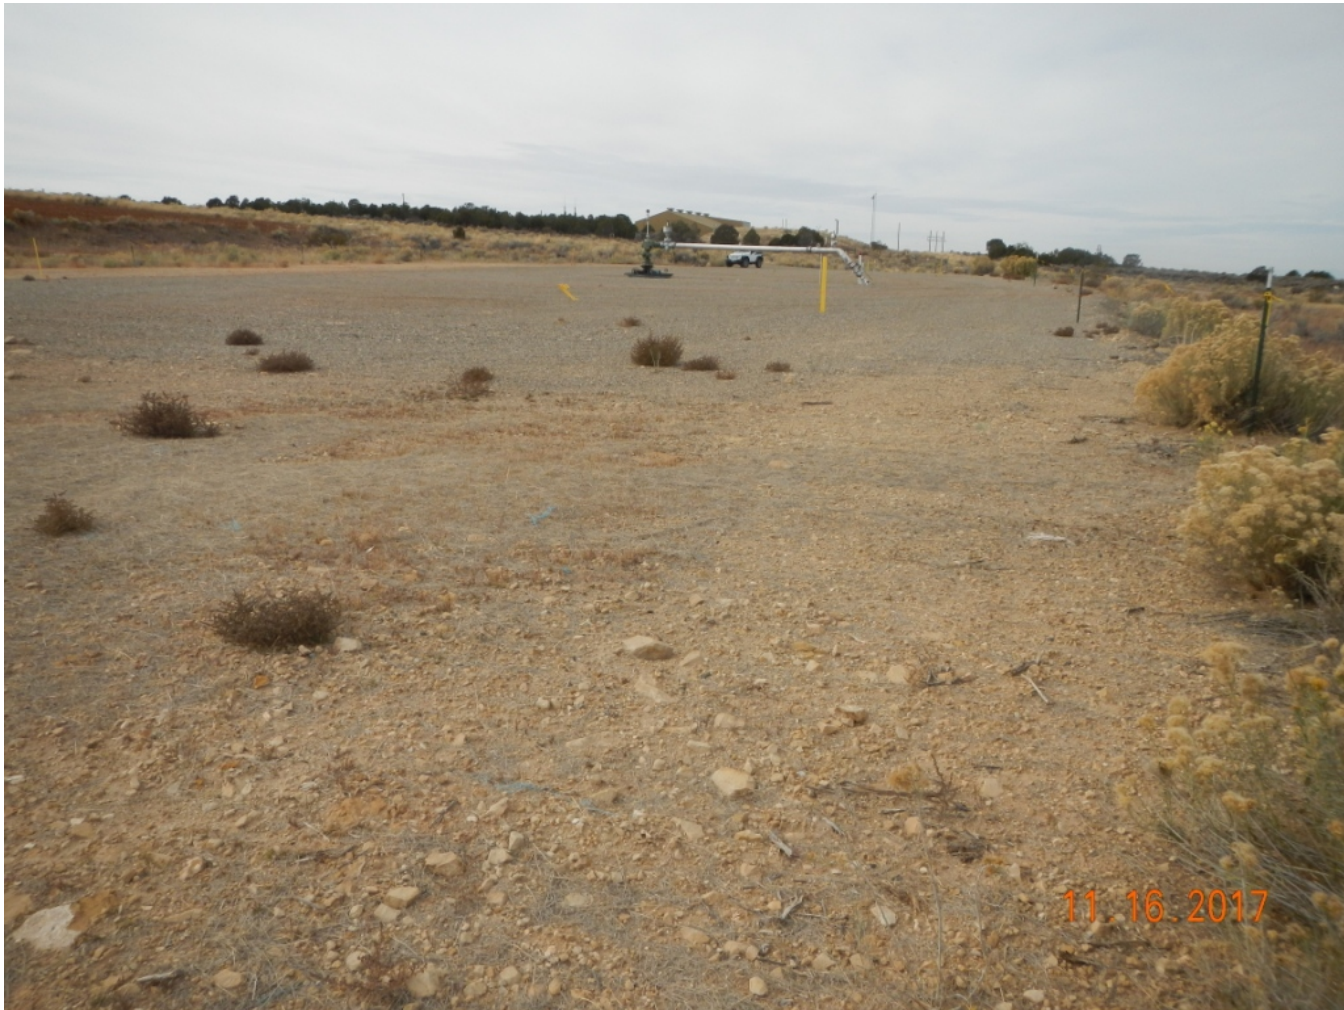
**Photo 1. View of the project area from the northeastern corner facing center.**

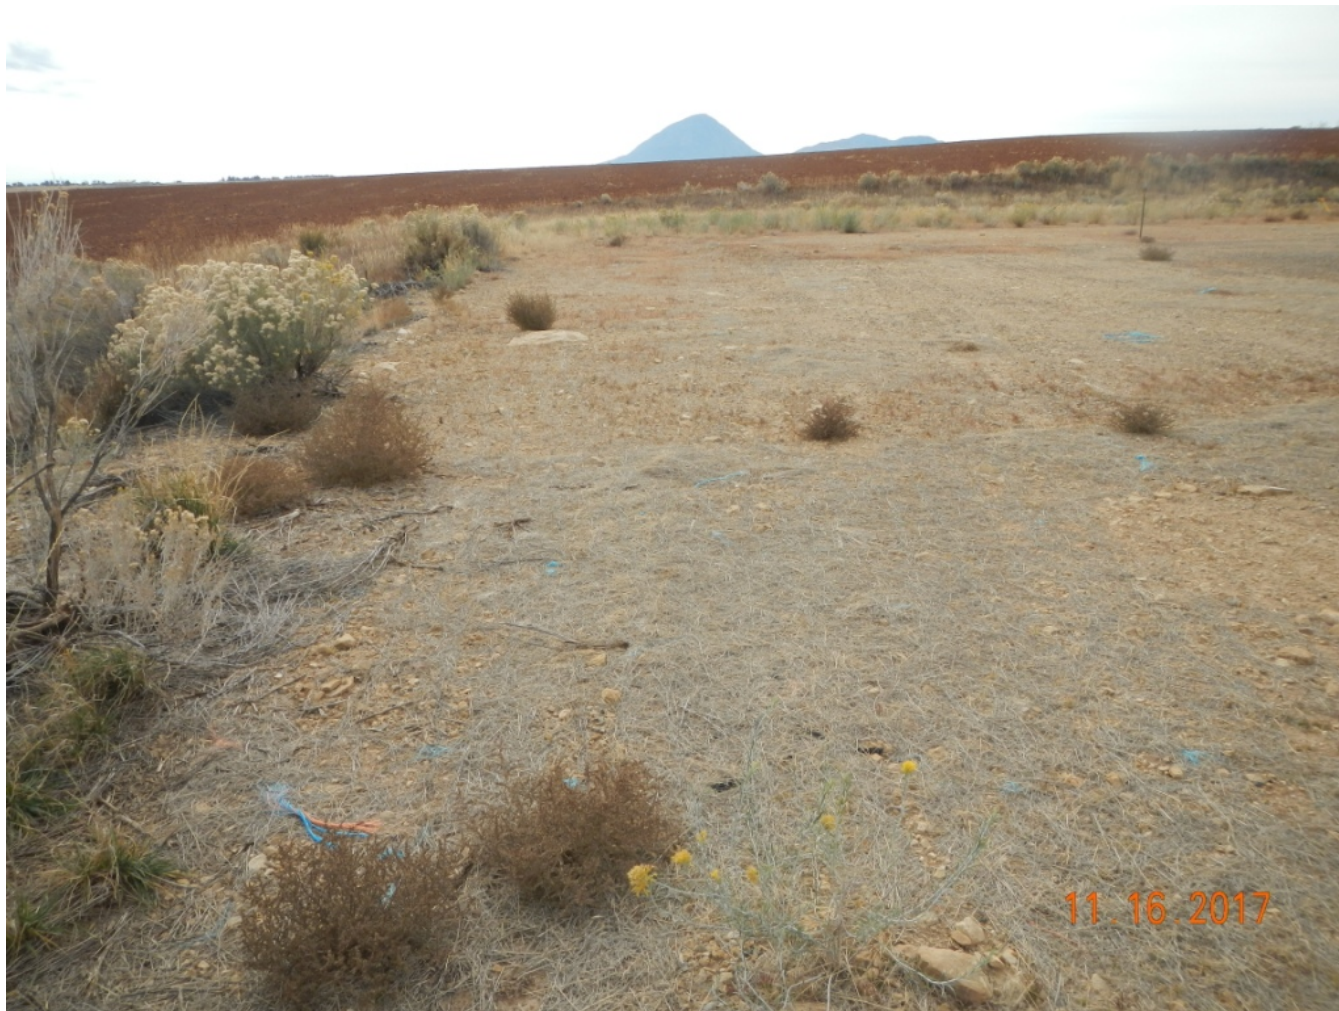
**Photo 2. View of the eastern portion of the project area from the northeastern corner facing southward. Flat, unused portions of the project area have recently been seeded and straw mulched.**

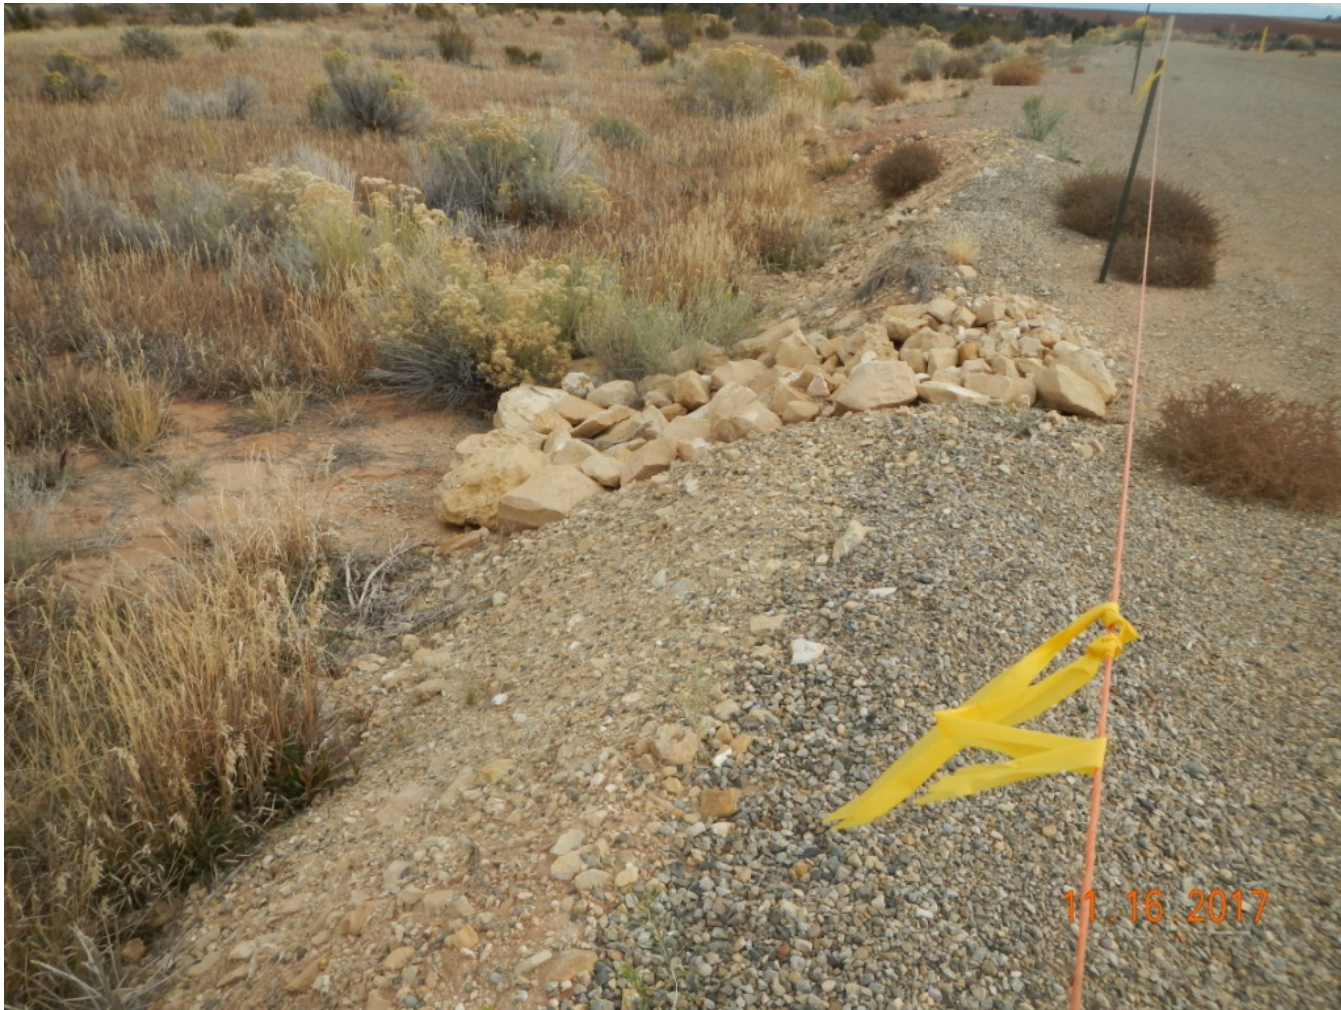
**Photo 3. View of rock run-down stormwater controls in the northern portion of the project area.**

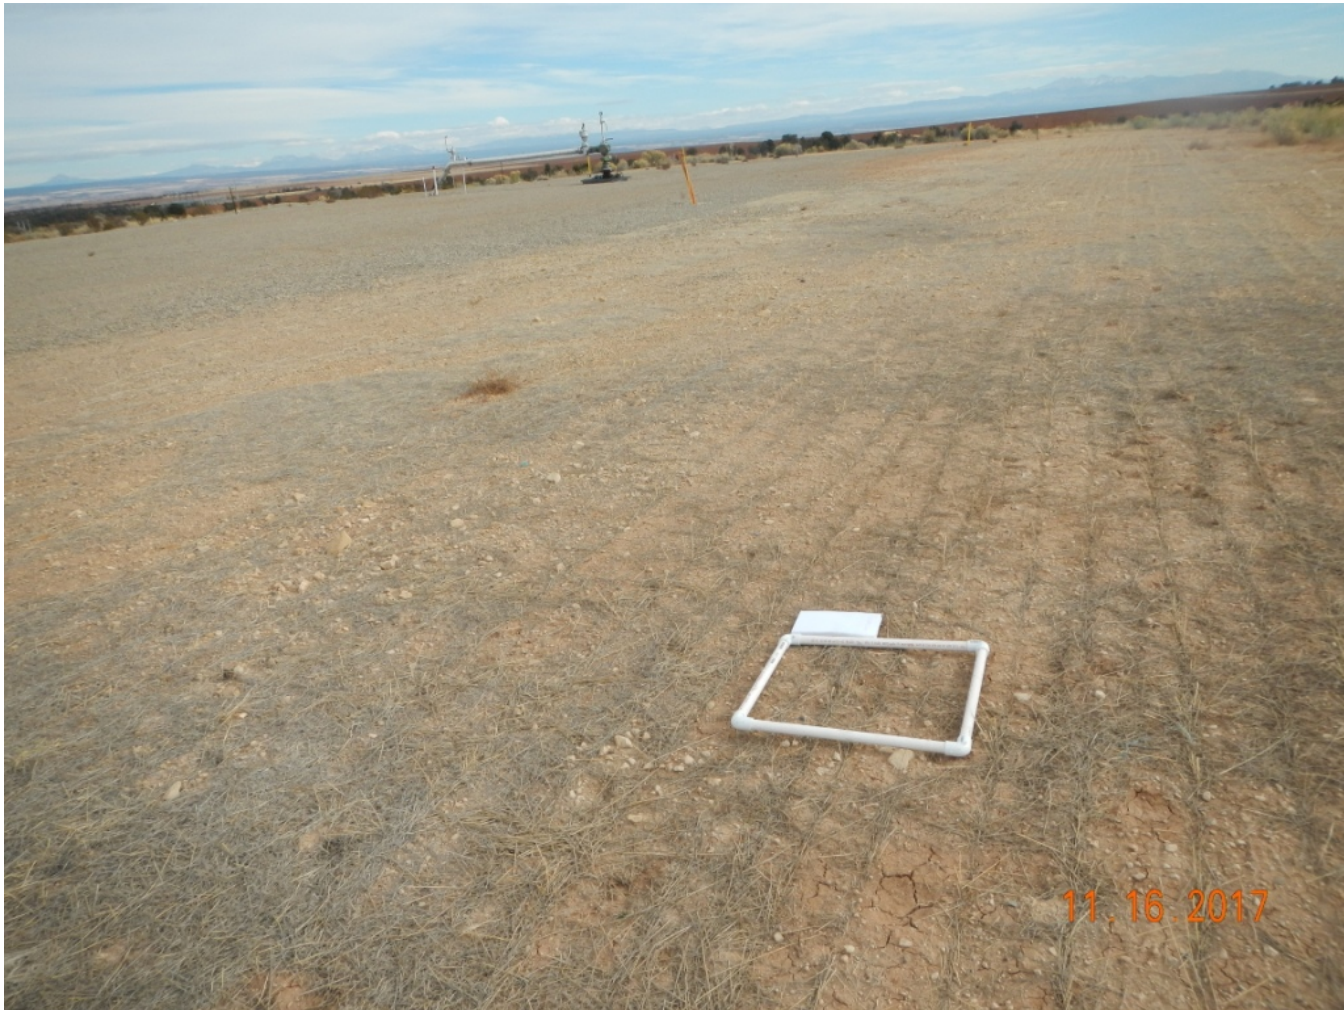
**Photo 4. View of germination Quadrat Sample-1 in the southwestern portion of the project area, facing center.**

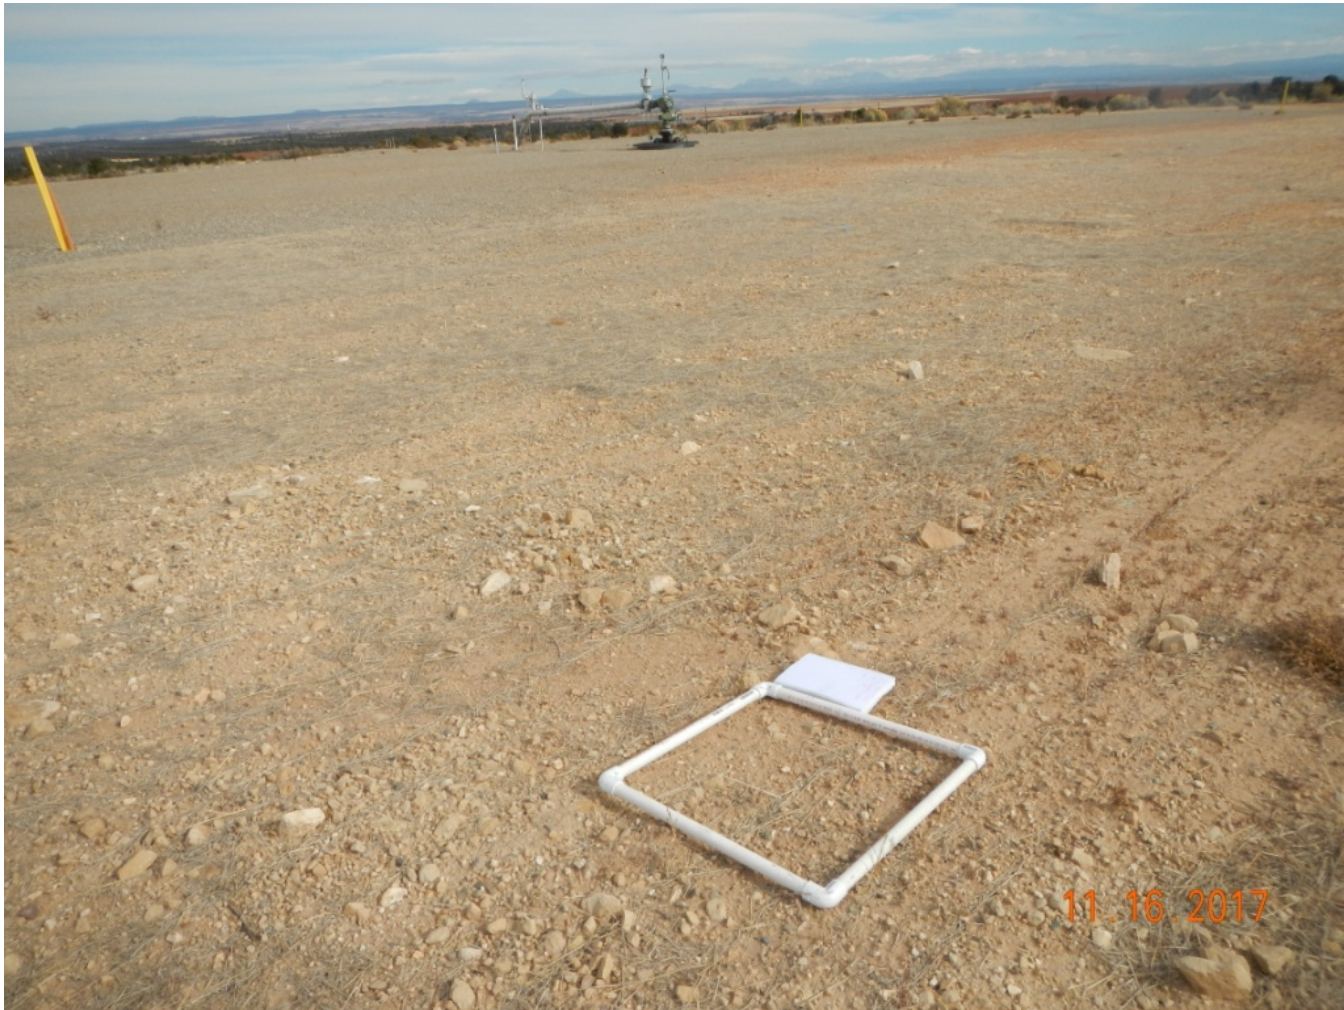
**Photo 5. View of germination Quadrat Sample-2 in the southern portion of the project area, facing center.**

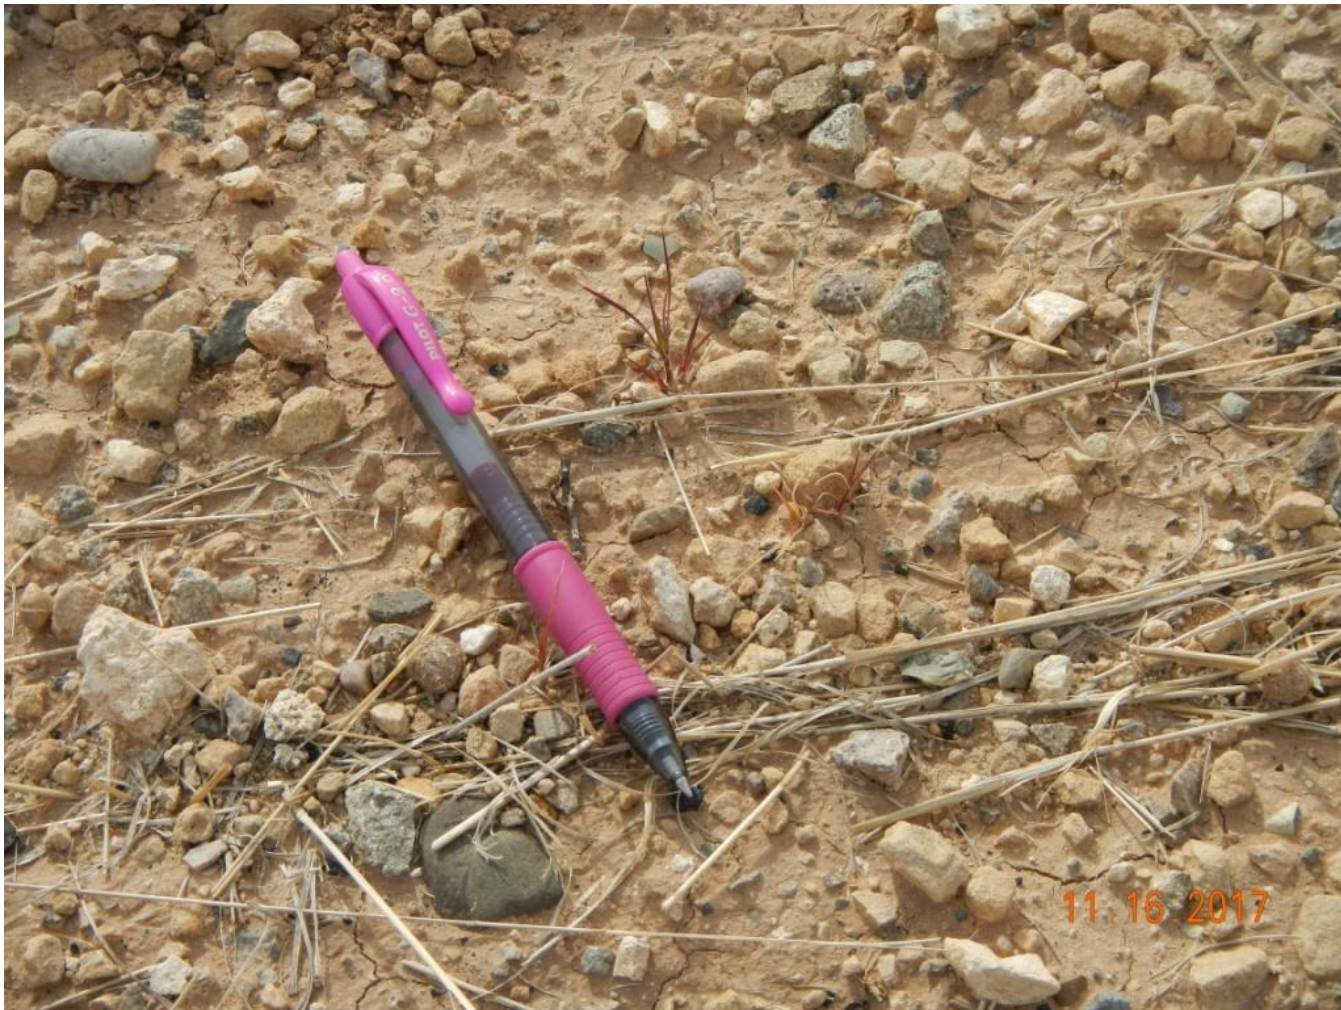
**Photo 6. Closeup view of typical young grass seedlings, appear to be blue grama (*Bouteloua gracilis*) within the germination quadrat sample area.**

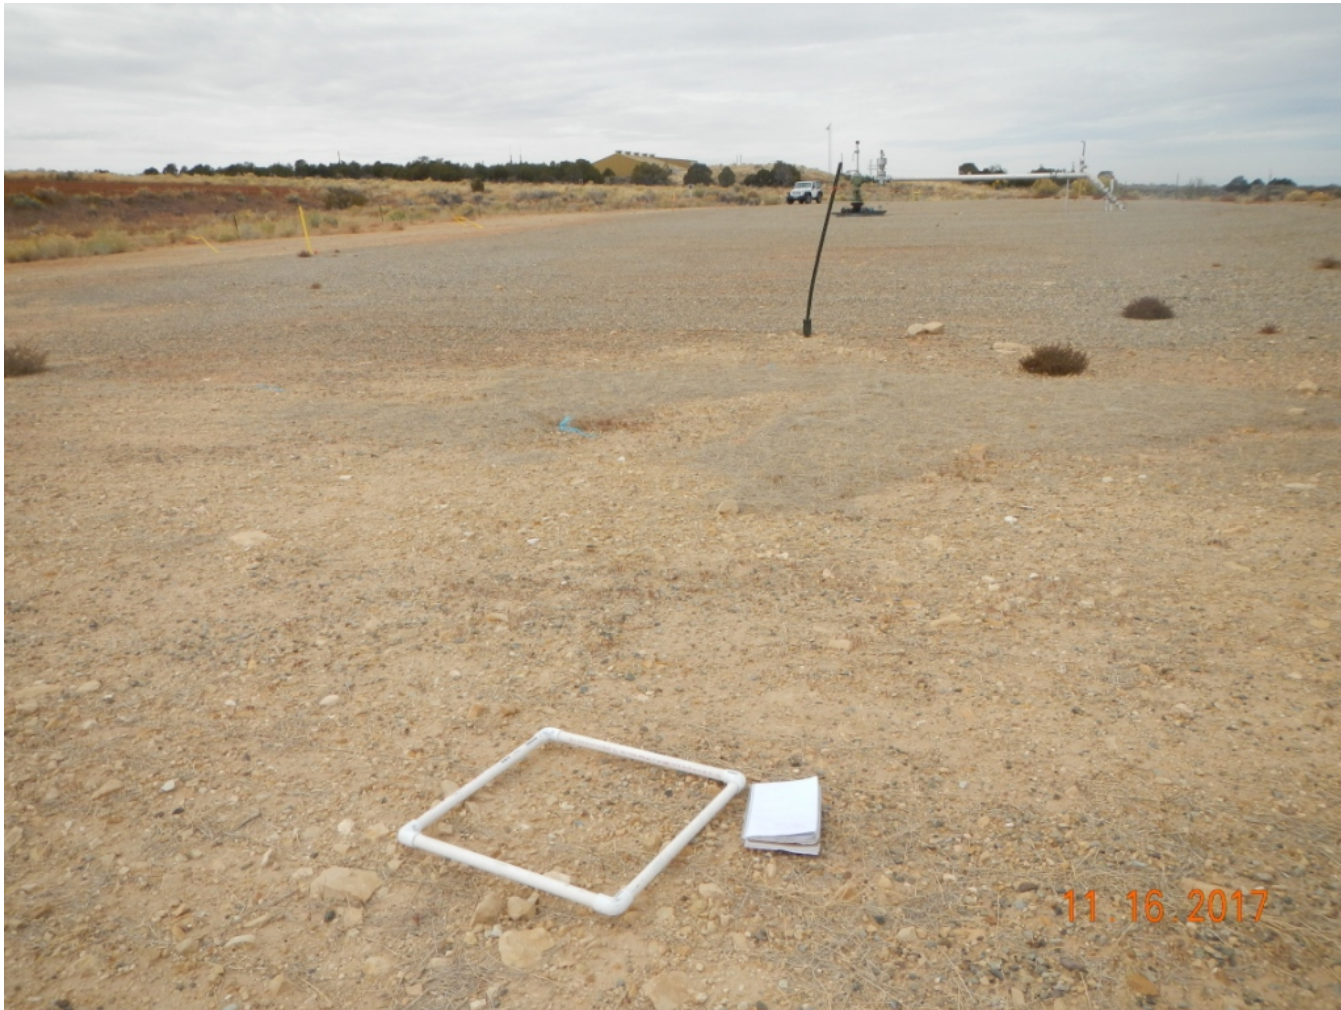
**Photo 7. View of germination Quadrat Sample-6 in the northeastern portion of the project area. Blue twine needs to be removed.**

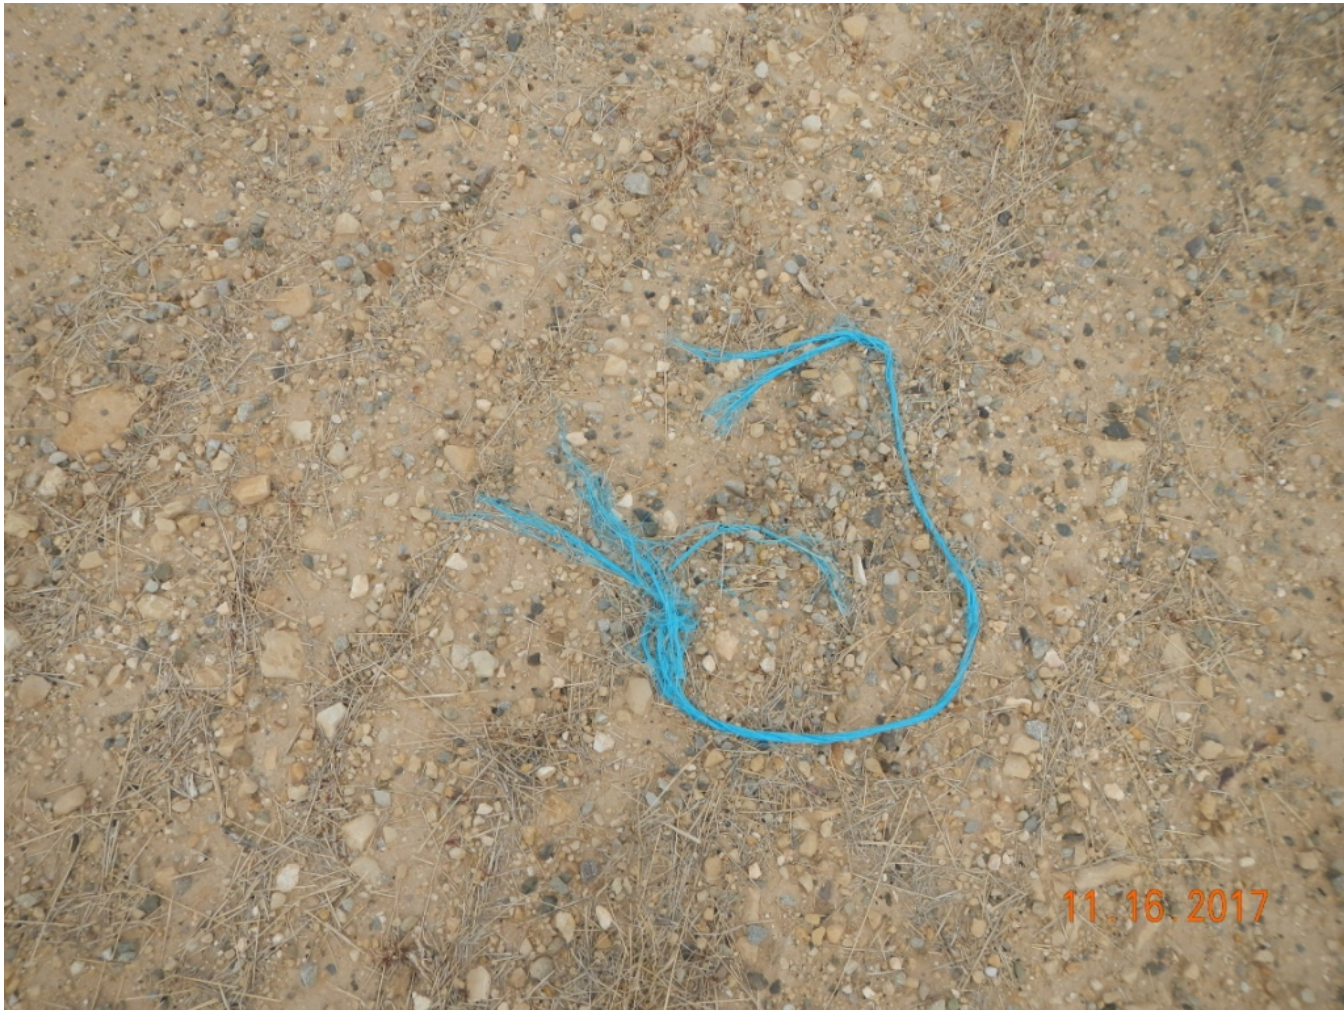
**Photo 8. Closeup view of blue twine section, typical of many scattered around the interim reclamation area.**
