Interim Reclamation and Stormwater Inspection

December 4, 2017

Operator: KERR MCGEE OIL & GAS ONSHORE LP #47120

Location ID: 452217

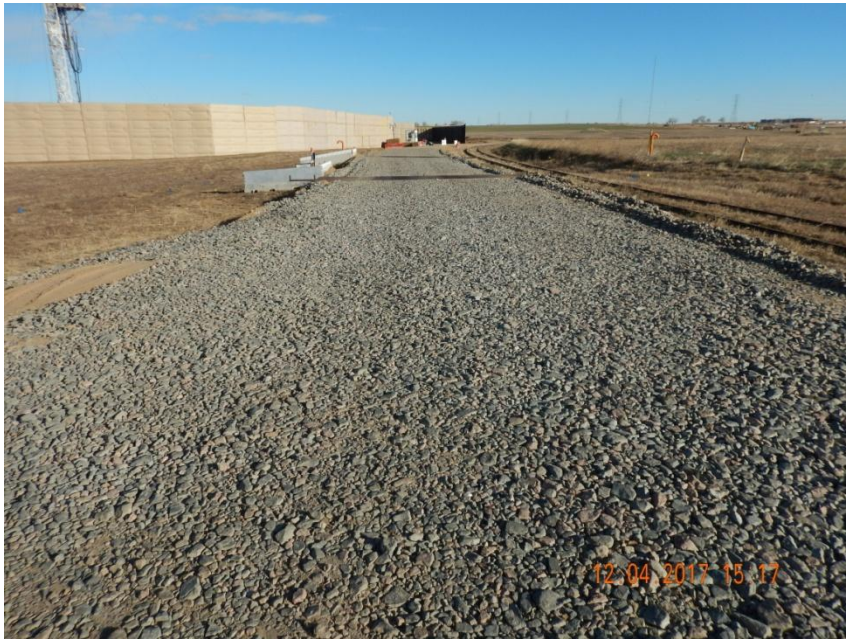
Photo 1. Photo taken from the entrance of the location, facing East. Tracking pad device has been installed.

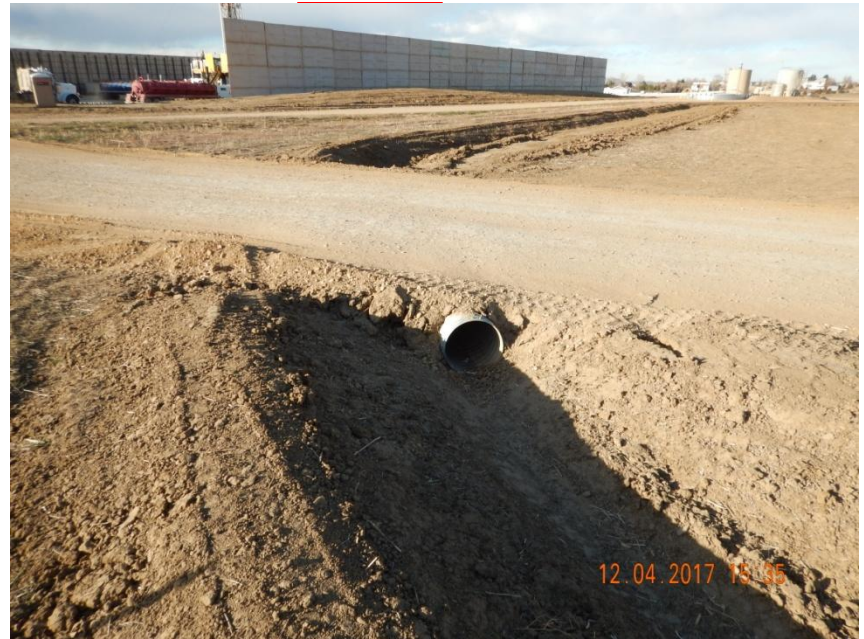
Photo 2. Photo taken from the southwest location of the east pad, facing North. Ditch and berm BMP installed around the perimeter of the location.

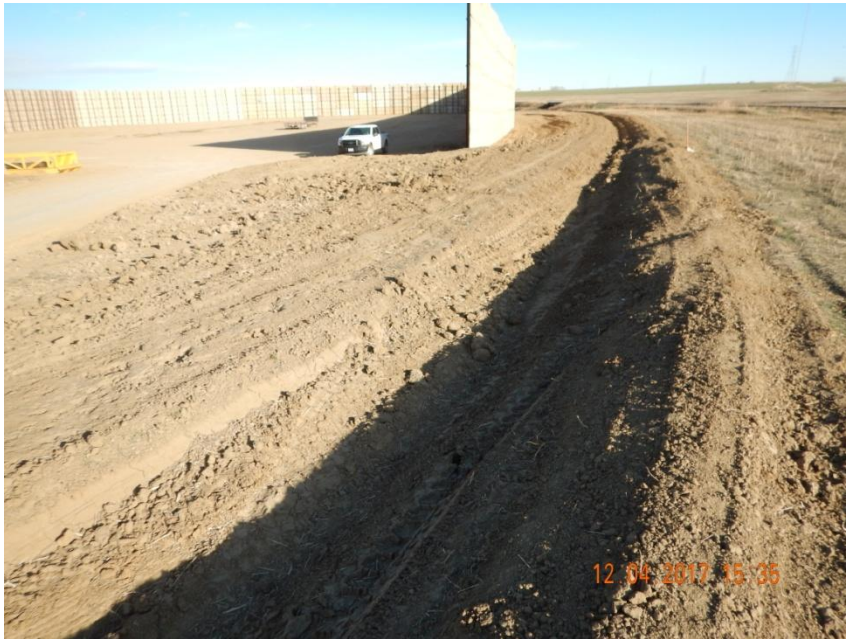
Photo 3. Photo taken from the southwest location of the east pad, facing East. See comments under Photo 2.

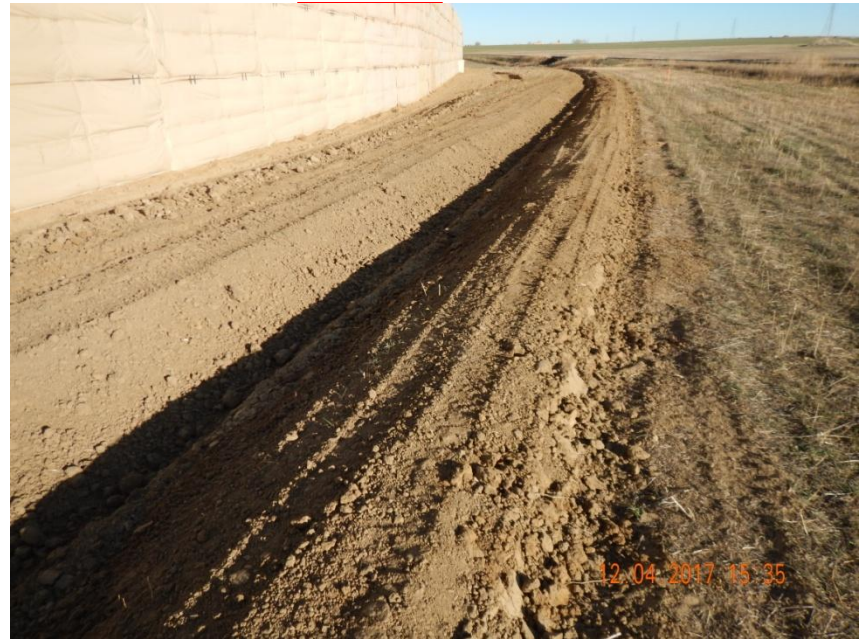
Photo 4. Photo taken from the southern location of the east pad, facing East. See comments under Photo 2.

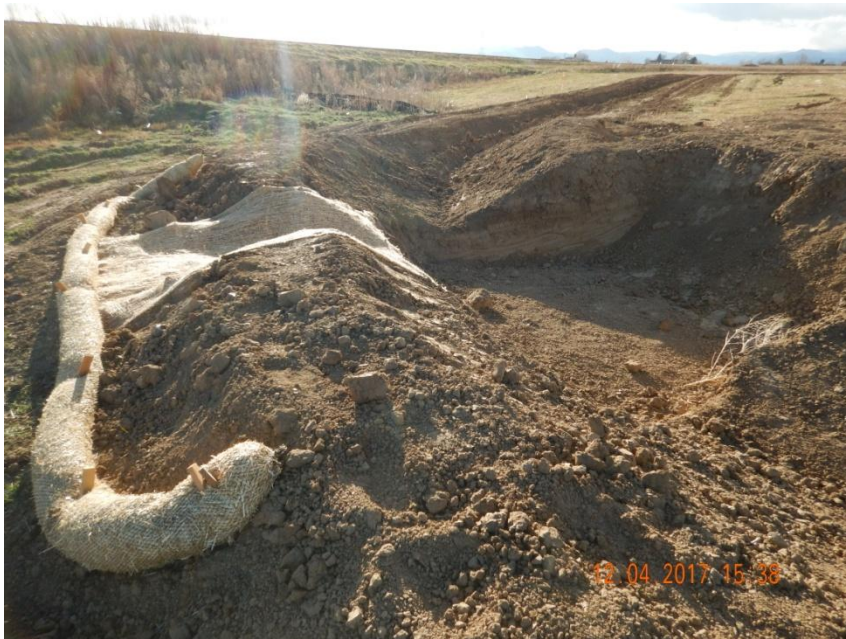
Photo 5. Photo taken from the southeast location of the east pad, facing West. Sediment trap installed with a stabilized outlet device.

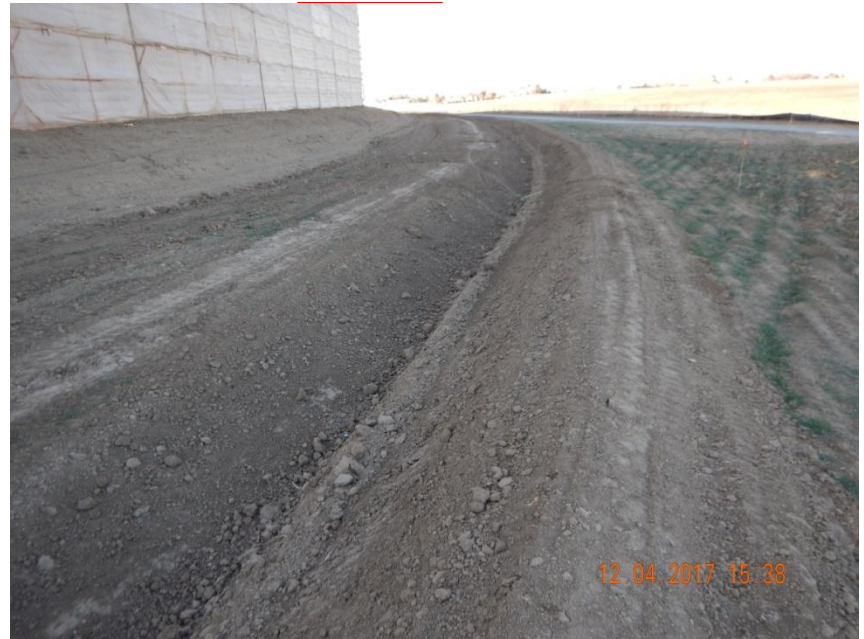
Photo 6. Photo taken from the southeastern location of the east pad, facing North. See comments under Photo 2.

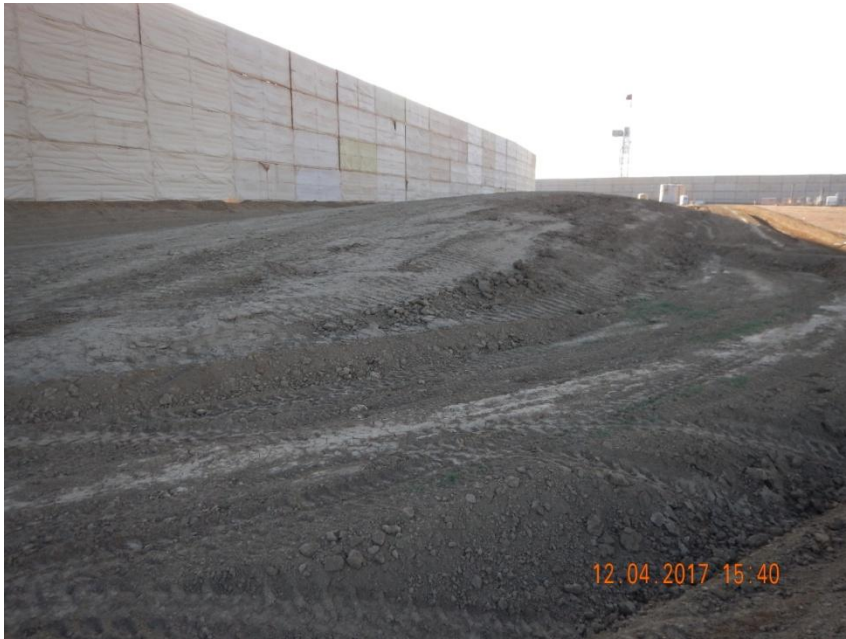
Photo 7. Photo taken from the northeast location of the east pad, facing West. See comments under Photo 2. Appears topsoil has been salvaged and stored along the northern perimeter of the location.

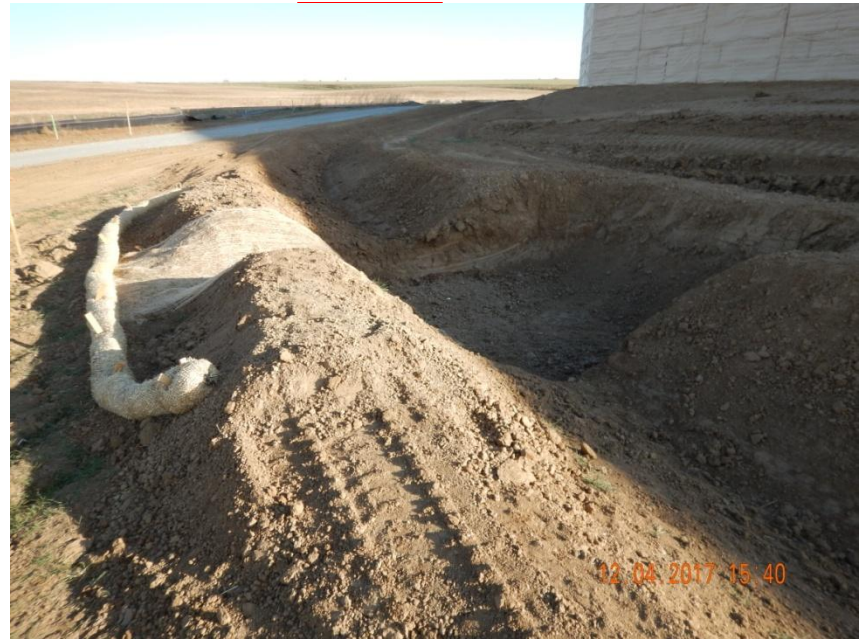
Photo 8. Photo taken from the northeast location of the east pad, facing Southeast. See comments under Photo 5.

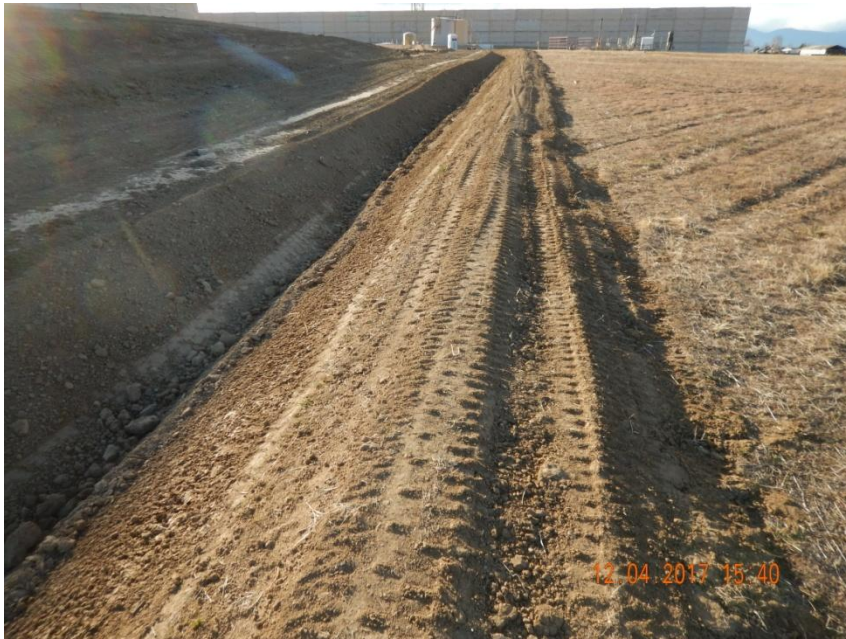
Photo 9. Photo taken from the northern location of the east pad, facing West. See comments under Photo 2.

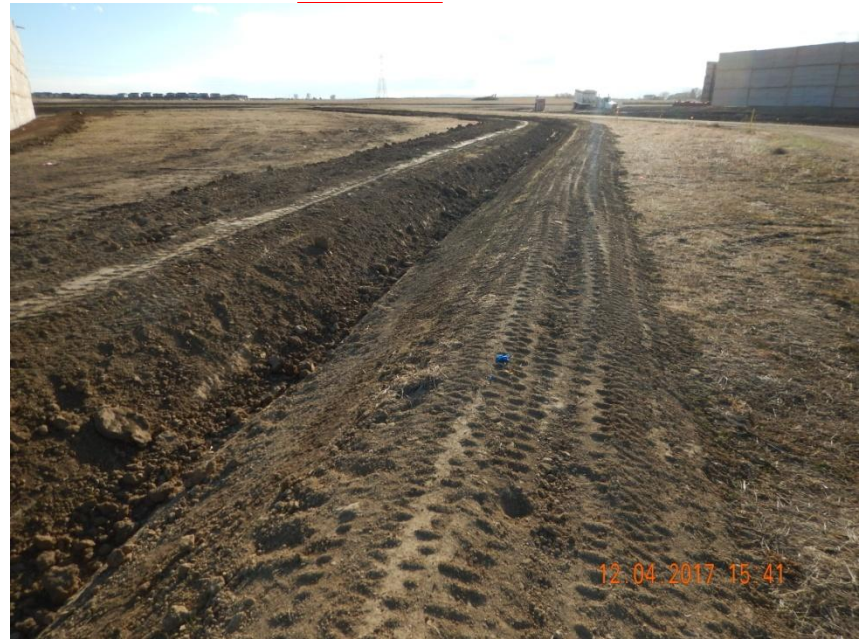
Photo 10. Photo taken from the northwest location of the east pad, facing Southwest. See comments under Photo 2.

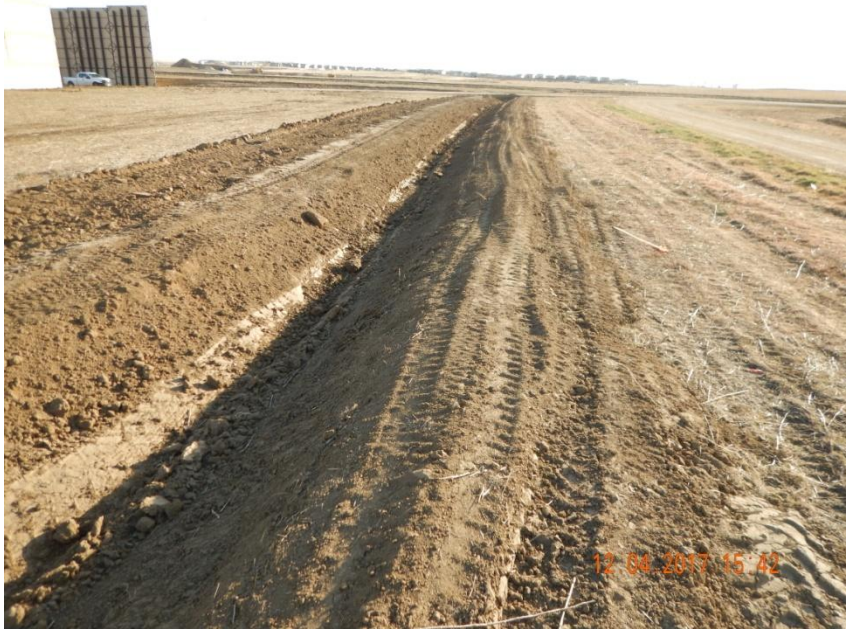
Photo 11. Photo taken from the western location of the east pad, facing South. See comments under Photo 2.

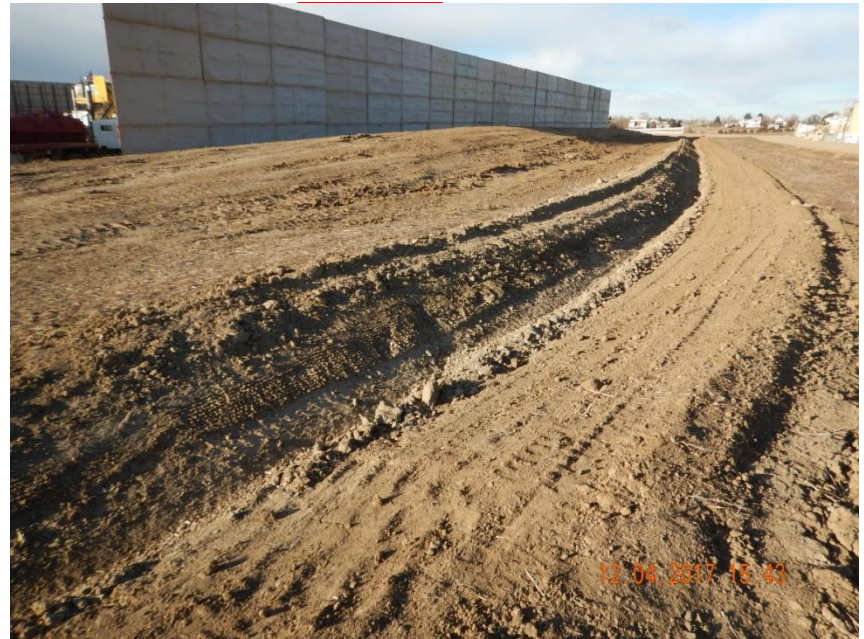
Photo 12. Photo taken from the southeast location of the west pad, facing North. See comments under Photo 2. Appears topsoil has been salvaged and stored along the eastern perimeter of the location.

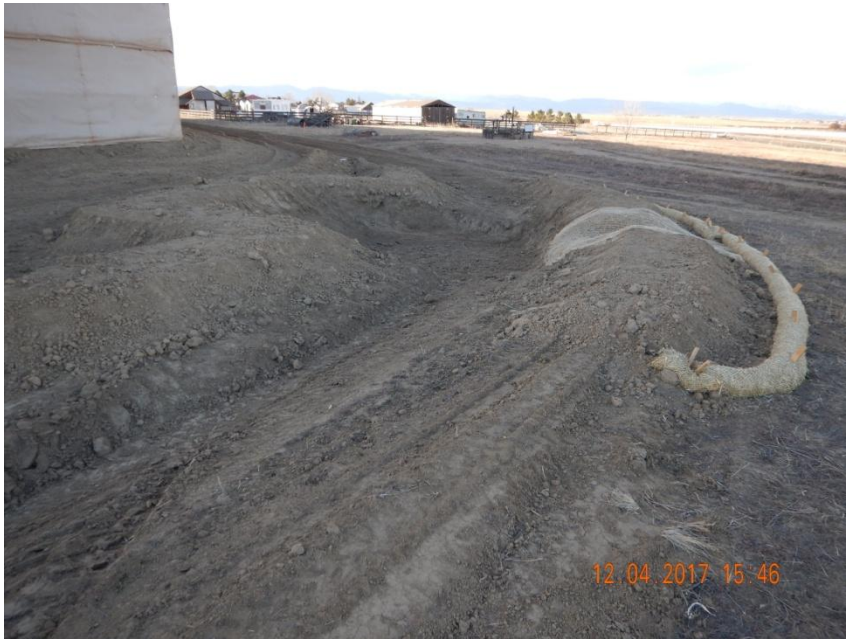
Photo 13. Photo taken from the northeast location of the west pad, facing Northwest. See comments under Photo 5.

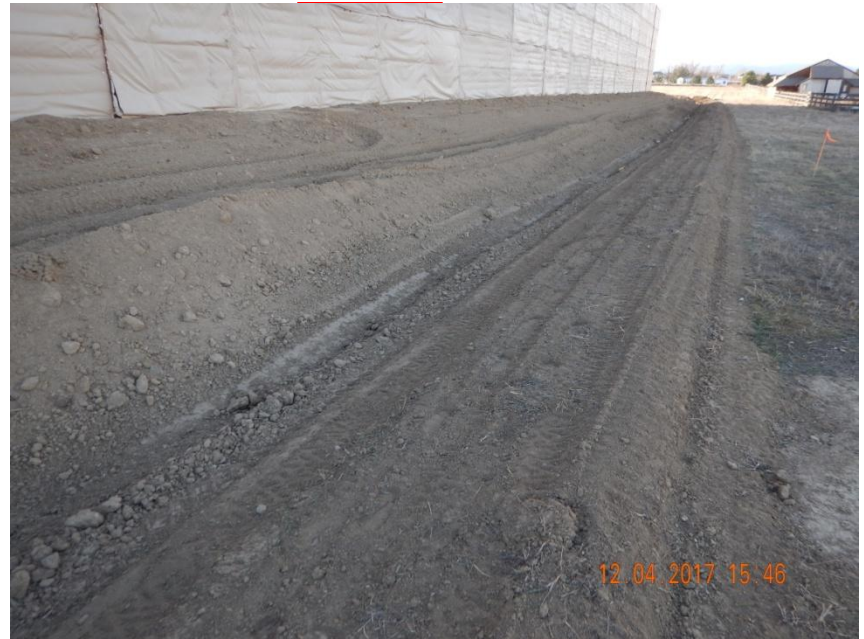
Photo 14. Photo taken from the northern location of the west pad, facing West. See comments under Photo 2.

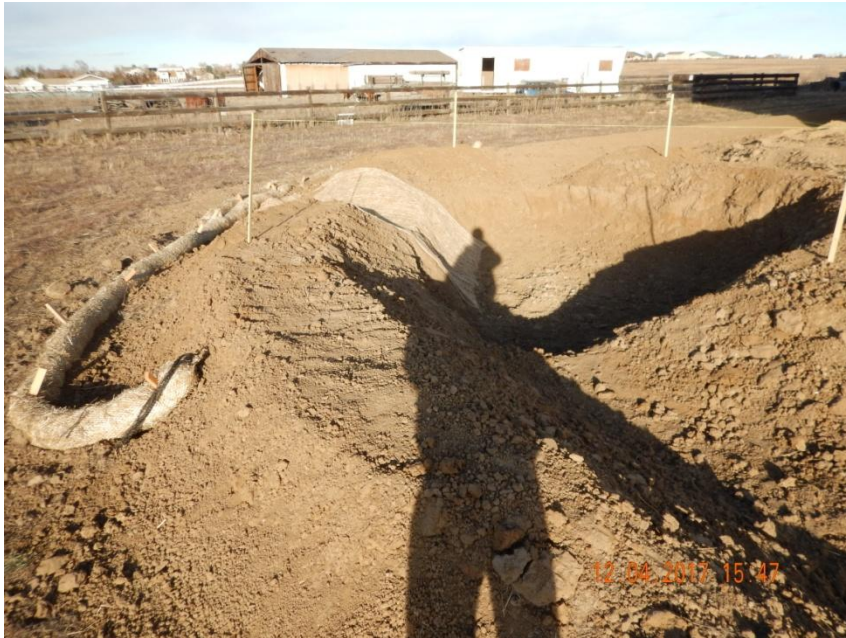
Photo 15. Photo taken from the northwest location of the west pad, facing East. See comments under Photo 5.

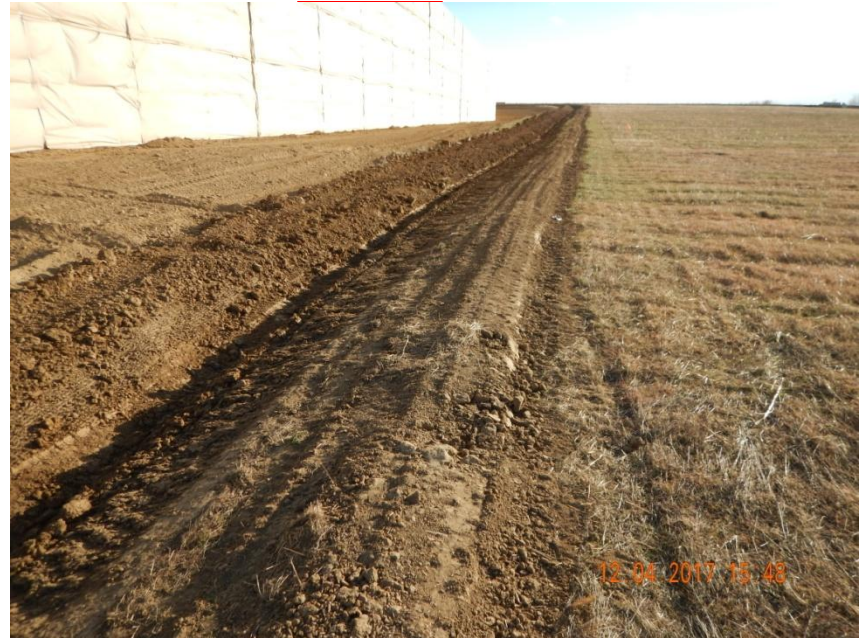
Photo 16. Photo taken from the western location of the west pad, facing South. See comments under Photo 2.

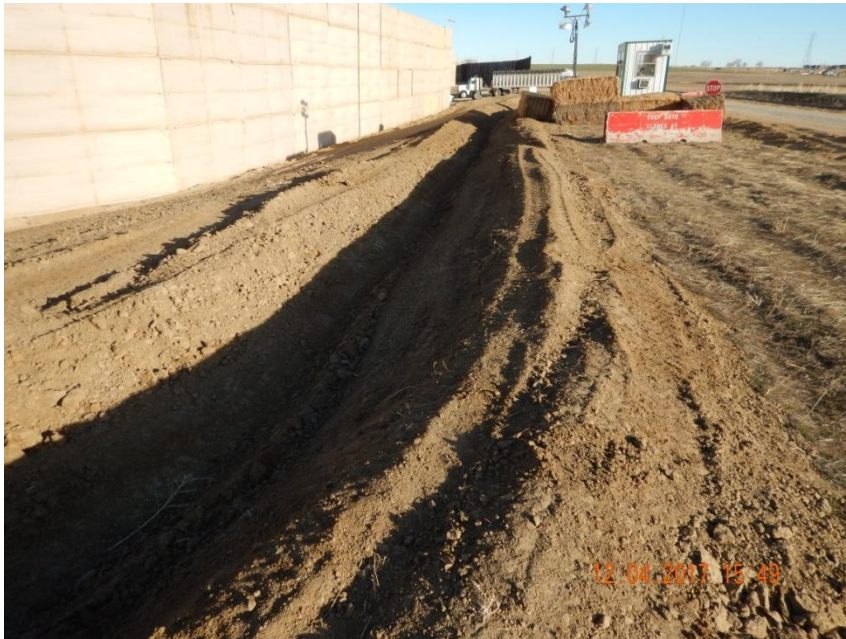
Photo 17. Photo taken from the southwest location of the west pad, facing East. See comments under Photo 2.

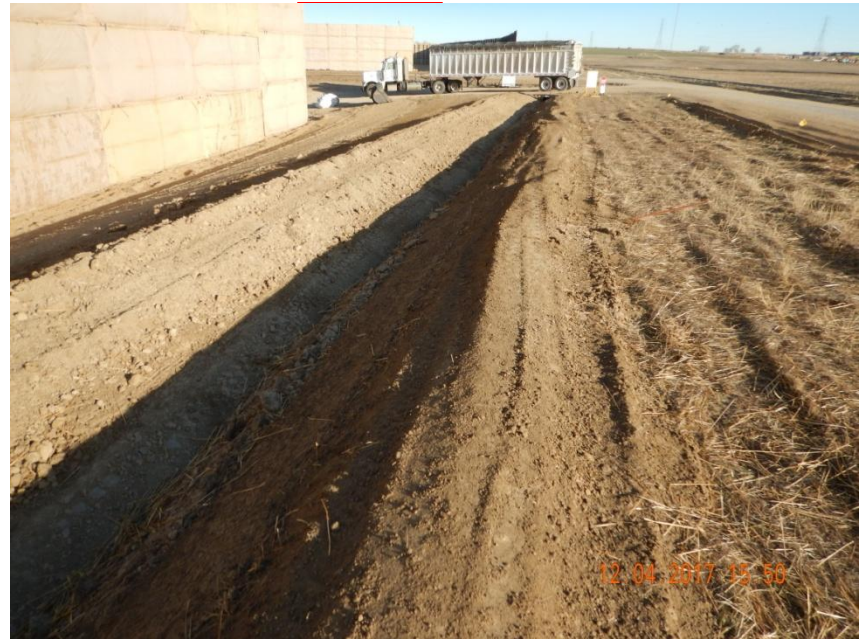
Photo 18. Photo taken from the southern location of the west pad, facing East. See comments under Photo 2.
