Interim Reclamation and Stormwater Inspection

December 4, 2017

Operator: KERR MCGEE OIL & GAS ONSHORE LP #47120

Location ID: 451533

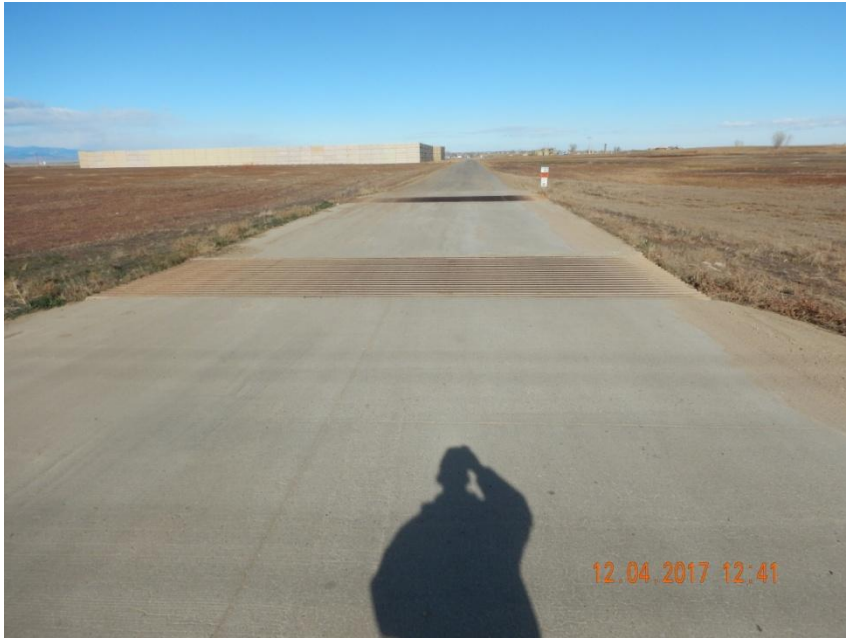
Photo 1. Photo taken from the entrance of the location, facing North. Tracking pad device has been installed.

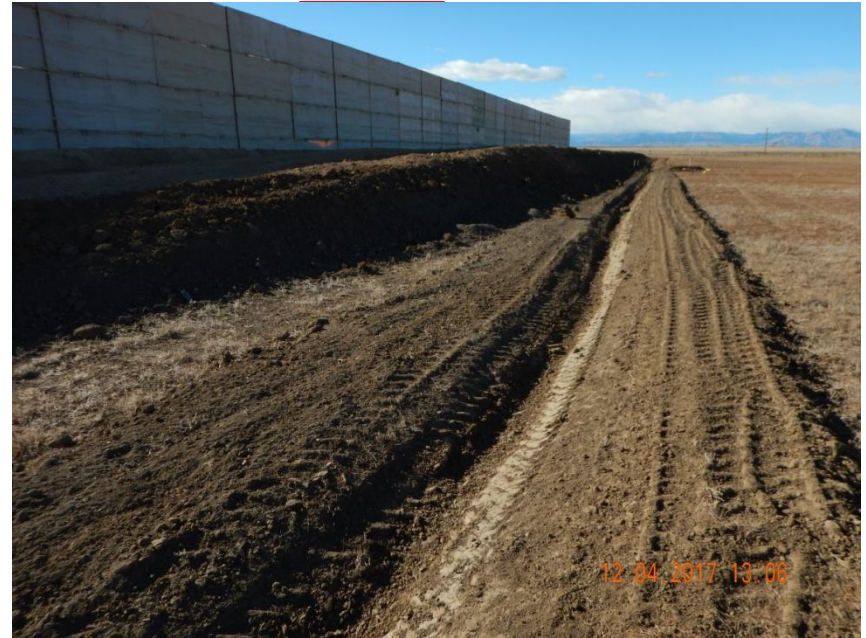
Photo 2. Photo taken from the northeast location, facing West. Ditch and berm BMP installed around the perimeter of the location.

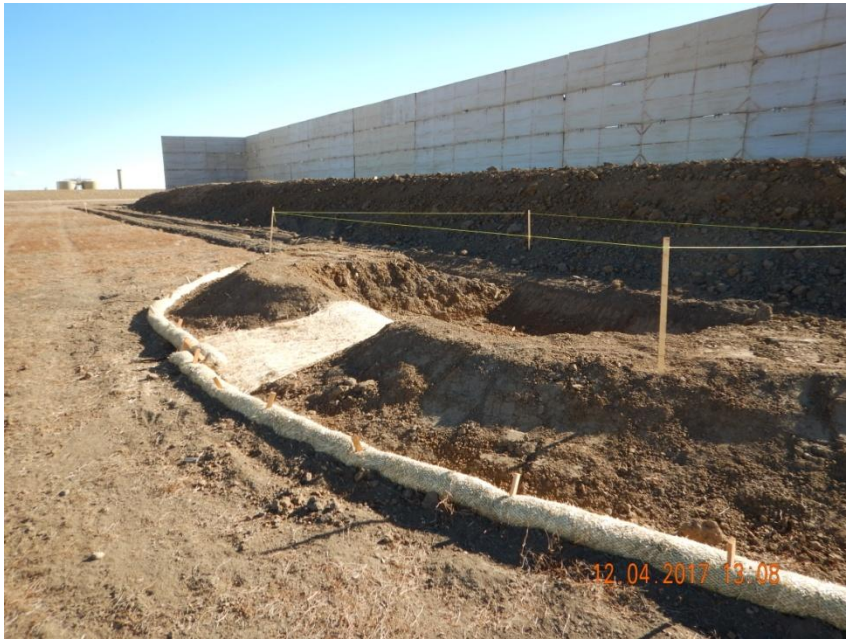
Photo 3. Photo taken from the northwest location, facing East. Sediment trap installed with a stabilized outlet.

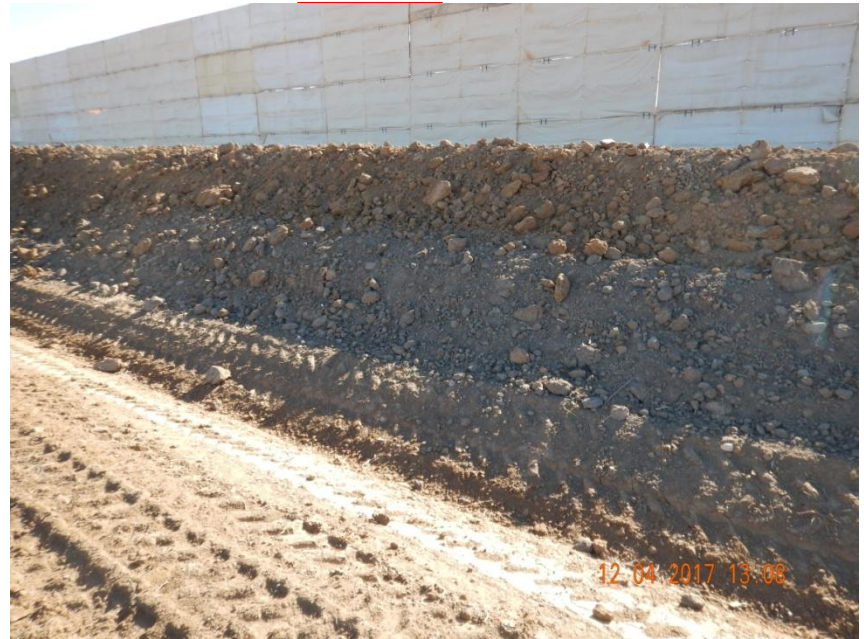
Photo 4. Photo taken from the northern location, facing East. Appears topsoil has been salvaged and stored along the northern perimeter of the location. North-facing side slope does not appear to be stabilized.

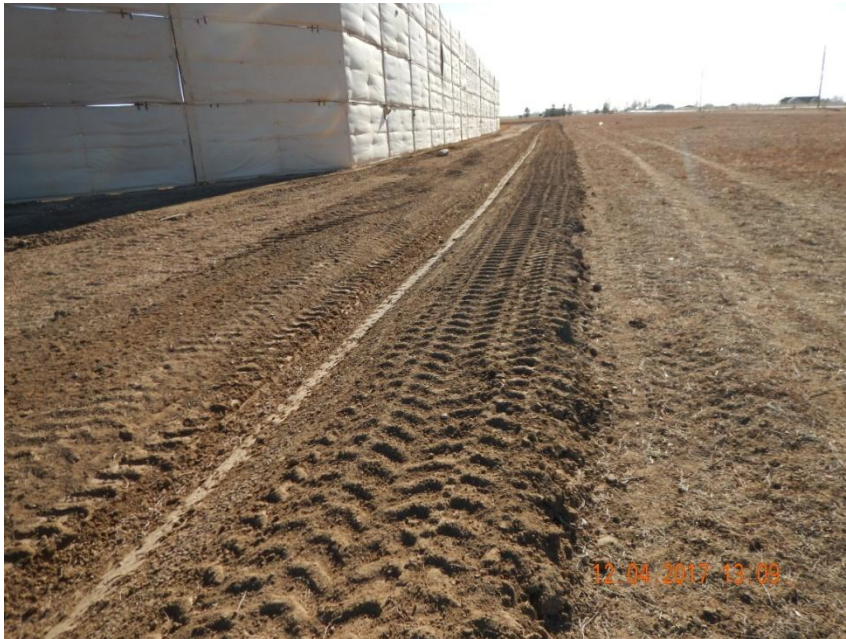
Photo 5. Photo taken from the northwest location, facing South. See comments under Photo 2.

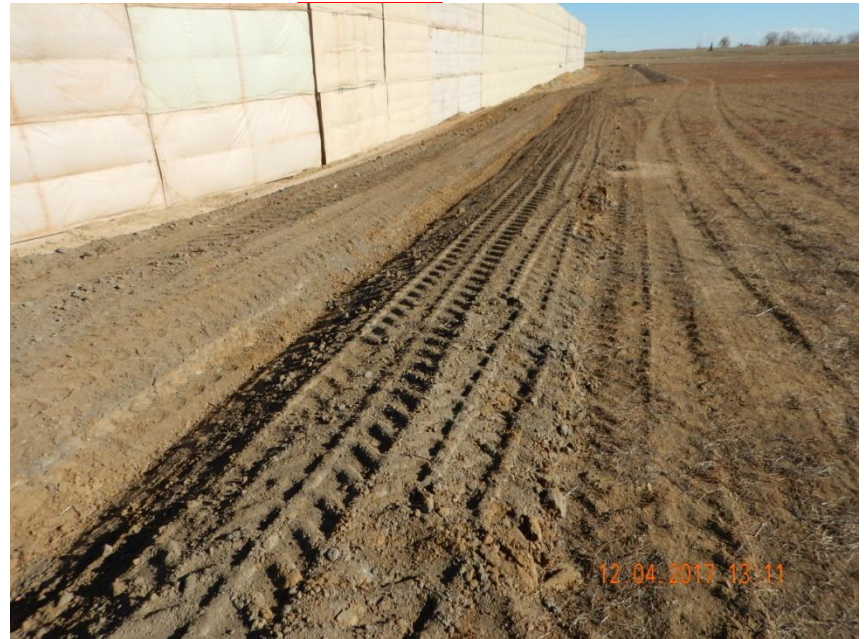
Photo 6. Photo taken from the southwest location, facing East. See comments under Photo 2.

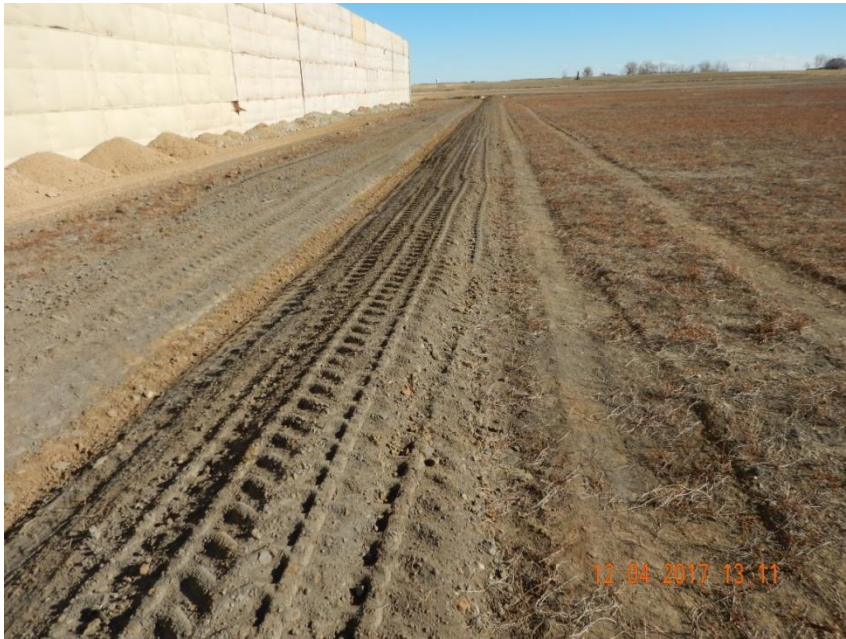
Photo 7. Photo taken from the southern location, facing East. See comments under Photo 2.

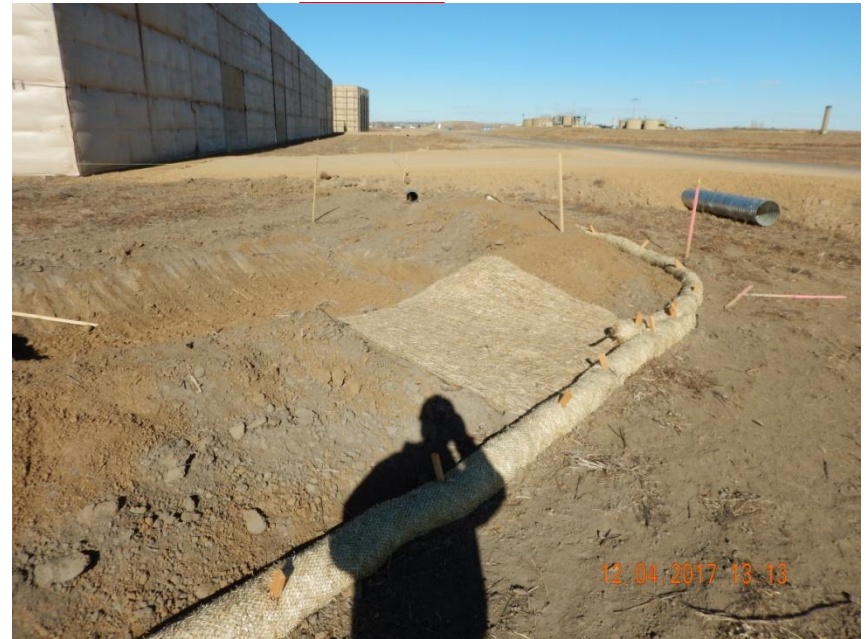
Photo 8. Photo taken from the southeast location, facing North. See comments under Photo 3.

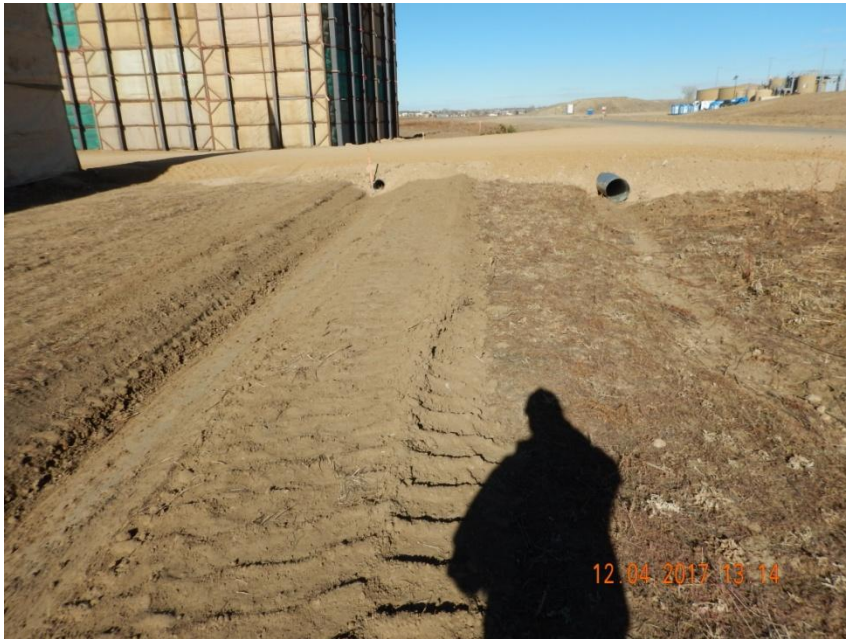
Photo 9. Photo taken from the southern location, facing East. See comments under Photo 2. Culverts installed in conjunction with the ditch BMP and road-side ditch along the access road.
