Inspection Photos

Location Name: Divide Rd WTF Pipeline Release

Spill/Release Point ID #453066

REM #10691

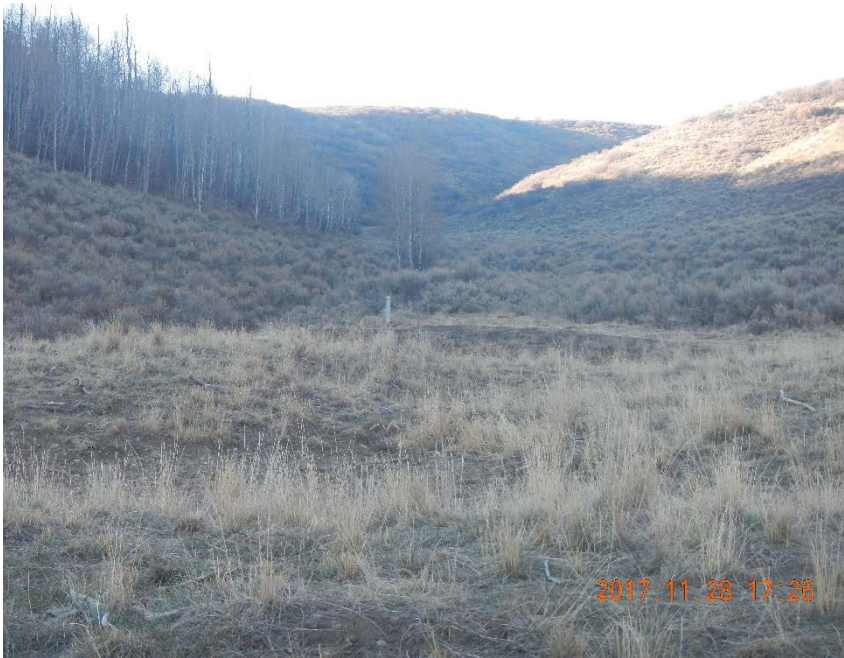
11/28/2017. First monitoring well installed at the bottom of the valley, north side of the Divide Rd Point of Release (Divide Rd at the top of the ridge).

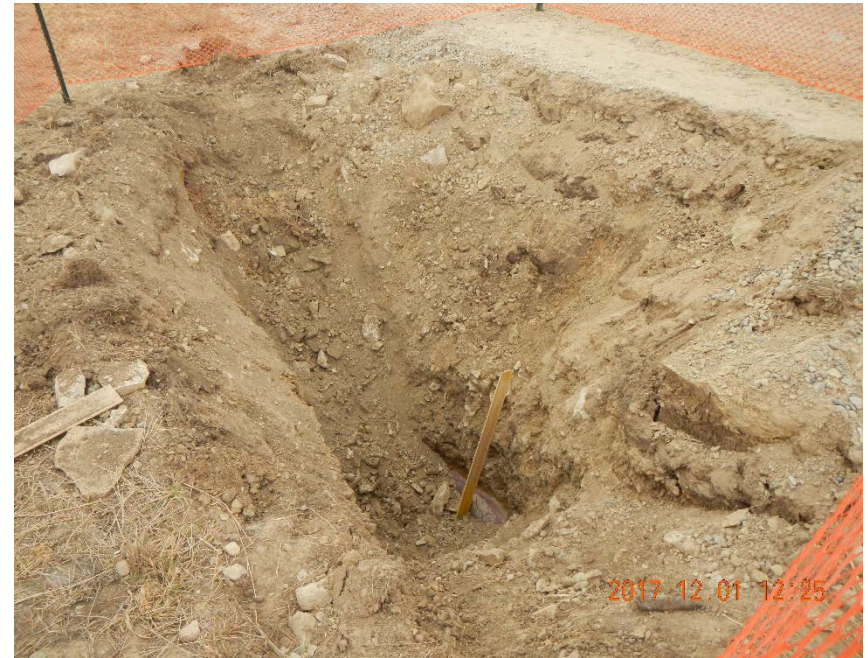
12/01/2017. Pot holing to uncover 10" condensate pipeline in the pipeline corridor that runs on the north side of the Divide Rd.

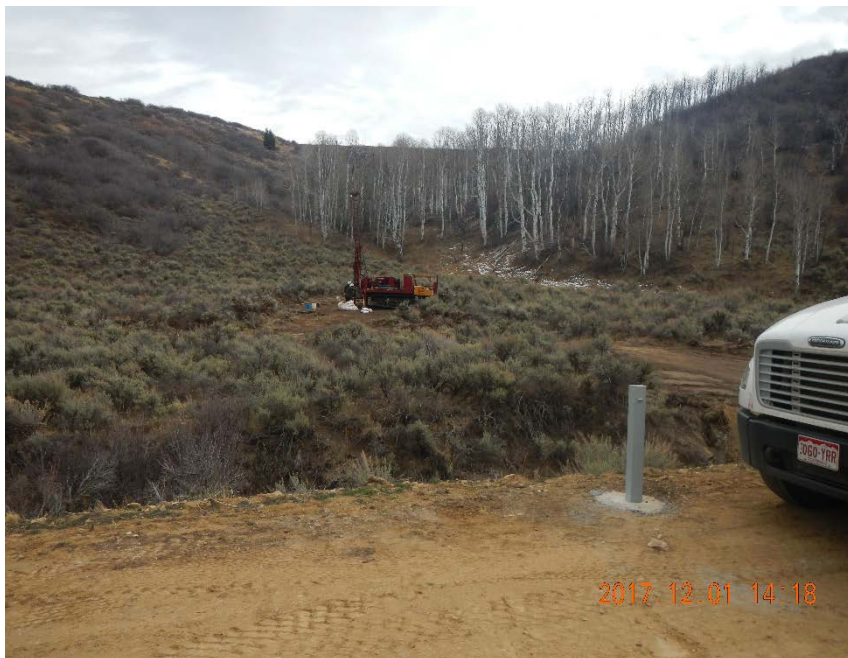
Looking southeast, from the road to A27 CDP. Divide Rd at the top of the ridge. Installing monitoring wells downhill of the Point of Release (POR)

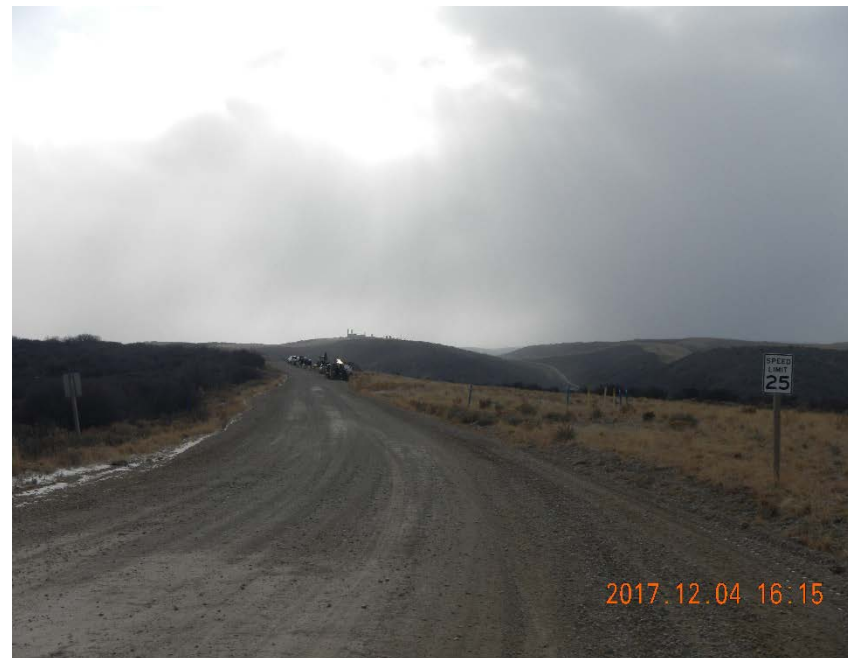
Looking west. Divide road follows the ridge. To the right (north) pipeline corridor follows the road.

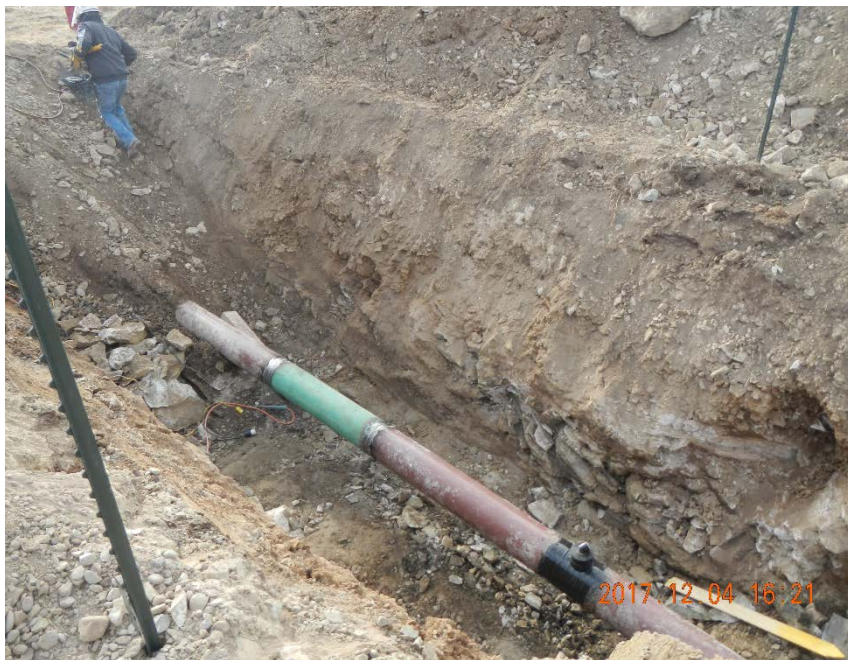
Exposed Pipeline. Green section corresponds to the piece of pipeline replaced. Some moisture at the bottom and on the walls. May be condensate or water. Distinctive hydrocarbon odor.

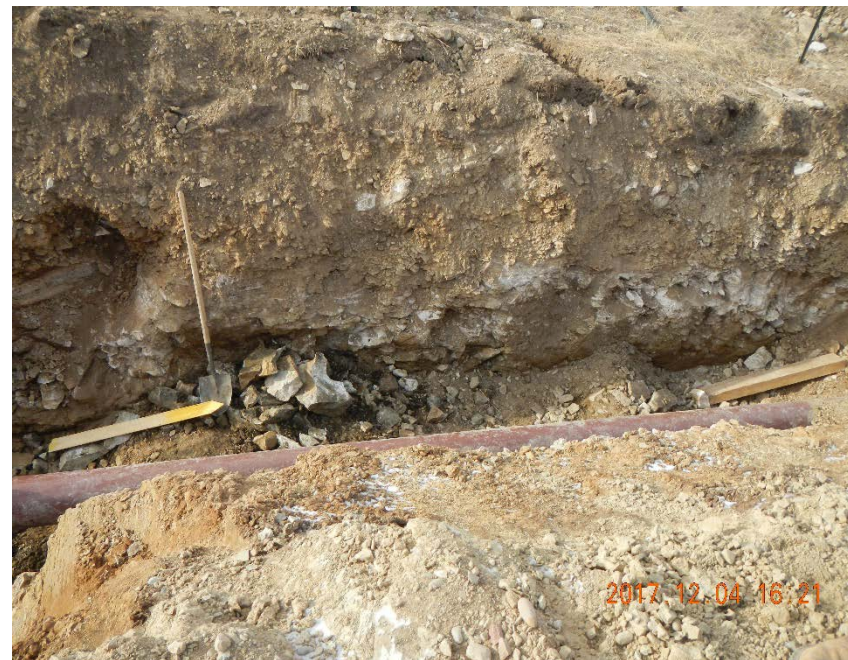
Lower part of the excavation: Fractured sandstone; overlain by weathered, crumbling rock. Sediment/soil at the top.

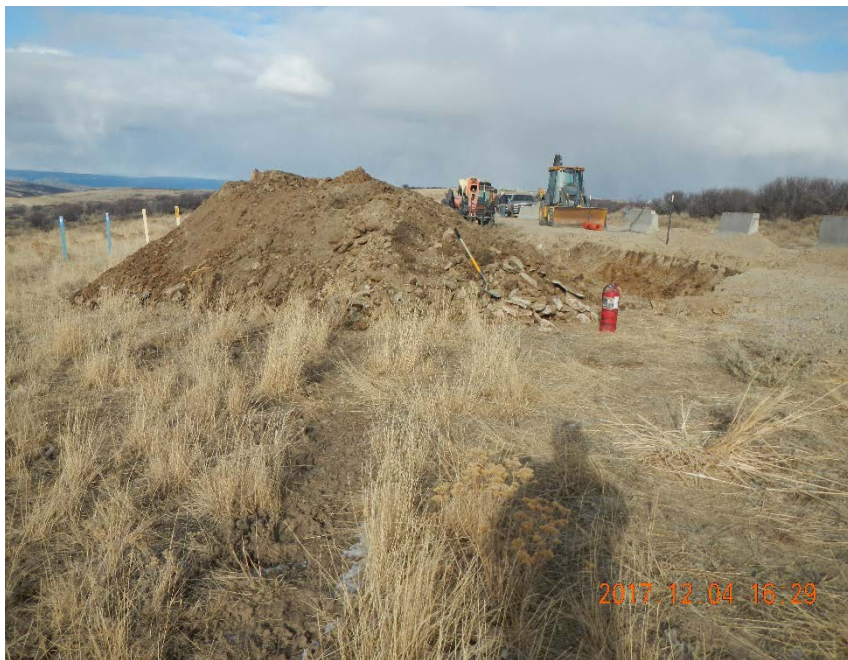
Looking east. Pipeline corridor and excavation at POR.

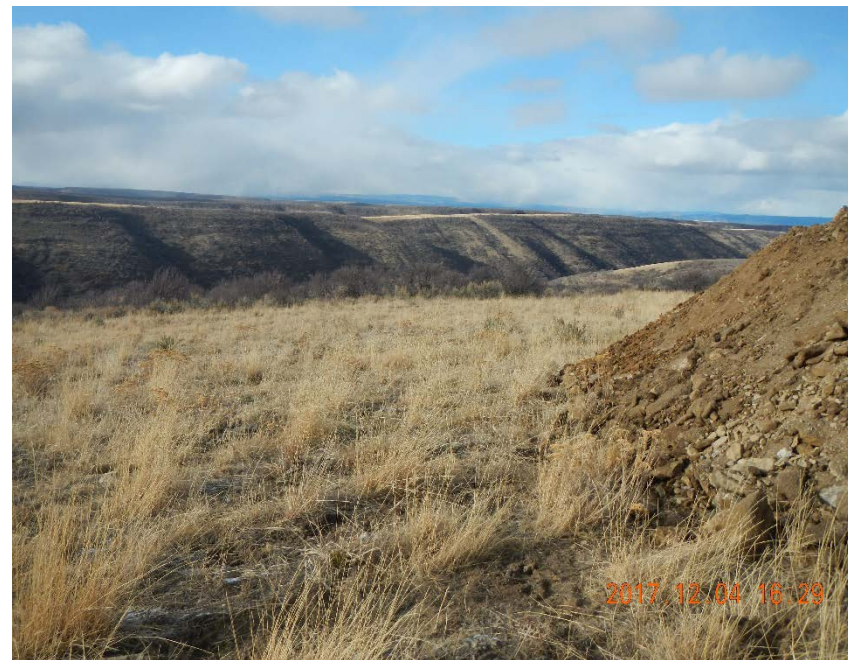
Looking northeast. A27 road at the bottom of the valley.

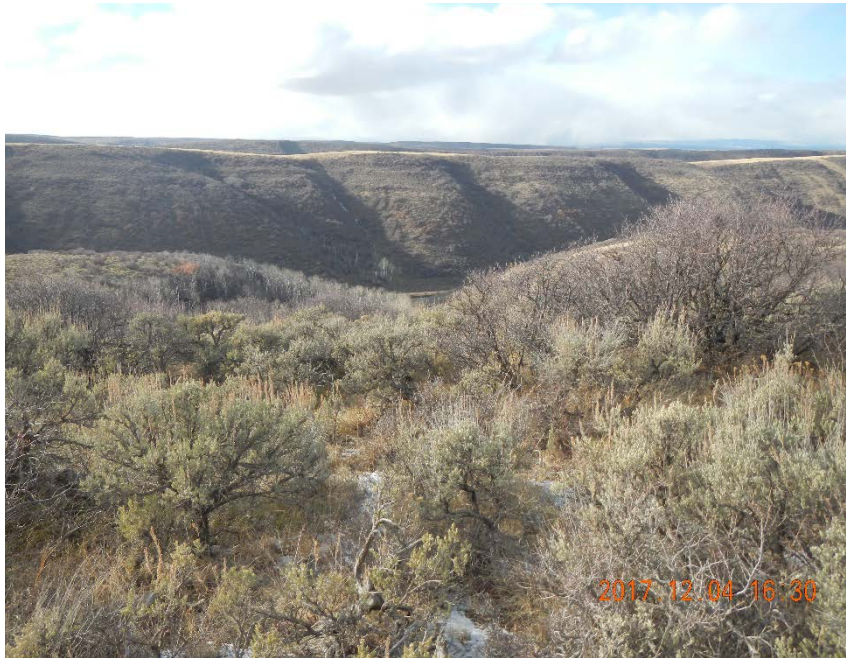
Walking northwest from the POR there is a depression, a cut. First monitoring wells were installed down at the bottom.

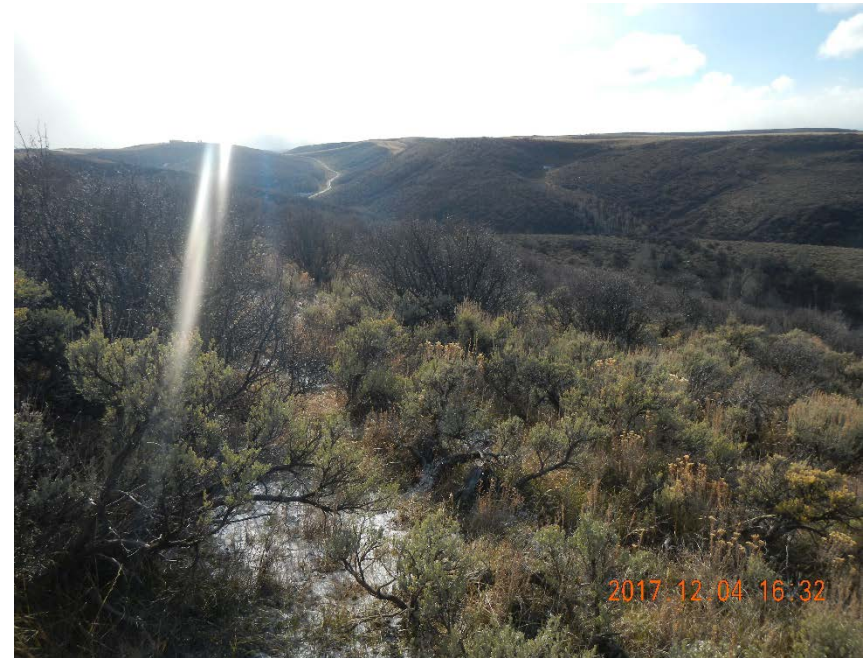
Looking west. Road to A27 CDP at the distance.

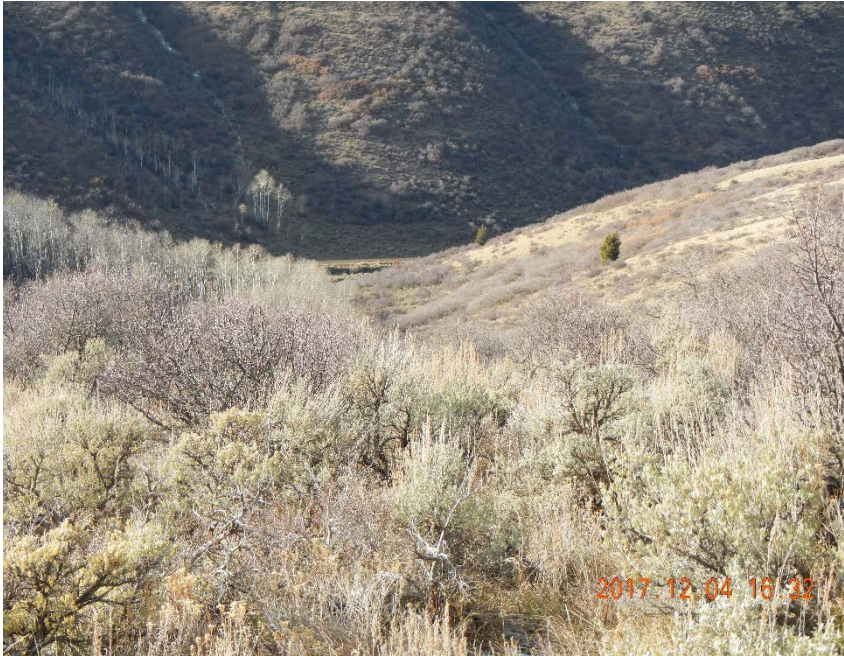
A27 road seen from above (from the ridge).

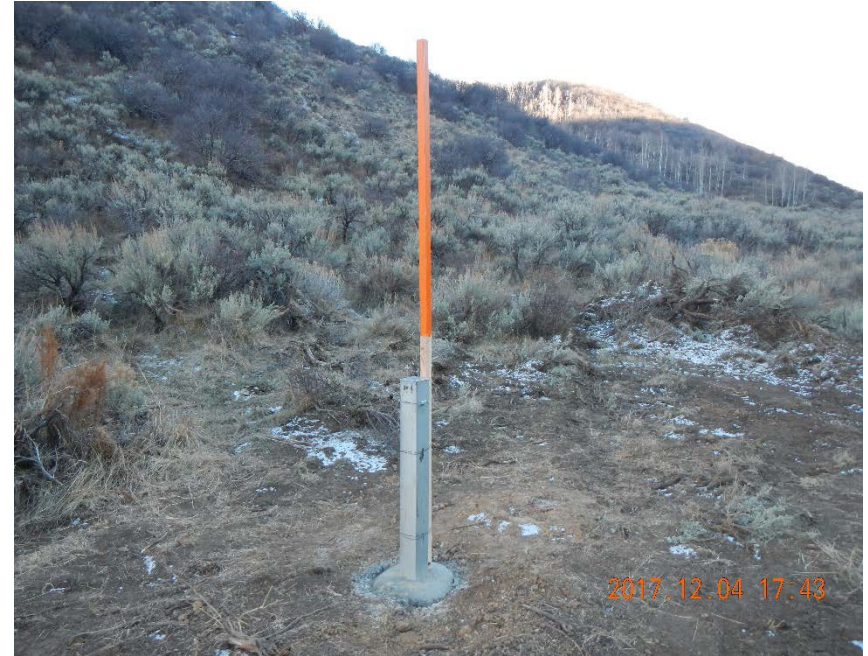
One of the monitoring wells installed by Caerus. Orange sticks differentiate Caerus wells from Encana wells (have yellow sticks).

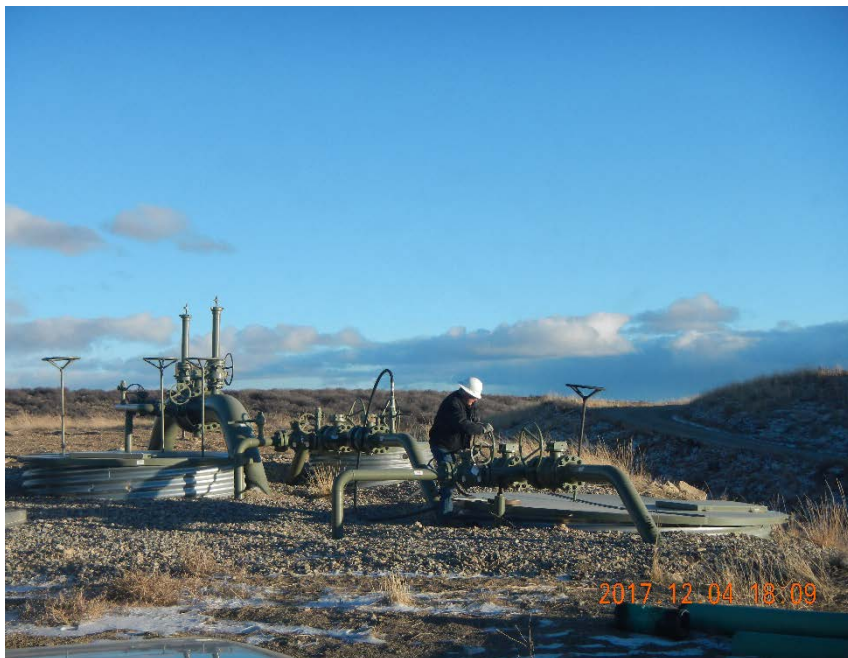
12/04/2017. Pressure test conducted on 10" condensate pipeline.
