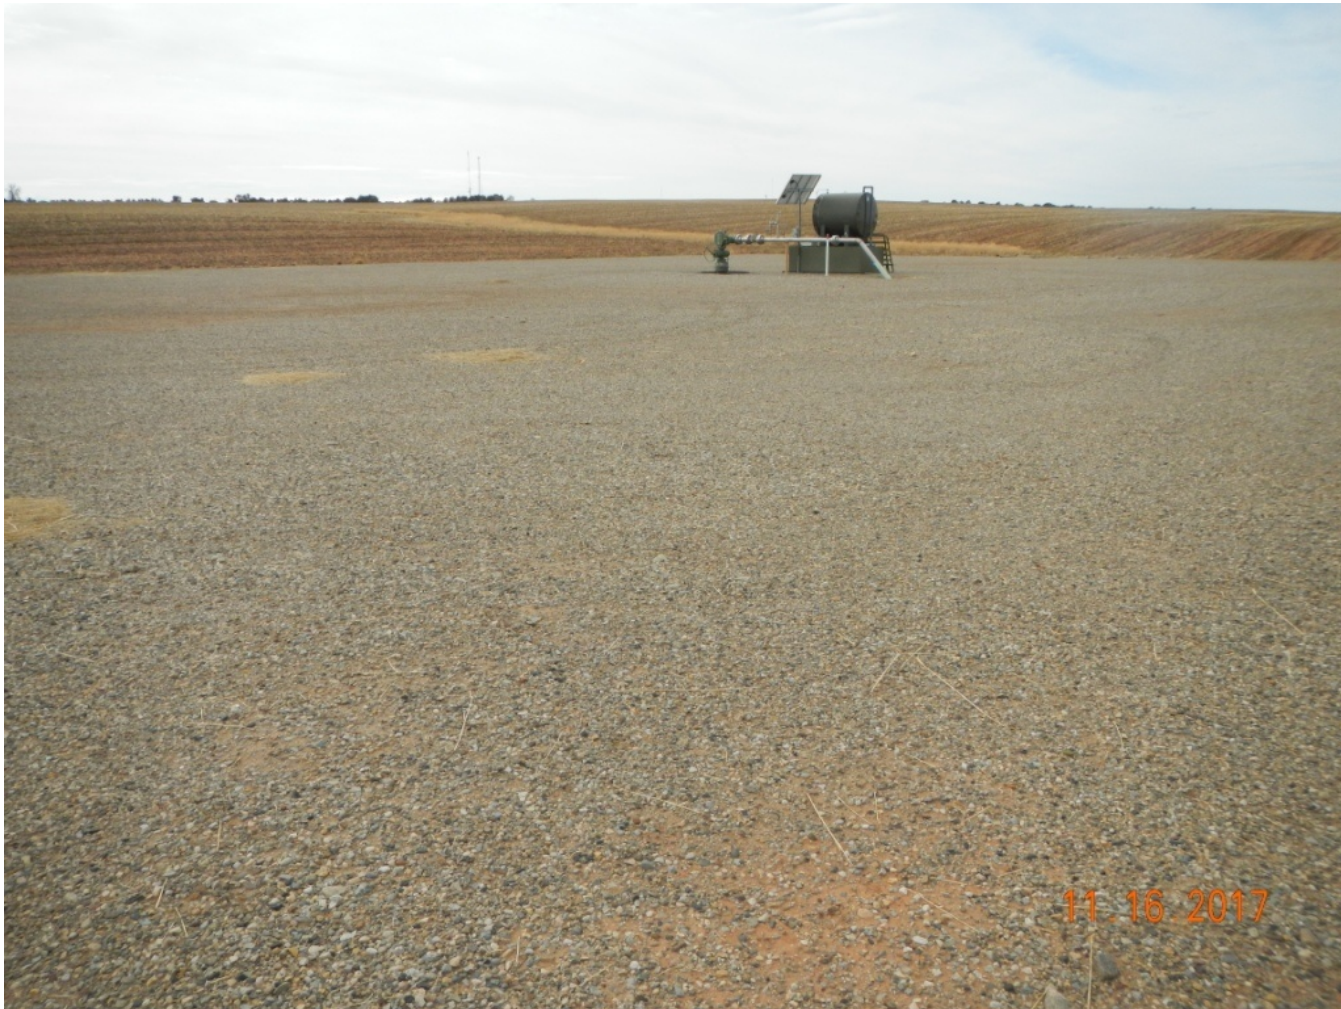
**Photo 1. View of the project area from the northeastern corner facing center.**

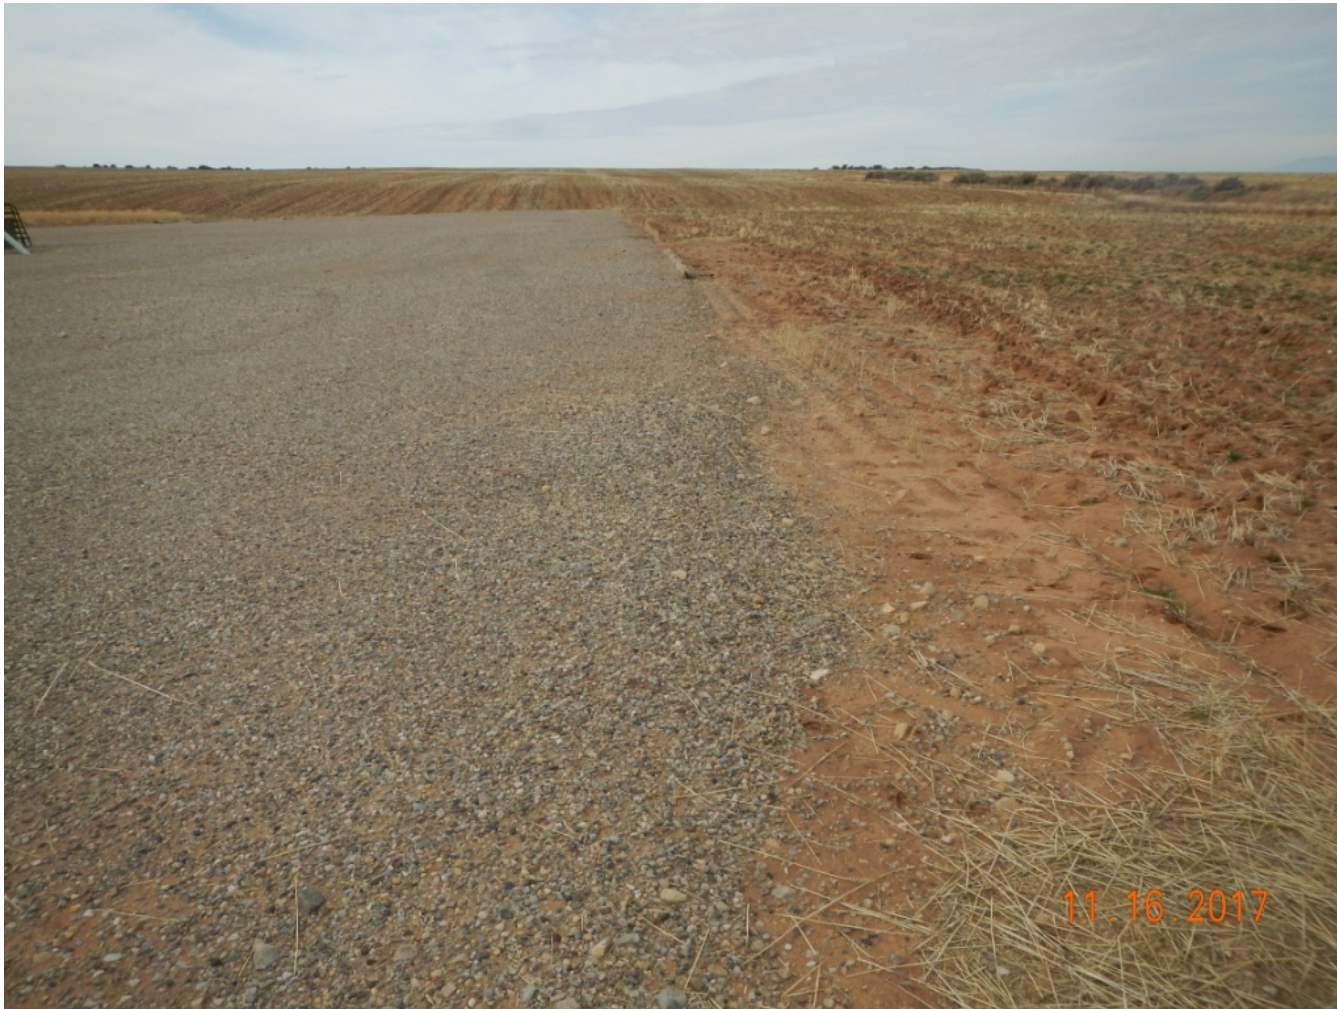
**Photo 2. View of the northern portion of the project area from the northeastern corner facing westward. Well pad size is reduced and interim reclamation areas are incorporated into surrounded cropland. Vegetation in disturbance areas should be monitored in comparison to reference vegetation.**

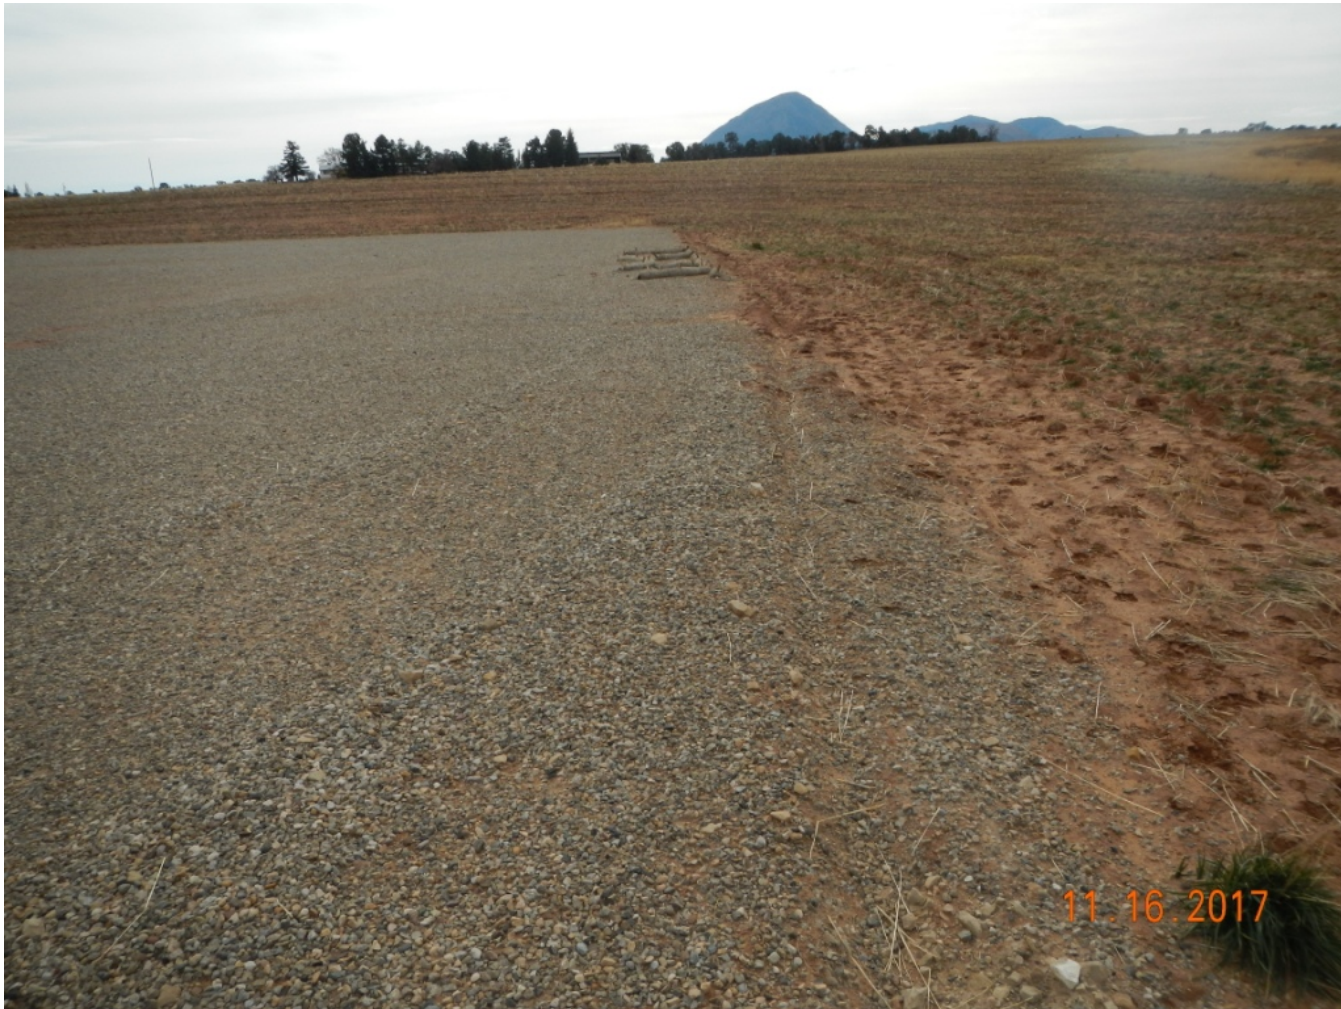
**Photo 3. View of the western portion of the project area from the northwestern corner facing southward.**

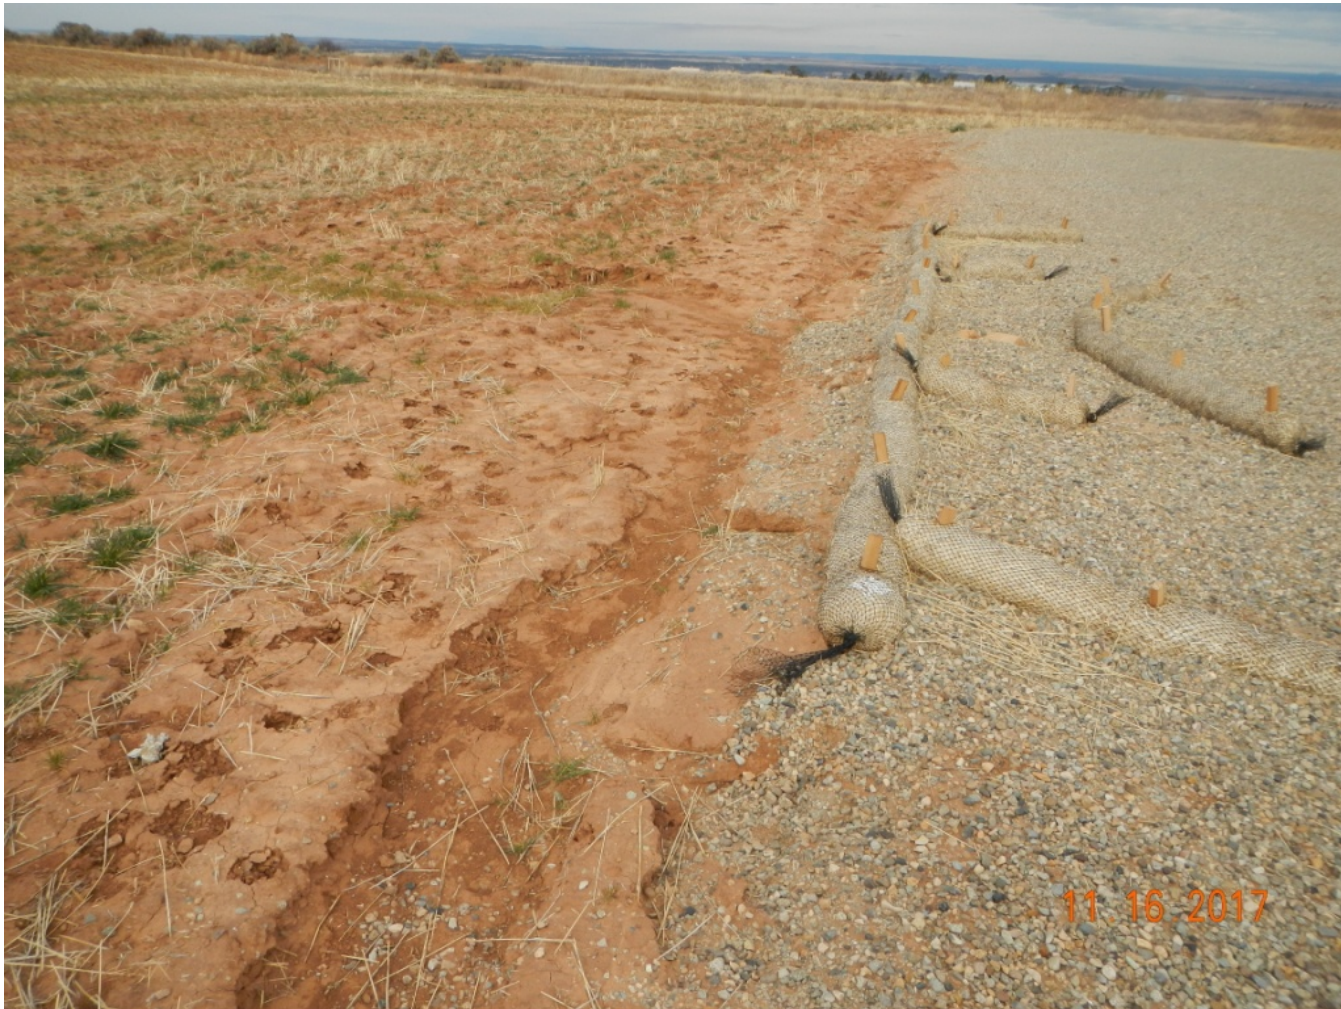
**Photo 4. View of wattles in the western portion of the project area. These appear to need maintenance, and do not appear to be sufficient length to prevent concentrated runoff from the well pad eroding adjacent crop soils.**

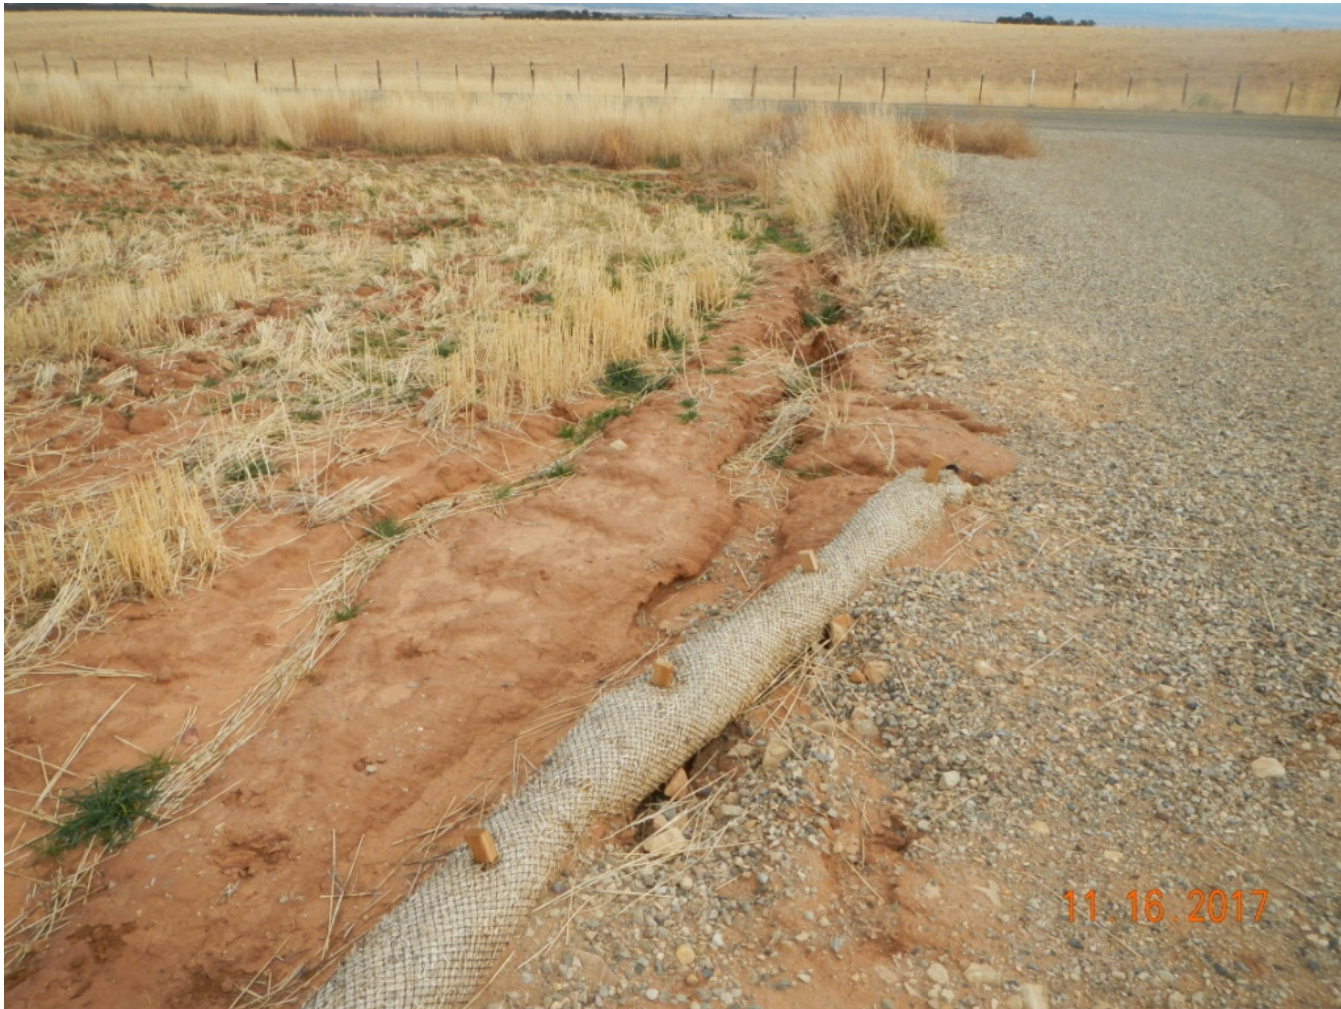
**Photo 5. View of wattle at the entrance to the well pad, needs maintenance.**

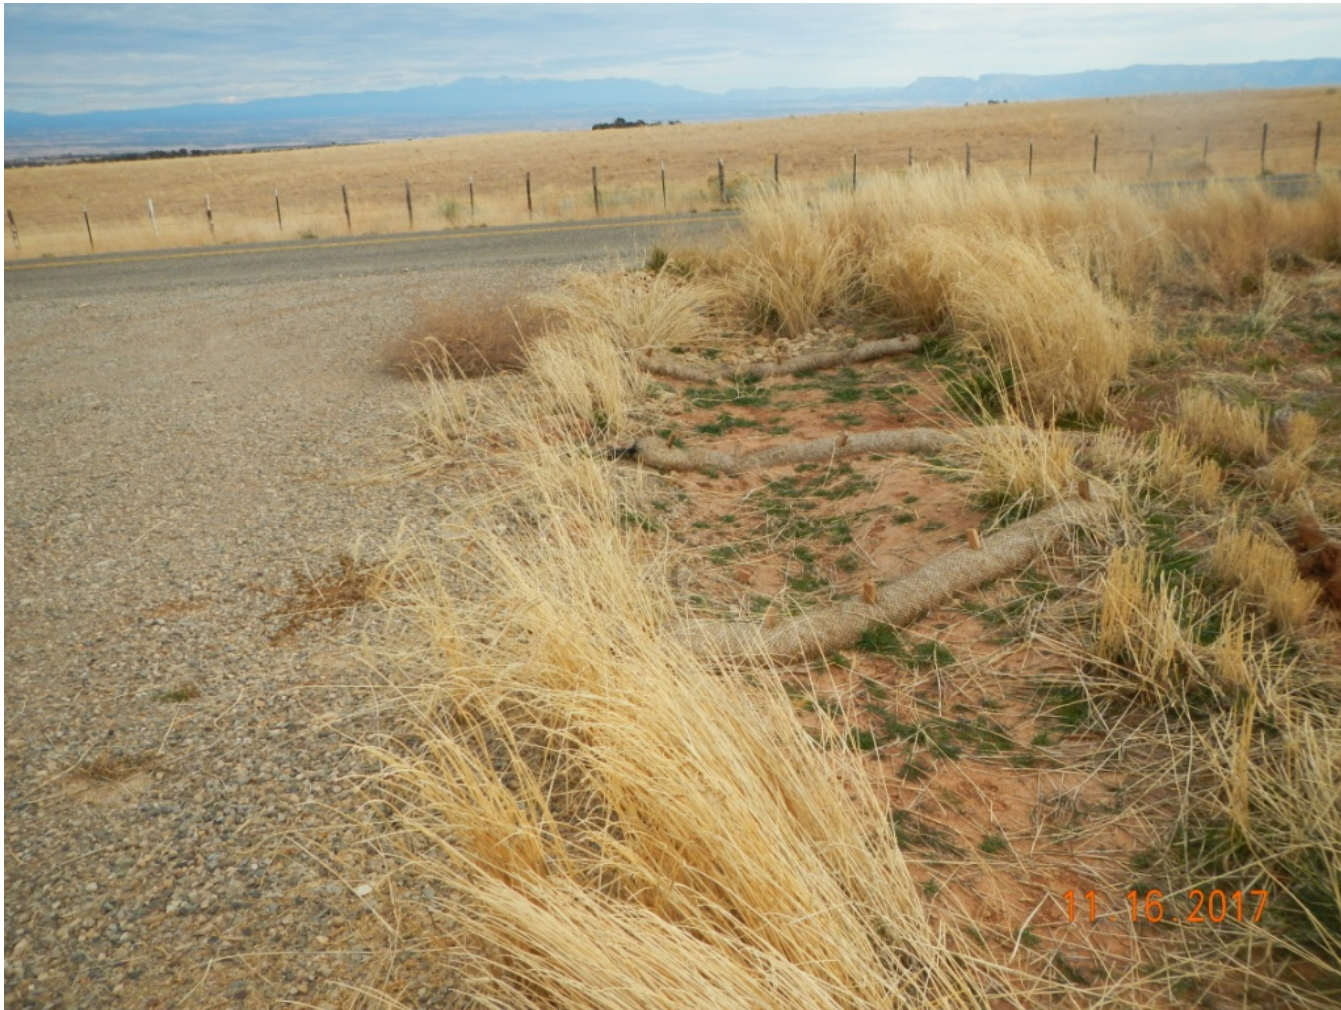
**Photo 6. View of wattles along the southern portion of the access road, appear to be functioning.**
